Re: Asbestos Reassessment

Eastside Secondary School, 275 Farley Avenue, Belleville, ON
Pinchin File: 200584.099

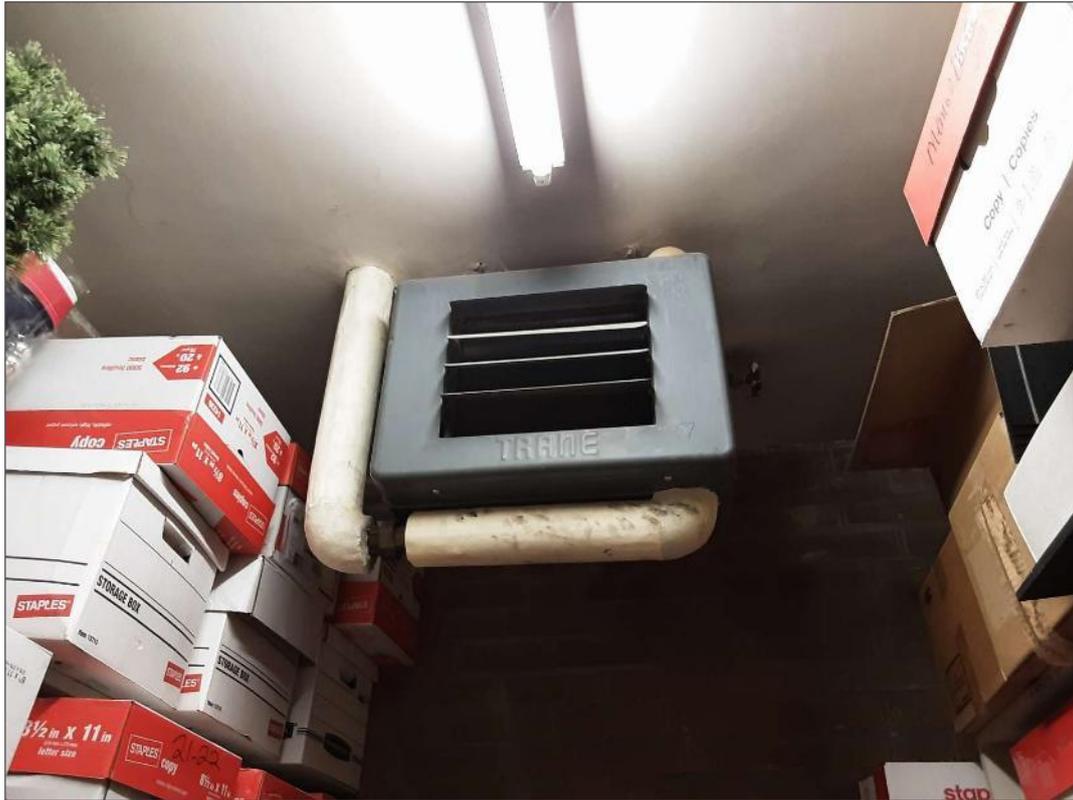
V0001 (Confirmed Asbestos), Piping, Aircell, Office (Location #: 124)

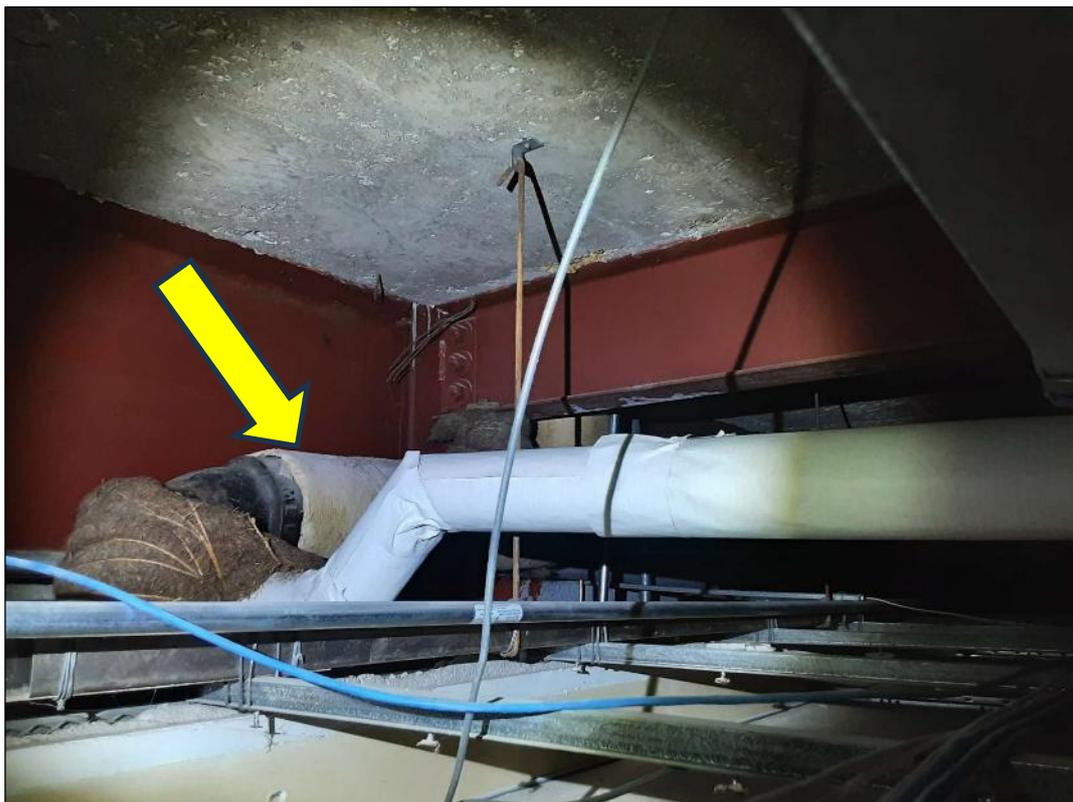
V0002 (Confirmed Asbestos), Piping, Rain Water Leader, Sweatwrap, Corridor (Location #: 190)

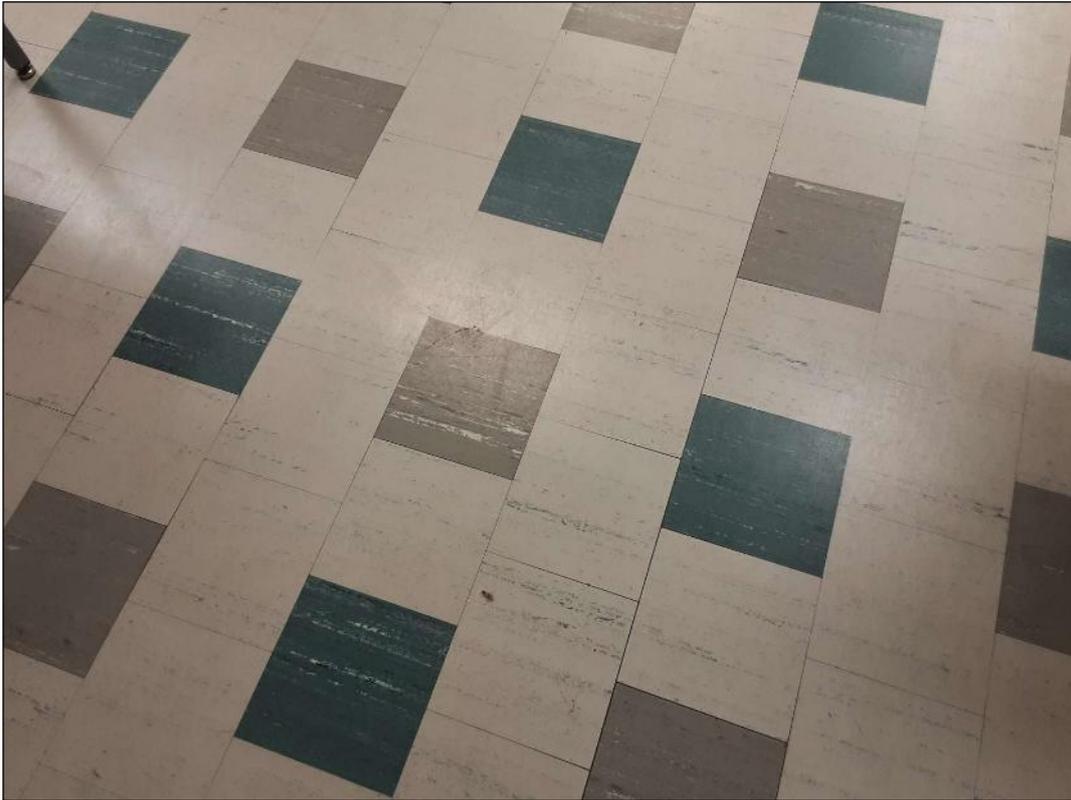
V0003 (Confirmed Asbestos), 9x9 various colours, Floor, All, Vinyl Floor Tile and Mastic, Classroom (Location #: 103)

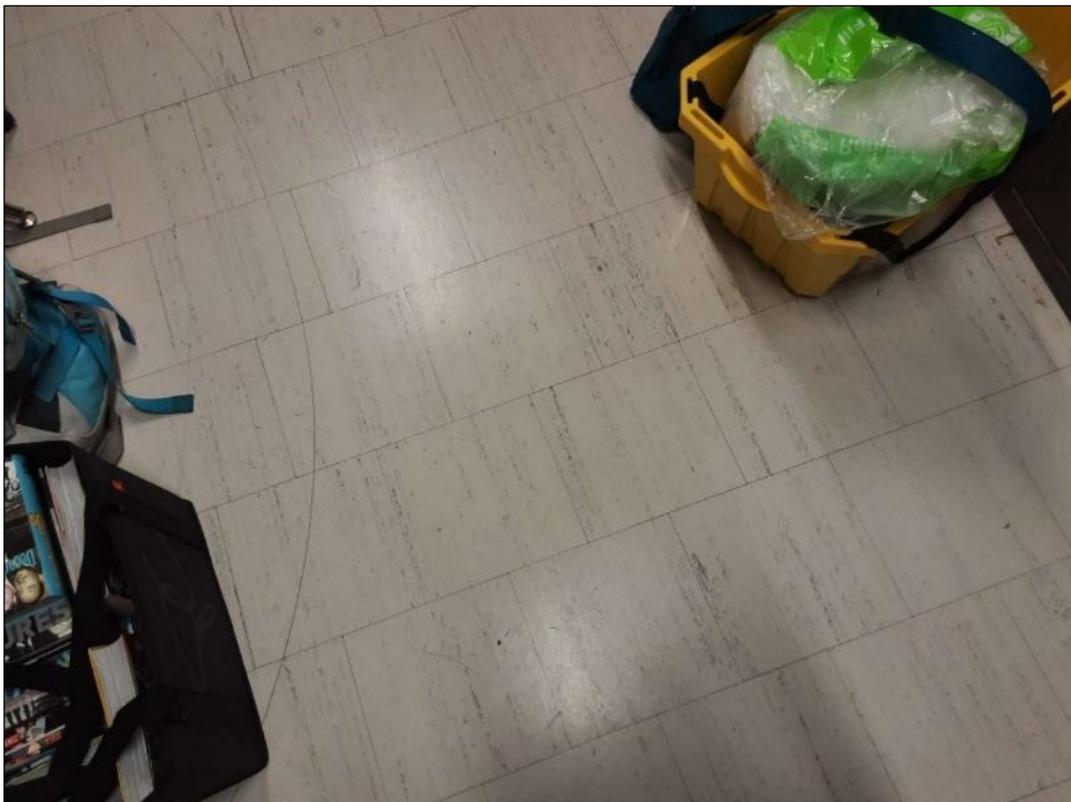
V0003 (Confirmed Asbestos), , All, Vinyl Floor Tile and Mastic, 9x9 various colours, Floor Resource Room (Location #: 105)

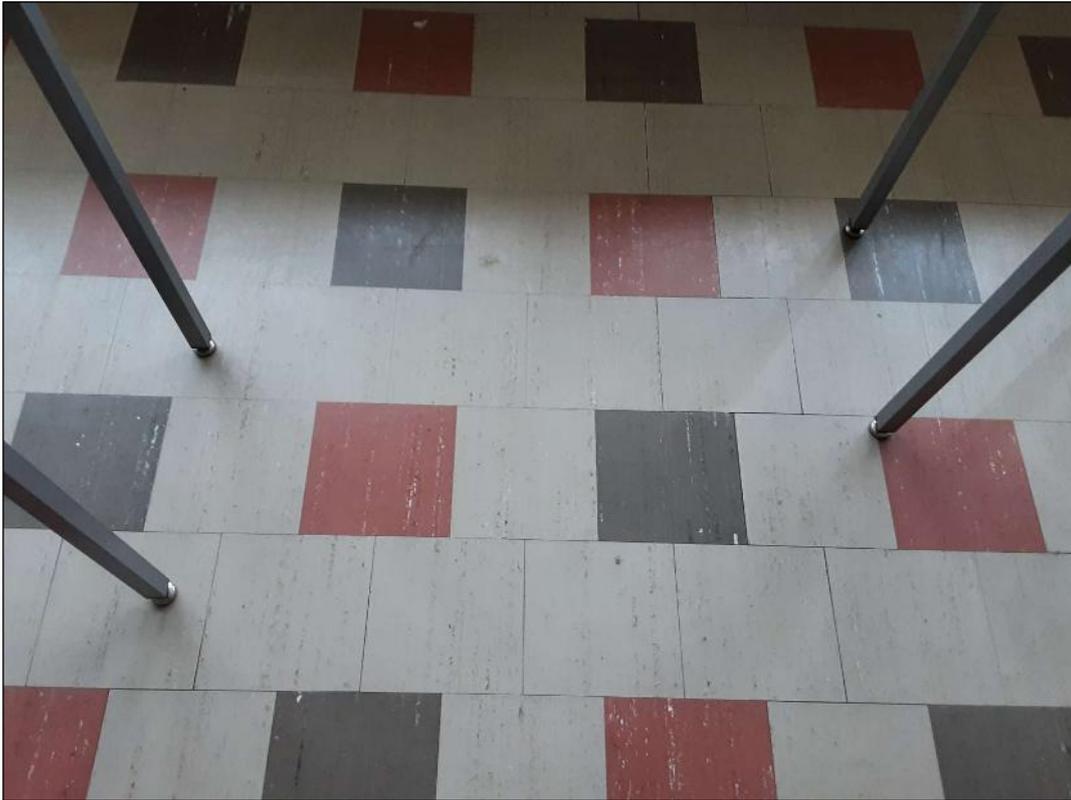
S0003B (Confirmed Asbestos), , All, Vinyl Floor Tile and Mastic, 9x9 various colours, Floor Classroom (Location #: 115)

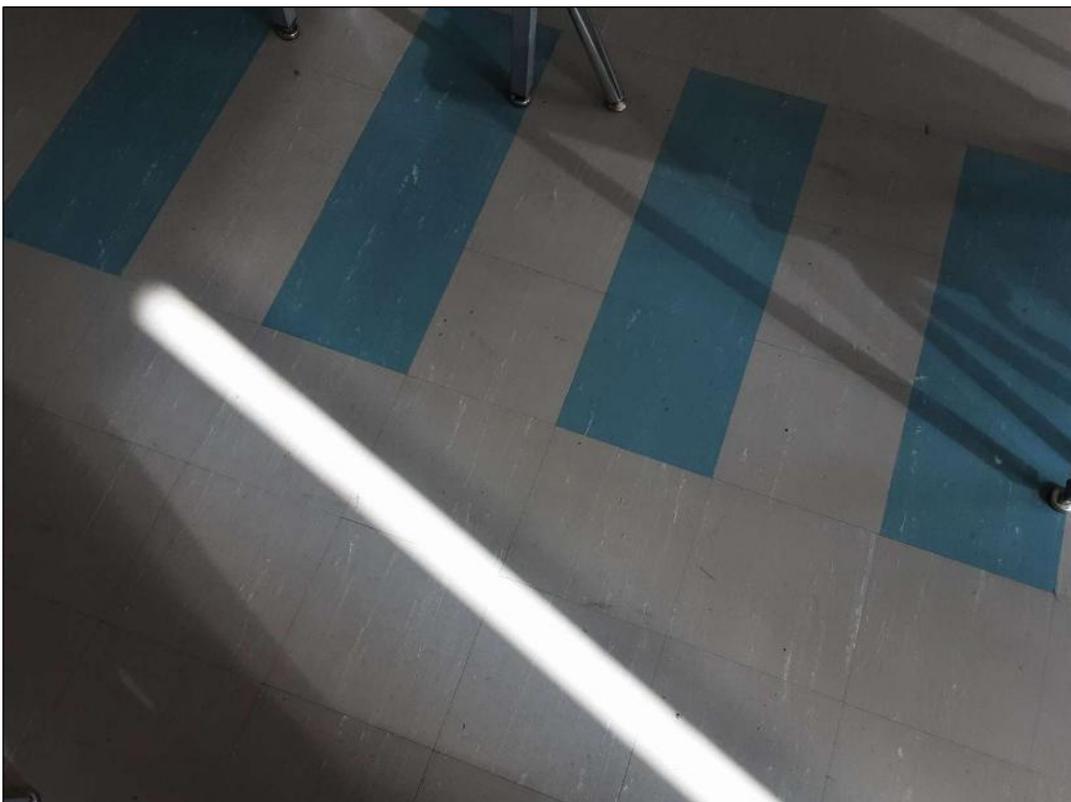
V0003 (Confirmed Asbestos), Floor, All, Vinyl Floor Tile and Mastic, 9x9 various colours, Classroom (Location #: 255)

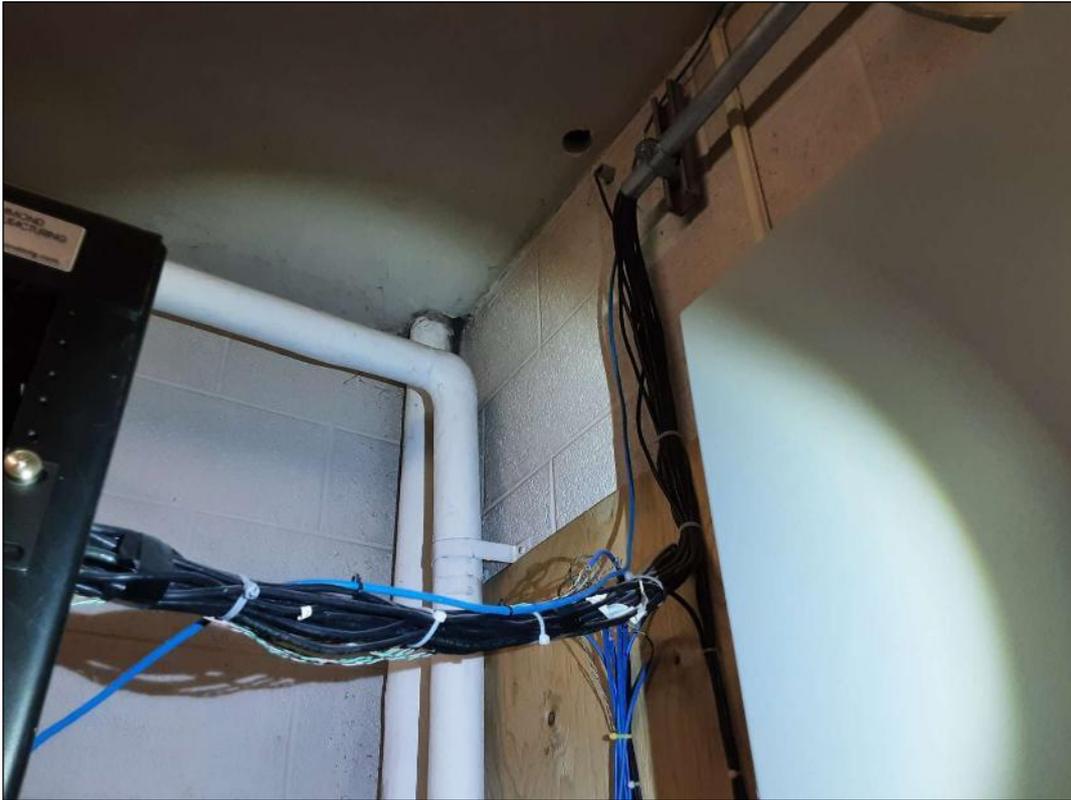
V0006 (Confirmed Asbestos), Piping, Parging Cement, Storage (Location #: 109)

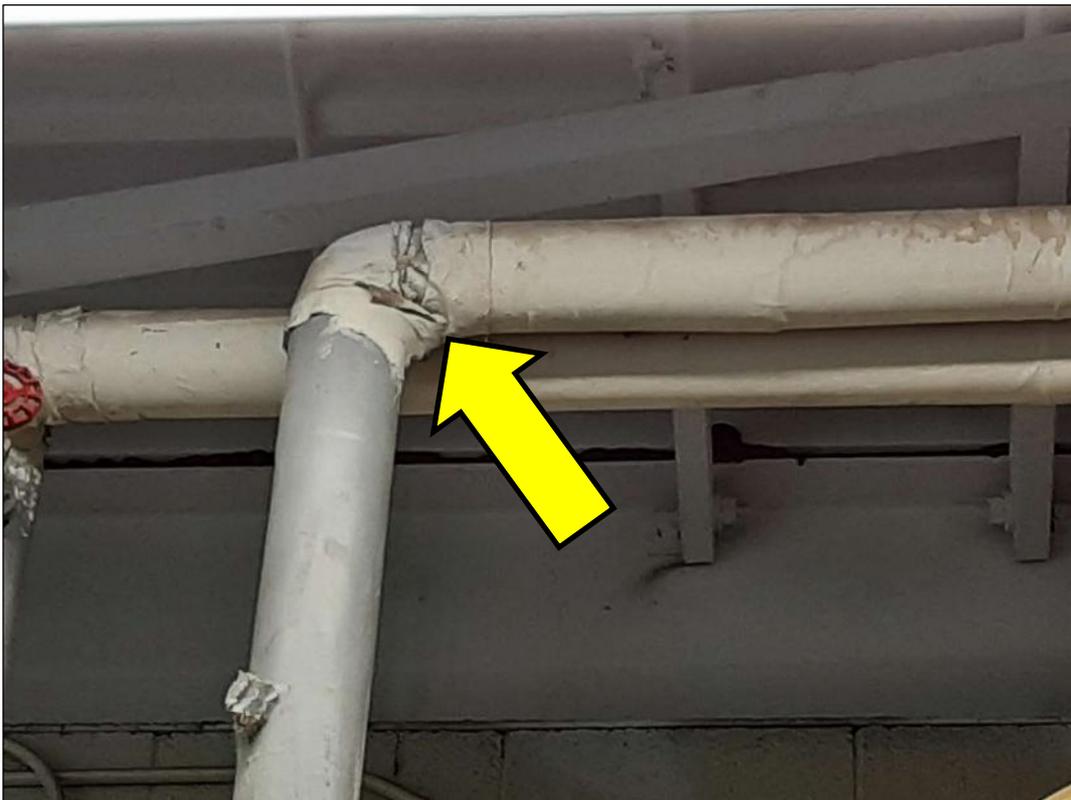
S0008A (Confirmed Asbestos), Piping, All, Parging Cement, Poor Condition, Autoshop (Location #: 153)

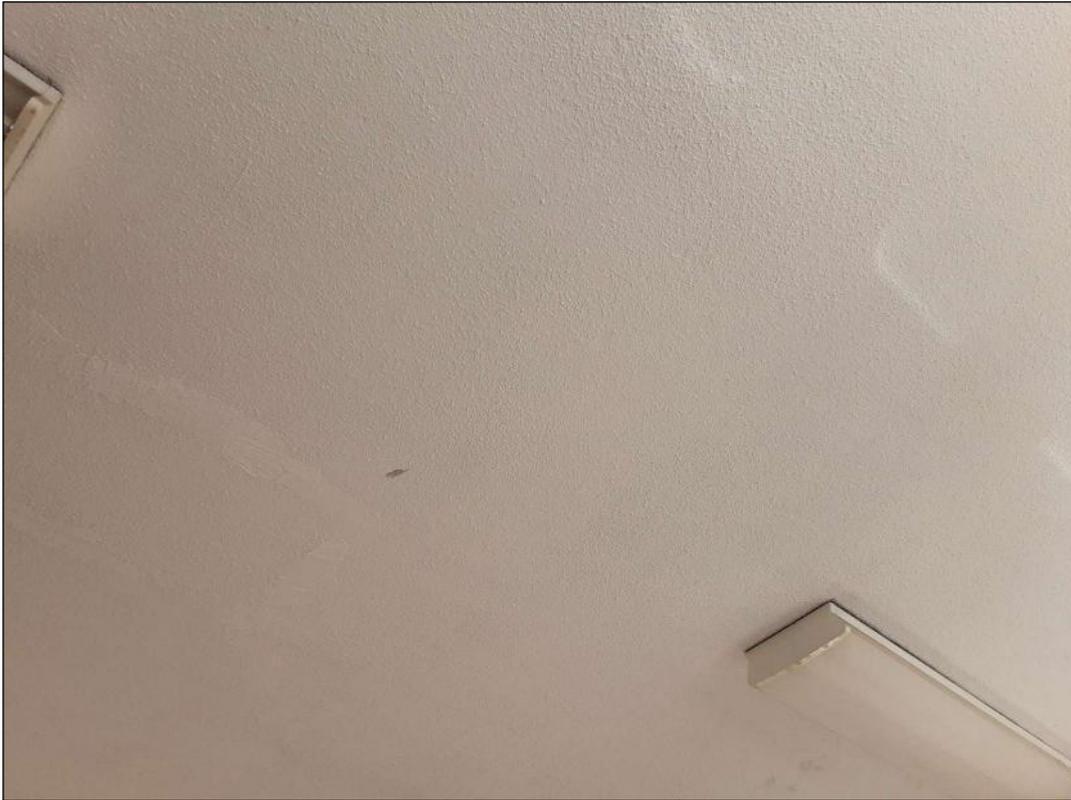
S0012A (Confirmed Asbestos), Ceiling, All, Texture Coat, Washroom (Location #: 159)

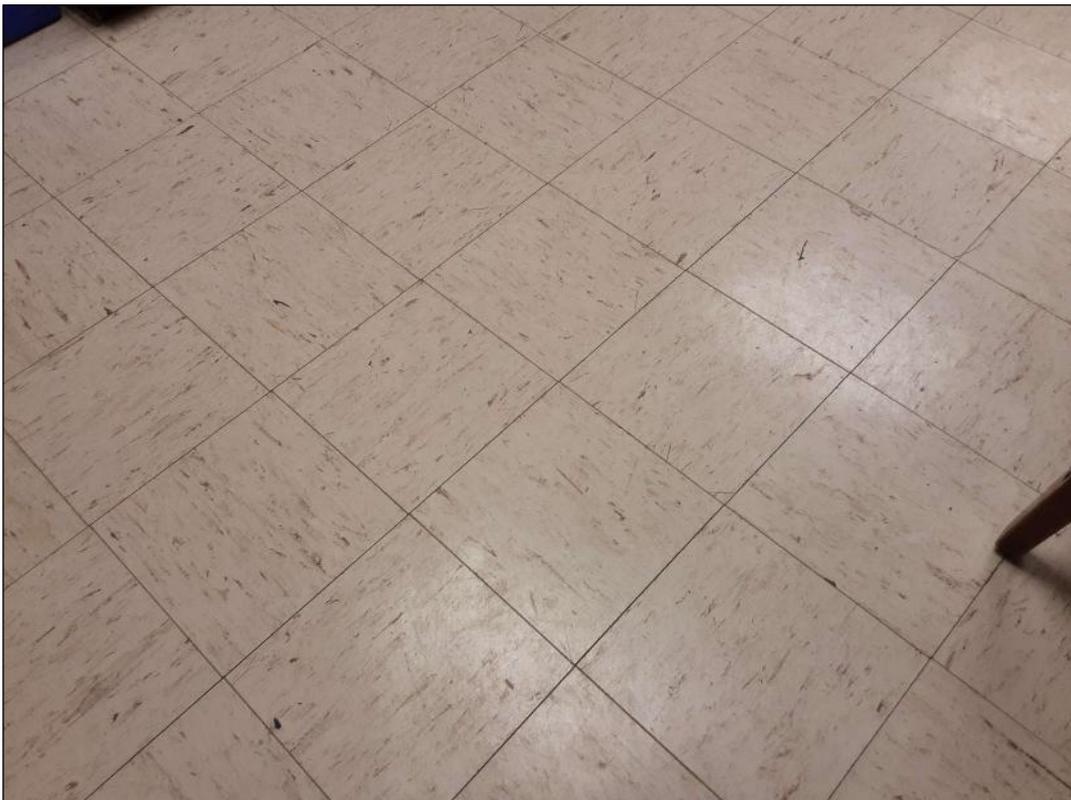
S0015A (Confirmed Asbestos), Floor, Vinyl Floor Tile, 12x12 beige with brown streaks, Boiler Room (Location #: 163)

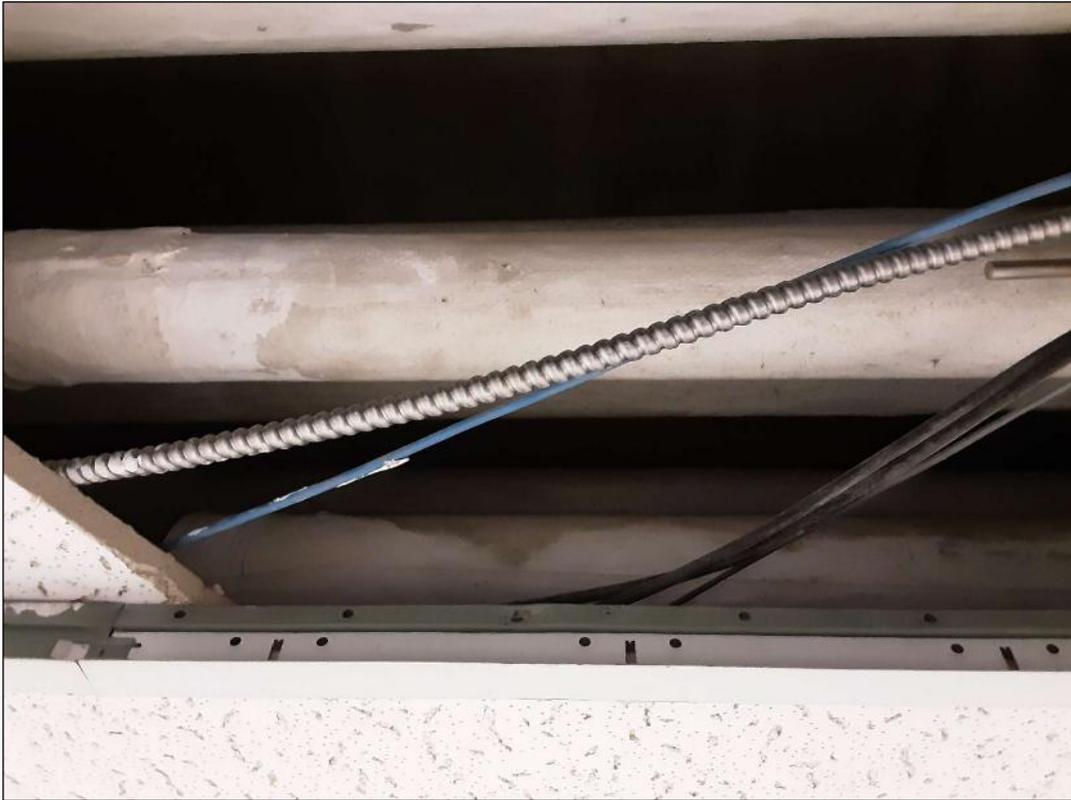
V0001 (Confirmed Asbestos), Piping, Aircell, Corridor (Location #: 192)

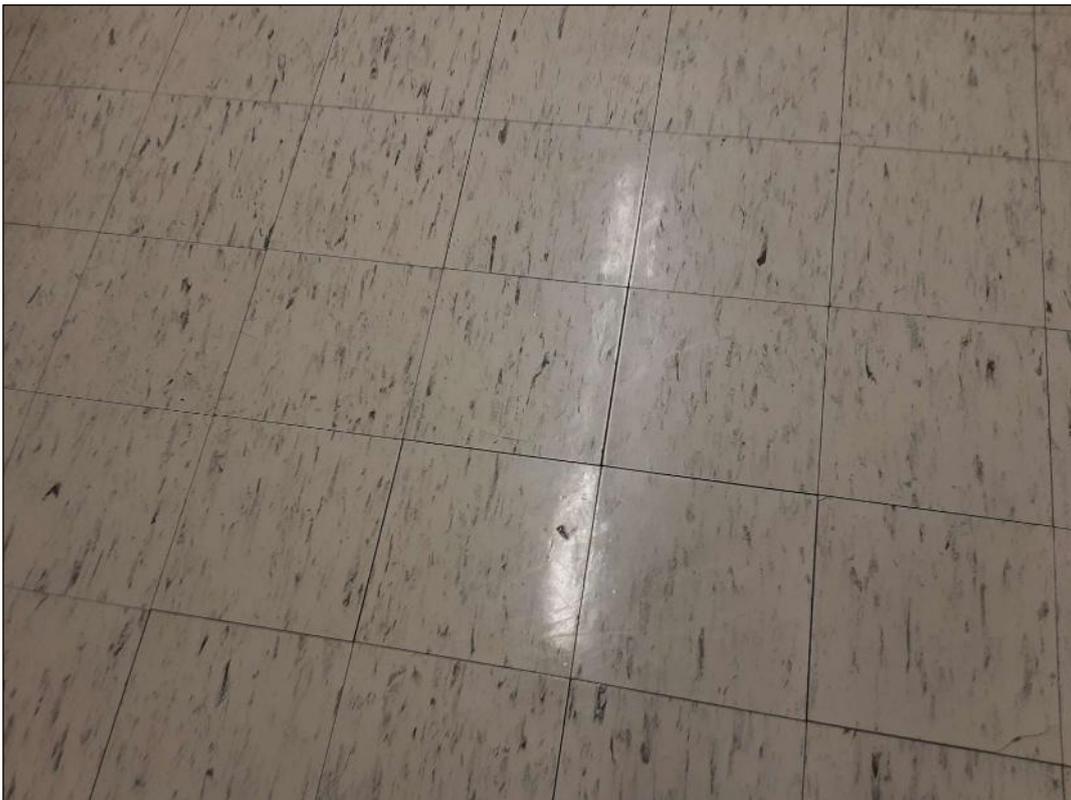
S0026C (Confirmed Asbestos), Floor, All, Vinyl Floor Tile, 12x12 off-white with black and grey streaks, Change Room (Location #: 135)

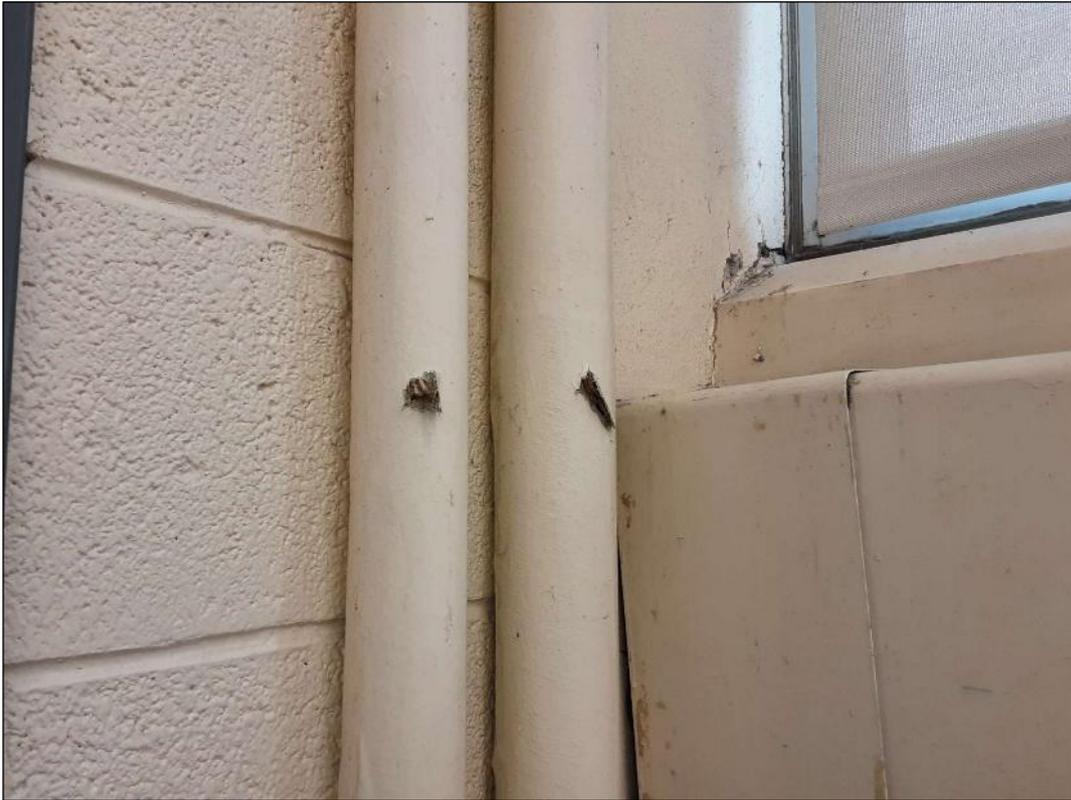
S0035A (Confirmed Asbestos), Piping, Sweatwrap, Poor Condition, Classroom (Location #: 150)

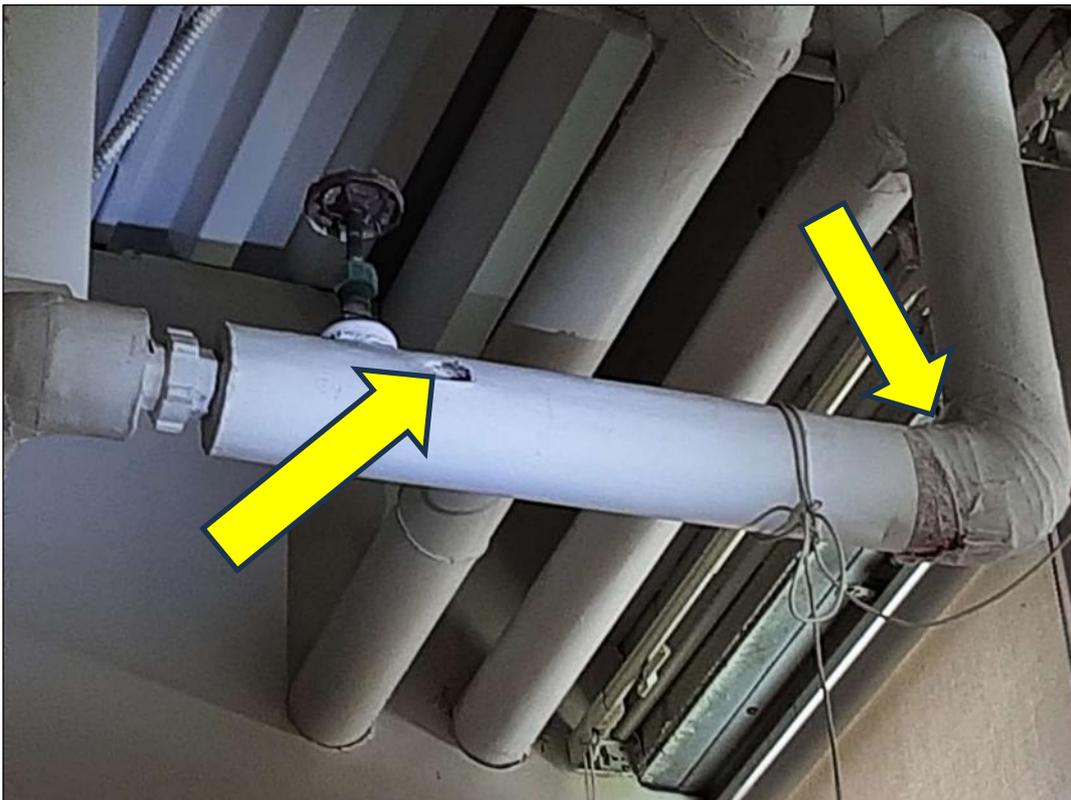
V0035 and V0006 (Confirmed Asbestos), Piping, Sweatwrap, Parging Cement, Poor Condition, Classroom (Location #: 151)

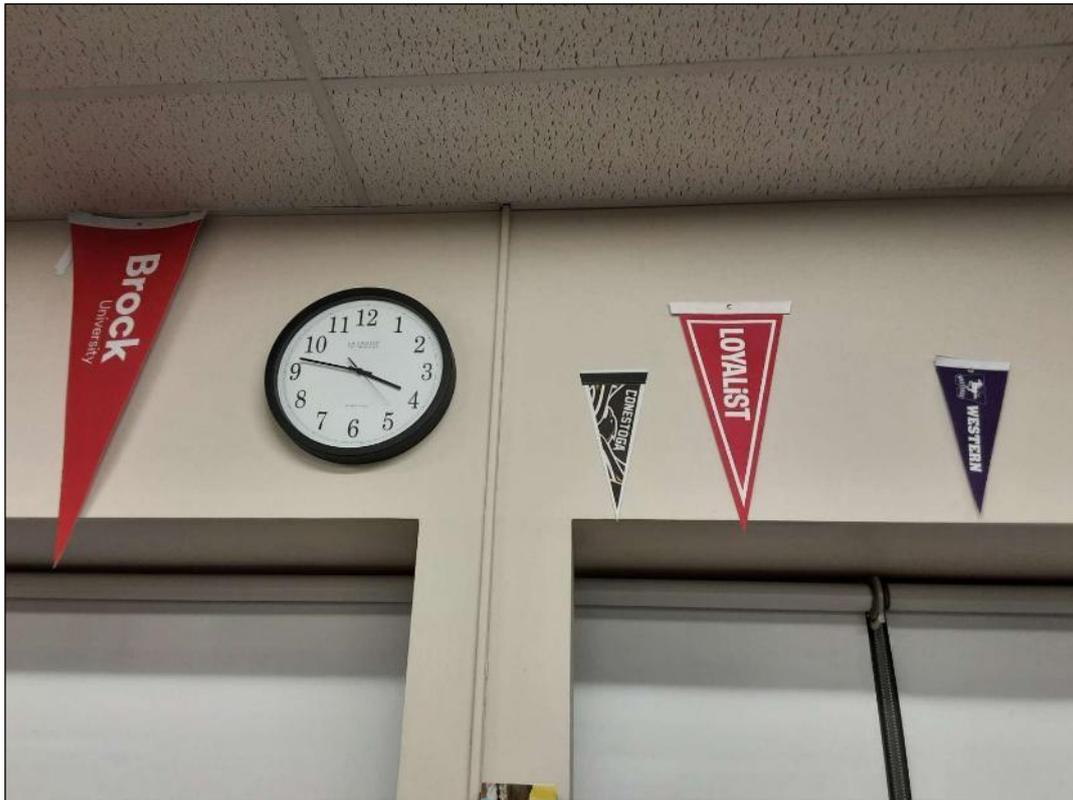
V0054 (Confirmed Asbestos), Wall, All, Drywall and joint compound, Guidance (Location #: 108)

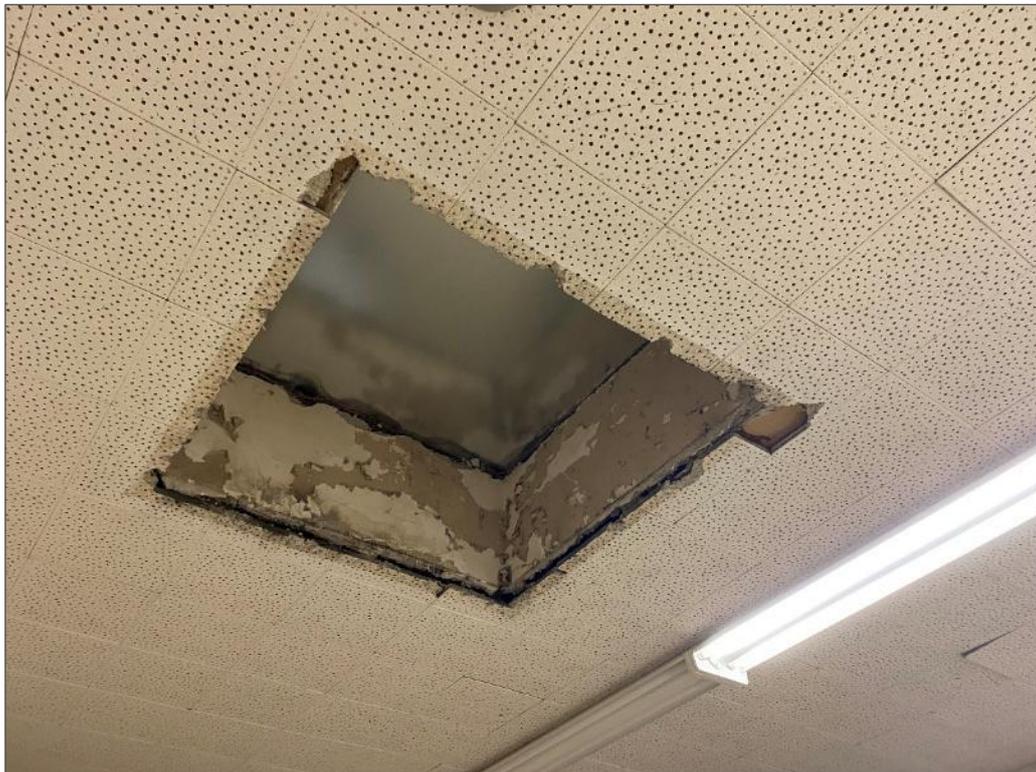
V0054 (Confirmed Asbestos), Ceiling, Bulkhead, Drywall and joint compound, Poor Condition, Classroom (Location #: 212)

| System | Material Description | Quantities per Condition | | Location Name, (Location No.) | Recommended Procedure |
|---|---|---|---|---|---|
| Wall | Drywall and Joint Compound | | 5 SF | Classroom (212) | Remove/repair in accordance with Type 1 asbestos abatement procedures |

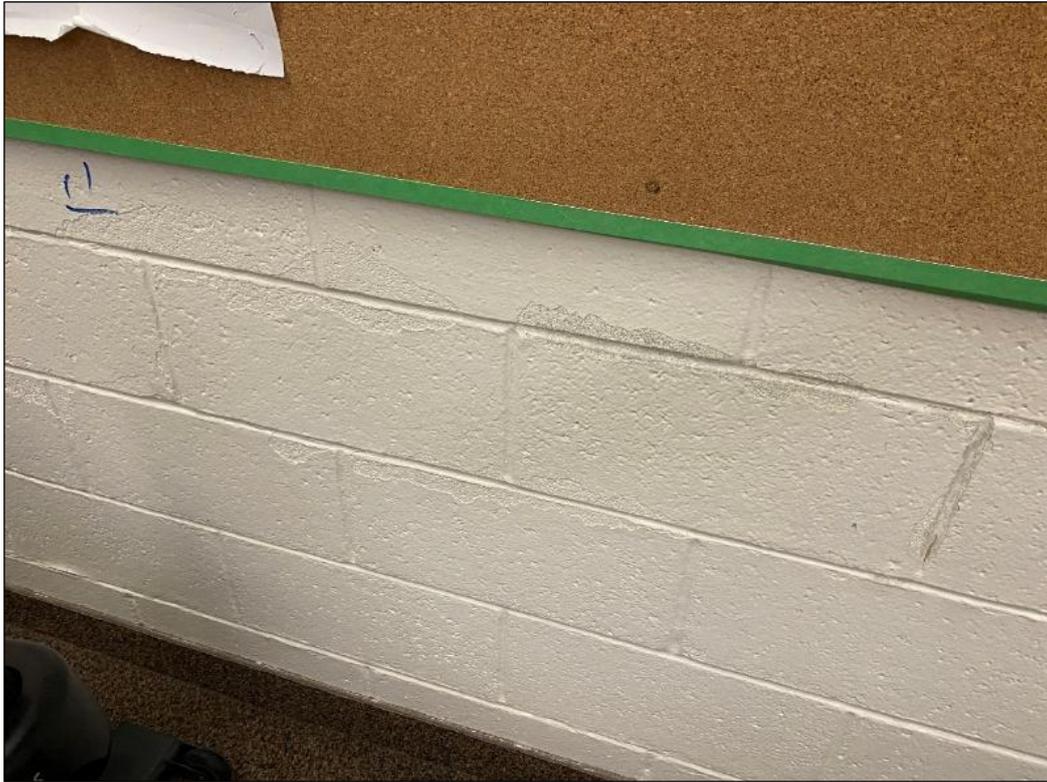
V0063 (Confirmed Asbestos), Wall, Paint, On concrete block, Equipment Storage (Location #: 141)

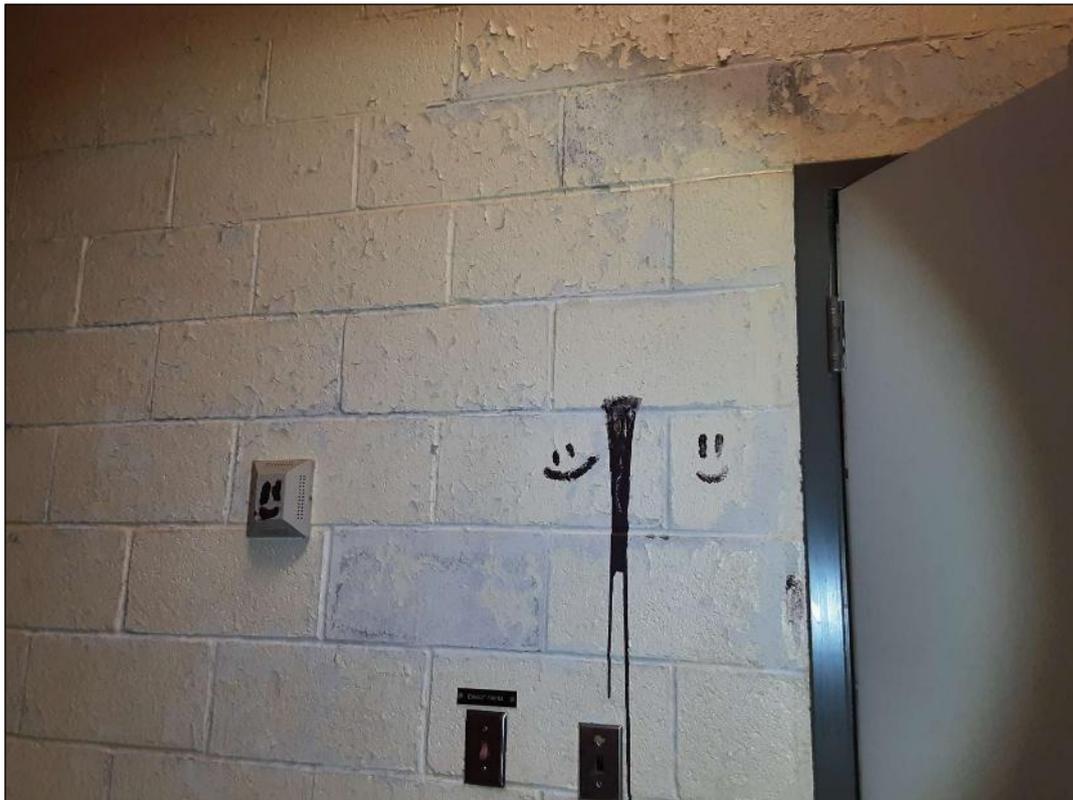
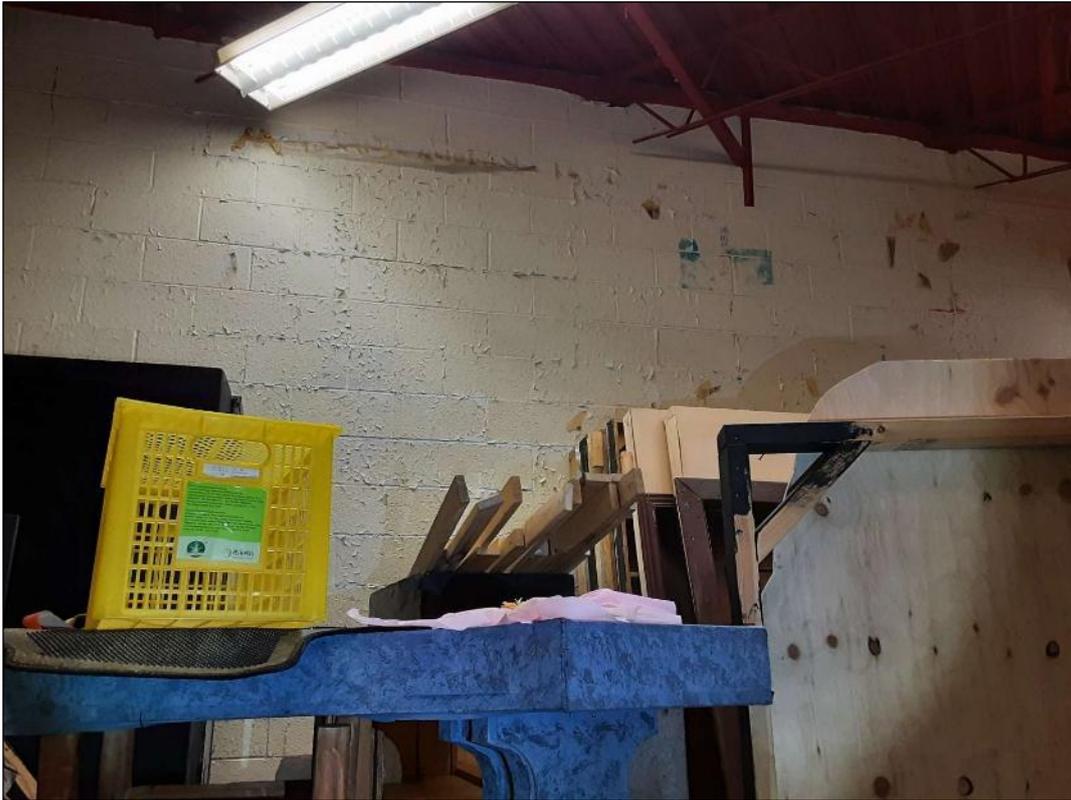
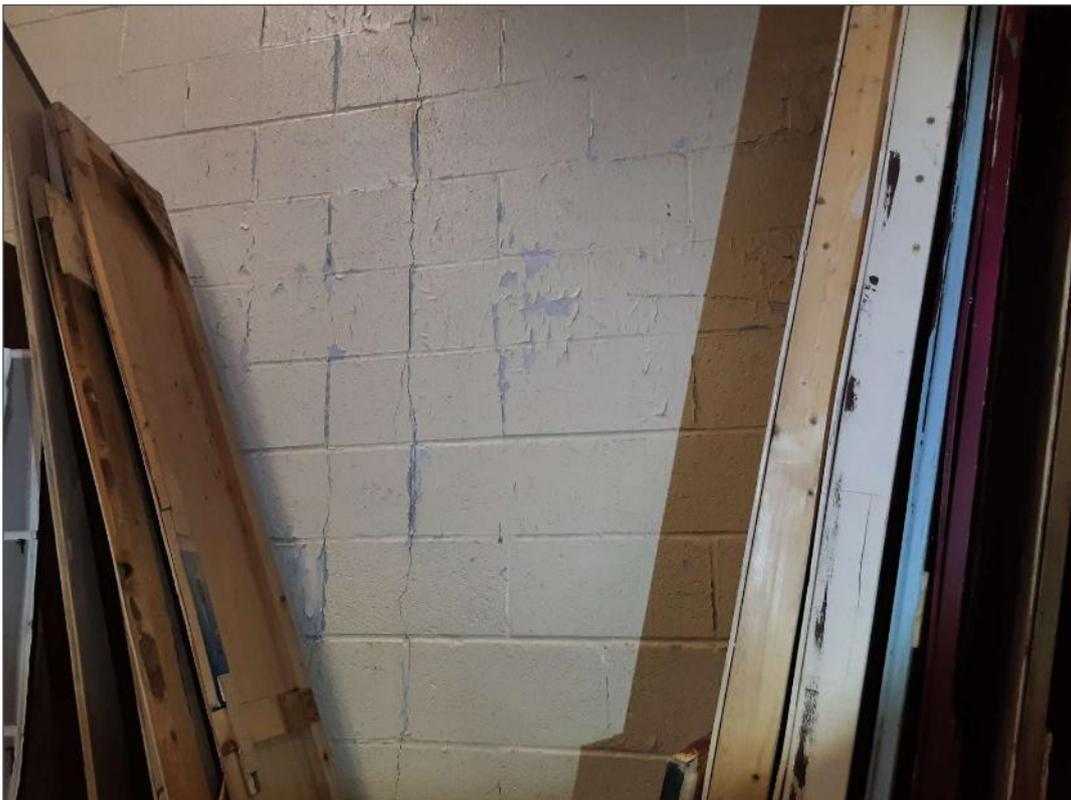
S0066A (Confirmed Asbestos), Wall, Paint, On concrete block, Poor Condition, Storage Room (Location #: 139)

| System | Material Description | Quantities per Condition | | Location Name, (Location No.) | Recommended Procedure |
|---|---|---|---|---|---|
| Wall | Paint on Concrete Block | | 300 SF | Storage Room (139) | Remove/repair in accordance with Type 1 asbestos abatement procedures |

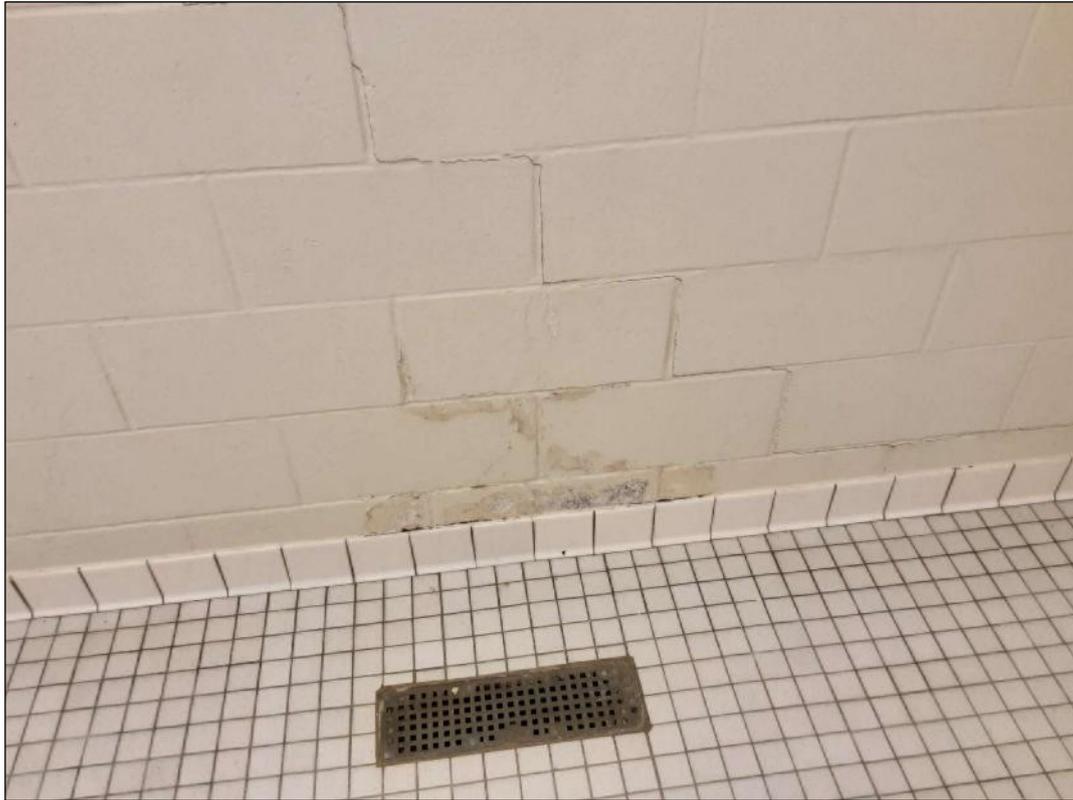
V0067 (Confirmed Asbestos), , Wall, Paint, On concrete block Poor Condition, Change Room (Location #: 135)
Room 135b

| System | Material Description | Quantities per Condition | | Location Name, (Location No.) | Recommended Procedure |
|---|---|---|---|---|---|
| Wall | Paint on Concrete Block | | 5 SF | Change Room (135) | Remove/repair in accordance with Type 1 asbestos abatement procedures |

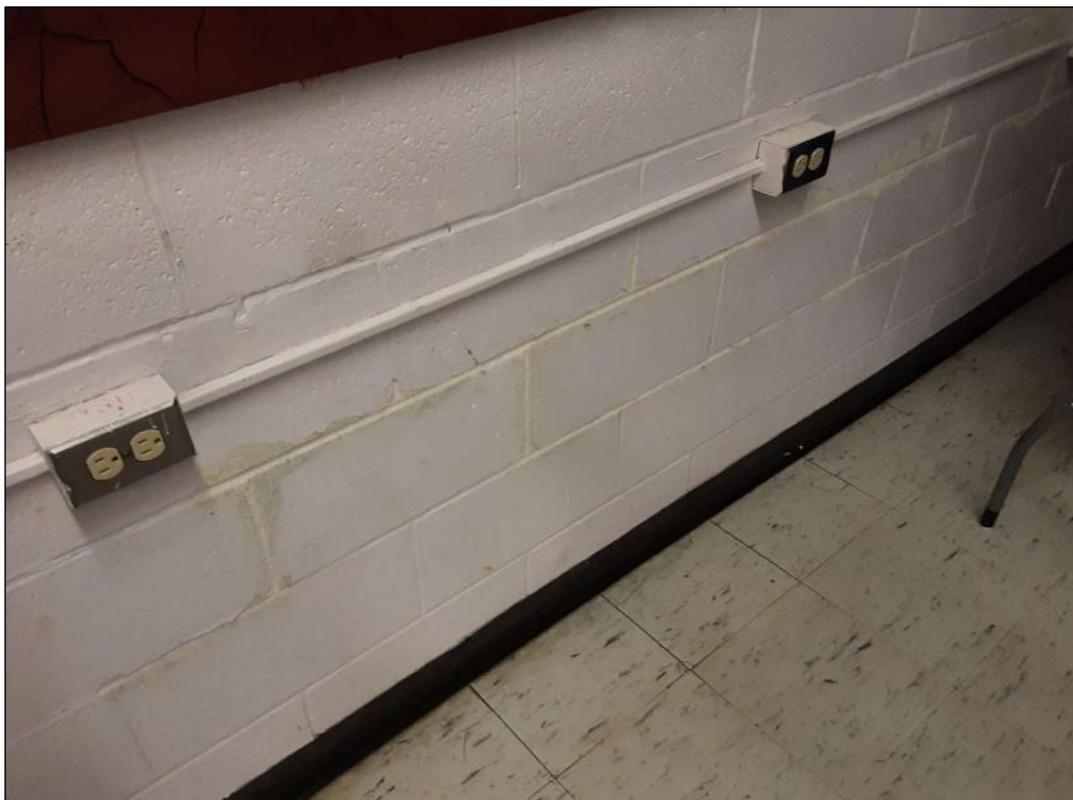
V0067 (Confirmed Asbestos), Wall, Paint, On concrete block, Poor Condition, Classroom (Location #: 187)

| System | Material Description | Quantities per Condition | | Location Name, (Location No.) | Recommended Procedure |
|---|---|---|---|---|---|
| Wall | Paint on Concrete Block | | 5 SF | Classroom (187) | Remove/repair in accordance with Type 1 asbestos abatement procedures |

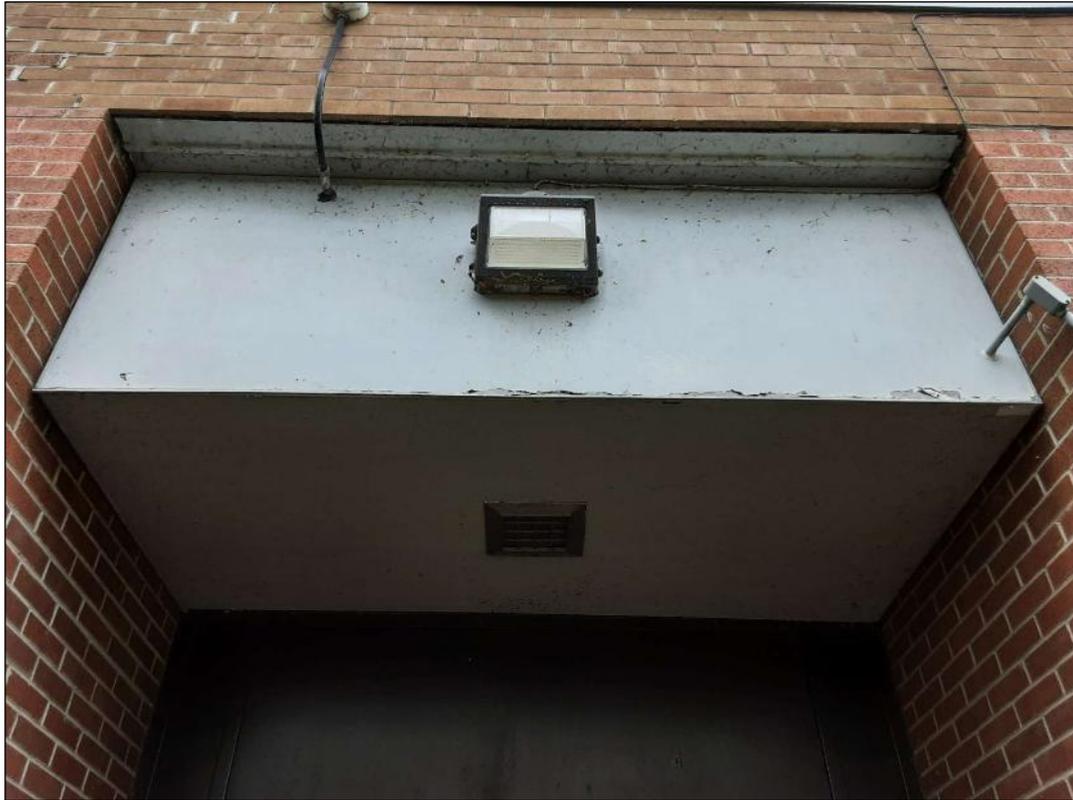
S0090C (Confirmed Asbestos), Transite, Structure, Canopy, Cement Product, Corridor (Location #: 194)
Exterior

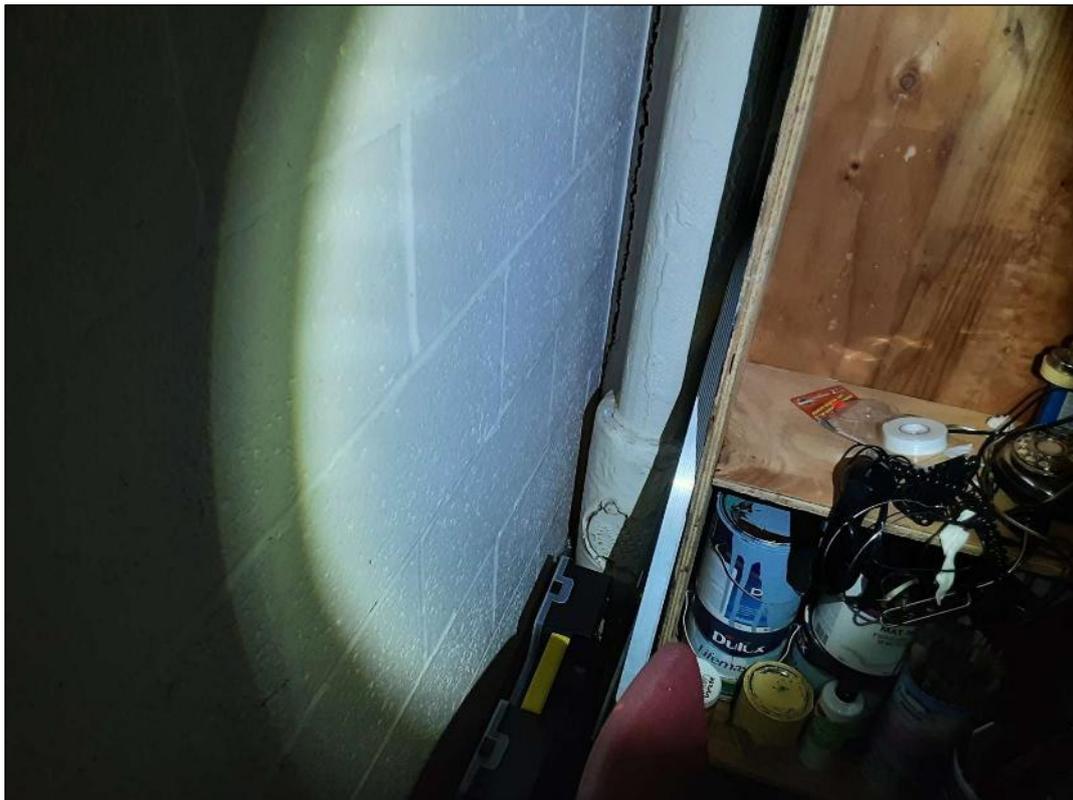
V9500 (Presumed Asbestos), Transite, Piping, Rain Water Leader, Cement Product, Stage (Location #: 140)

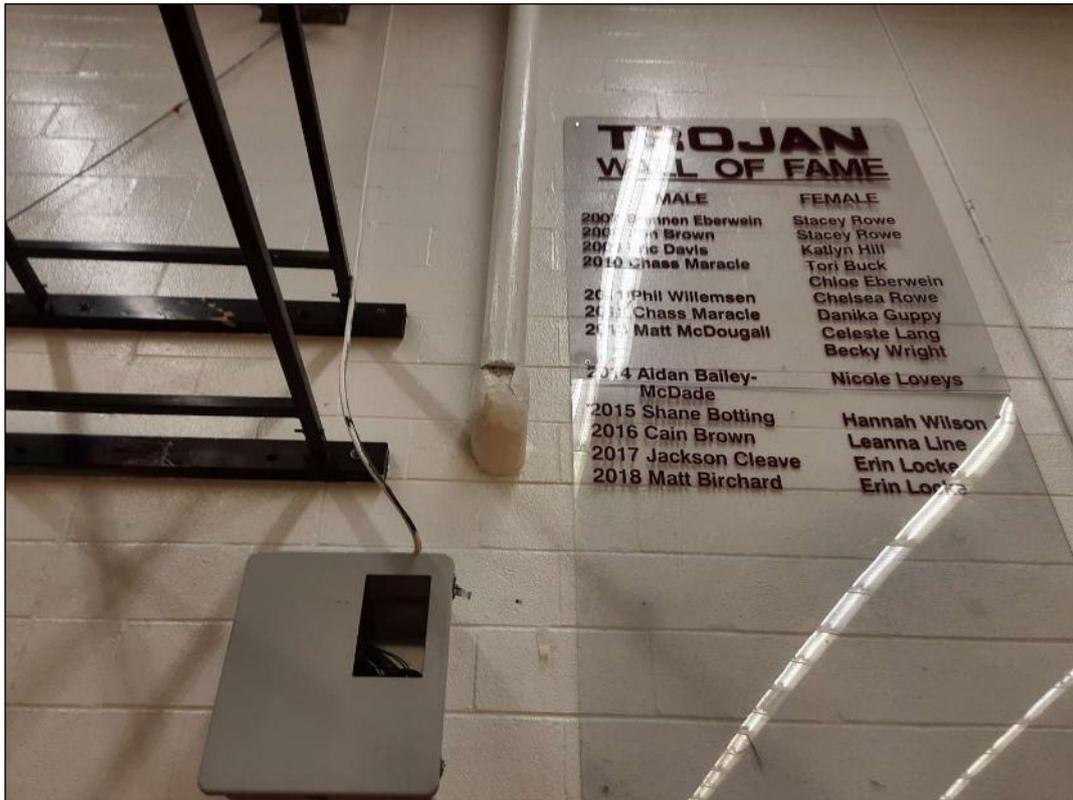
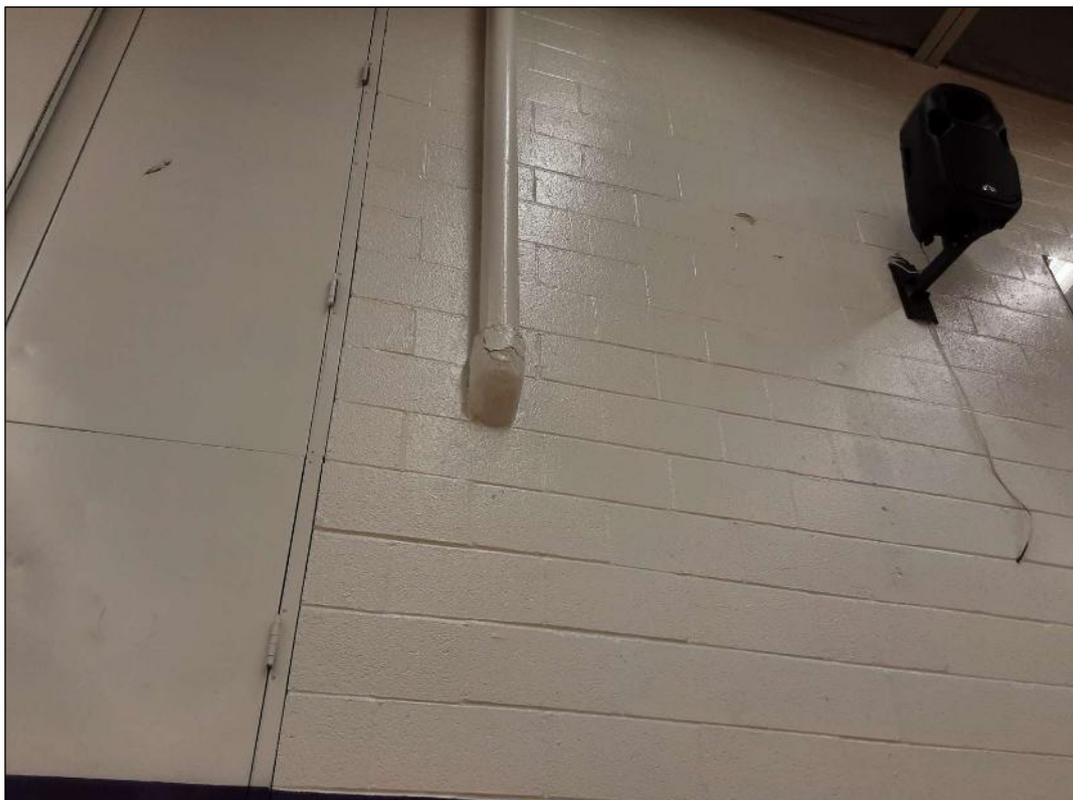
V9500 (Confirmed Asbestos),, Piping, Rainwater Leader, Parging Cement, Poor Condition, Gym (Location #: 142)

V9500 (Presumed Asbestos), , Piping, Rain Water Leader, Parging Cement, Poor Condition, Gym (Location #: 142)

| System | Material Description | Quantities per Condition | | Location Name, (Location No.) | Recommended Procedure |
|---|---|---|---|---|---|
| Piping | Parging Cement | | 2 EA | Gym (142) | Remove in accordance with Type 2 or Glove Bag asbestos abatement procedures |
