Re: Asbestos Reassessment

Eastside Secondary School, 275 Farley Avenue, Belleville, ON
Pinchin File: 200584.099

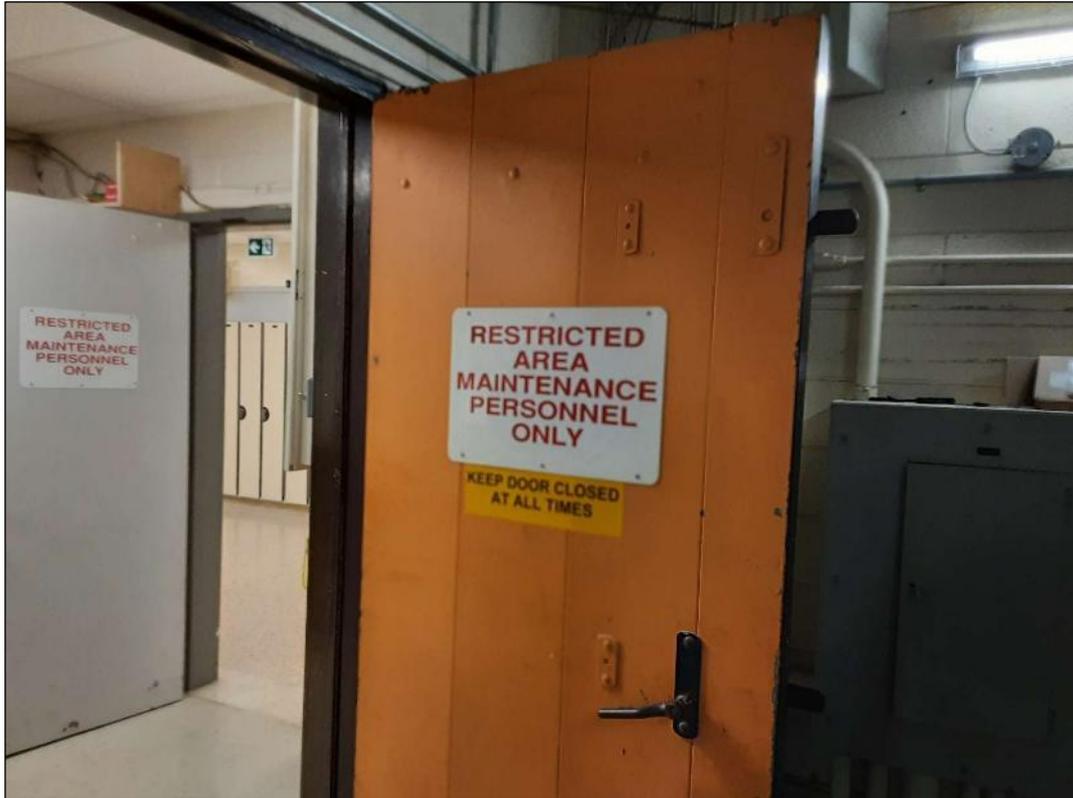
V9500 (Presumed Asbestos), Wall, Door, Thermal Insulation, Boiler Room (Location #: 163)

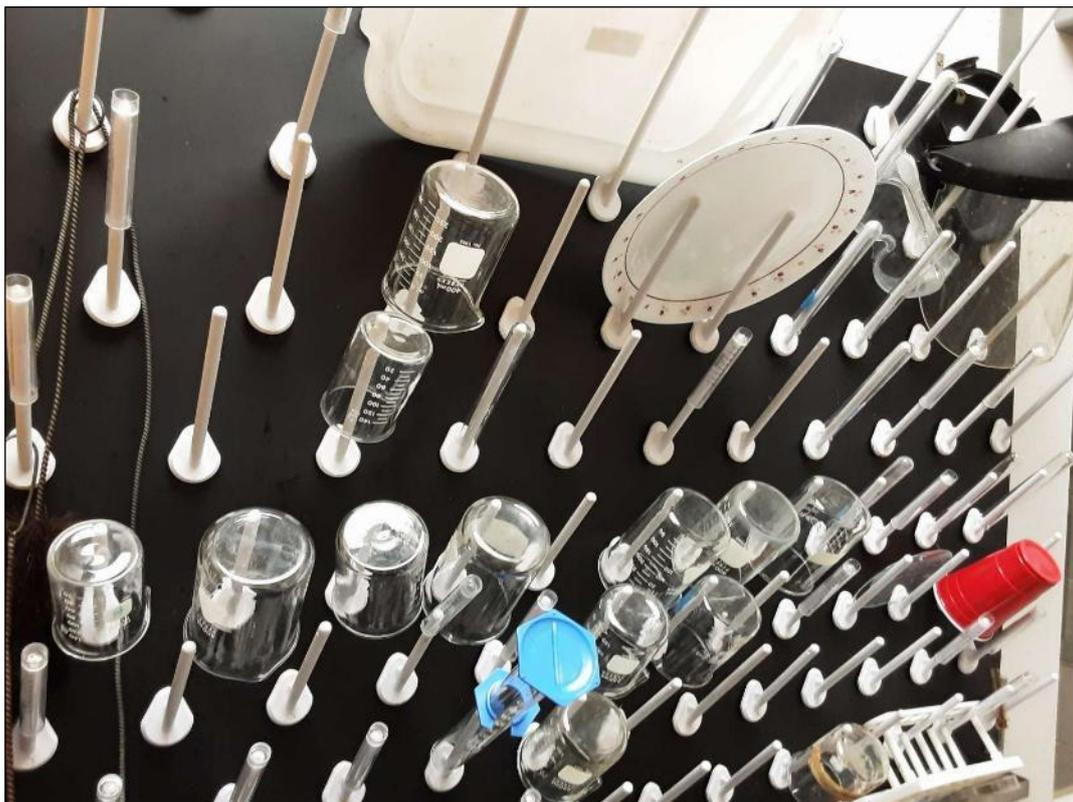
V9500 (Presumed Asbestos), Transite drying rack, Other, Cement Product, Resource Room (Location #: 218)

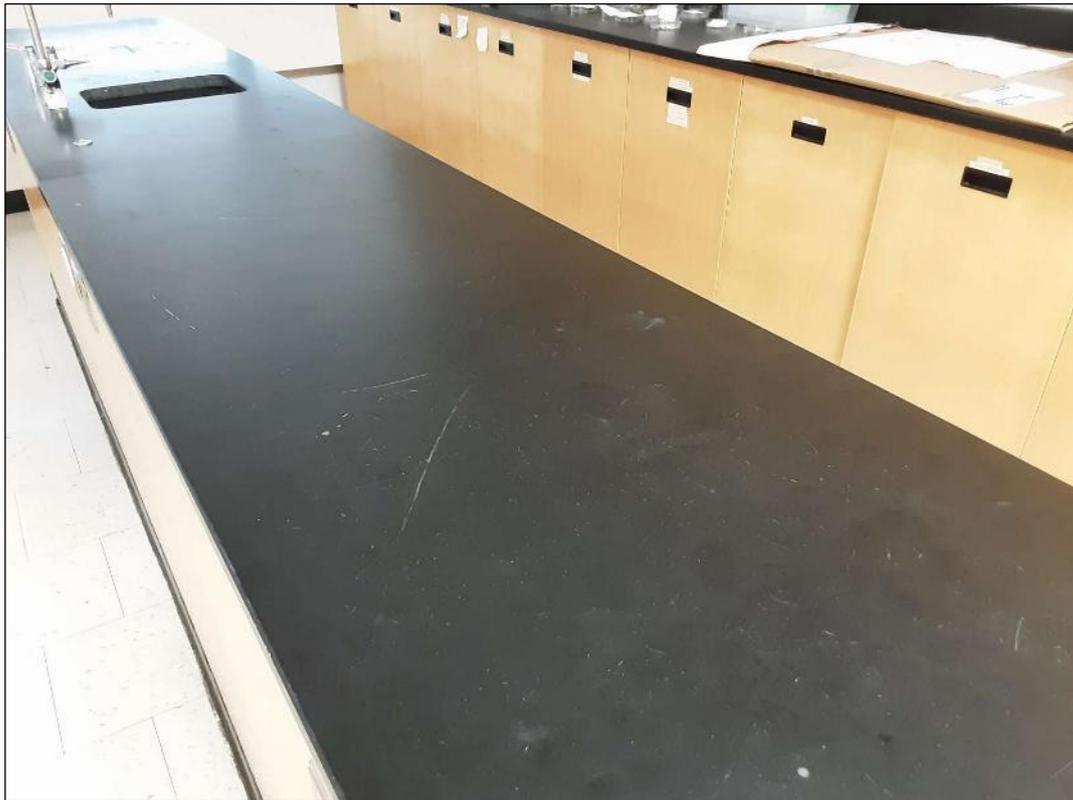
V9500 (Presumed Asbestos), Transite, Other, Countertop, Cement Product, Classroom (Location #: 219)

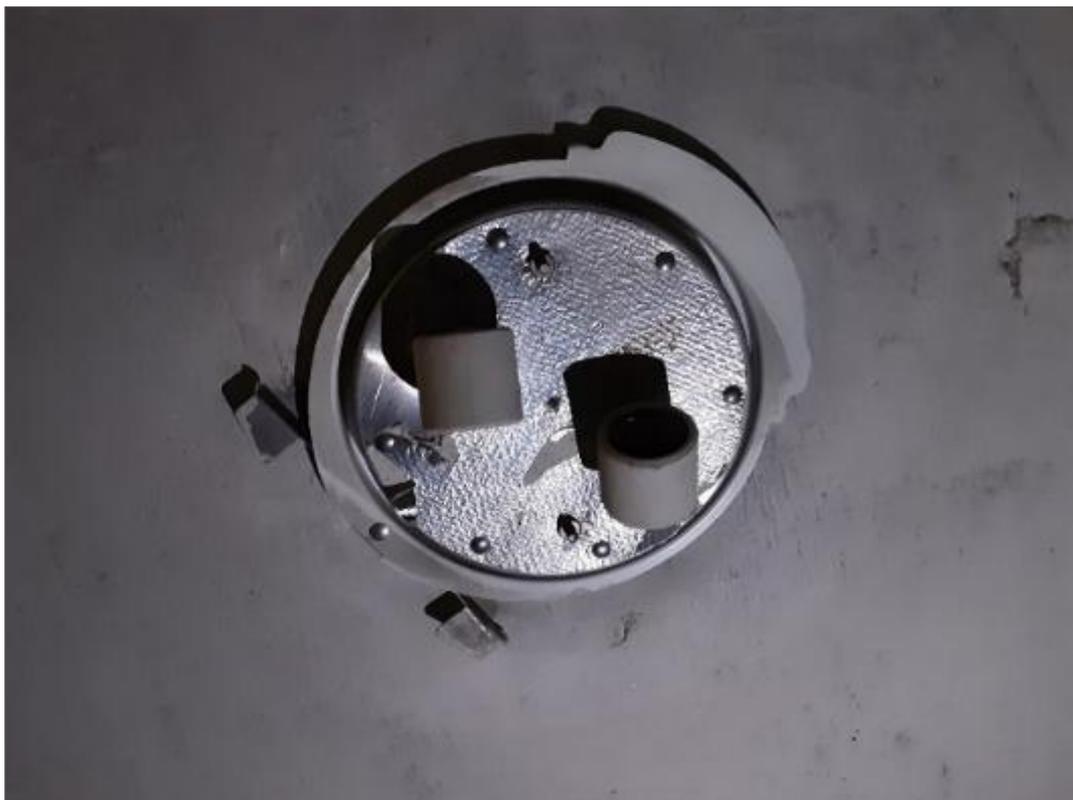
S0017A-C (Confirmed Asbestos), Structure, Paper Covering, Paper Heat Shield, Basement (Location #: 2)

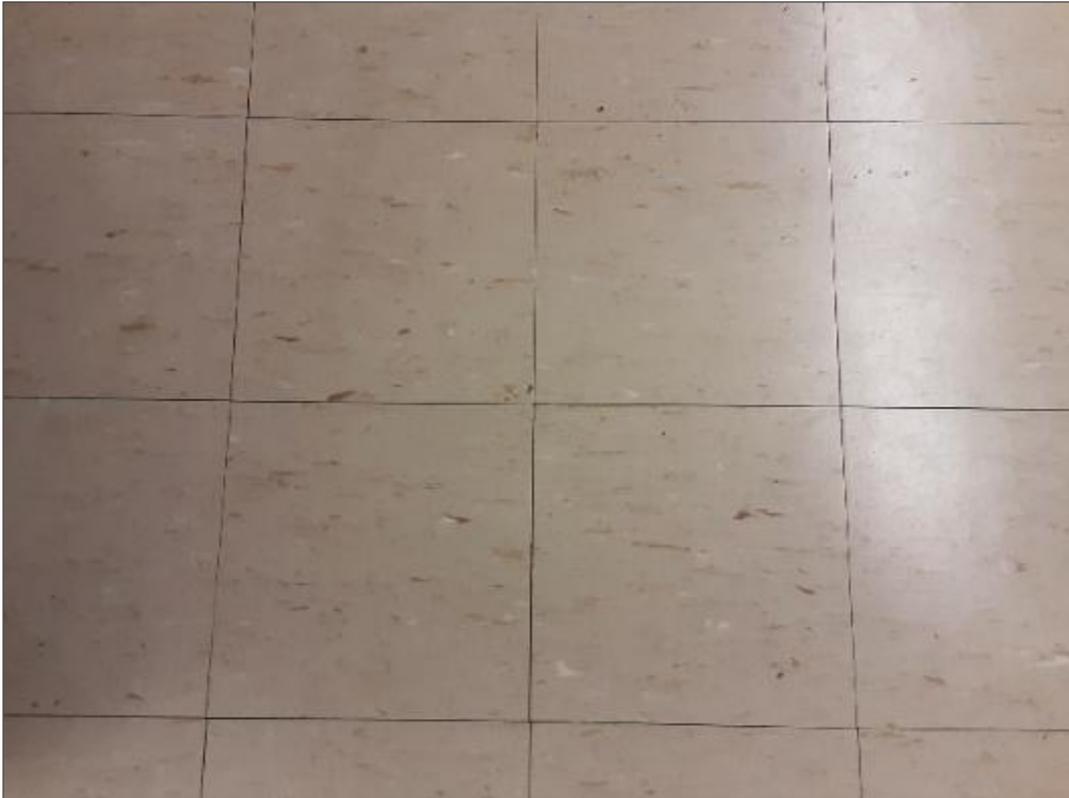
S0024A-C (Confirmed Asbestos), Floor, Vinyl Floor Tile, 12"x12" Beige with Sparse White and Brown Flecks, Storage Room (Location #: 139)

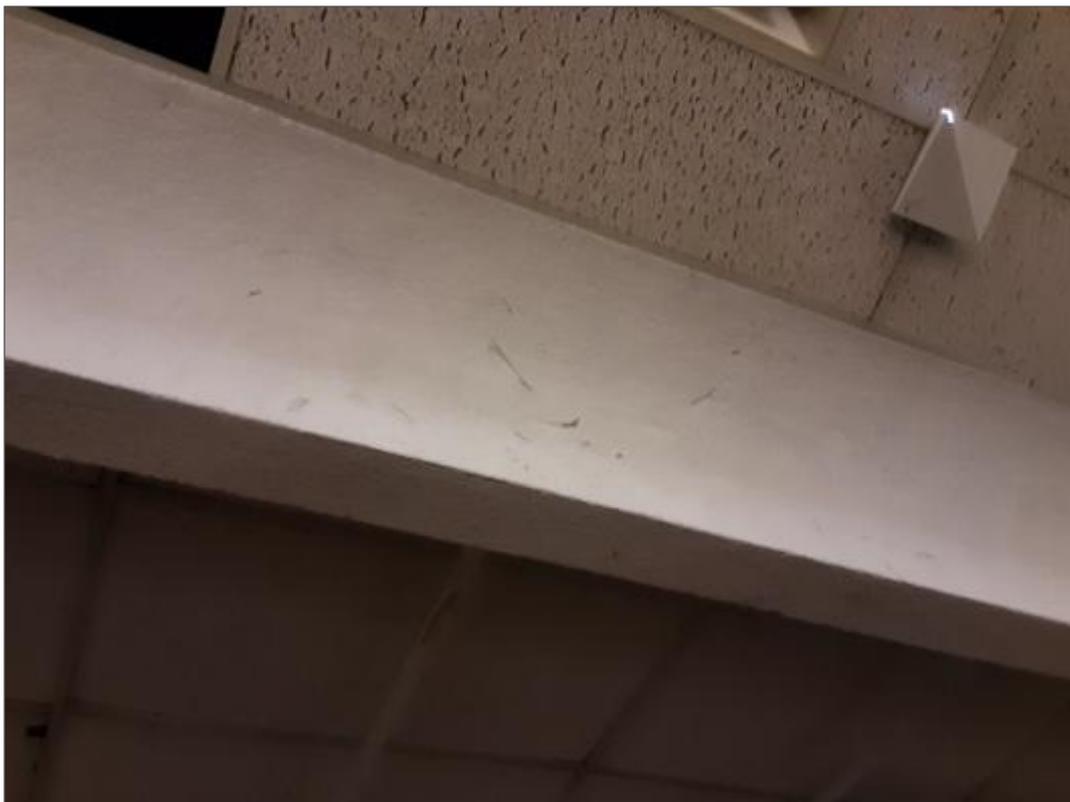
S0030A-C (Confirmed Asbestos), Ceiling, Bulkhead, Texture Coat, Theatre (Location #: 214)

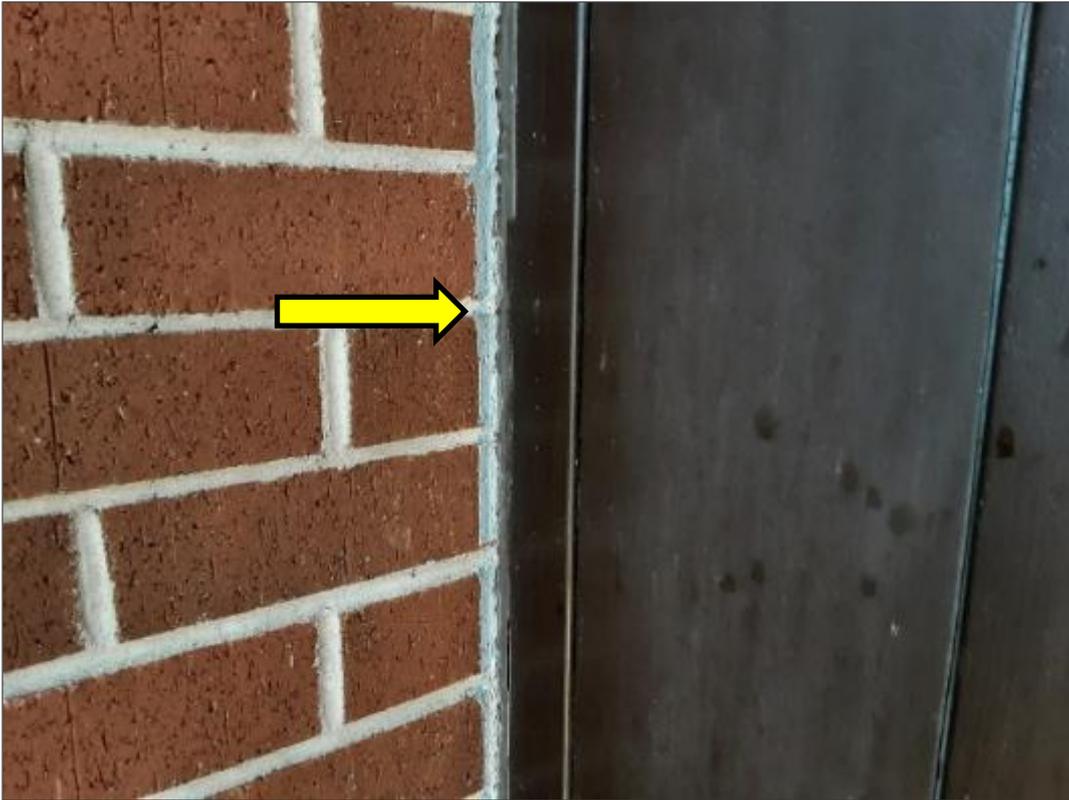
S0031A-C (Confirmed Asbestos), Wall, Exterior Door Frames, Beige Caulking, Exterior (Location #: 3)

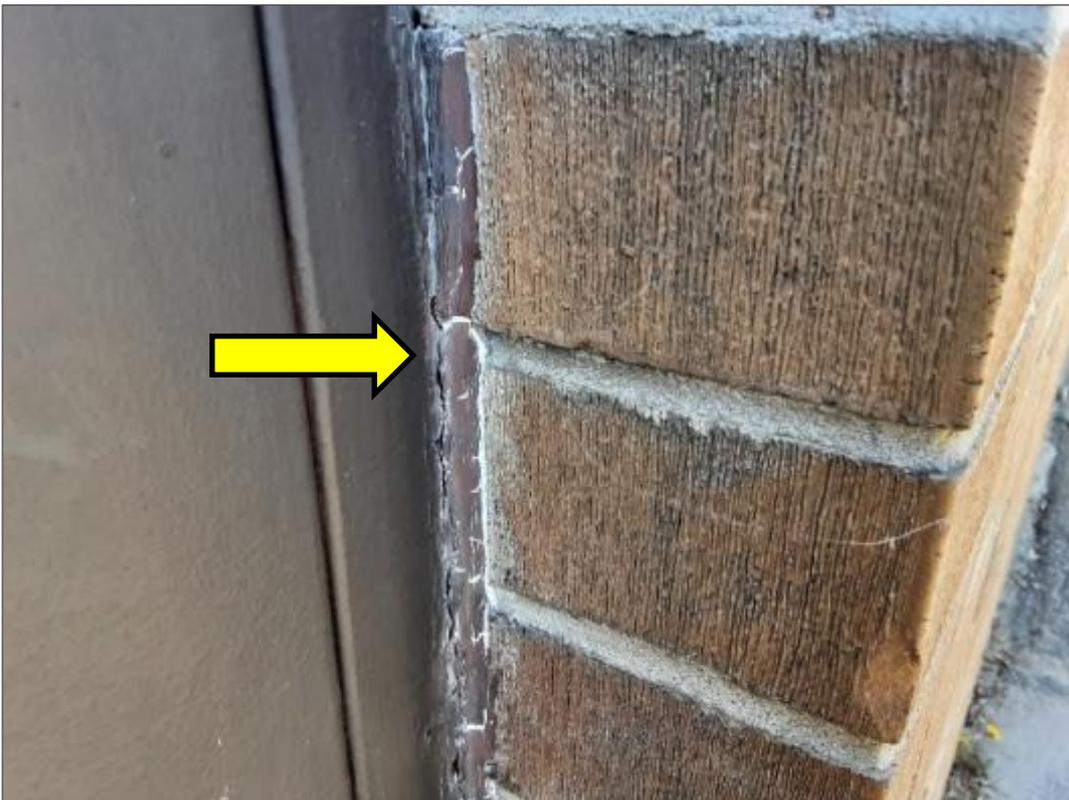
S0033A-C (Confirmed Asbestos), Wall, Exterior Door Frames, Brown and Grey Caulking, Exterior (Location #: 3)

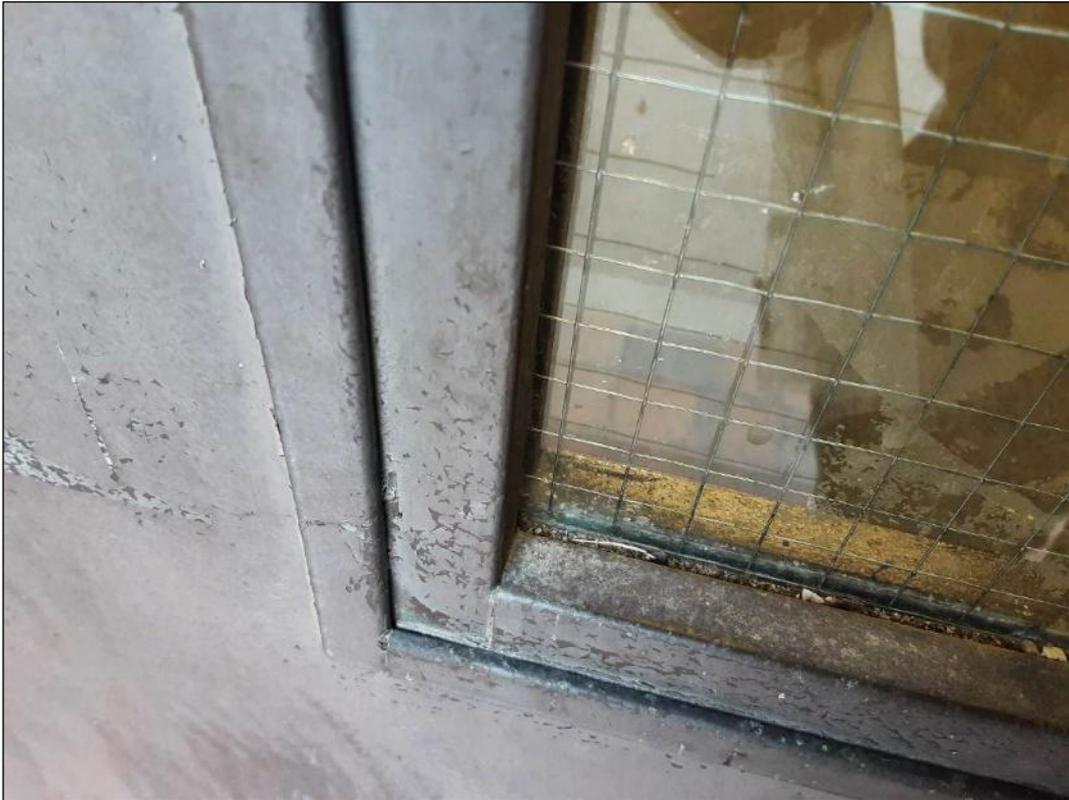
S0080C (None), Grey, Wall, Window Liner, Sealant, Corridor (Location #: 194)

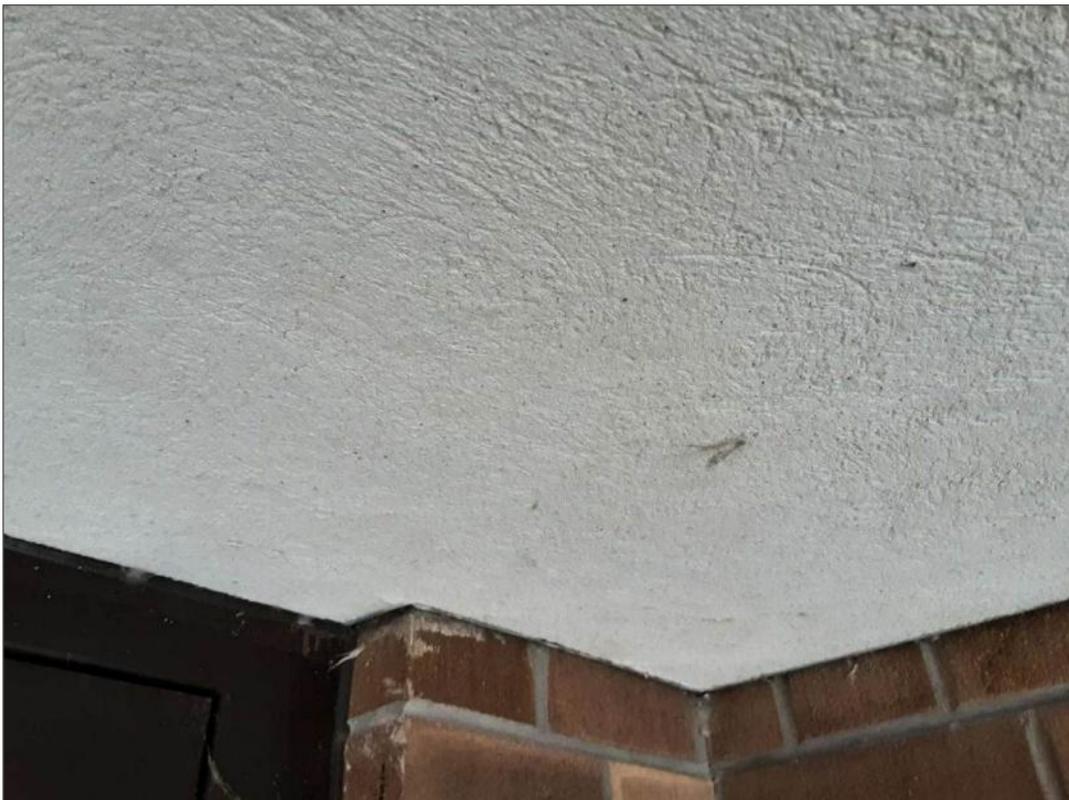
S0087C (Confirmed Asbestos), Structure, Texture Coat, Corridor (Location #: 195)
Exterior canopy
