**REVISED**  
**Hazardous Building**  
**Materials Assessment**  
**(Pre-construction)**

Eastside Secondary School  
275 Farley Avenue, Belleville,  
Ontario

July 12, 2023

Pinchin File: 200584.061

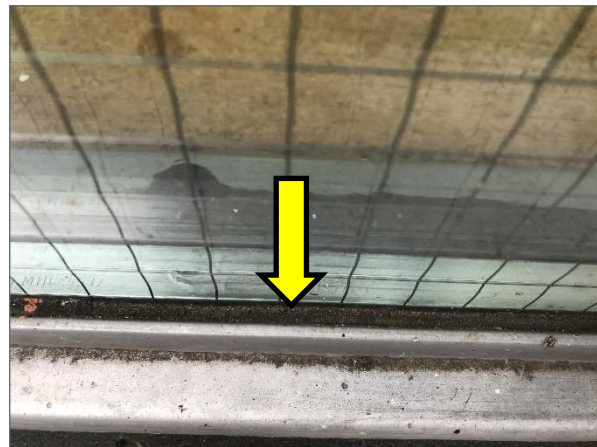
Asbestos-containing black butyl sealant on interior window.

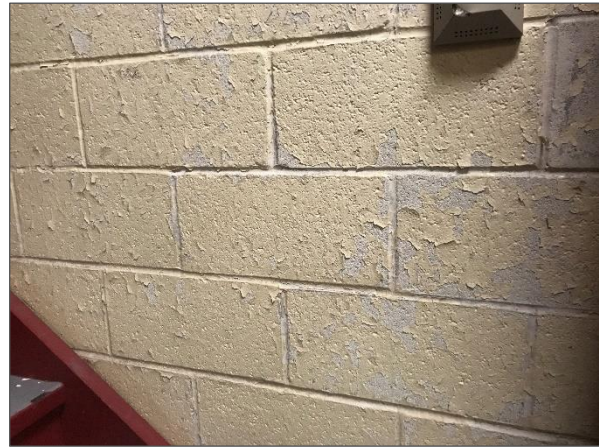
Damaged asbestos-containing paint on concrete block wall in Storage Room 139.

| Material, Quantity & Condition | Current Room Number | Recommended Procedure |
|---|---|---|
| Paint on concrete block wall, 300 square feet, poor condition | Room 139 | Remove in accordance with Type 1 asbestos abatement procedures |

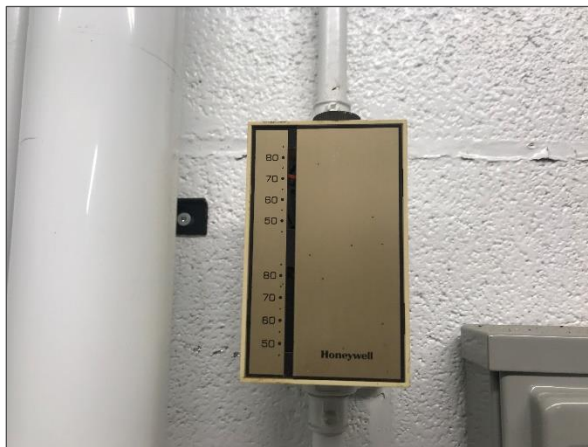
Liquid mercury is present in thermostat ampules.

Do not break lamps or separate liquid mercury from components. Recycle and reclaim mercury from fluorescent lamps and thermostats when taken out of service. Mercury is classified as a hazardous waste and must be disposed of in accordance with applicable regulations.

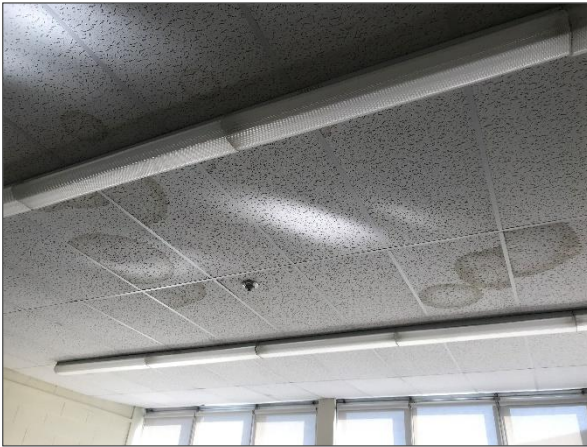
Water stained lay-in acoustic ceiling tiles in Classroom 112.

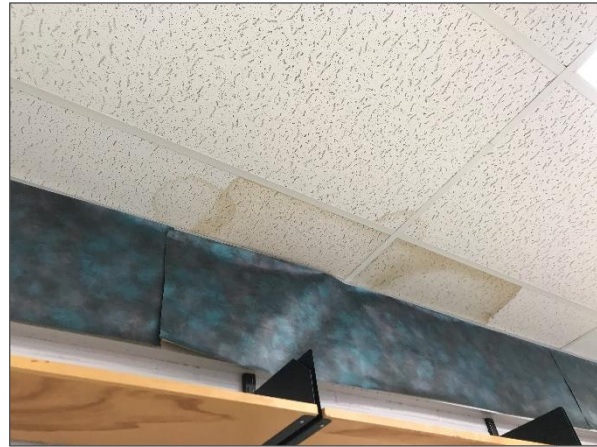
Water stained lay-in acoustic ceiling tiles in Classroom 225.
