Re: Asbestos Reassessment

Susanna Moodie Elementary School, 376 Avonlough Road, Belleville, ON
Pinchin File: 0200584.085

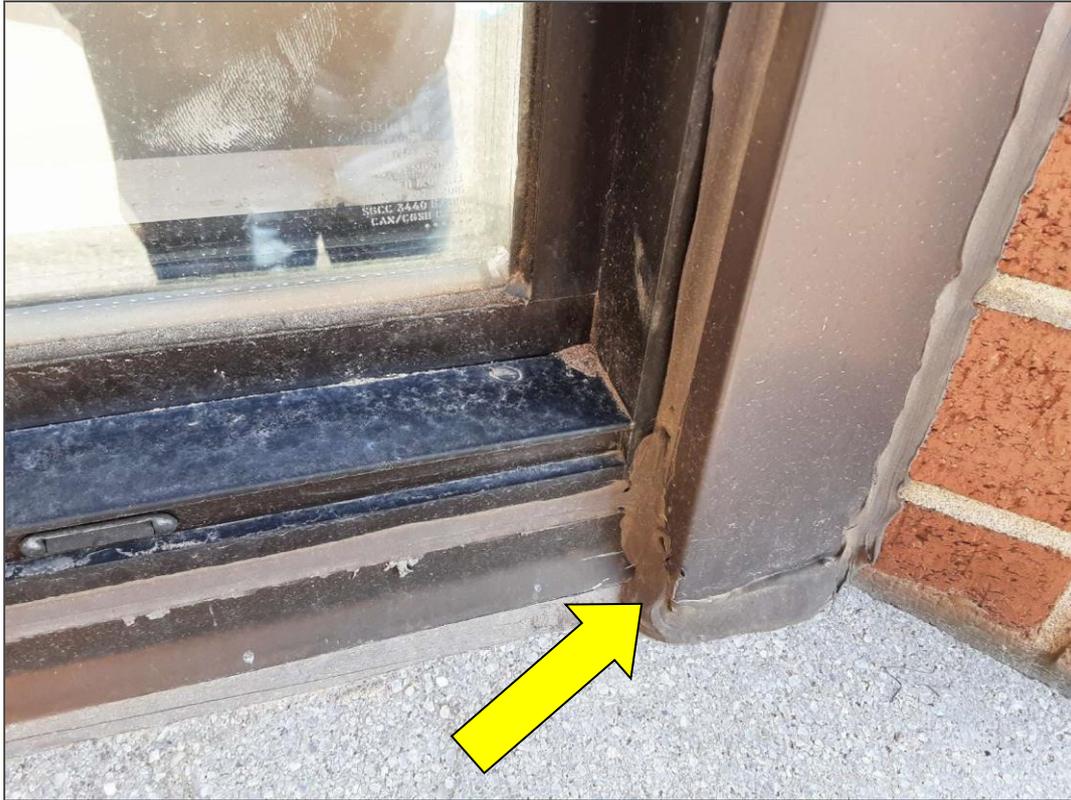
S0001A (Confirmed Asbestos), Wall, Window, Caulking, Brown, Exterior (Location #: 22)

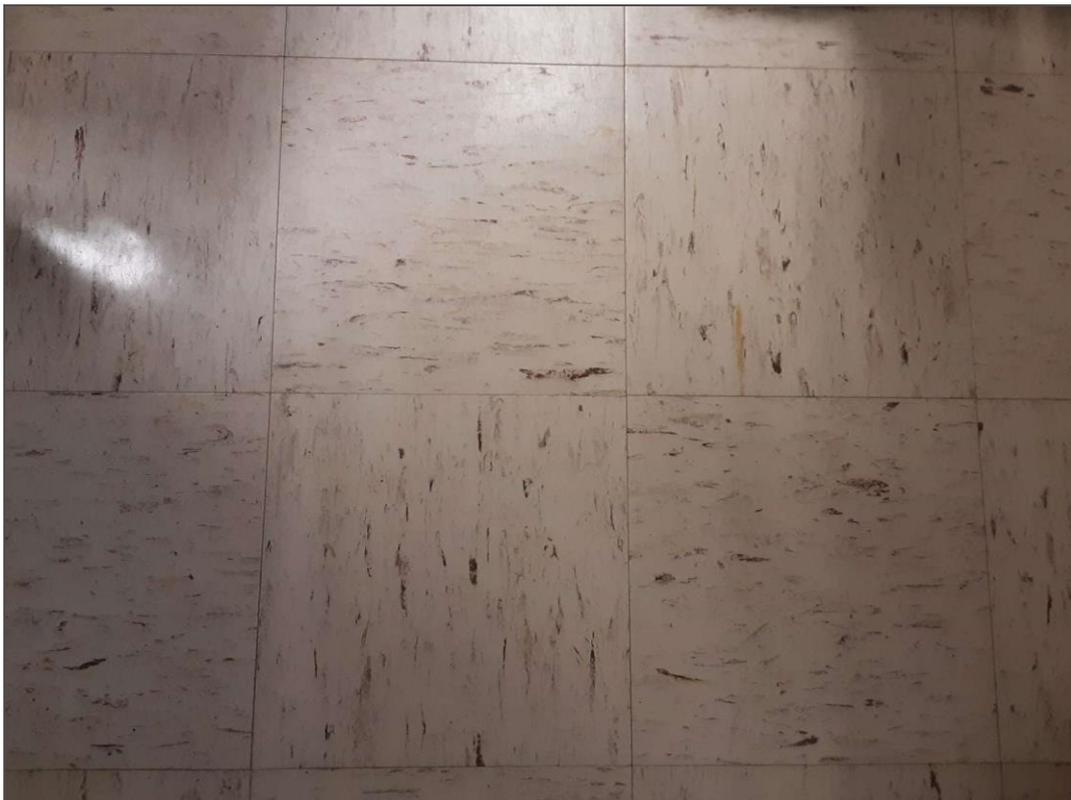
V0004 (Confirmed Asbestos), Floor, Vinyl Floor Tile and Mastic, 12x12 Grey with brown streaks, Storage (Location #: 11)

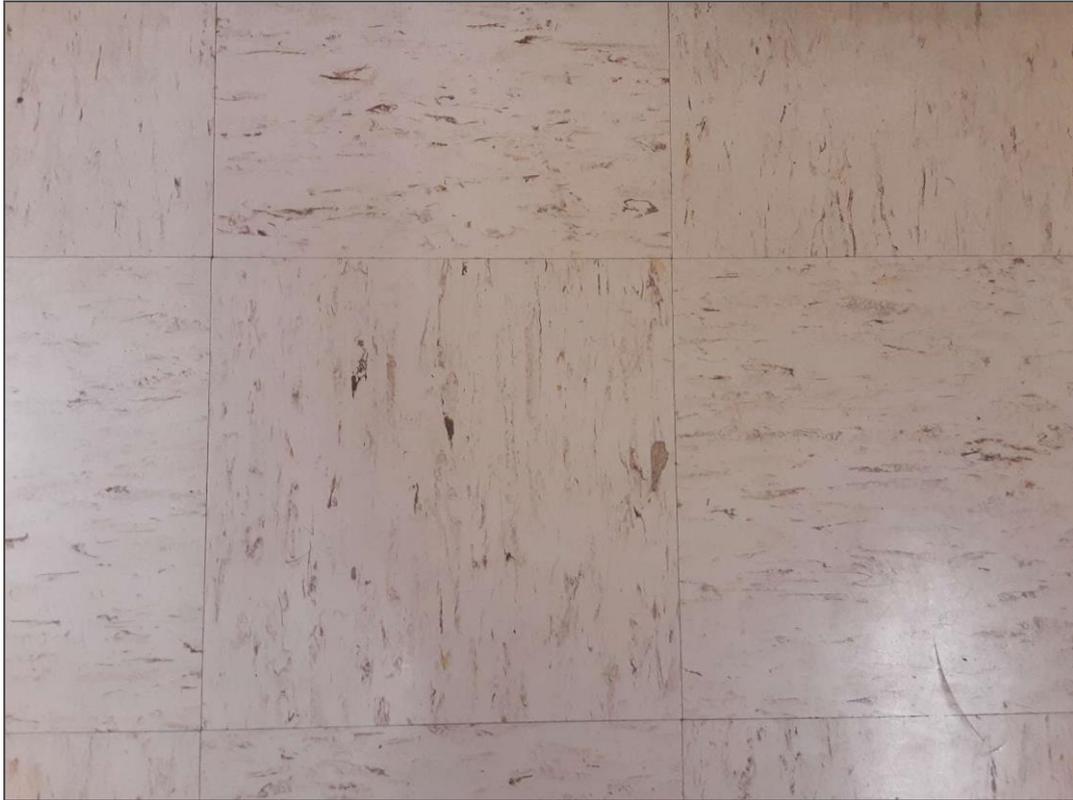
V0004 (Confirmed Asbestos), Floor, Vinyl Floor Tile and Mastic, 12x12 Grey with brown streaks, Classroom (Location #: 7)

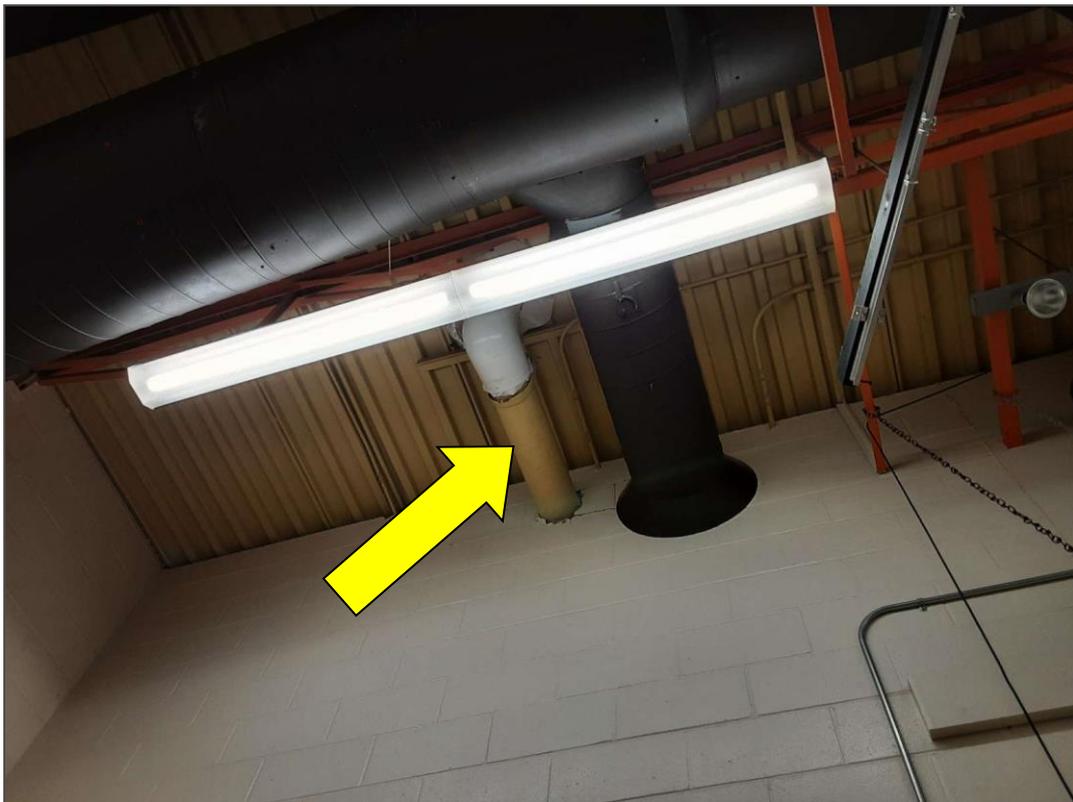
V9500 (Presumed Asbestos), Piping, Rain Water Leader, Cement Product (Transite), Stage (Location #: 23)

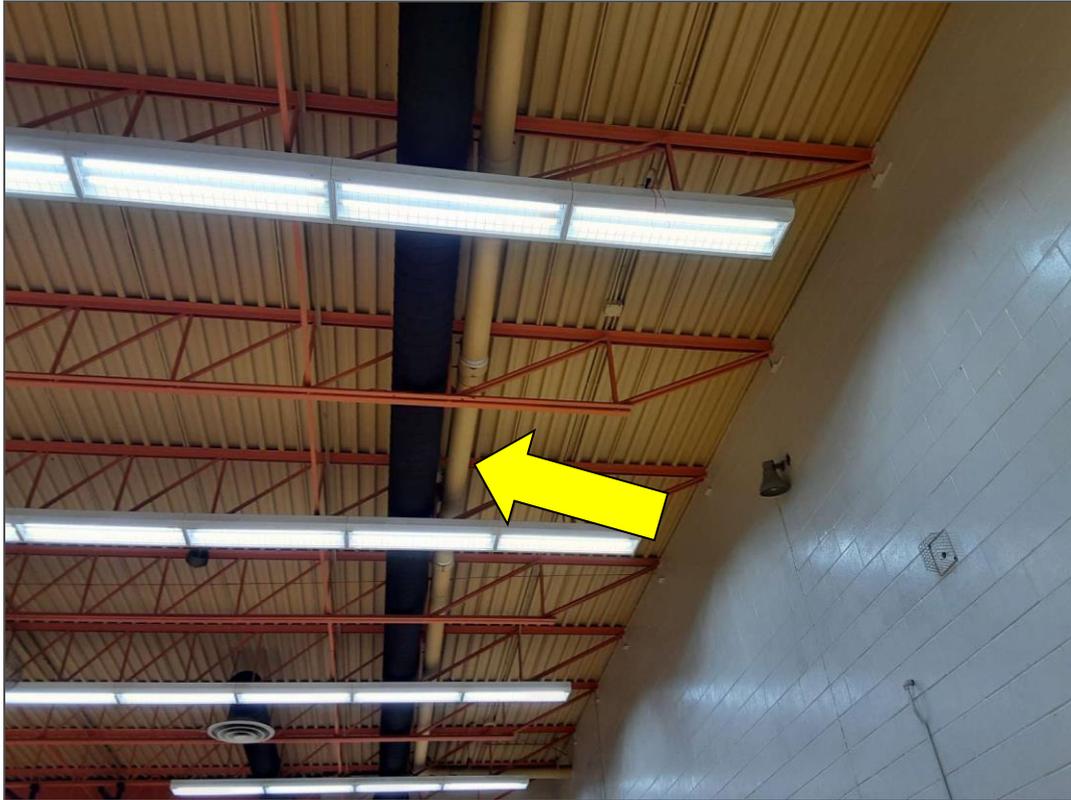
V9500 (Presumed Asbestos), Piping, Rain Water Leader, Cement Product (Transite), Gym (Location #: 4)

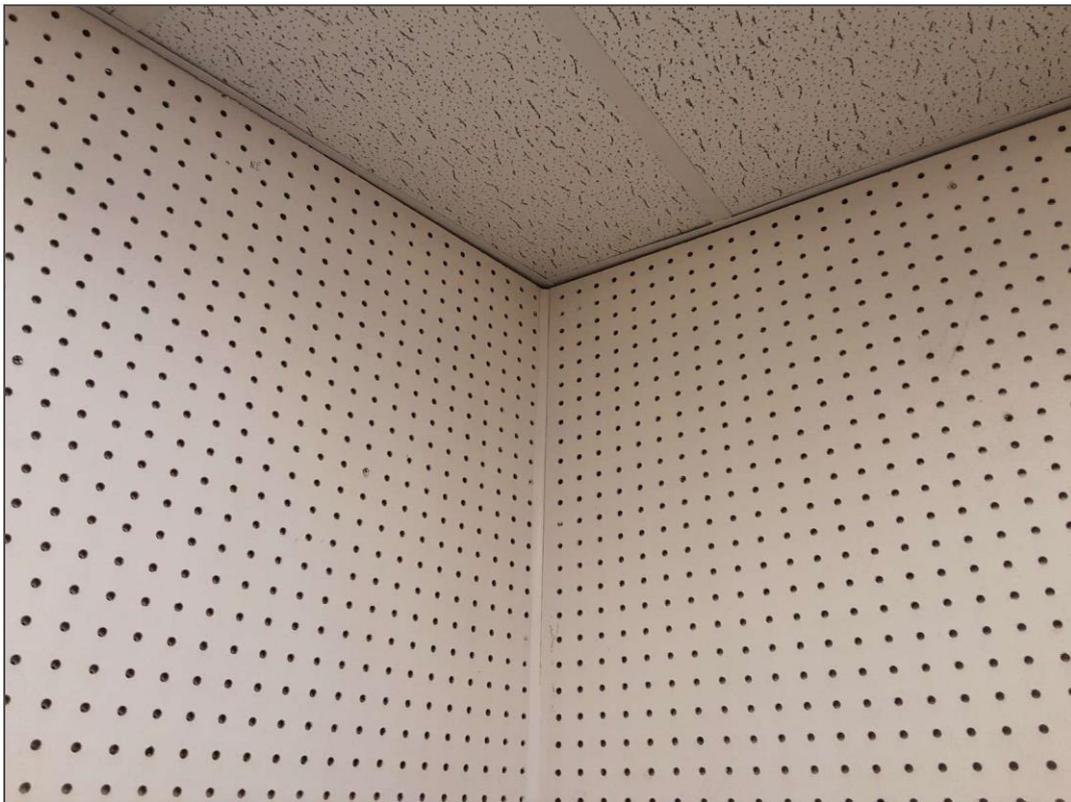
V9500 (Presumed Asbestos), Wall, Cement Product (Transite Panels), Concealed Behind Wood Pegboard, Storage (Location #: 51)

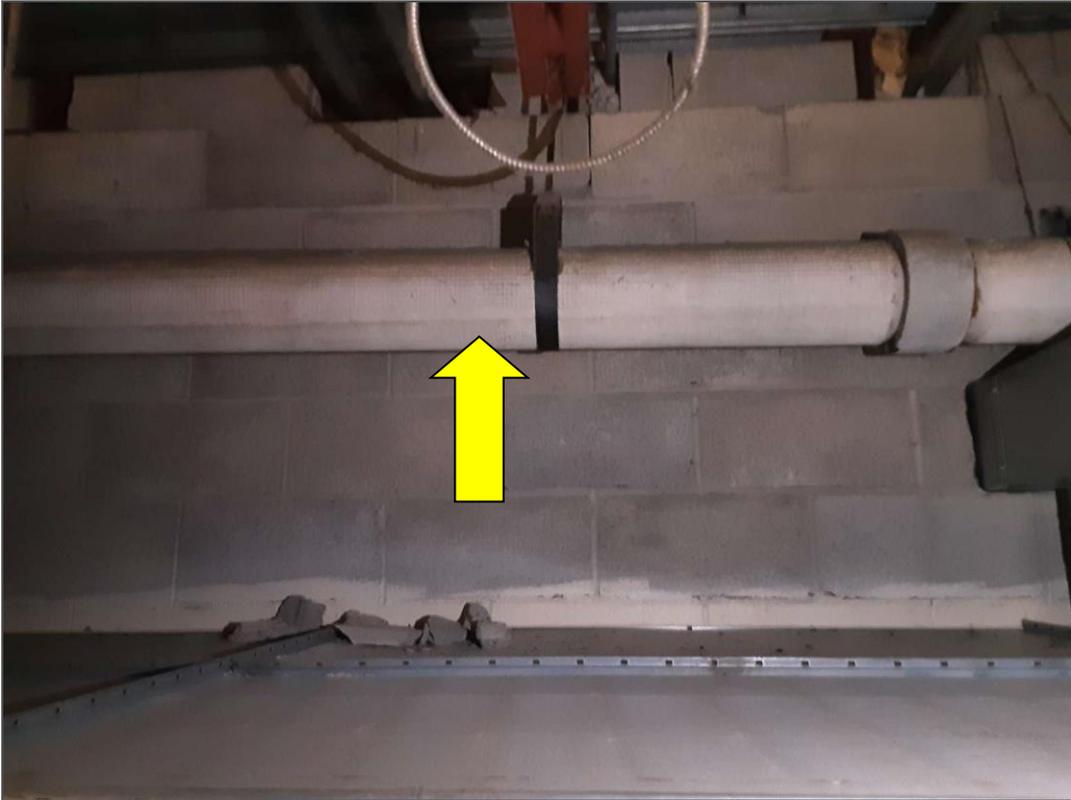
V9500 (Presumed Asbestos), Piping, Rain Water Leader, Cement Product (Transite), Classroom (Location #: 7)
