Revised
Hazardous Building
Materials Assessment

Susanna Moodie Public School
376 Avonlough Road, Belleville,
Ontario

July 10, 2017

Pinchin File: 200584.003

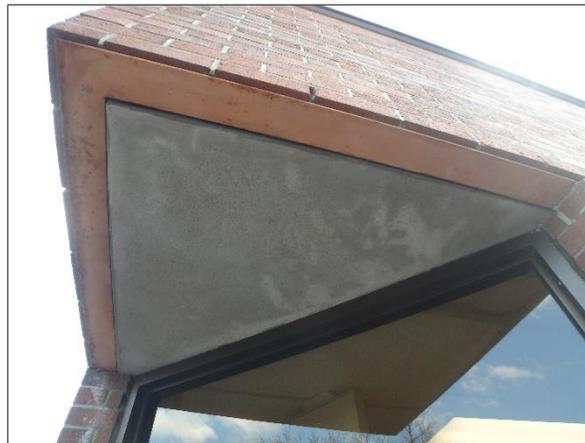
Texture finish, present at exterior canopies, does not contain asbestos (Samples 0002A-C). Presumed asbestos-containing Transite, present above exterior windows in the assessed area, may be present beneath texture finishes.

Non-asbestos exterior texture finish.

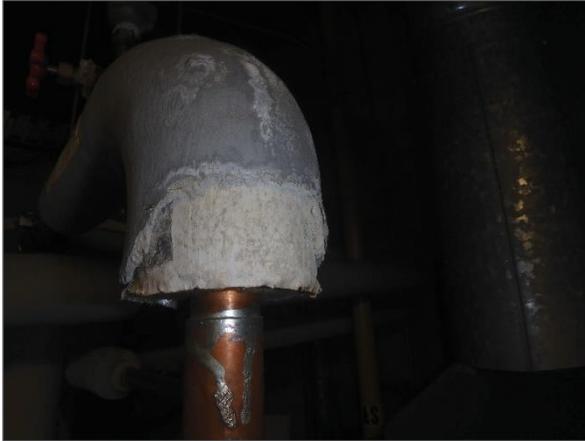
Parging cement, present on pipe fittings in the second floor mechanical room, Location 103 and Location 110, does not contain asbestos (Samples 0010A-C).

Non-asbestos paring cement present on pipe fittings.

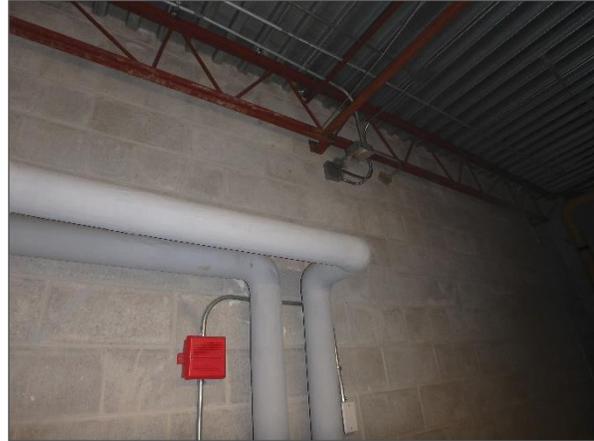
Remaining pipes are either uninsulated or insulated with non-asbestos fibreglass.

Non-asbestos fiberglass insulation on pipe straights.

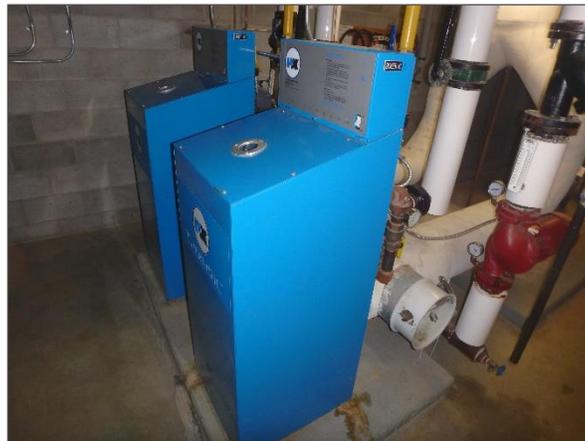
Mechanical equipment is either uninsulated or insulated with non-asbestos fiberglass.

Non-asbestos insulated boilers.

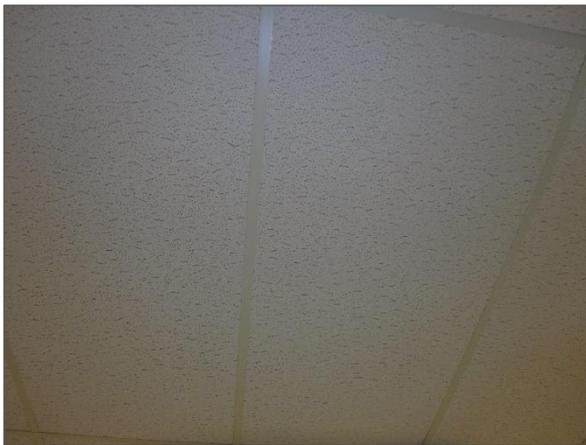
Ceiling tiles are presumed to be non-asbestos based on the date of manufacture determined from the date stamp applied to the top of the tiles. The tiles were manufactured after asbestos stopped being used in acoustic ceiling tiles.

Non-asbestos lay-in tiles with width wise fissures and pinholes.

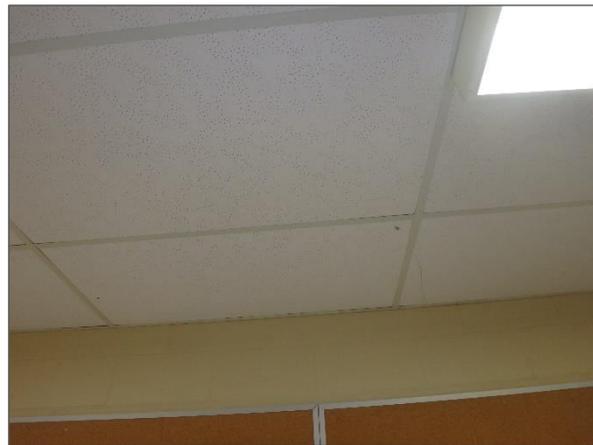
Ceiling tiles are considered to be non-friable and are in good condition.

Non-friable asbestos containing ceiling tiles with a small and medium pinhole pattern.

If ceiling tiles are to be removed (for disposal or if being reinstalled) as a result of planned demolition, renovation, etc., use Type 1 procedures as outlined within Ontario Regulation 278/05 to remove less than 7.5 square metres, and use Type 2 procedures as outlined within Ontario Regulation 278/05 to remove more than 7.5 square metres.

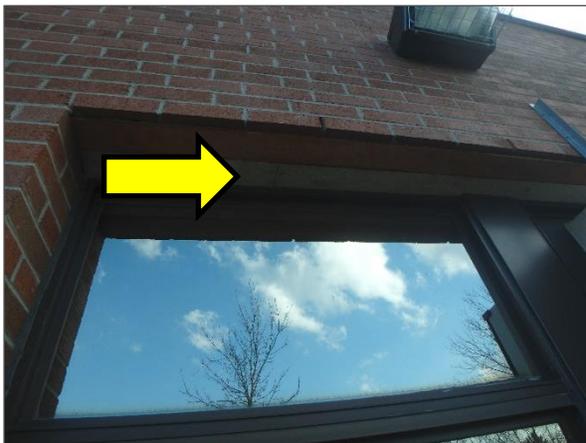
Transite panels, are present at heads of six exterior windows and one door. Approximately 40 square feet (total area) of Transite panels is visible.

Transite is a non-friable material and in good condition.

Transite panels above exterior windows.

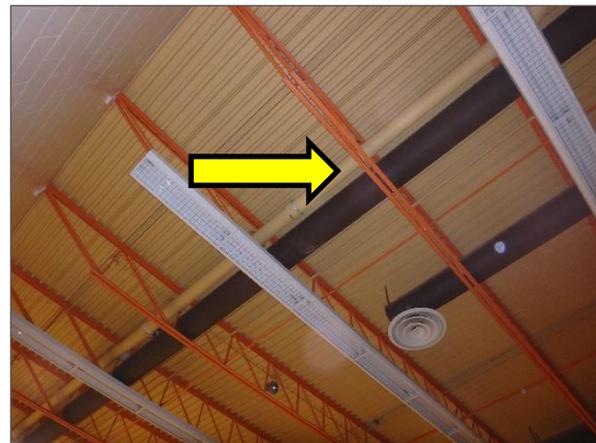
Transite pipe is present as rain water leaders in isolated locations within the building and is presumed to contain asbestos based on visual observation. Approximately 280 linear feet of Transite was visible; however, additional pipe may be concealed in wall and ceiling spaces.

Transite rain water leaders.

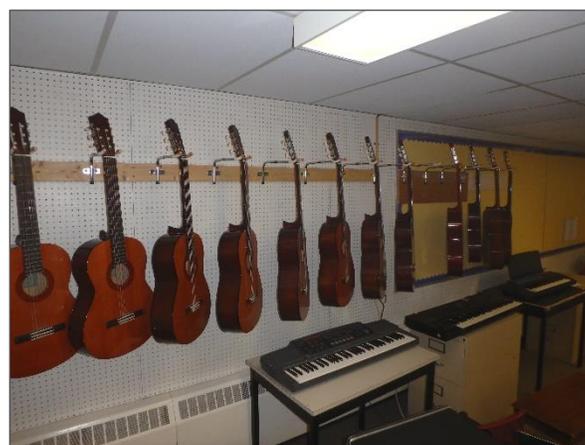
Transite board is present behind wood pegboard in Location 118 and associated practice rooms. Transite is presumed to contain asbestos based on visual observation. Approximately 800 square feet of Transite is present in Location 118.

Transite panels behind wood pegboard in Location 118.

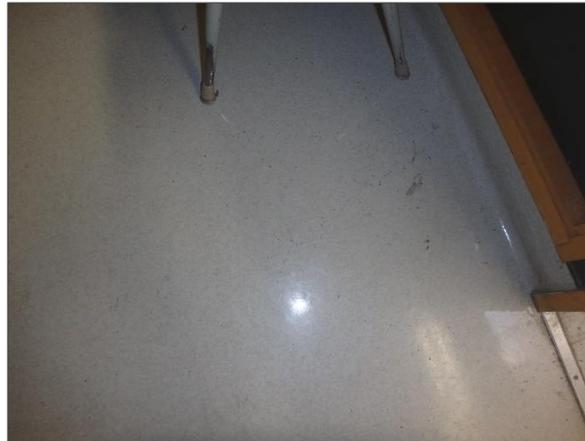
White vinyl sheet flooring with grey flecks, present in Locations 134 and 135, does not contain asbestos (Samples 0008A-C).

Non-asbestos vinyl sheet flooring.

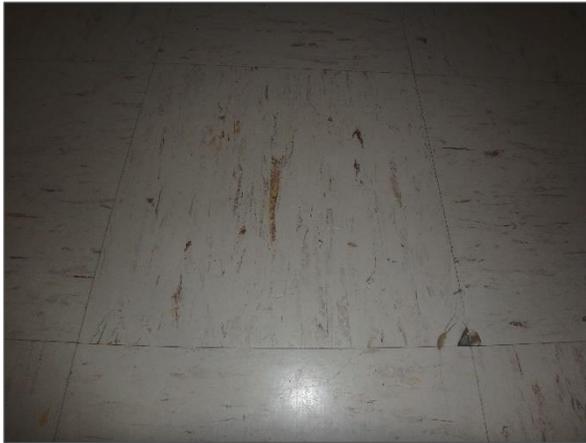
The vinyl floor tiles and mastic are non-friable and are in good condition.

Non-friable asbestos-containing grey vinyl floor tile with brown streaks.

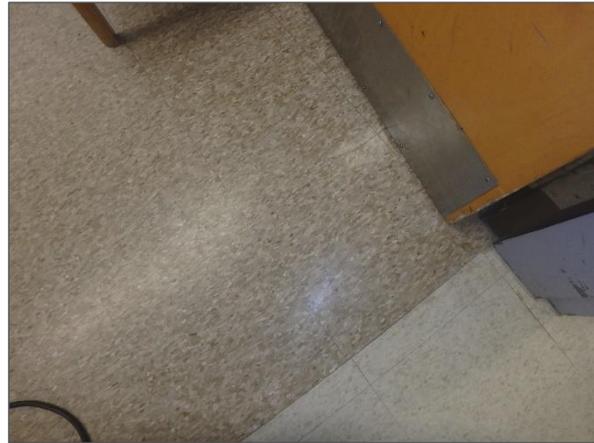
Non-asbestos off-white and brown vinyl floor tiles.

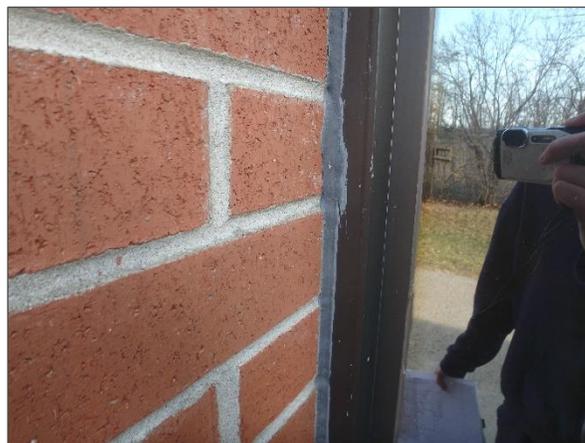
Brown caulking, present at approximately 15 exterior windows and doors, contains chrysotile asbestos (Samples 0001A-C). Caulking is non-friable and is in good condition.

Non-friable brown caulking present at exterior windows and doors.

Brown caulking and expansion joint sealant, present at exterior windows, doors and control joints (Samples PCB1 and PCB2) contains <5.00 ppm PCBs. The materials are a non-PCB solids based on the threshold given in SOR/2008-273 (50 ppm).

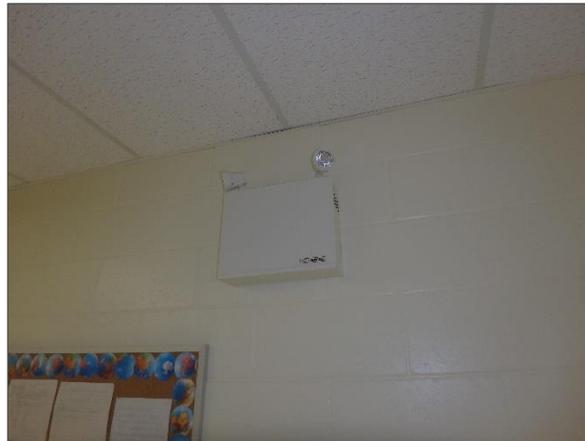
Lead-containing batteries are present in emergency lighting.

Emergency light containing lead acid batteries.
