Limited Designated Substance Survey Report

Bolton C. Falby Public School

80 Falby Court, Ajax, Ontario

October 23, 2025
Parasol Project No: 13335

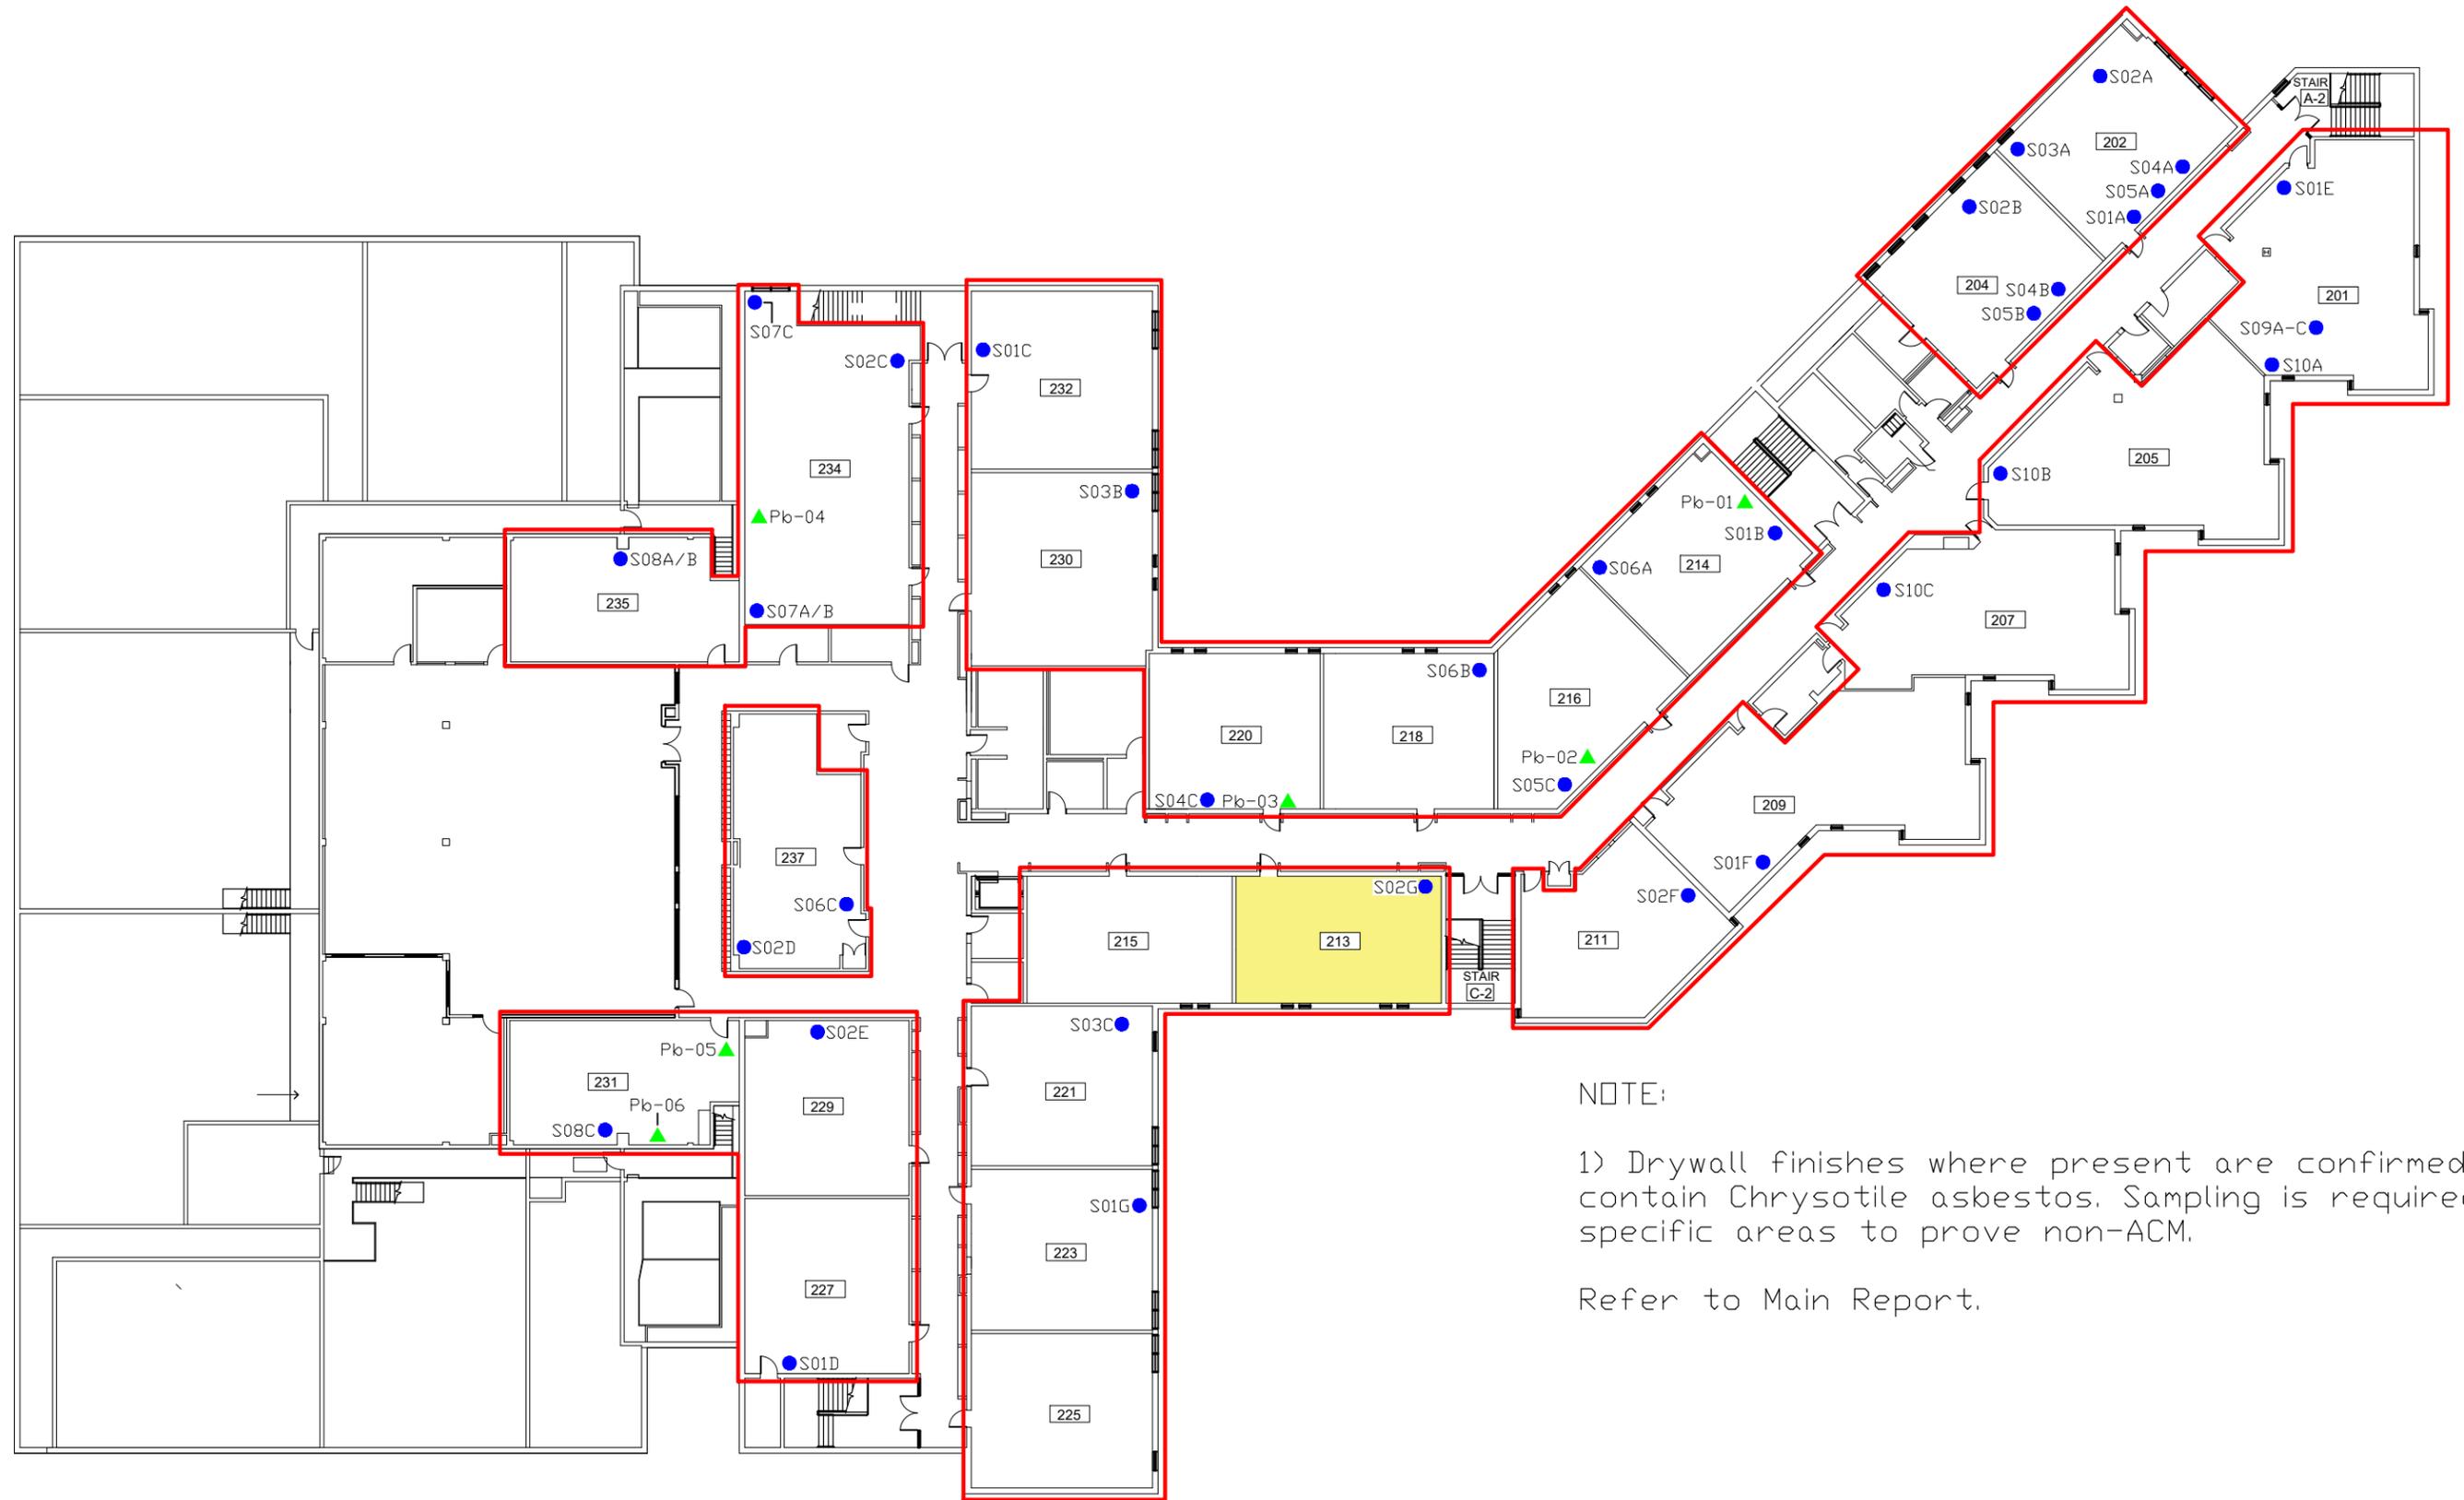
Transite cement products were observed to be present in the form of rainwater leaders (piping) and limited to Location #213.

No samples of the transite cement products were collected as sampling could disrupt the integrity of the material. Transite cement products typically contain Chrysotile or Amosite asbestos of varying percents. Visual identification is typically reliable for identifying transite cement products; however, a non-asbestos-containing equivalent of transite cement products is manufactured. At the time of the assessment, the transite cement rainwater leader was observed in GOOD condition.

1) Drywall finishes where present are confirmed to contain Chrysotile asbestos. Sampling is required in specific areas to prove non-ACM.
