Limited Designated Substance Survey Report

Uxbridge Secondary School

127 Planks Lane, Uxbridge, Ontario

October 23, 2025
Parasol Project No: 13338

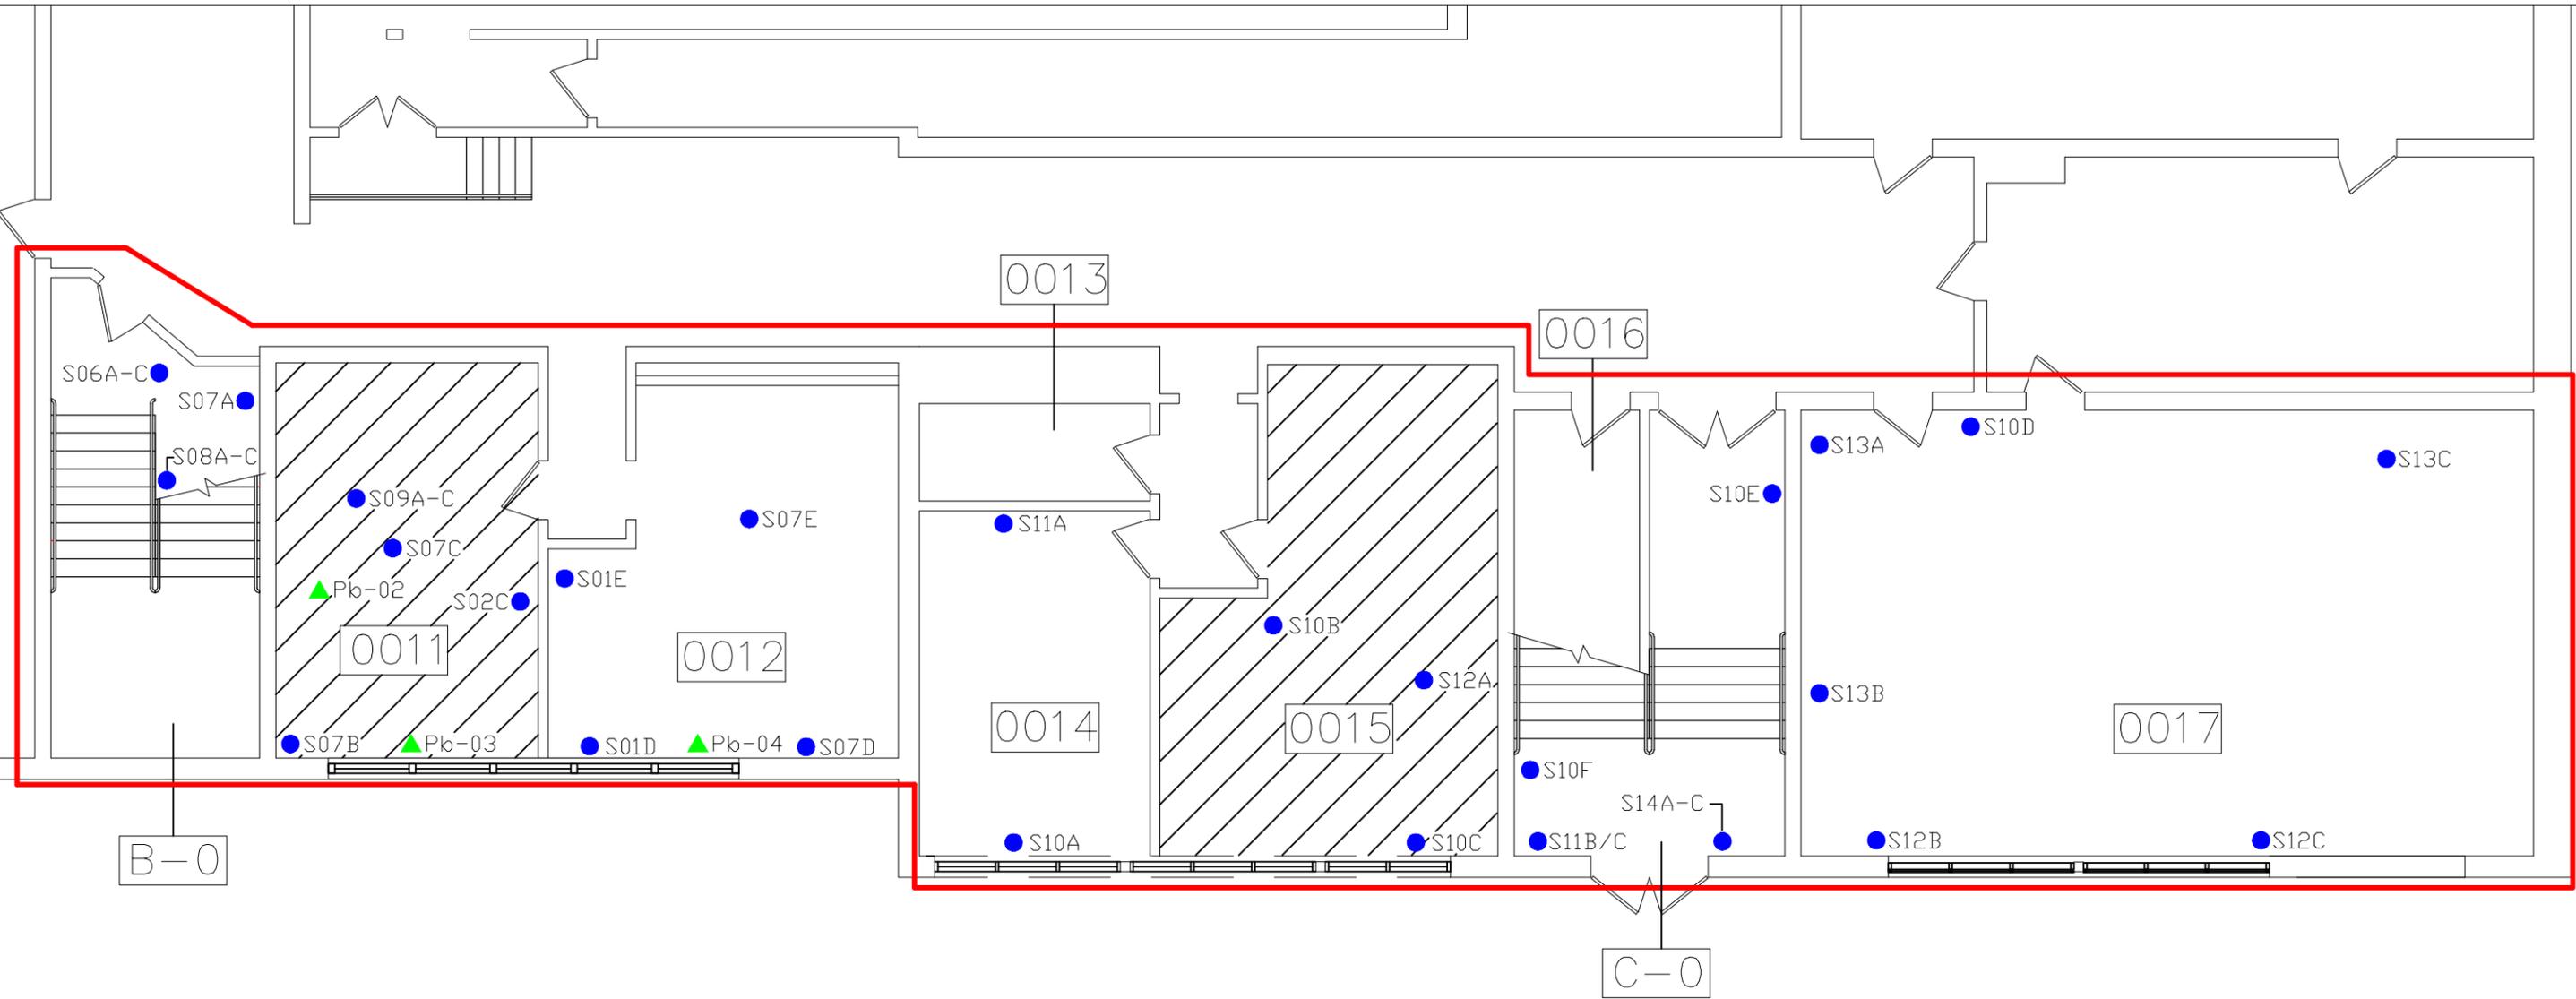
1) Smooth plaster finishes where present within the 1928 Original Building Survey Area are confirmed to contain Chrysotile asbestos. Sampling is required in specific areas to prove non-ACM.

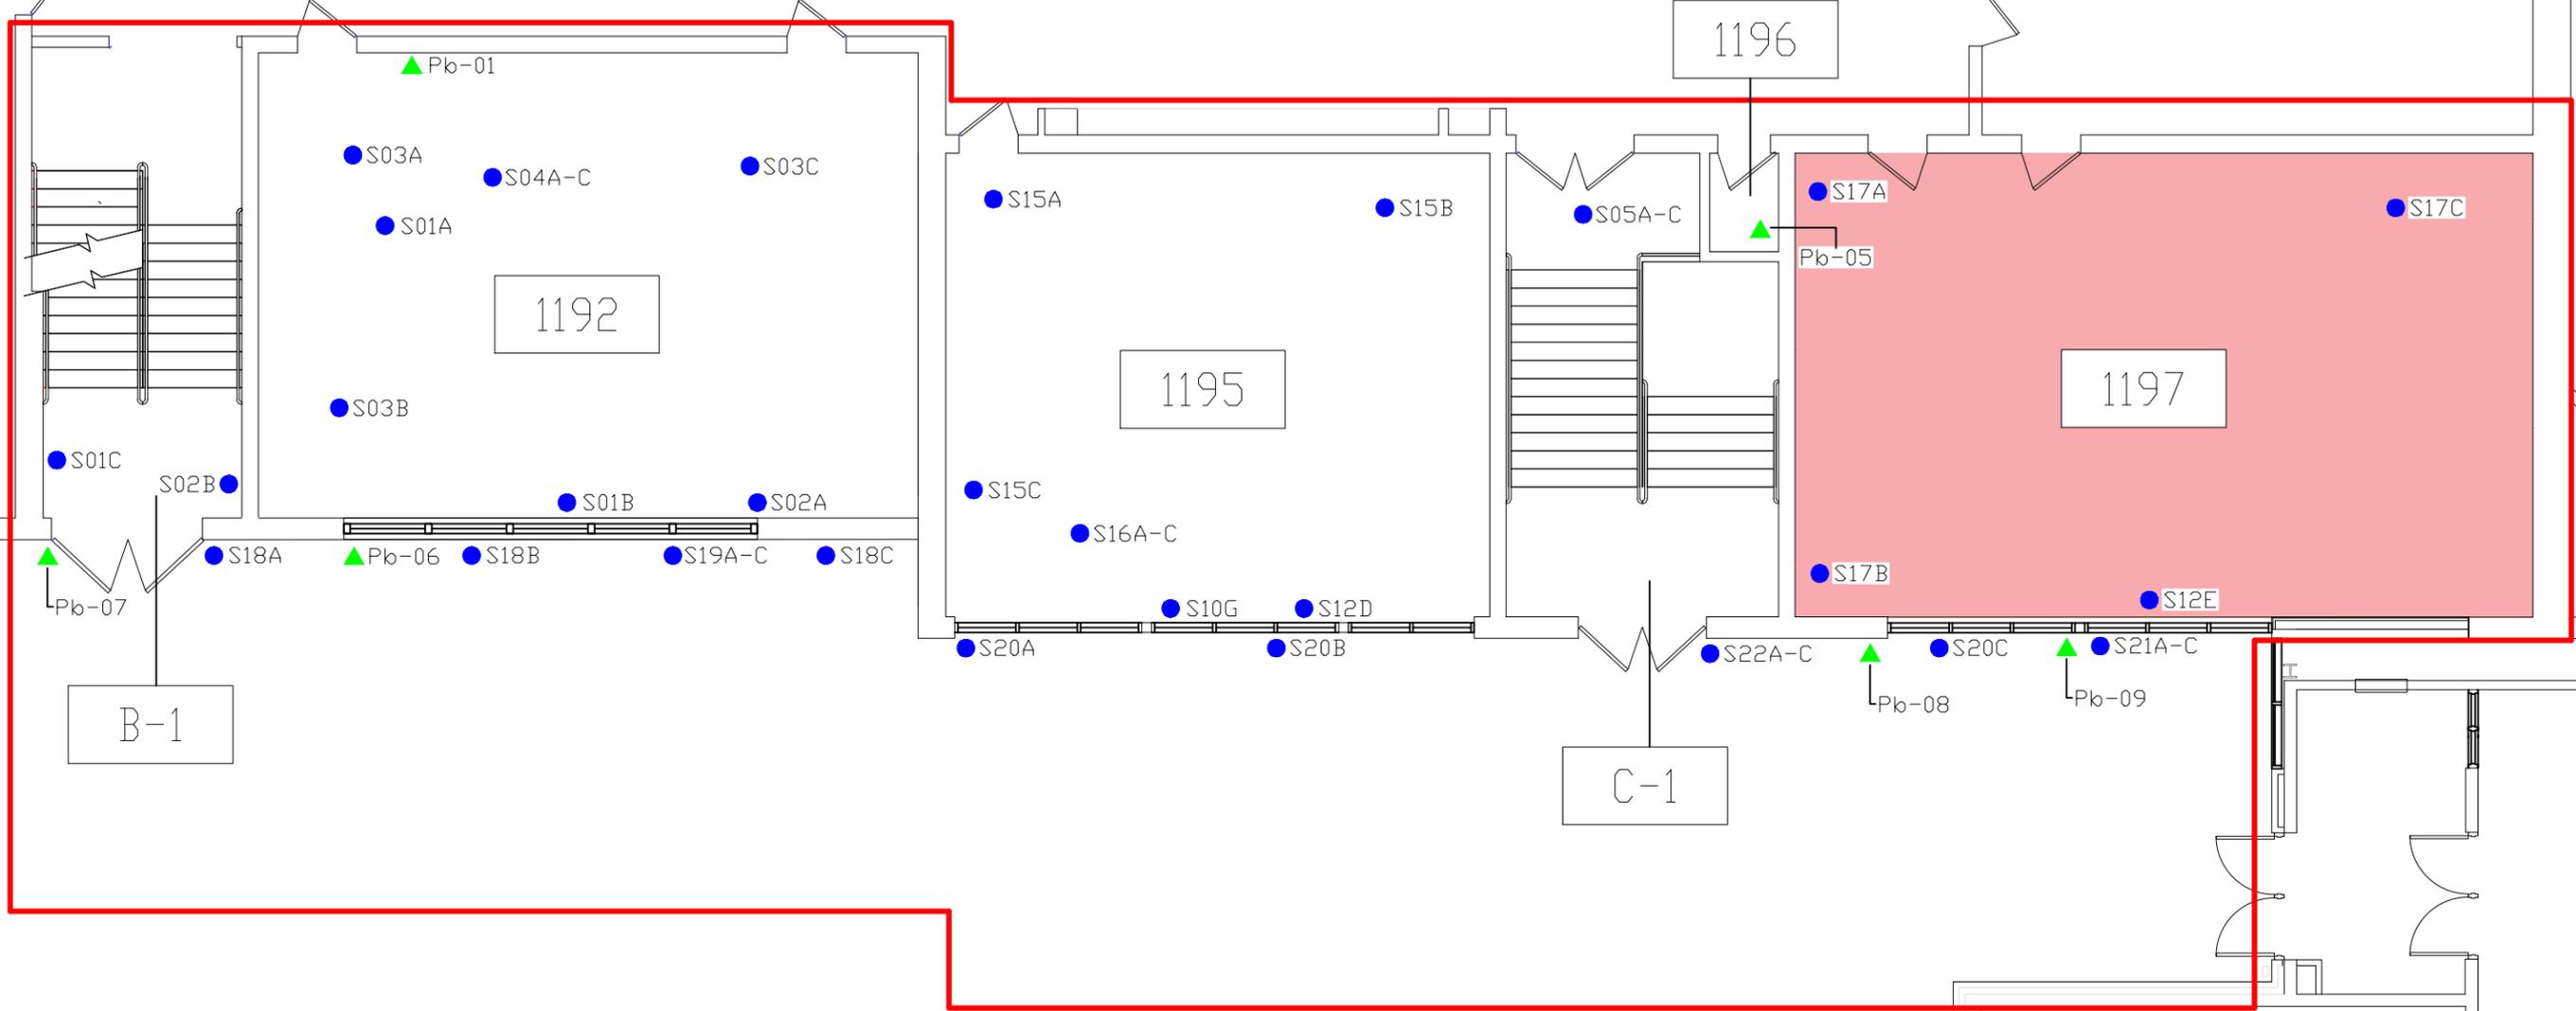
1) Smooth plaster finishes where present within the 1928 Original Building Survey Area are confirmed to contain Chrysotile asbestos. Sampling is required in specific areas to prove non-ACM.
