DESIGNATED SUBSTANCES - SPREADSHEET OF FINDINGS
FOR PAINTING OPERATIONS
Wasaga/Cedar/Carlton, Oshawa, Ontario

ASBESTOS-CONTAINING MATERIALS (Cont'd)

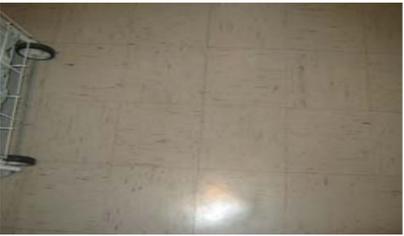
ASBESTOS-CONTAINING MATERIALS												
Area	Level	Location	Material & Description	Est. Qty*	Units	Condition	Friable Yes/No	Accessibility	Sample #	% Asbestos and Type	Photographs	Recommended Procedures For Painting Operations
317 Carlton Court (Second Floor Hall and Closet) and 313 Carlton Court (Ground Floor Hall and Closet)	First and Second Floors	Floor	Beige 23 cm x 23 cm vinyl floor tiles with brown streaks	12	Square meters	Good	No	High	2A-C	5% chrysotile asbestos

Do not disturb the material. If disturbance is required or the material is damaged, remove following Type 1 Asbestos Procedures.
Exterior	All	Windows and doors	White Caulking	30	Meters	Good to fair	No	High	5A-B	2% chrysotile asbestos

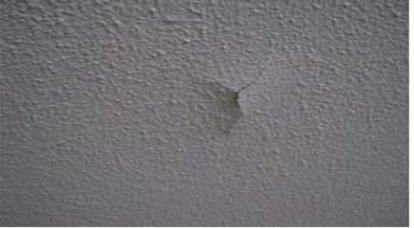
Cedar Street and Wasaga Court	Ground Floor	Living Room Ceilings	Texture coat	31	Square meters (per unit)	Good (with some areas of minor damage)	Yes	Moderate	7A-E	6% chrysotile asbestos

Do not disturb the material. If disturbance is required or the material is damaged (i.e. less than 1 square metre only), repair following Type 2 Asbestos Procedures. If greater than 1 square metre of damage is present, removal and repair will require Type 3 Asbestos Procedures. Painting asbestos-containing texture coat in good condition requires Type 2 asbestos procedures.
Exterior	Ground Floor	Exterior walls and windows	White caulking	30	Meters	Good	No	High	8A-C	4% chrysotile asbestos

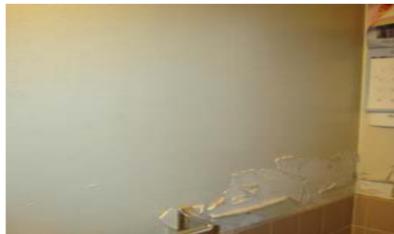
Light sanding of surfaces containing moderate levels of lead is classified as a Type 2a Lead Operation, provided the airborne concentration of lead is maintained below >0.05 to 0.5 mg/m ³ of air. Applying paint causes no disturbance to the lead-containing paint that is present in good condition. Lead Awareness Procedures are recommended.
Interior	Throughout	Walls	Various Paint	N/A	Good	Moderate	LP1, LP3 to LP07	All remaining paint samples collected were found to contain low levels of lead ranging from <0.0076% to 0.34%

Light sanding of surfaces containing low levels of lead is classified as a Type 1 Lead Operation, provided the airborne concentration of lead is maintained below <0.05 mg/m ³ of air. Applying paint causes no disturbance to the lead-containing paint that is present in good condition. Lead Awareness Procedures are recommended.

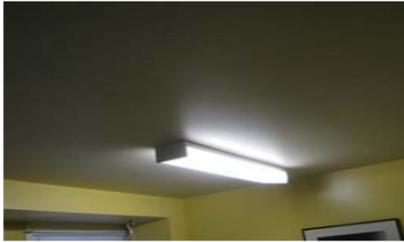
OTHER DESIGNATED SUBSTANCES								
Substance	Level	Location	Estimated Quantity	Condition	Accessibility	Sample #	Photographs	Recommended Procedures For Painting Operations
Mercury - vapour	All	Fluorescent light fixtures	N/A	Good	Moderate	Not sampled - presumed

Disturbance of this mercury-containing product is not anticipated during painting operations.
Mercury Thermostat	Various	Wall mounted Thermostat	N/A	Good	High	N/A
