Designated Substances Survey

**Immaculate Conception
Catholic Elementary
School**

**76 Robinson Street,
Peterborough, Ontario**

January 21, 2026

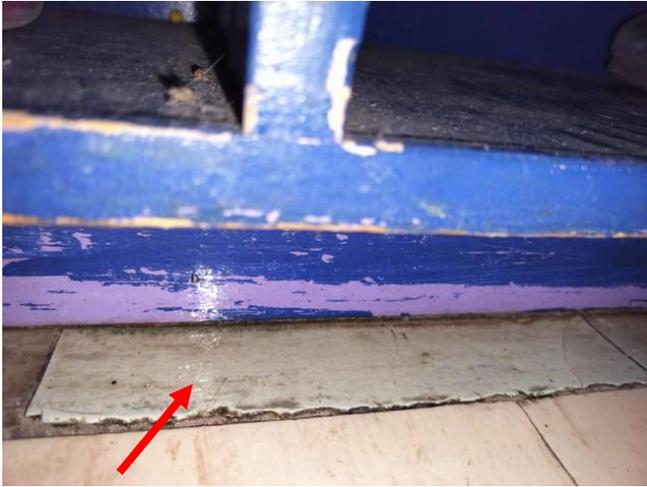
Photo 1: View of the asbestos containing 9"x9" blue/grey vinyl floor tiles (see arrow) observed to be in fair condition beneath the shelving unit within Classroom 204.

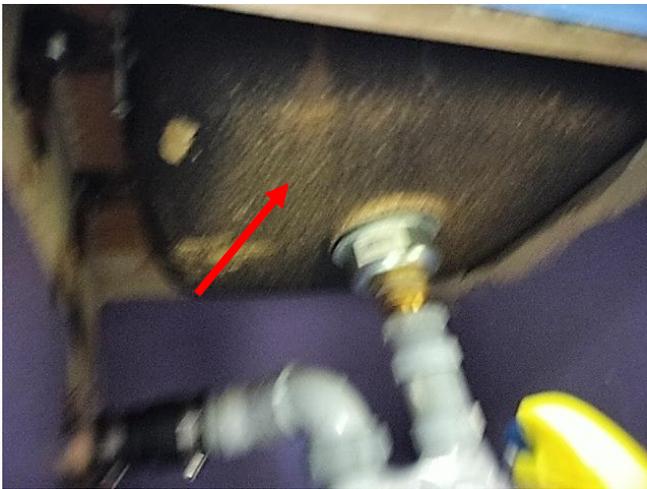
<p>Gold sink coating (S2S, 2019) present within Classrooms 114, 115, 204 and 205 was identified to contain 8% Chrysotile asbestos by laboratory analysis. At the time of the site visit, approximately 16 ft² (4 sinks) of asbestos containing gold sink coating was observed to be in good condition.</p>

Photo 3: View of the asbestos containing gold sink coating (see arrow) observed to be in good condition within Classroom 115.

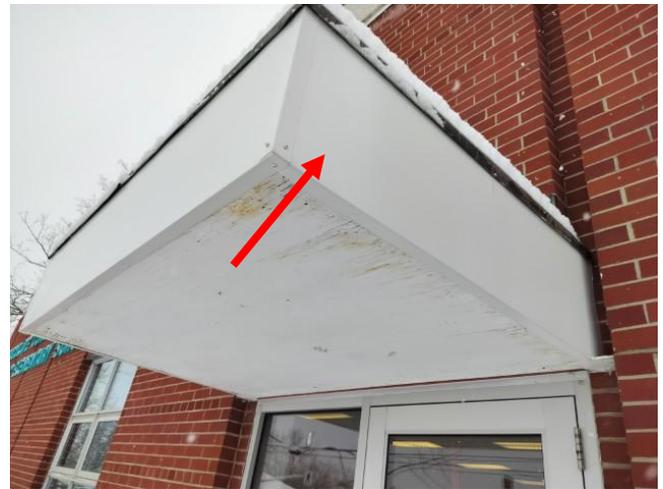
Photo 4: View of the encapsulated asbestos containing cement board (see arrow) observed to be in good condition on east exterior soffits.

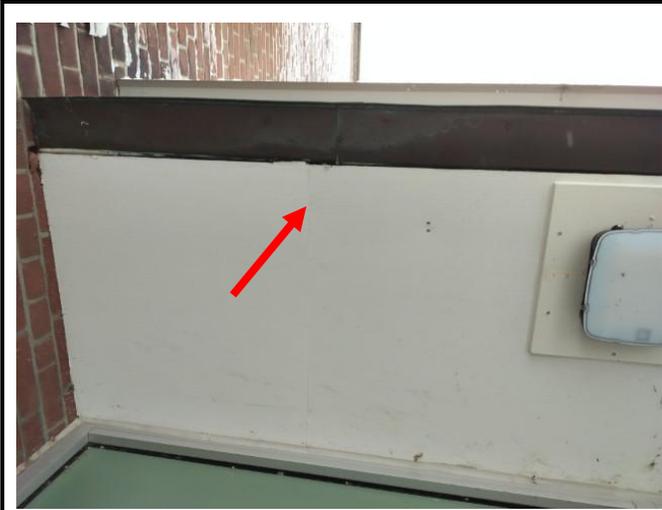
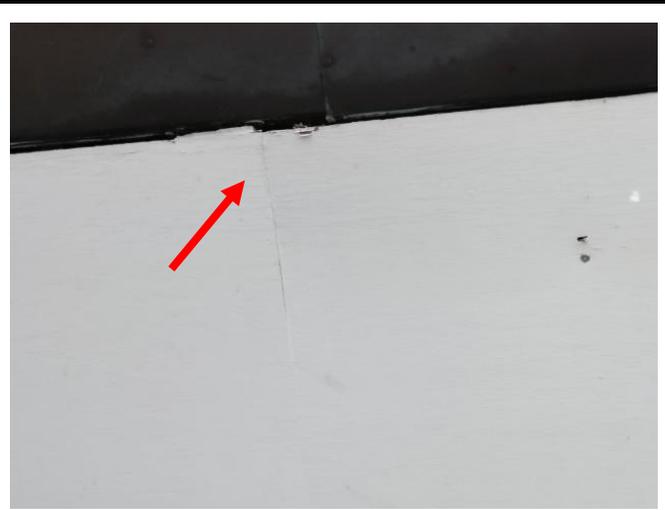
Photo 5: View of the asbestos containing cement board (see arrow) observed to be in fair condition at the exterior of Corridor 219.

Photo 6: Additional close-up view of the asbestos containing cement board (see arrow) observed to be in fair condition at the exterior of Corridor 219.

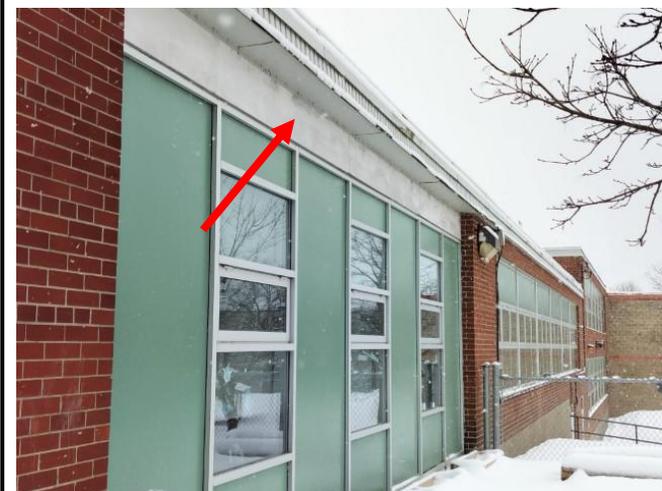
Photo 7: View of the asbestos containing cement board (see arrow) observed to be in good condition on siding near the Parking Lot of the Subject Building.

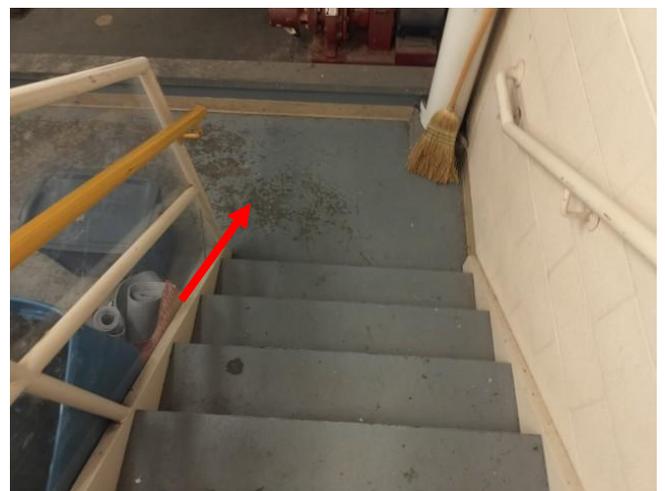
Lead	<p>Grey paint (WSP, 2016) observed on the concrete floor of the Mechanical Room was previously identified to contain 0.0084% lead content by dry weight. At the time of the site visit, the low-level lead containing grey paint was observed to be in fair condition.</p> <p>Cream paint (S2S, 2021) observed on the concrete block walls in Corridor 119 was previously found to contain 0.043% lead content by dry weight. At the time of the site visit, the low-level lead containing cream paint was observed to be in good condition.</p> <p>Blue/purple paint (S2S, 2021) observed on the stair railings and doors was previously found to contain 0.012% lead content by dry weight. At the time of the site visit, the low-level lead containing blue/purple paint was observed to be in good condition, with the exception of approximately 4 linear feet which was observed to be in fair condition on the railings in Stairwell No. 3.</p> <p>Peach paint (S2S, 2021) observed on drywall walls within Room 122 was previously found to contain 0.0071% lead content by dry weight. At the time of the site visit, the low-level lead containing peach paint was observed to be in good condition.</p> <p>Cream paint (S2S, 2021) observed on drywall walls within Room 120 was previously found to contain 0.0070% lead content by dry weight. At the time of the site visit, the low-level lead containing cream paint was observed to be in good condition.</p> <p>Lead may also be present in electronic components (e.g., wiring connections, wire bundles, etc.), plumbing solder, roof flashing, noise baffles, emergency lighting</p>

Photo 8: View of the low-level lead containing grey paint (see arrow) observed to be in fair condition on the floor of the Mechanical Room.

- 4) Paints identified in Table 2 above were found to contain detectible concentrations of lead. Based on visual observations during the DSS, the identified low-level lead containing paints noted in Table 2 were observed to be in good condition, with the exception of the fair condition grey paint within Mechanical Room and the fair condition blue/purple paint on the Stairwell railing. Paints with similar texture and appearance that are present throughout the Subject Building should be presumed to contain similar concentrations of lead. It is recommended that the fair condition paint be stabilized with fresh paint using appropriate worker protection.

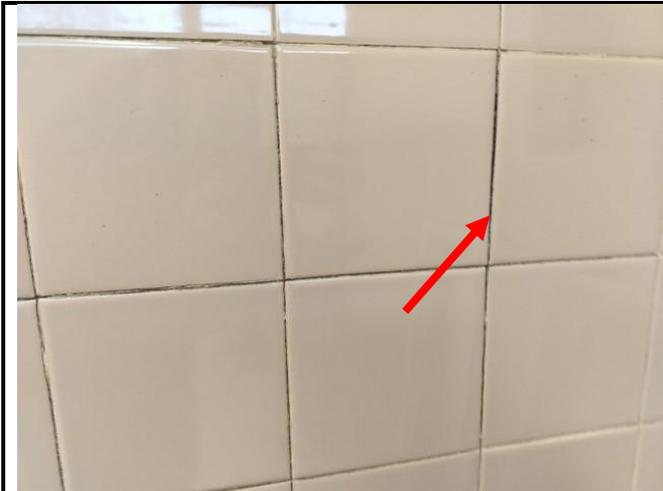
Photo 9: View of the visual suspect mould growth (see arrow) observed on the non-asbestos containing ceramic tile grout on the wall within the Boy's Washroom.

- 8) Evidence of visual suspect mould growth was identified on building finishes within the Subject Building and are detailed in Table 2. S2S recommends that apparent water-stained acoustic ceiling tiles be removed by trained maintenance staff and that the sources of all apparent water staining be investigated and repaired to prevent the development of mould growth. S2S also recommends that the visual suspect mould growth be removed following Level 1 mould abatement procedures in accordance with the EACC (2015) and CCA (2018) guidelines.

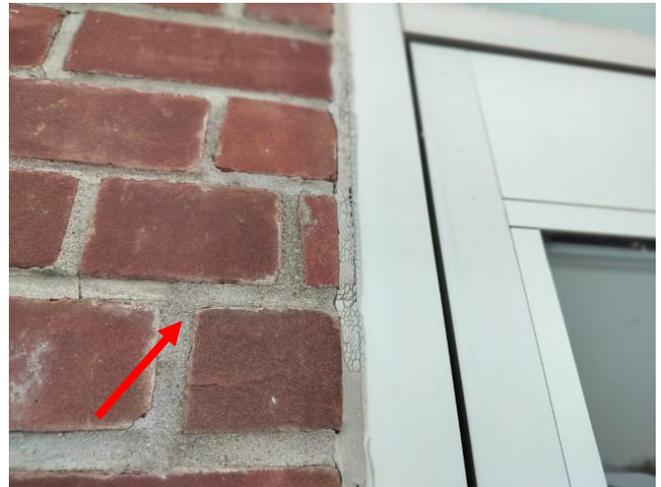
Photo 10: View of the non-asbestos containing brick mortar (see arrow) observed on the exterior walls throughout the Subject Building.

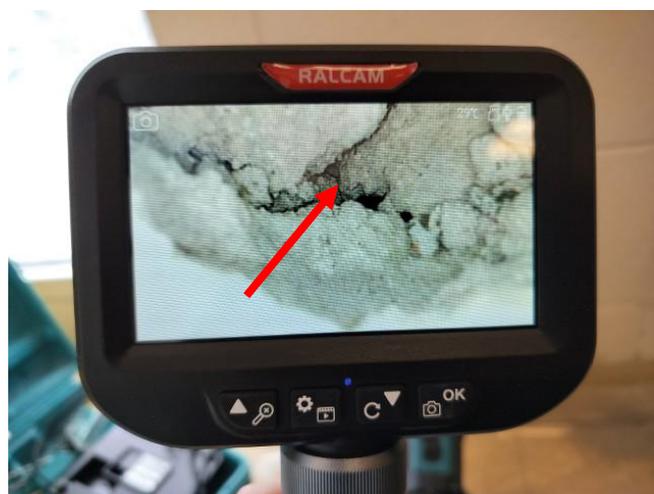
Photo 11: View of the borescope (see arrow) observing within the drill hole conducted in Classroom 210 during the vermiculite investigation.

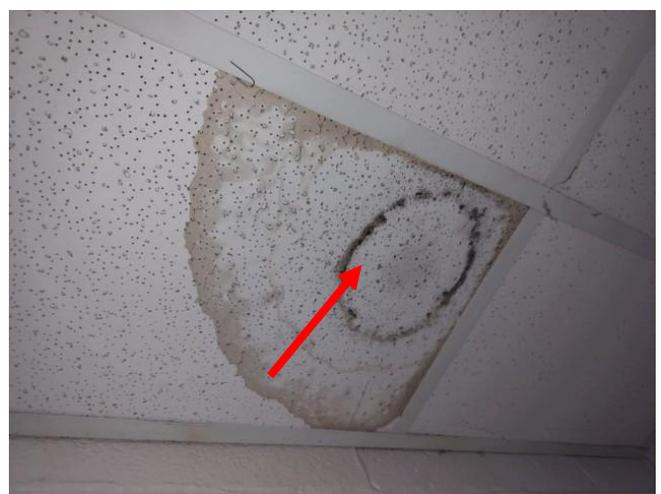
Photo 12: View of the visual suspect mould growth (see arrow) observed on the non-asbestos containing acoustic ceiling tile outside of the Gymnasium Door.
