Limited Designated Substance Survey Report

Waverly Public School

100 Waverly Street South, Oshawa, Ontario

March 6, 2026
Parasol Project No: 13370

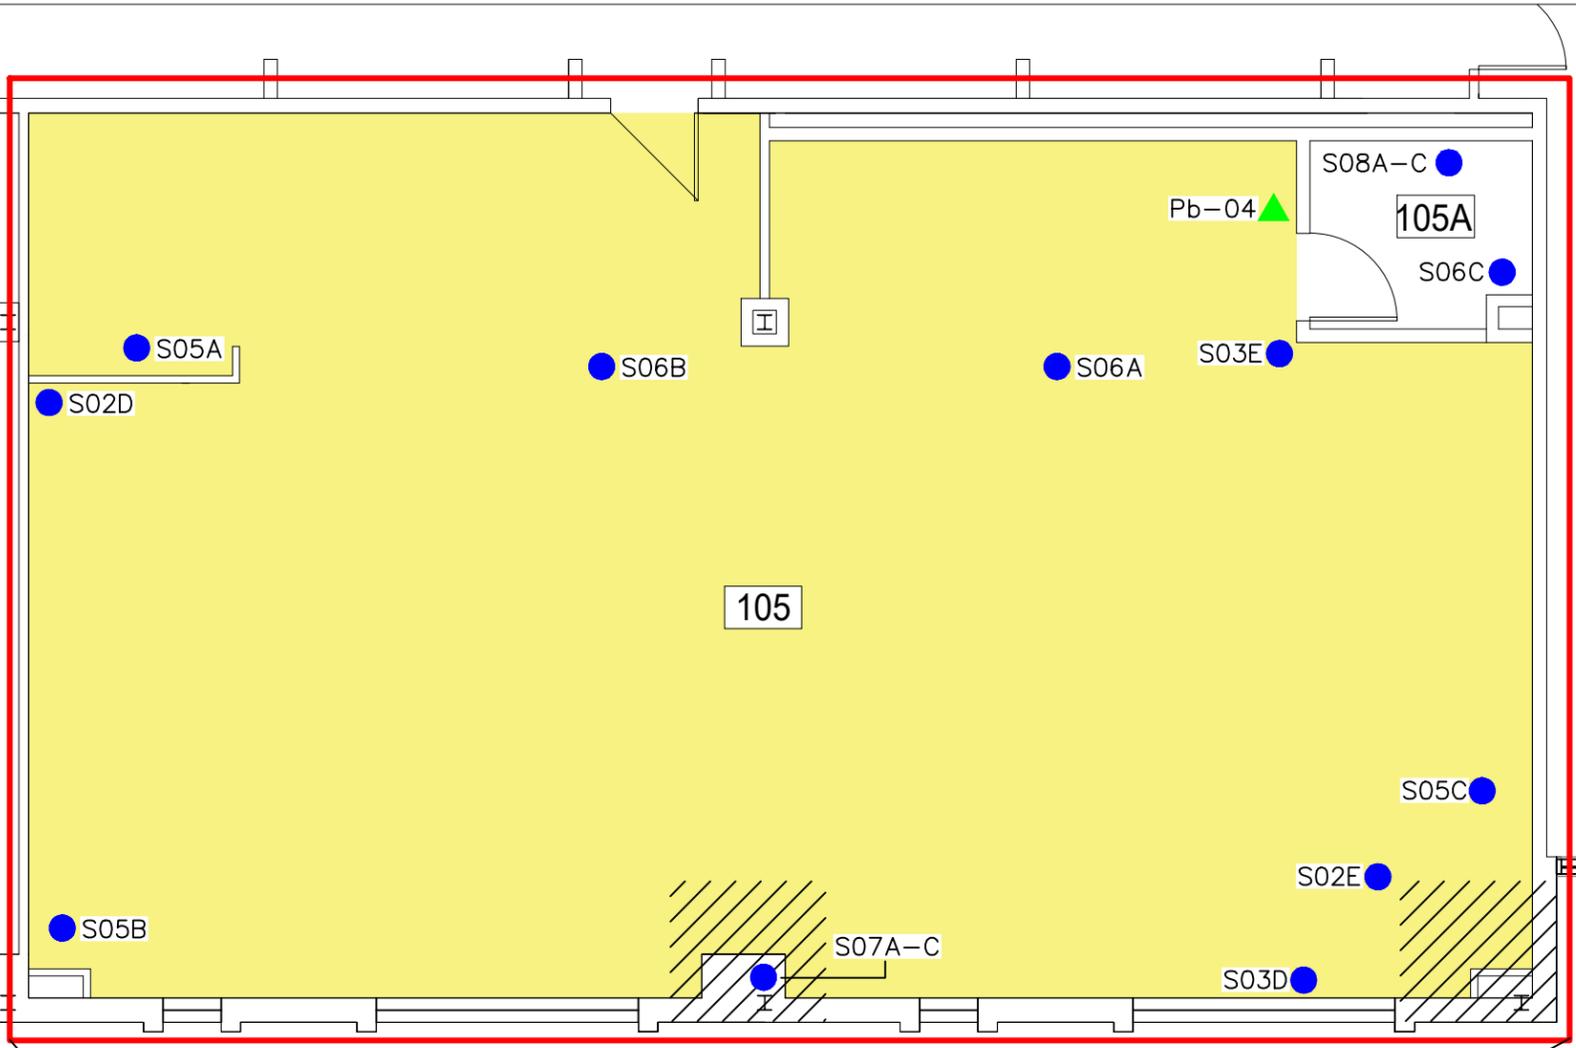
TITLE
**Limited Designated Substance Survey
 First Floor Plan**

- 1) Drywall finishes where present with joint compound applied are confirmed to contain Chrysotile asbestos. Sampling is required in specific areas to prove non-ACM.
- 2) Loose fill insulation (Vermiculite) is confirmed to contain Amphibole asbestos and is suspected to be present within the voids of the masonry block within the surveyed area. Specific locations of the material are not known.
- 3) Asbestos-containing sprayed fireproofing may be concealed behind non-asbestos sprayed fireproofing or within wall and ceiling cavities.

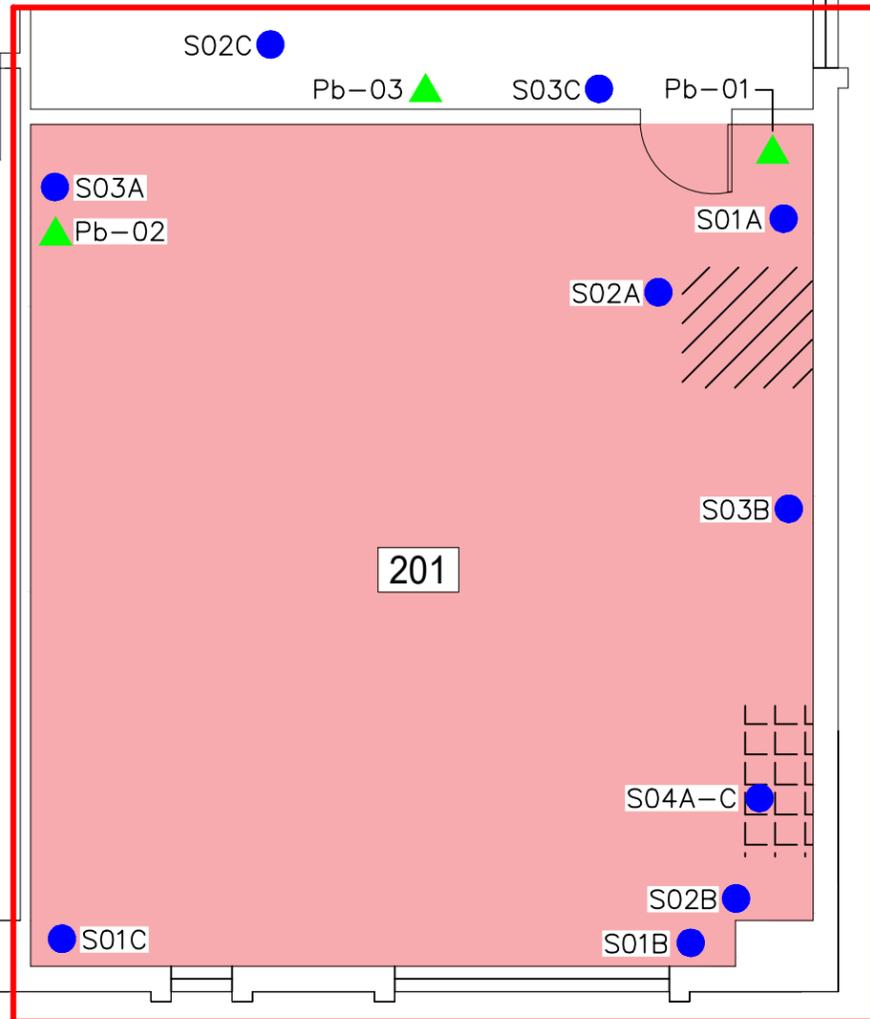
DRAWING NO	DSR-02
SCALE	NTS
DATE	March 6, 2026

- 1) Drywall finishes where present with joint compound applied are confirmed to contain Chrysotile asbestos. Sampling is required in specific areas to prove non-ACM.
 - 2) Loose fill insulation (Vermiculite) is confirmed to contain Amphibole asbestos and is suspected to be present within the voids of the masonry block within the surveyed area. Specific locations of the material are not known.
 - 3) Asbestos-containing sprayed fireproofing may be concealed behind non-asbestos sprayed fireproofing or within wall and ceiling cavities.
- Refer to Main Report.
