August 29, 2025

**Re: Asbestos Reassessment**

St. James Catholic School, 10 Clover Ridge Drive West, Ajax, Ontario  
Pinchin File: 358839.000

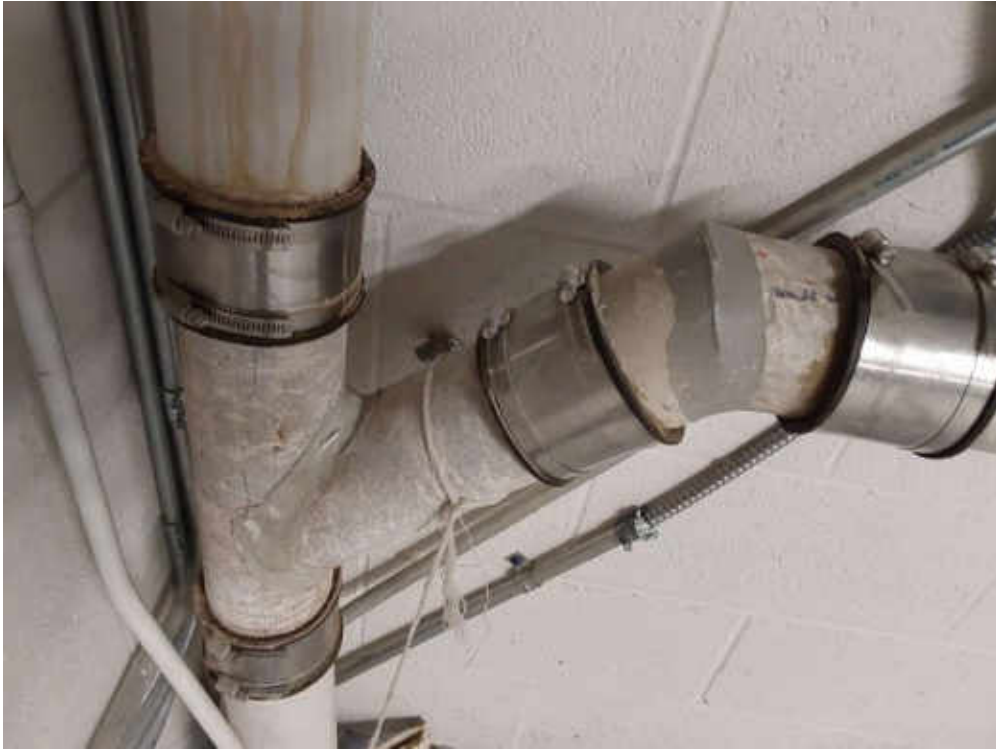
S0002A (Confirmed Asbestos), Cementitious adhesive, Other, Adhesive/mastic, Boiler Room (Location #: 44)  
On Transite rainwater leaders

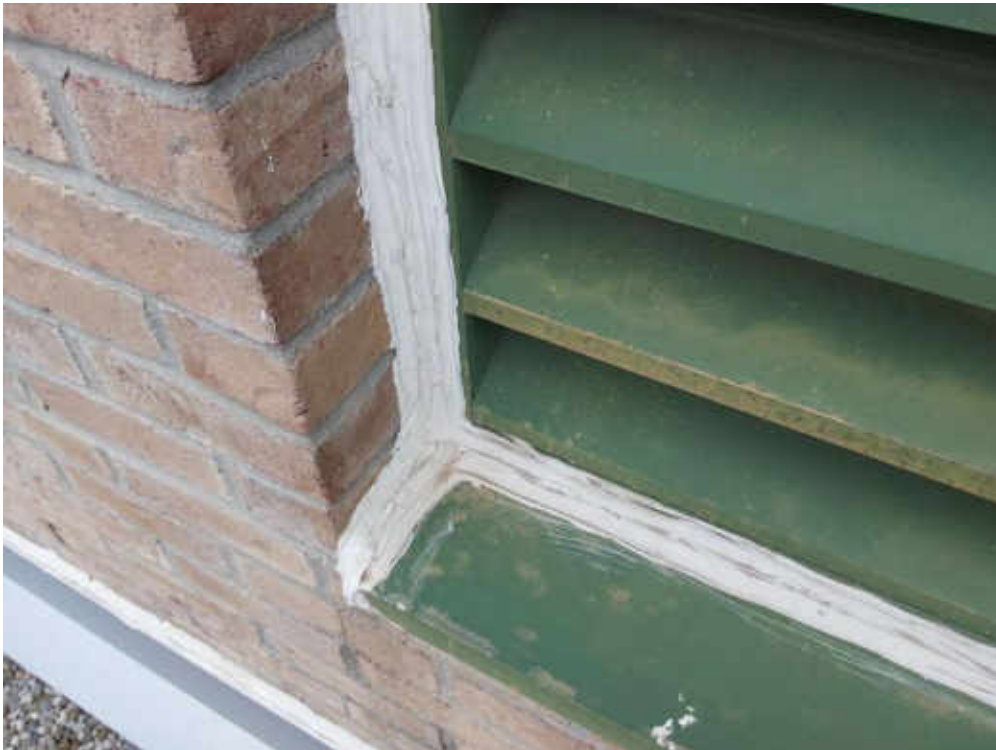
S0006A (Confirmed Asbestos), Black caulking on roof louvers, Other, Caulking, Roof 1 (Location #: 54)  
Beneath new white caulking on roof louvers, b126740 - 2016 - 0002

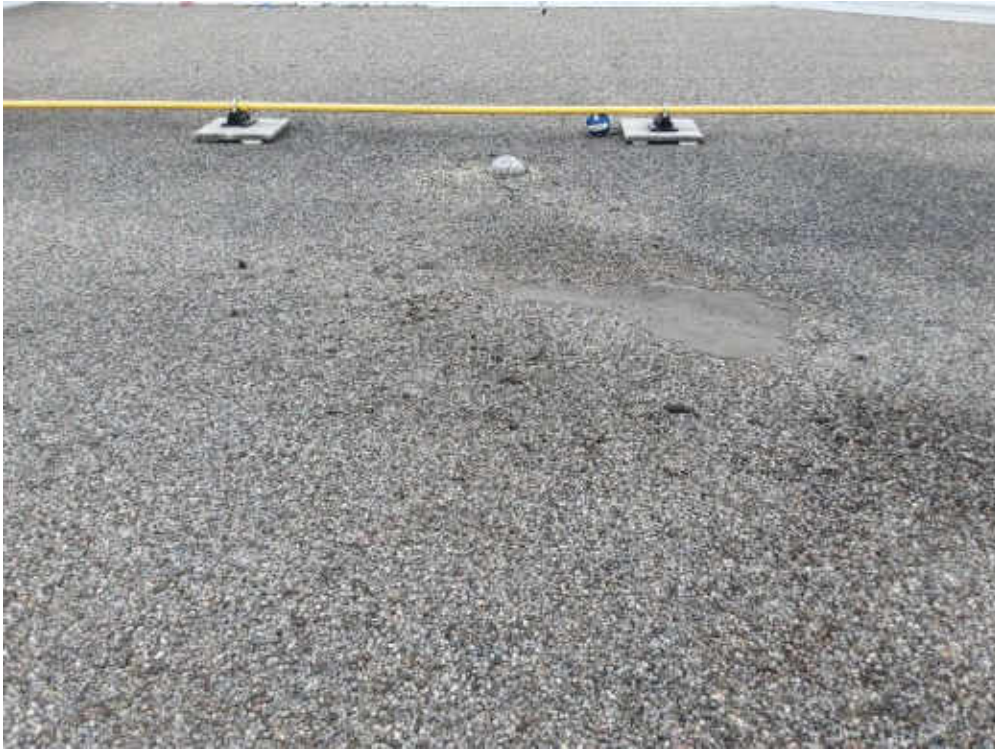
S0009C (Confirmed Asbestos), Built up roofing, Other, Roofing material, Roof 1 (Location #: 54)

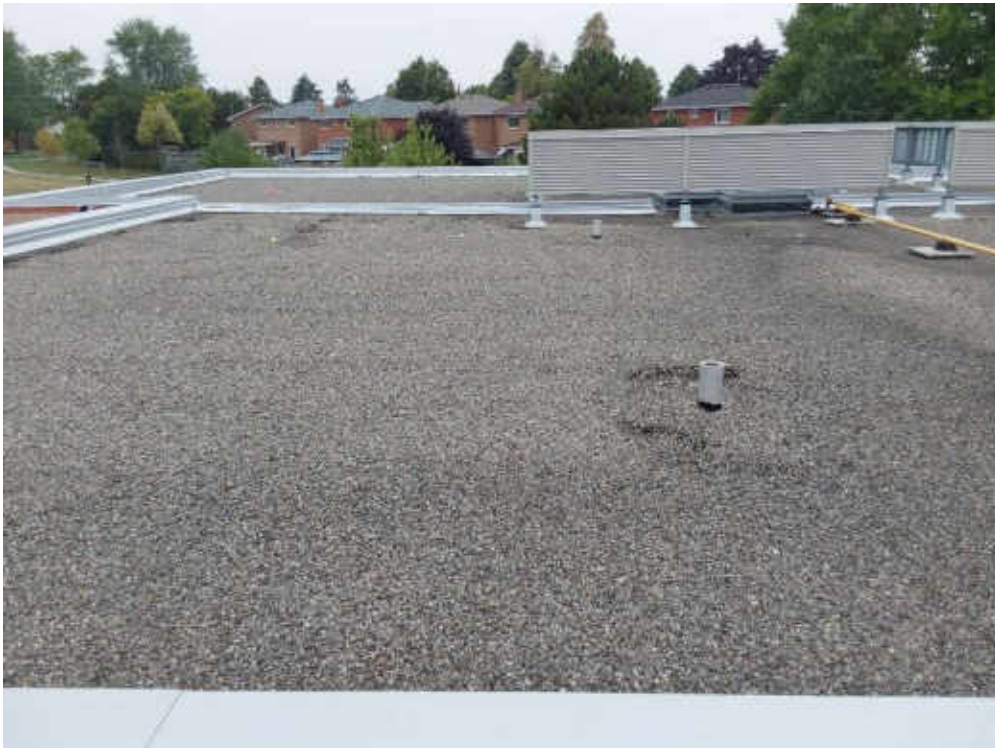
S0009A (Confirmed Asbestos), Other, Roofing material, Roof2 (Location #: 55)

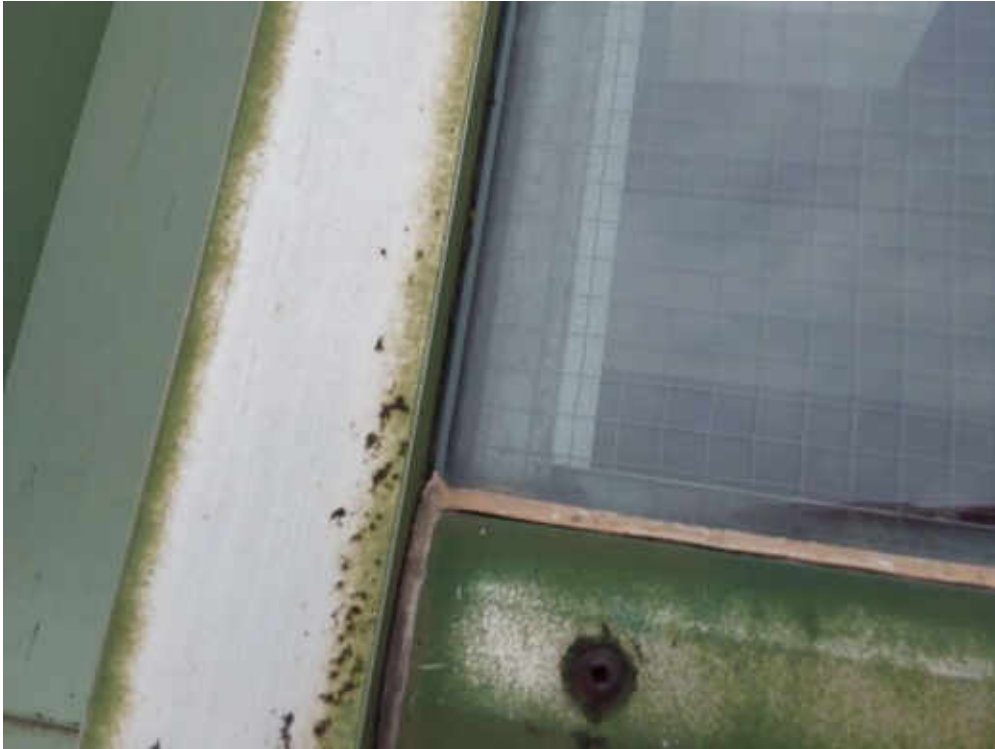
S0017A (Confirmed Asbestos), Butyl Sealant, Other, Window Liner, Caulking, Roof 1 (Location #: 54)  
On Atrium and Chapel window panes and frames.

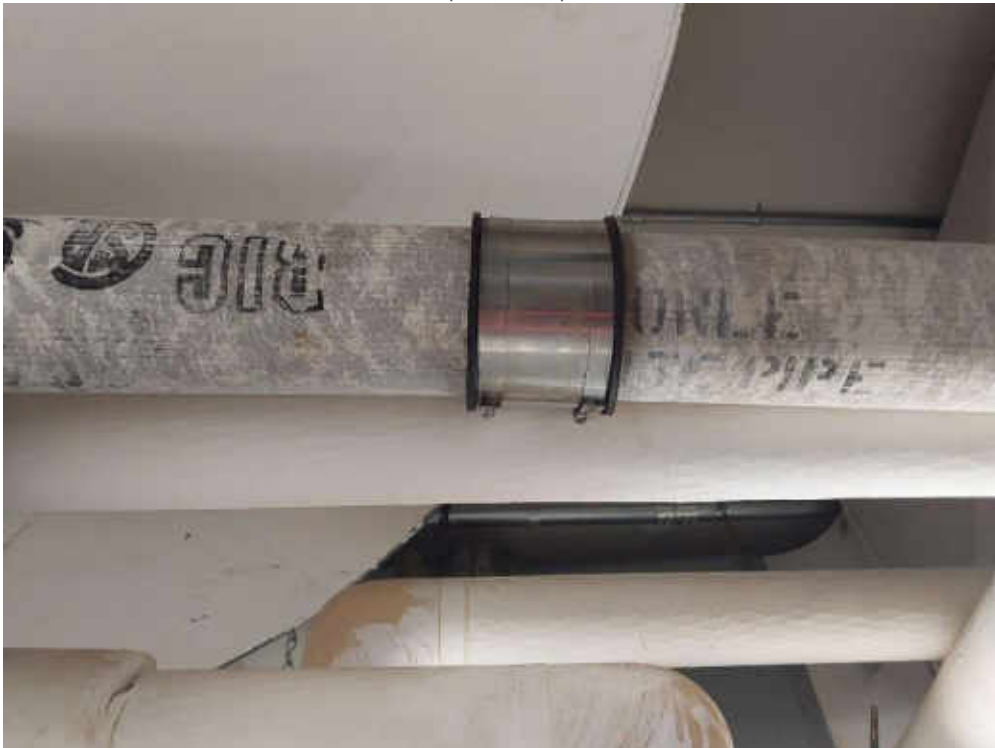
V9000 (Confirmed Asbestos), Piping, Rainwater Leader, Cement Product, Boiler Room (Location #: 44)  
Transite pipe

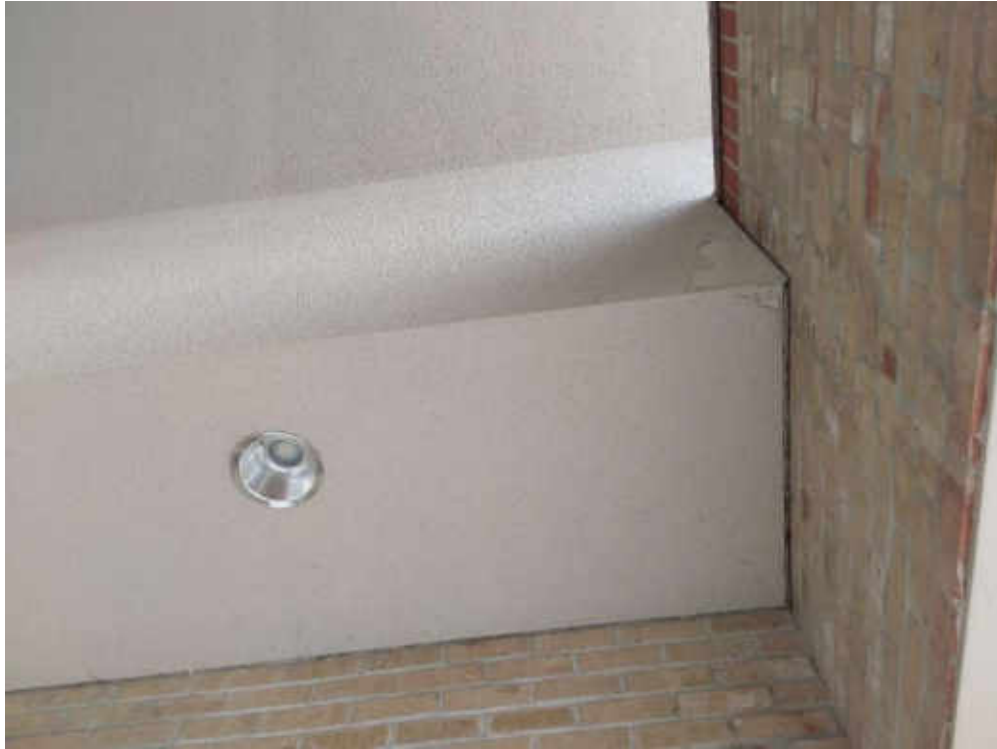
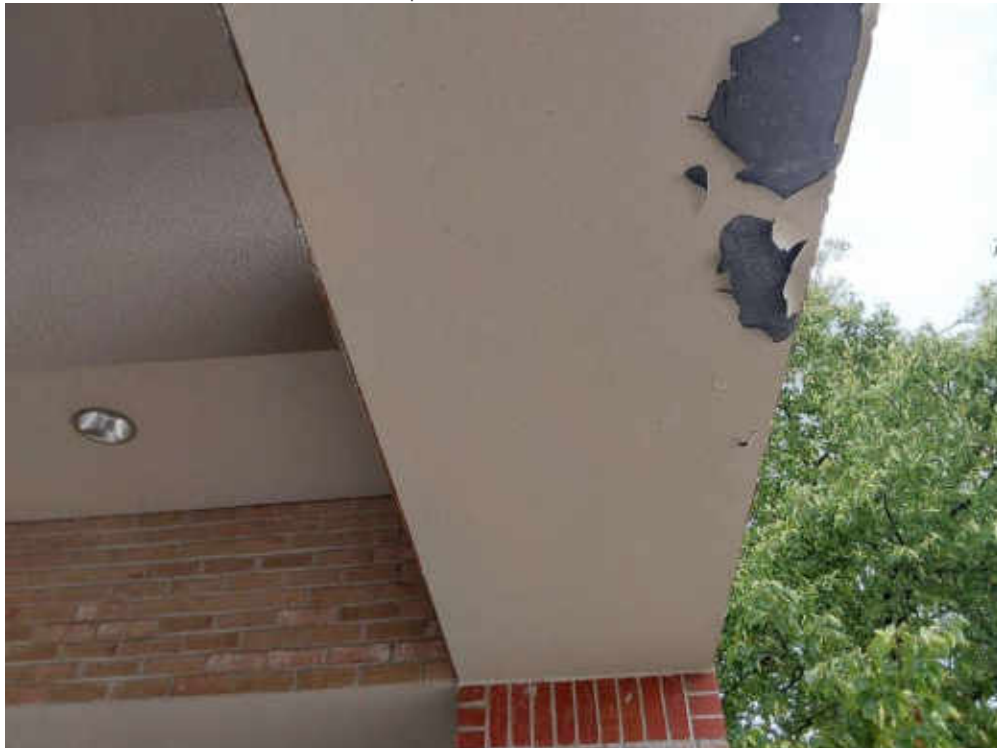
V9500 (Presumed Asbestos), Other, Cement Product, Exterior (Location #: 1)  
Transite panels above main entrance

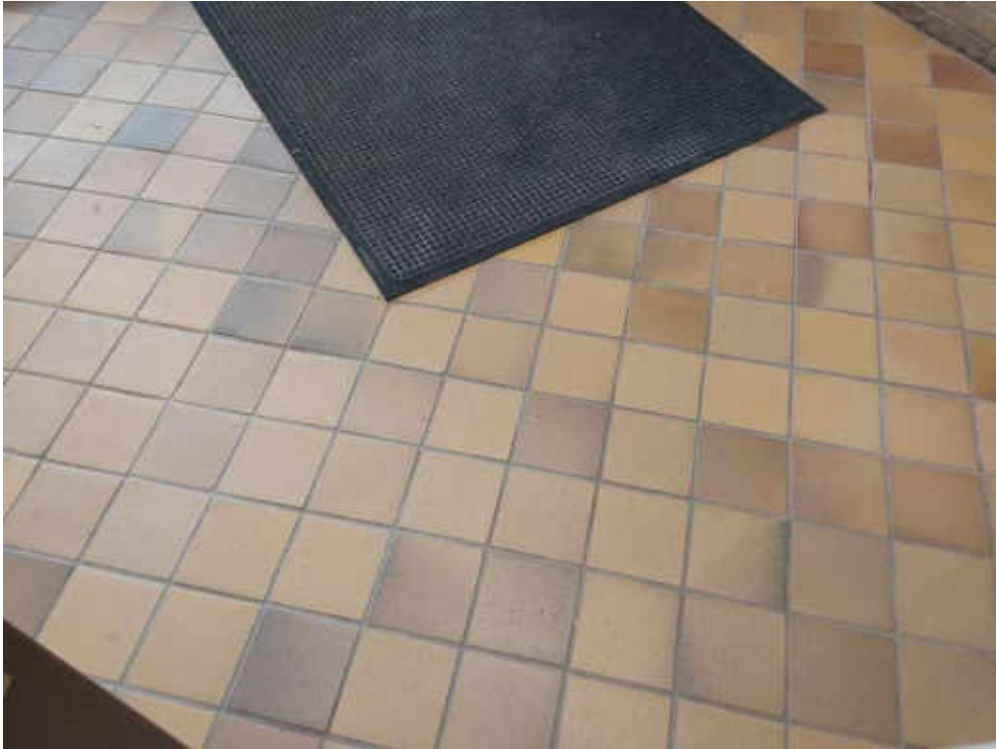
V9500 (Presumed Asbestos), Floor, All, Mortar, Vestibule (Location #: 2)
