September 2, 2025

Re: Asbestos Reassessment

St. John the Evangelist Catholic Element, 1103 Giffard Street, Whitby, Ontario
Pinchin File: 358839.000

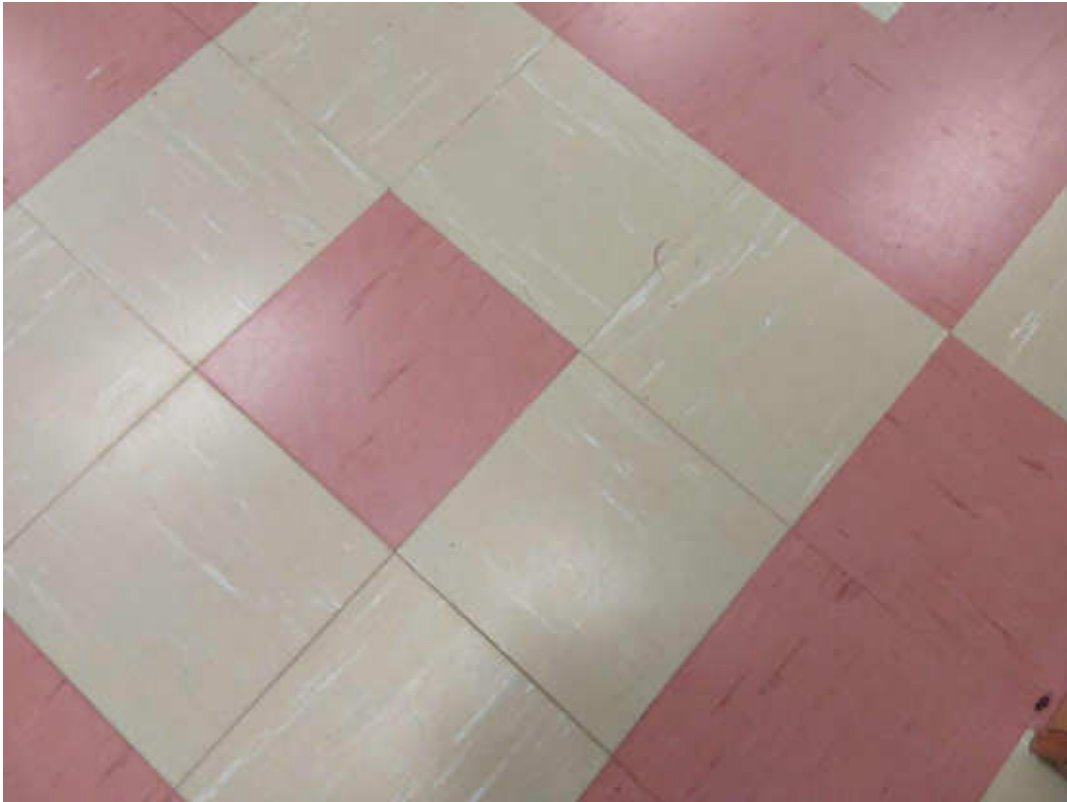
V0002 (Confirmed Asbestos), 9 x 9 beige with white streaks, Floor, Vinyl Floor Tile and Mastic, Room 3 (Location #: 5)
Mastic is presumed to contain asbestos

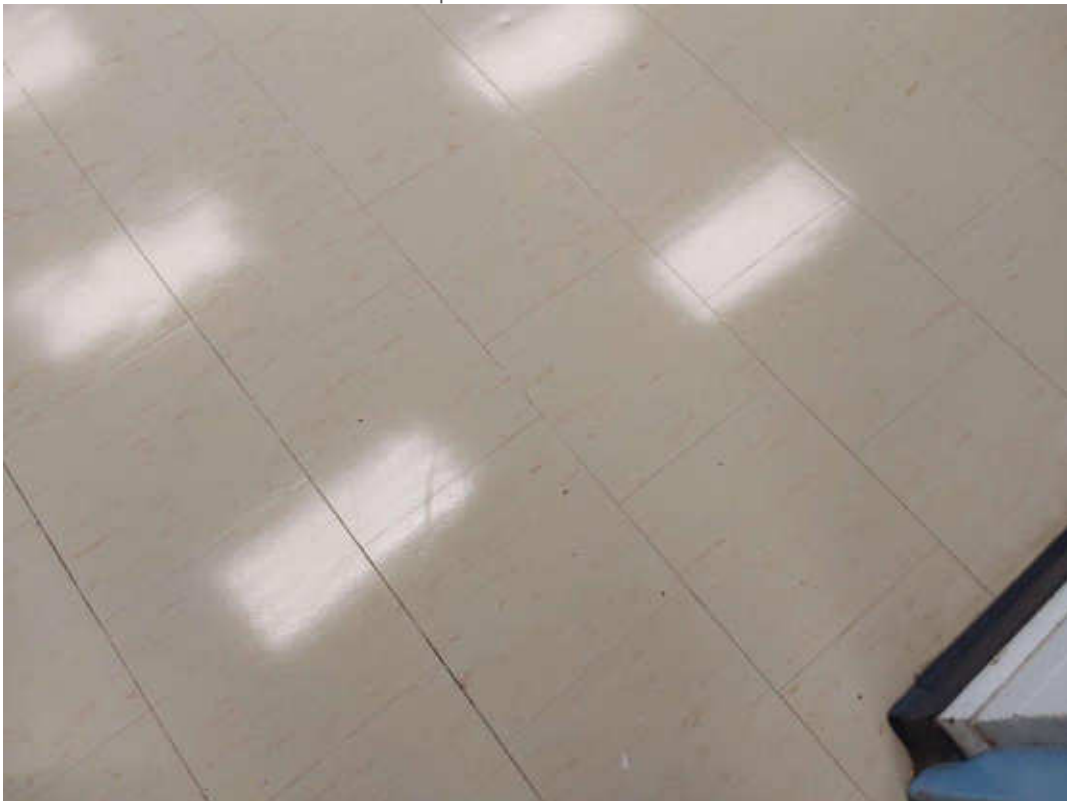
V0003 (Confirmed Asbestos), 12 x 12 tan with white and brown flecks, Floor, Vinyl Floor Tile and Mastic, Classroom 109
(Location #: 29) Mastic is presumed to contain asbestos

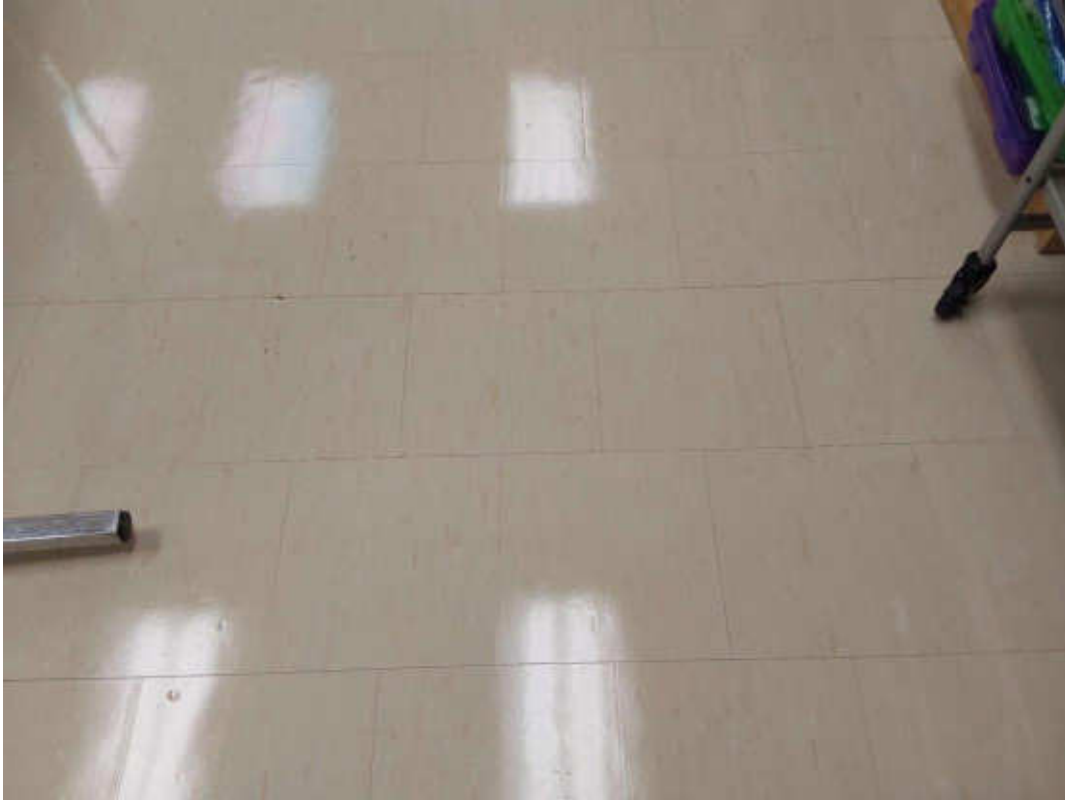
S0010 (Confirmed Asbestos), 12 x 12 tan with white and brown flecks, Floor, Vinyl Floor Tile and Mastic, Classroom 103
(Location #: 26) Mastic is presumed to contain asbestos

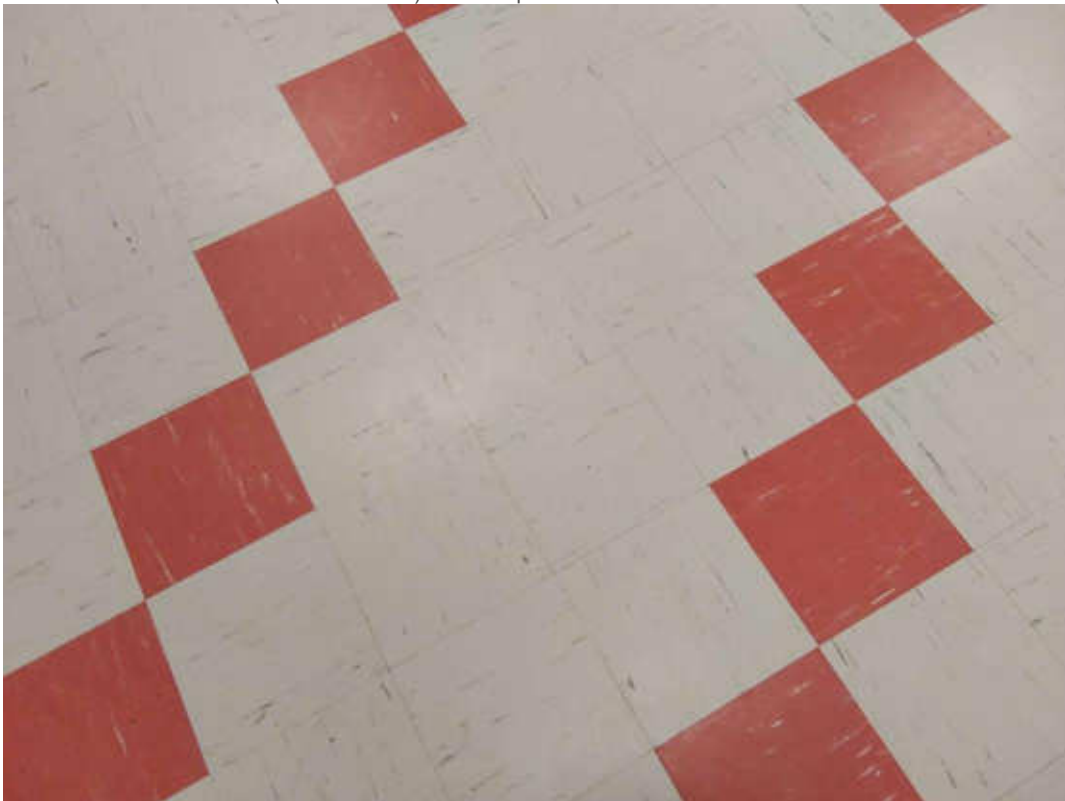
S0017 (Confirmed Asbestos), 9 x 9 grey with black streaks, Floor, Vinyl Floor Tile and Mastic, Room 1 (Location #: 4)
Mastic is presumed to contain asbestos

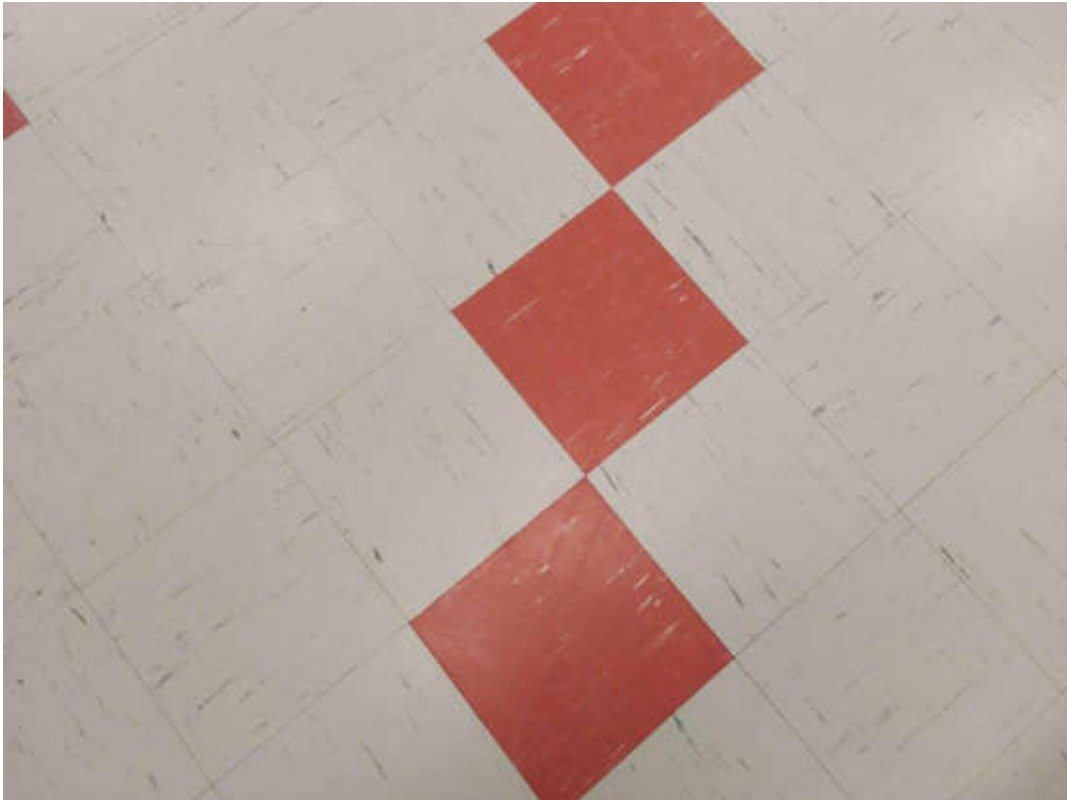
S0018 (Confirmed Asbestos), 9 x 9 red with white streaks, Floor, Vinyl Floor Tile and Mastic, Room 1 (Location #: 4)
Mastic is presumed to contain asbestos

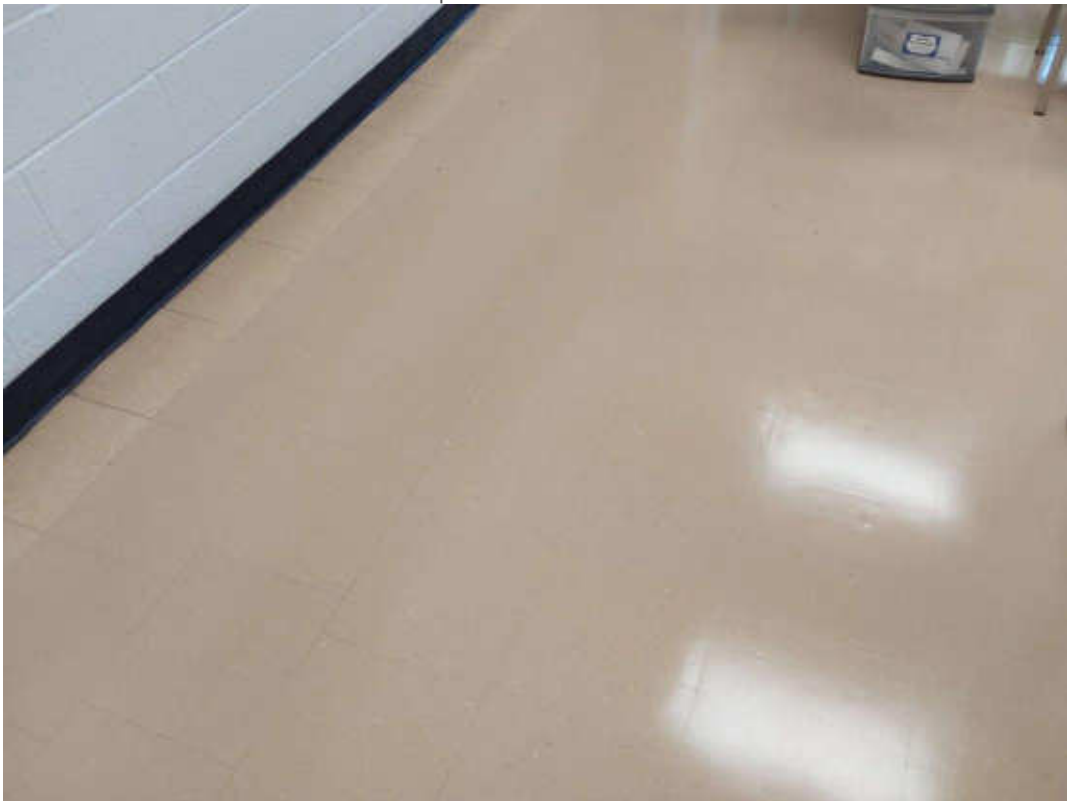
S0019 (Confirmed Asbestos), 12 x 12 orange, Floor, Vinyl Floor Tile and Mastic, Classroom 105 (Location #: 27)
Mastic is confirmed to contain asbestos

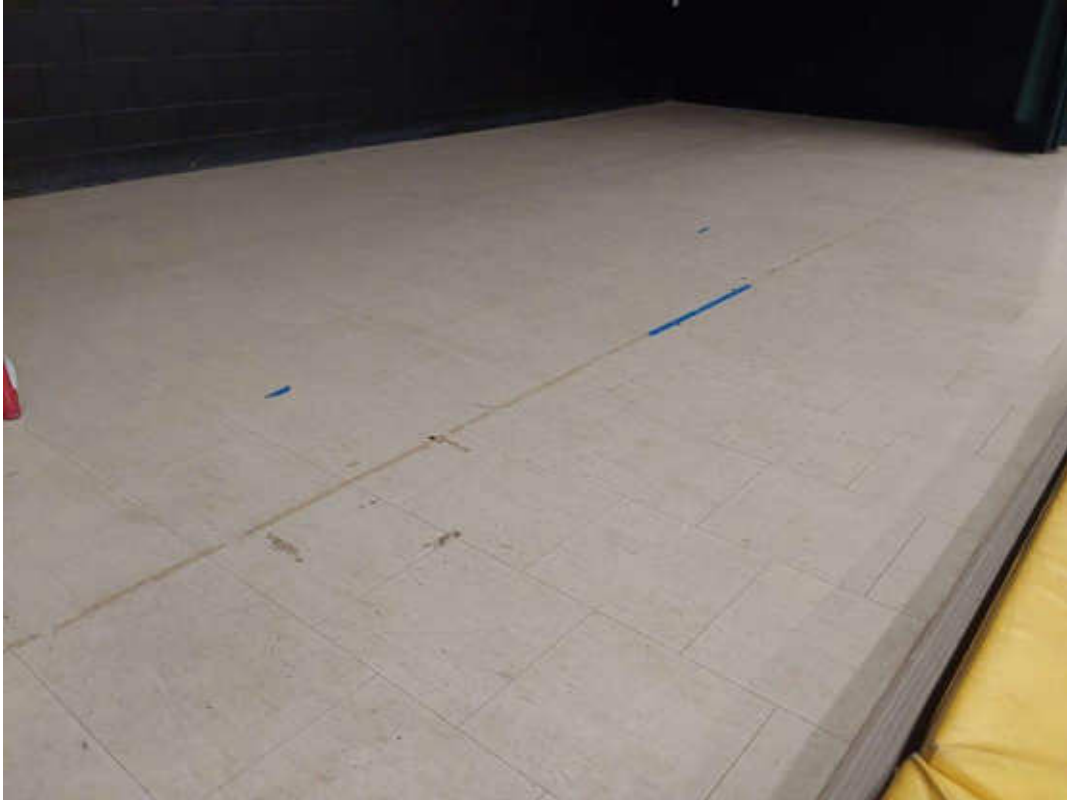
V0020 (Confirmed Asbestos), 12 x 12 off-white with brown streaks, Floor, Vinyl Floor Tile and Mastic, Gym (Location #: 1)
Stage floor, Mastic is presumed to contain asbestos

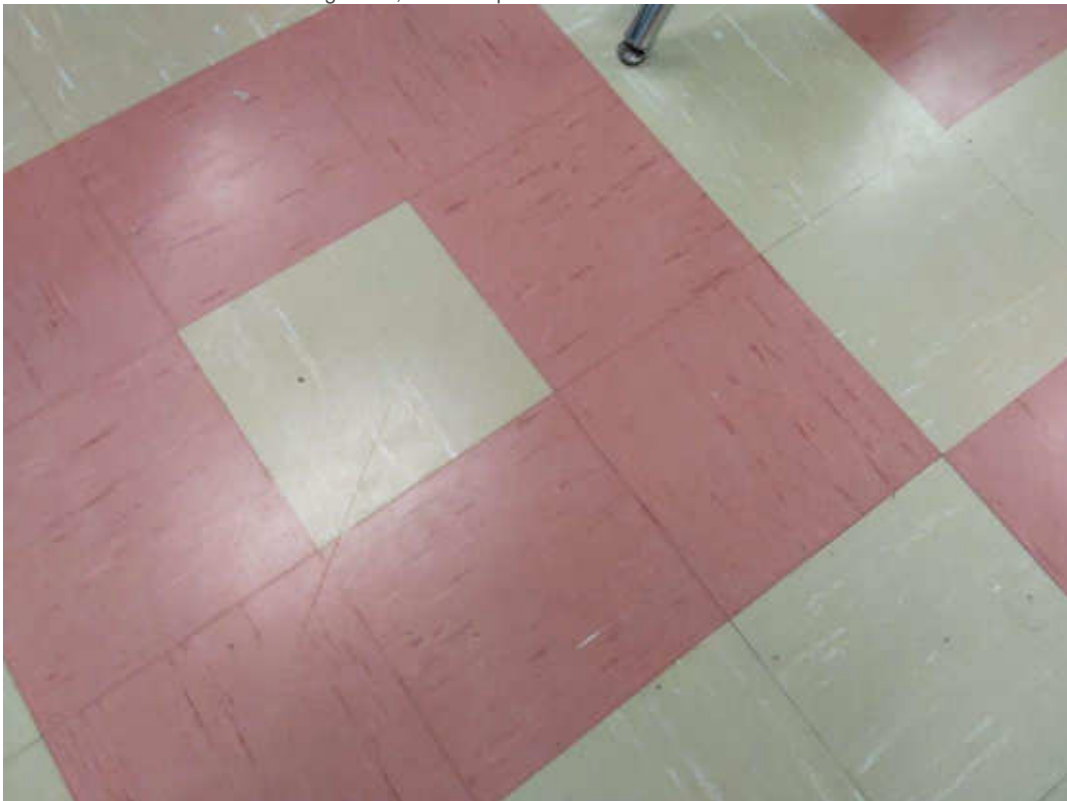
S0021 (Confirmed Asbestos), 9 x 9 red with dark red streaks, Floor, Vinyl Floor Tile and Mastic, Room 3 (Location #: 5)
Mastic is presumed to contain asbestos

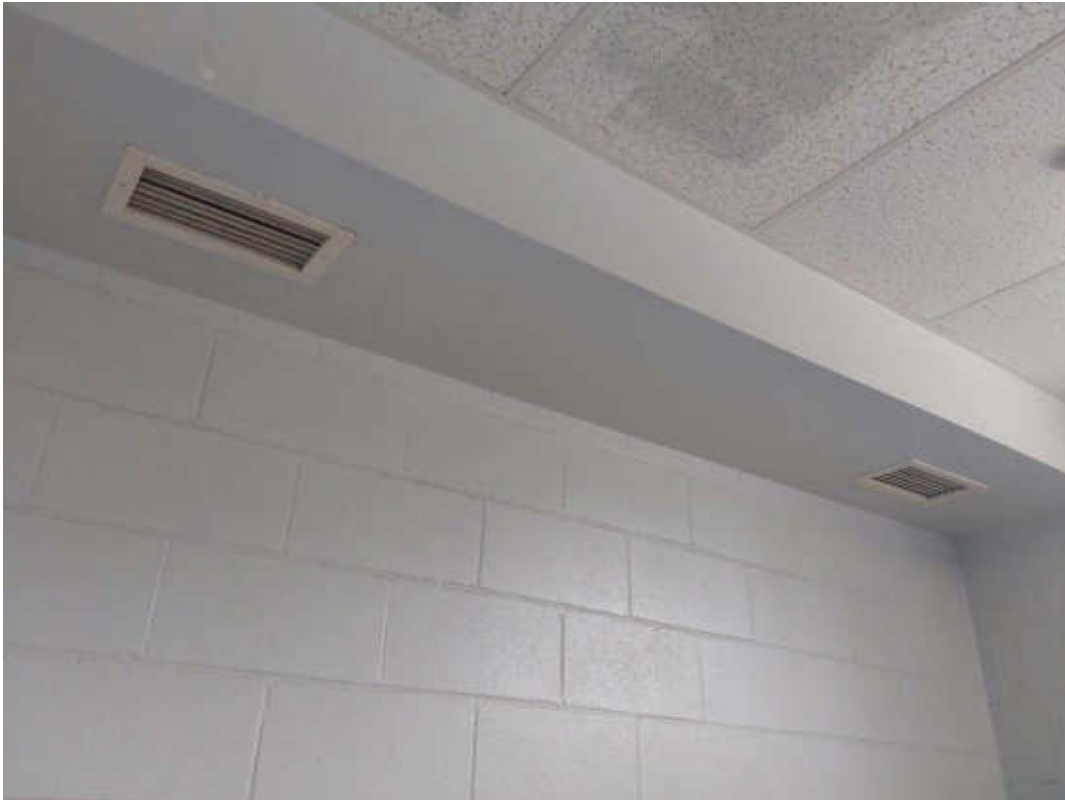
V0028 (Confirmed Asbestos), Ceiling, Drywall and joint compound, Men's Washroom (Boys) (Location #: 12)

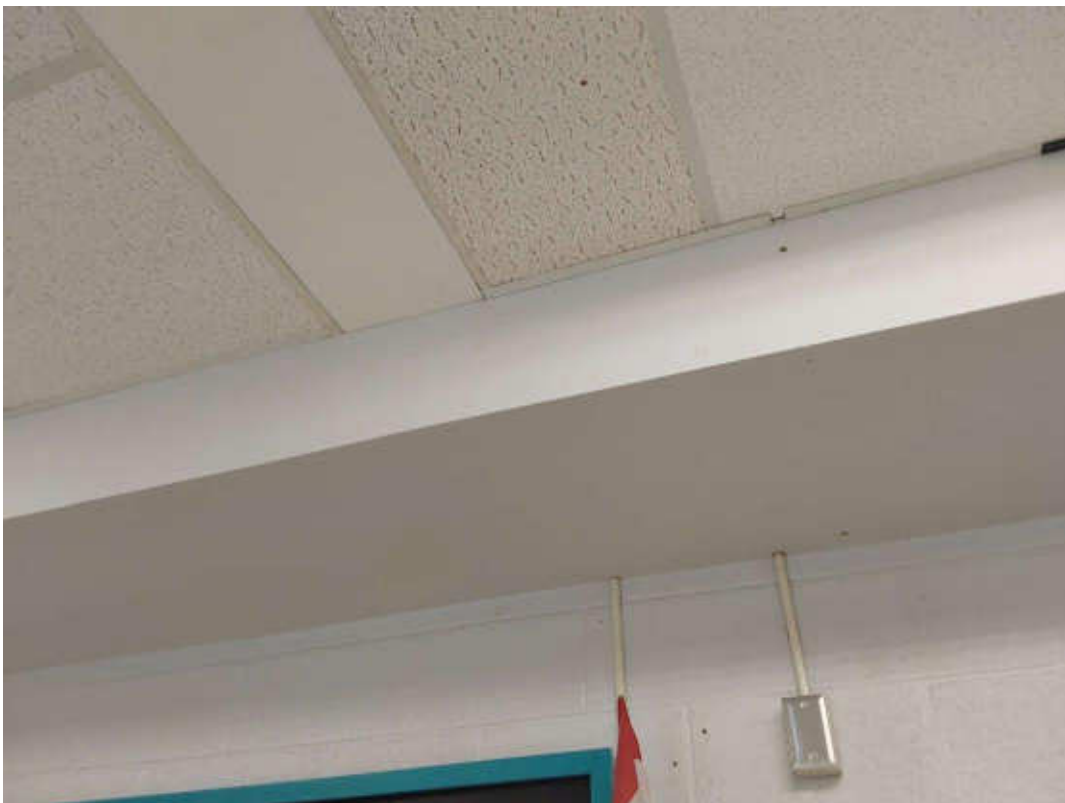
V0028 (Confirmed Asbestos), Ceiling, Drywall and joint compound, Classroom 109 (Location #: 29)

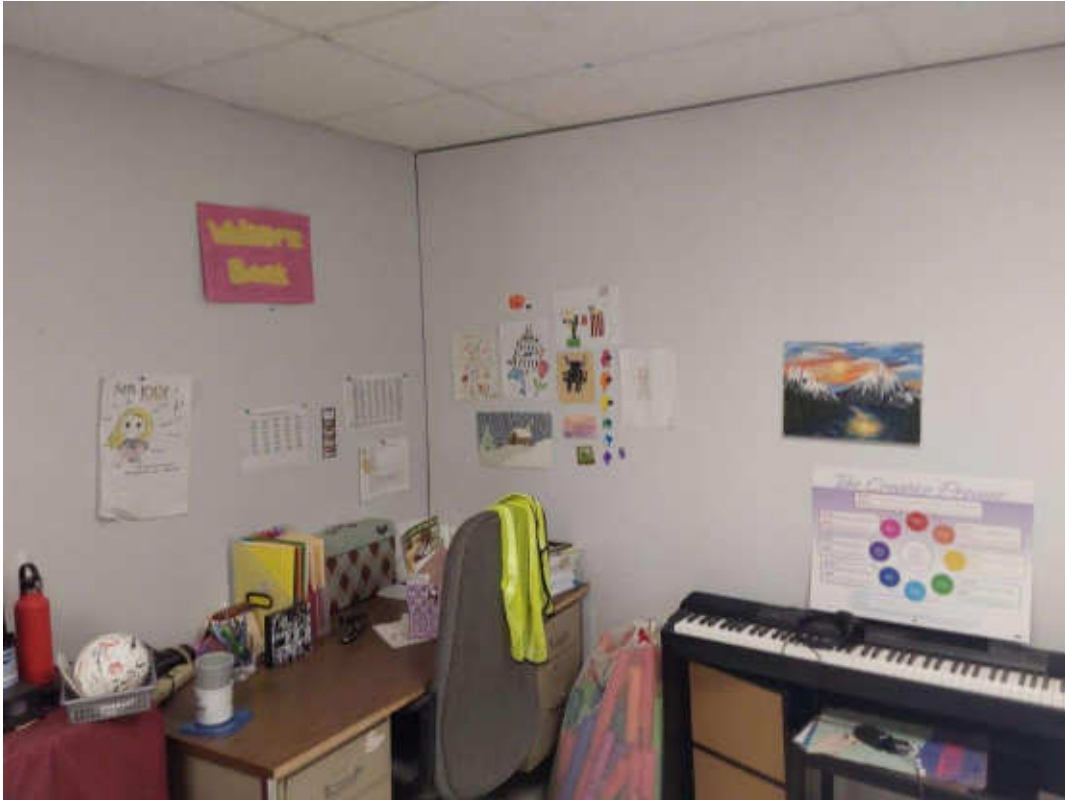
V0028 (Confirmed Asbestos), Wall, Drywall and joint compound, Physiotherapy Room (Location #: 31)

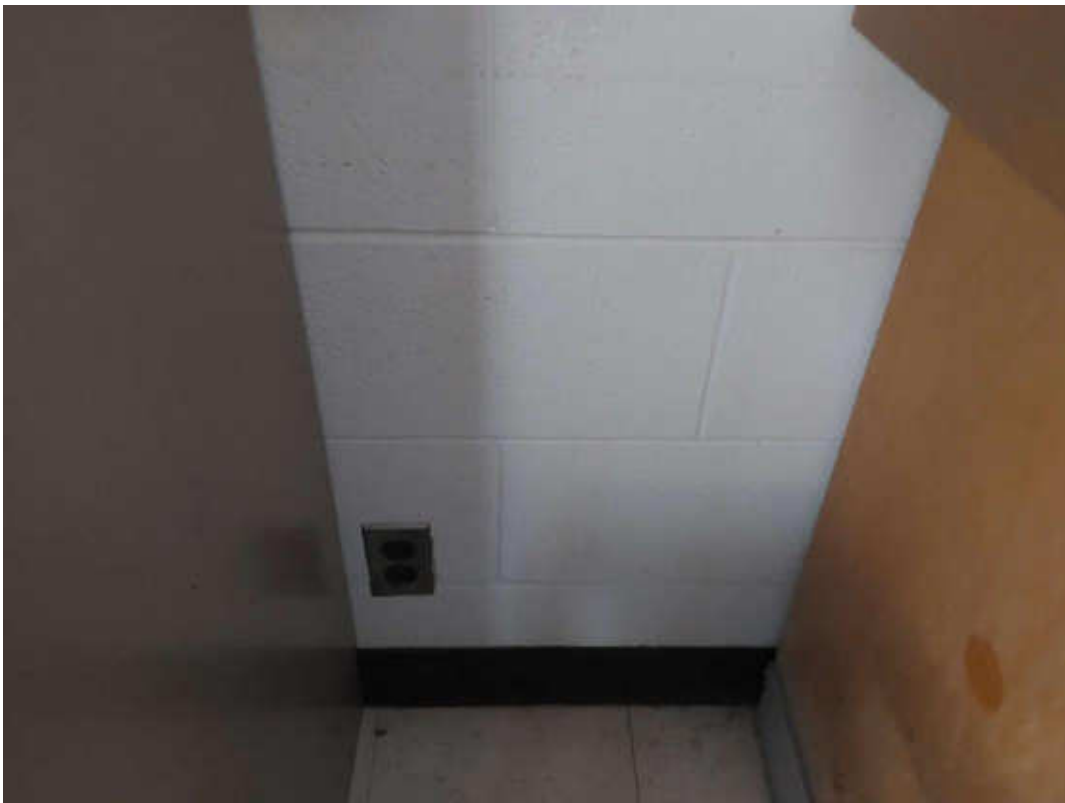
V9000 (Confirmed Asbestos), Wall, Vermiculite Investigation, Offices (Location #: 30)
Vermiculite found

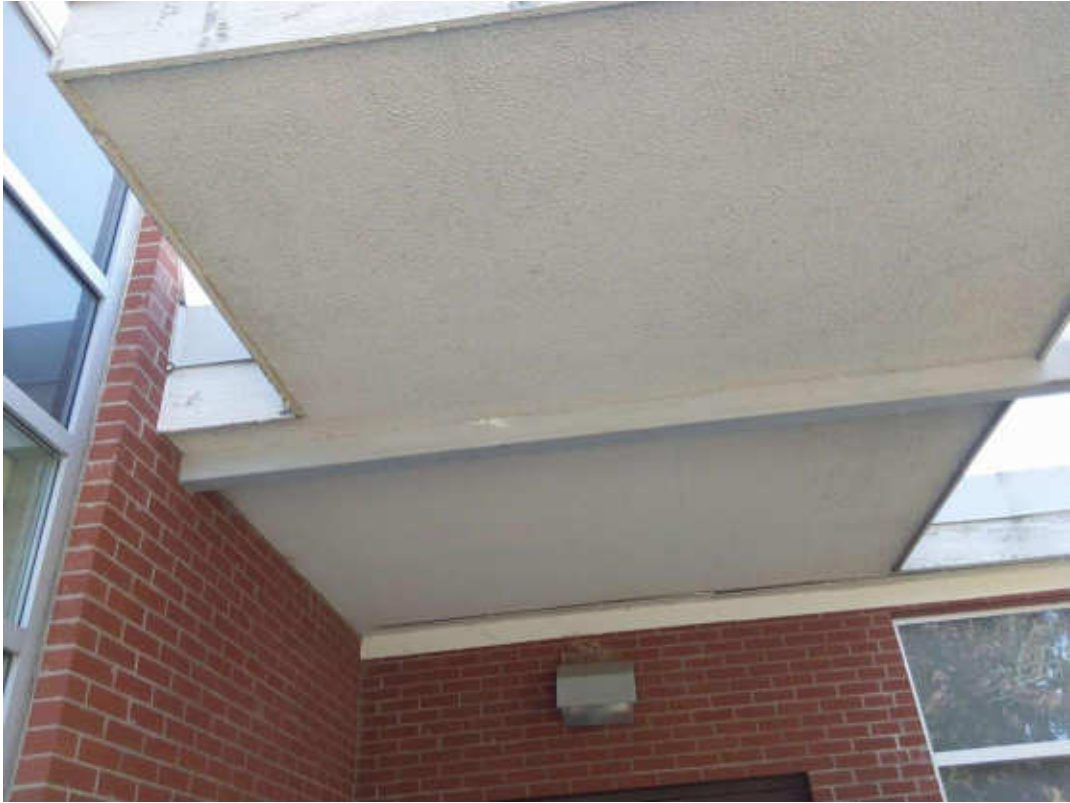
V9000 (Confirmed Asbestos), Wall, Fascia, Cement Product, Exterior (Location #: 47)
Above the front entrance and on the exterior of the gym

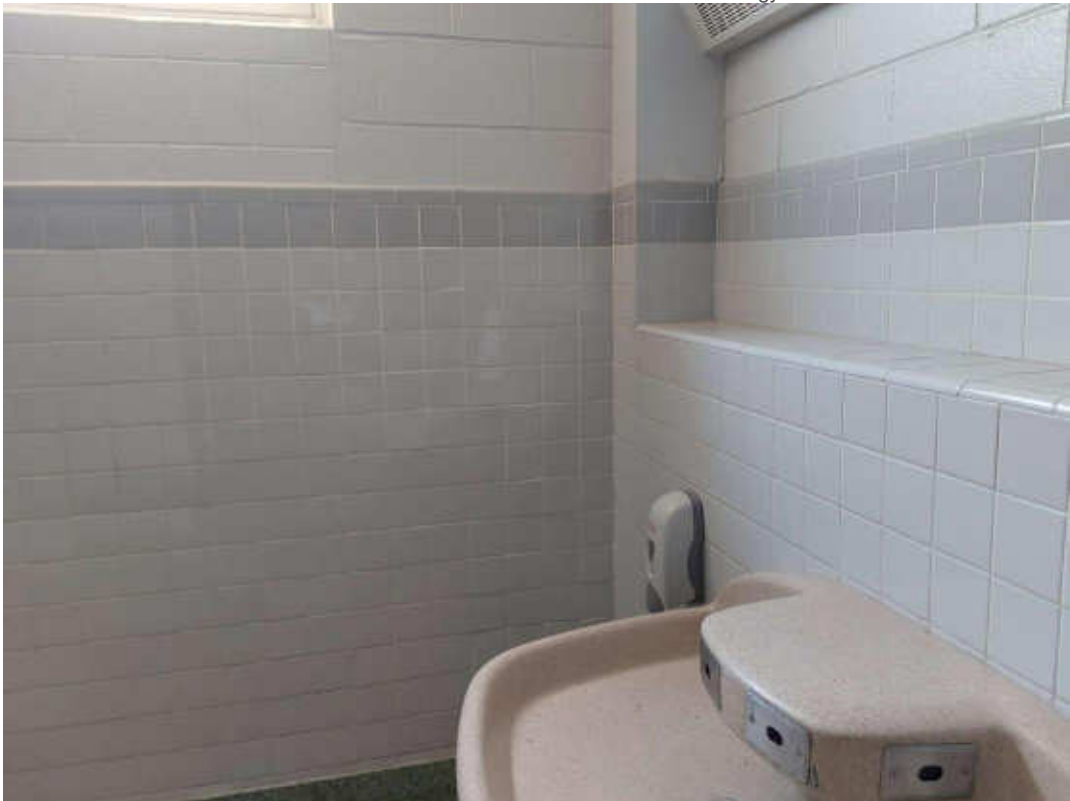
V9500 (Presumed Asbestos), Wall, Mortar, Men's Washroom (Boys) (Location #: 12)

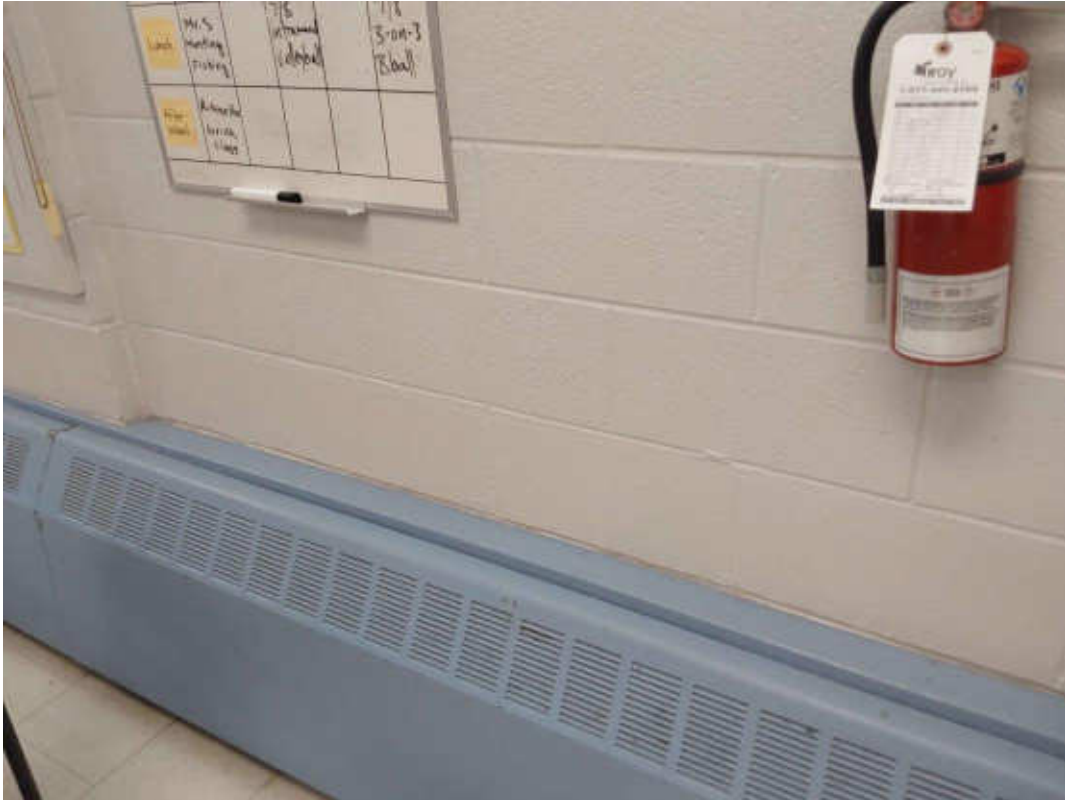
V9500 (Presumed Asbestos), Wall, Vermiculite/concrete block walls, Staff Room (Location #: 16)

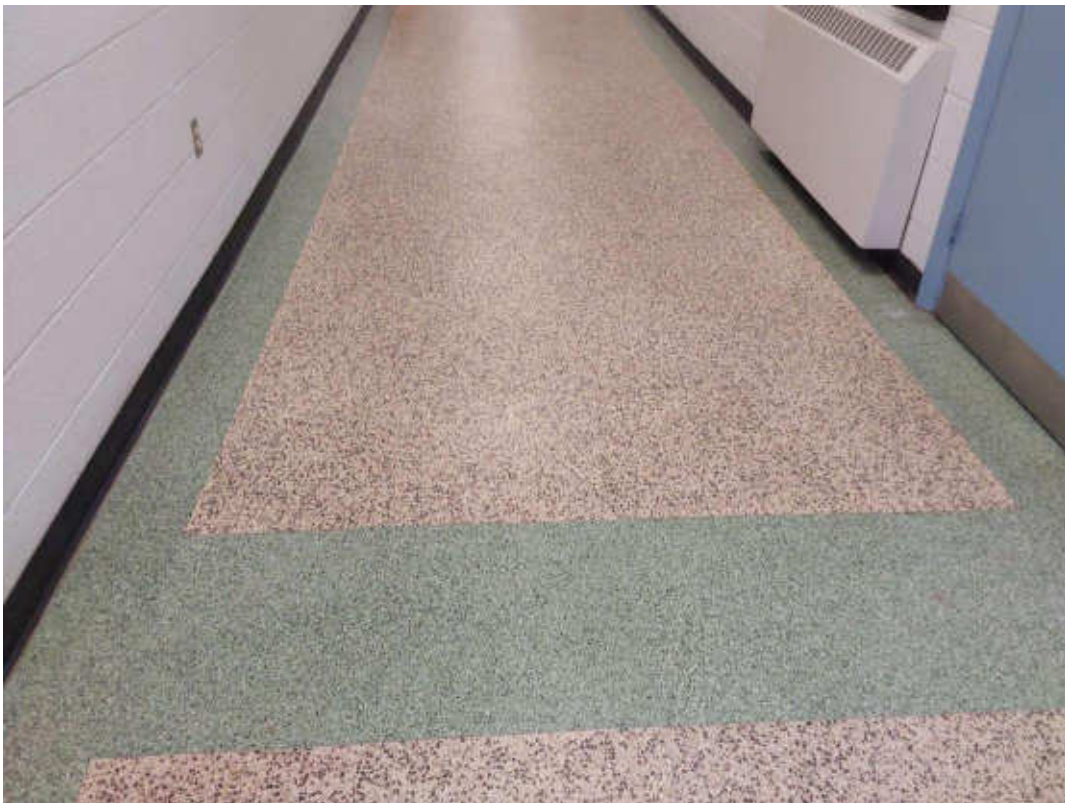
V9500 (Presumed Asbestos), Floor, Terrazzo, Corridor (Location #: 25)

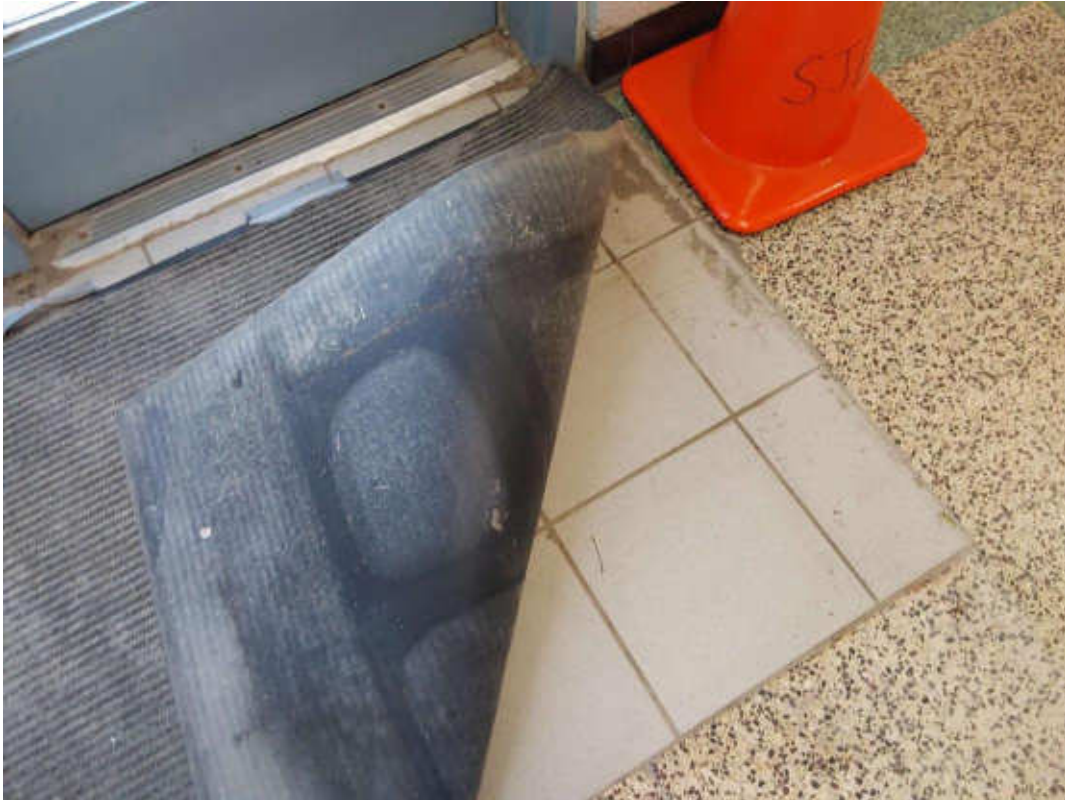
V9500 (Presumed Asbestos), Floor, Mortar, Corridor (Location #: 25)

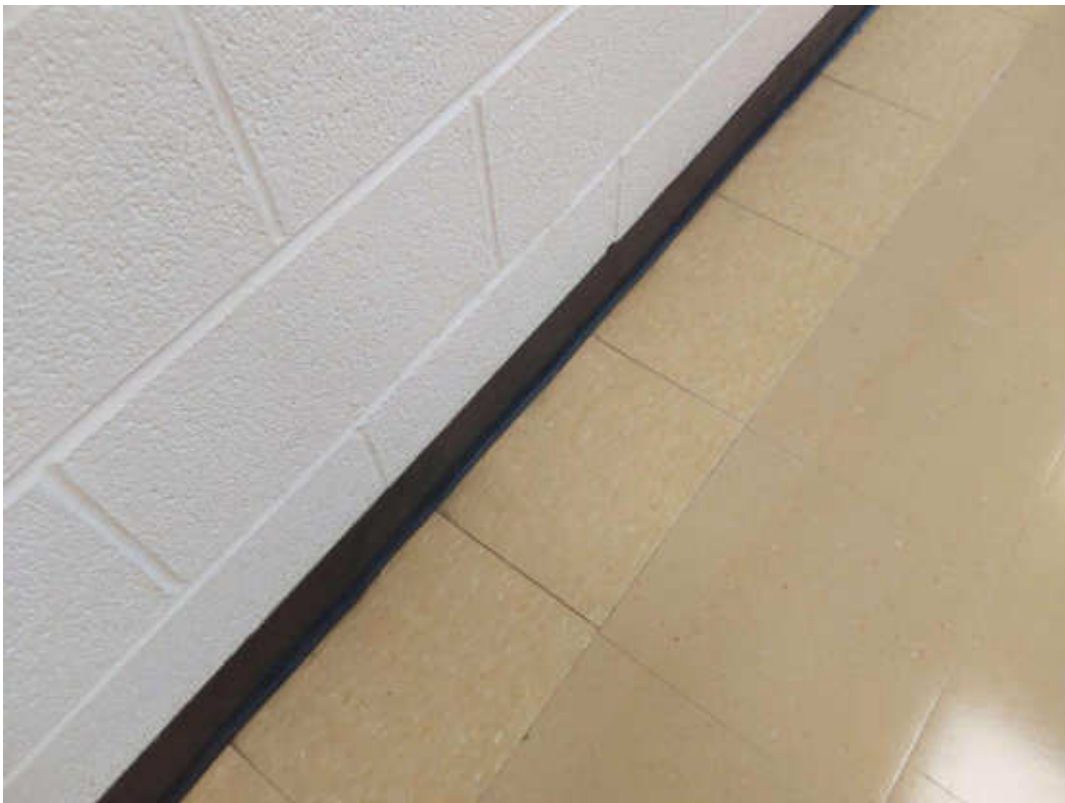
V9500 (Presumed Asbestos), 12 x 12 beige with white mottle, Floor, Vinyl Floor Tile and Mastic, Classroom 105 (Location #: 27)
Mastic is presumed to contain asbestos

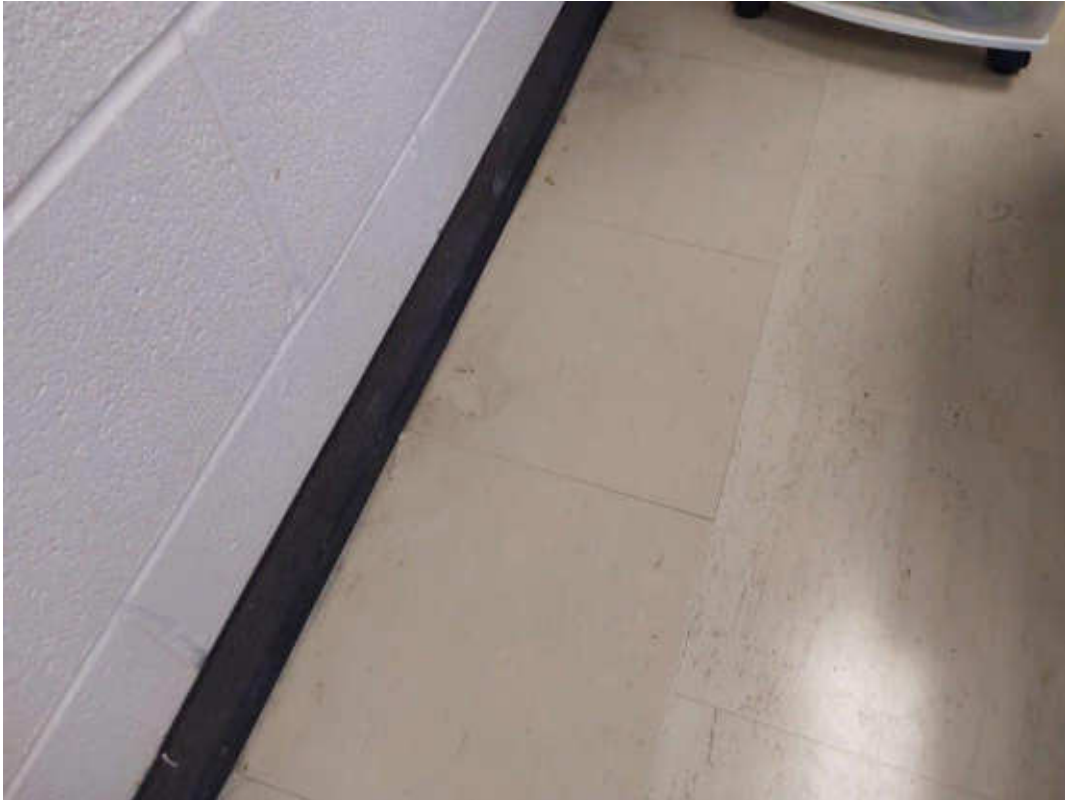
V9500 (Presumed Asbestos), 12 x 12 beige with brown flecks, Floor, Vinyl Floor Tile and Mastic, Classroom 115 (Location #: 43)
Mastic is confirmed to contain asbestos

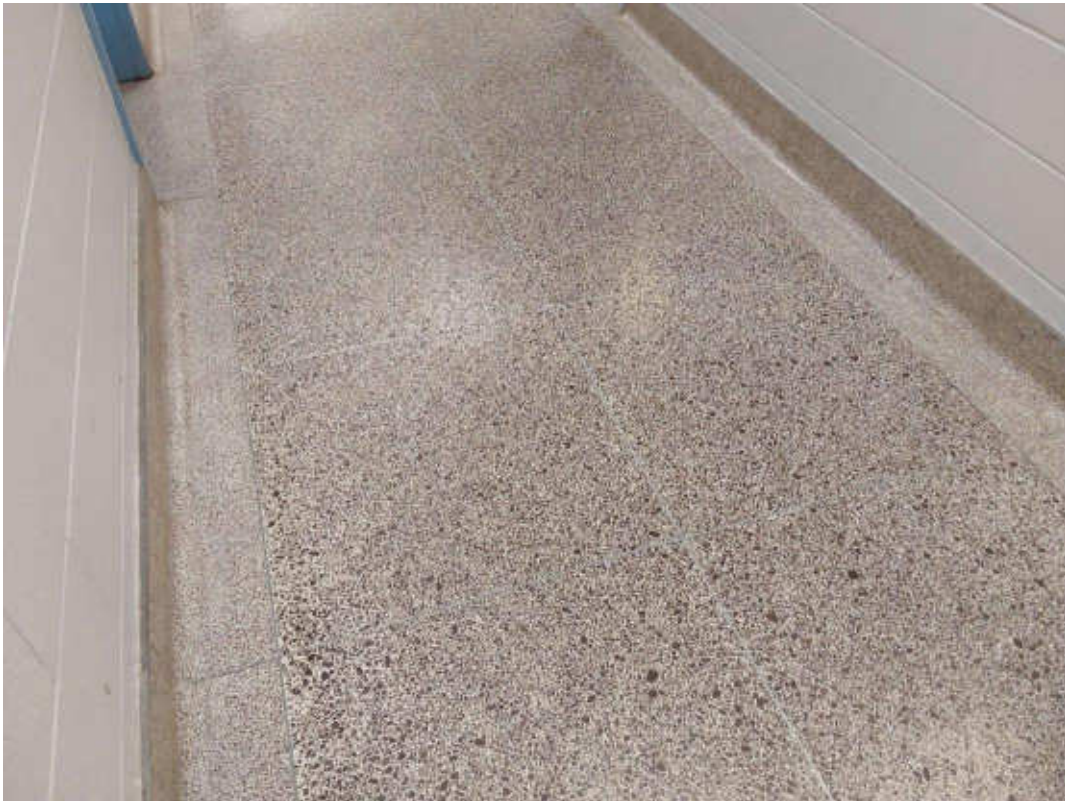
V9500 (Presumed Asbestos), Floor, Terrazzo, Corridor (Location #: 46)

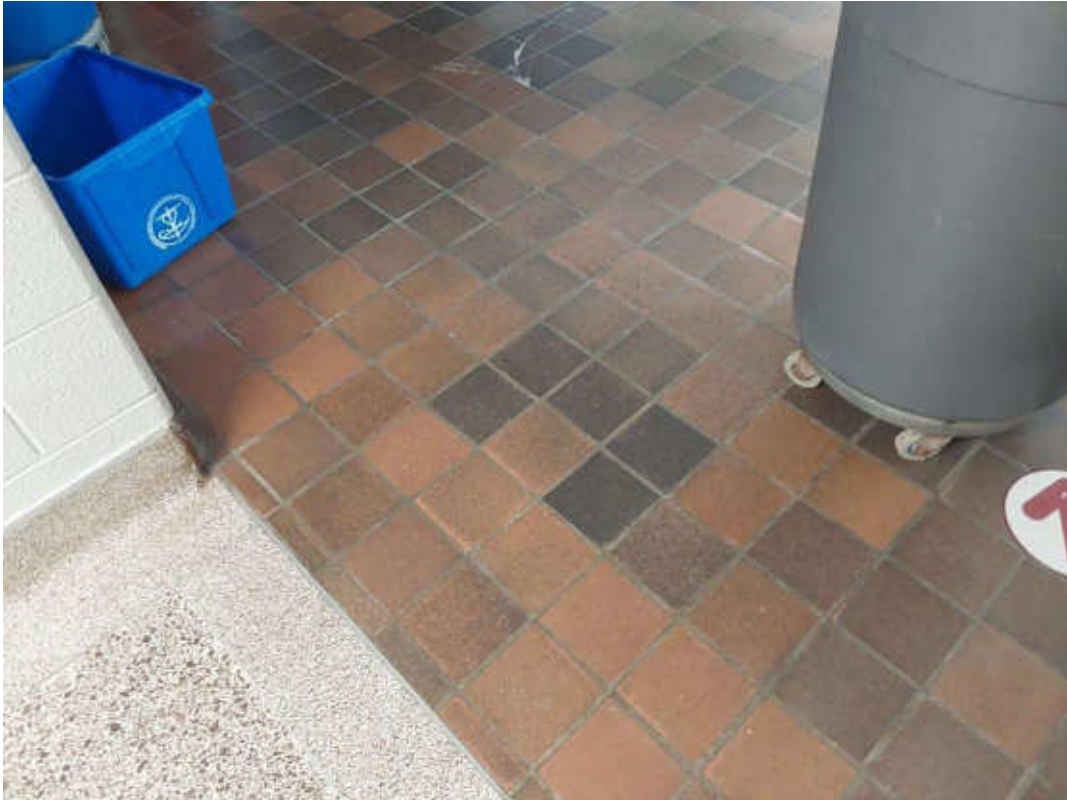
V9500 (Presumed Asbestos), Floor, Mortar, Corridor (Location #: 46)

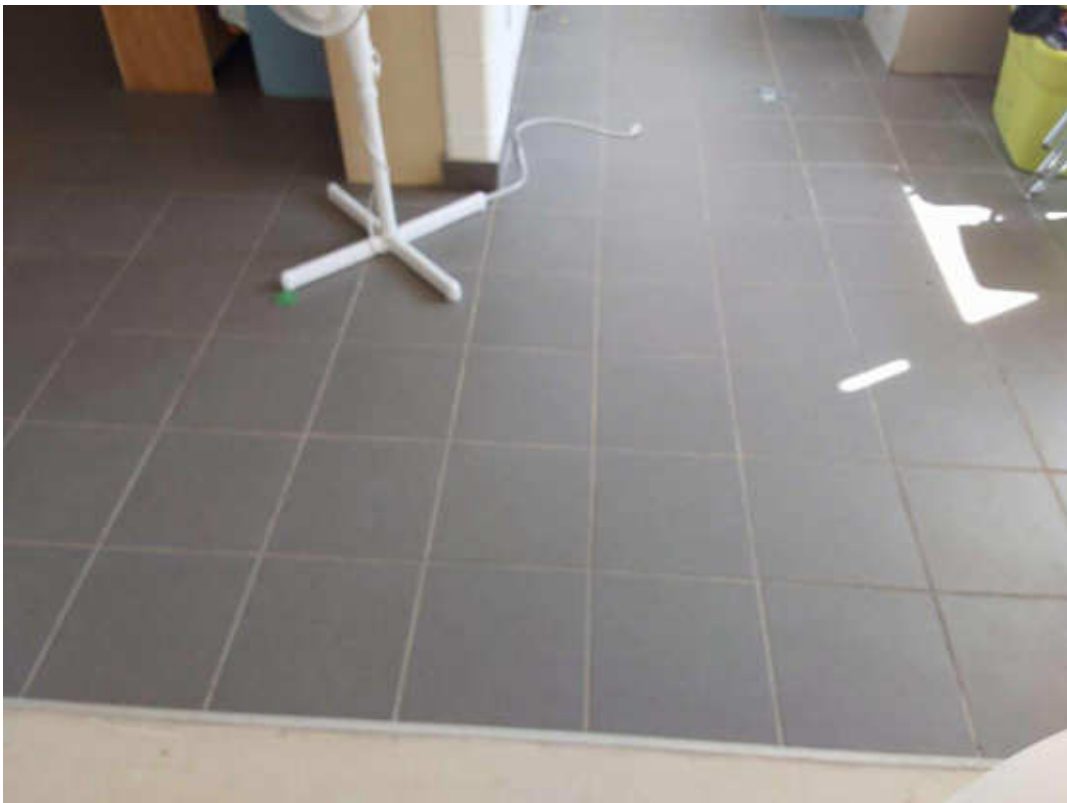
V9500 (Presumed Asbestos), Floor, Mortar, Room 2 (Location #: 8)
Renovated space
