NORTH HASTINGS HIGH SCHOOL DUST COLLECTOR REPLACEMENT

14 Monck St, Bancroft, Ontario K0L 1C0

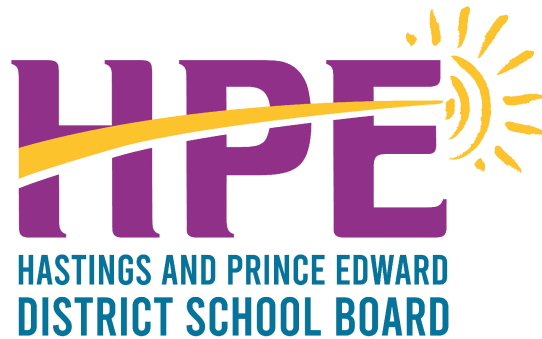
HASTINGS AND PRINCE EDWARD DISTRICT SCHOOL BOARD

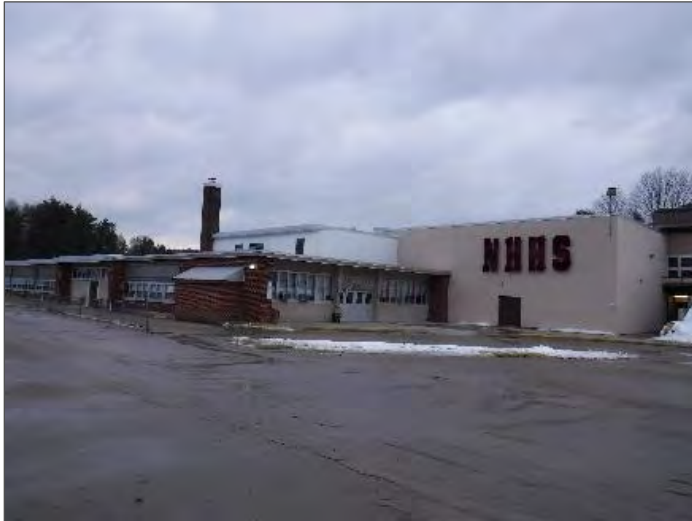
Hazardous Building Materials Assessment North Hastings Secondary School

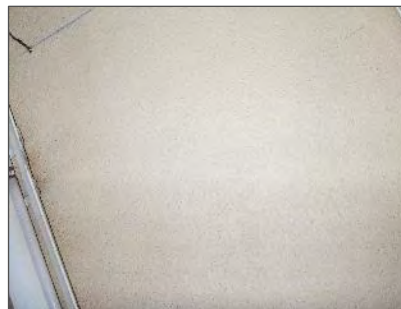
Asbestos-containing texture finish on the ceilings in Room 118B.

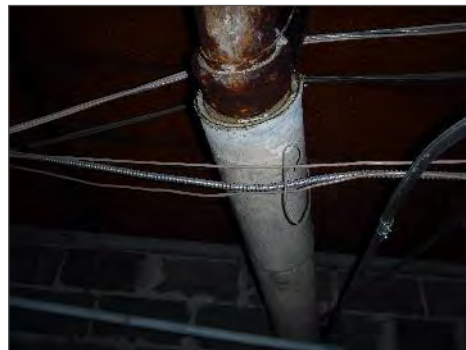
Asbestos-containing sweatwrap pipe insulation, in good condition.

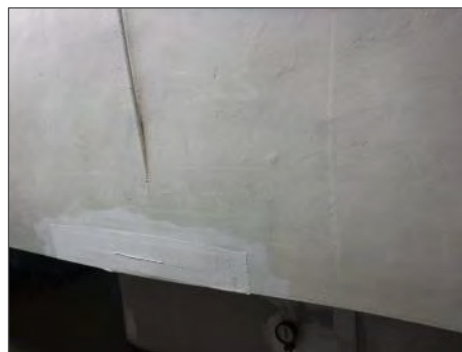
Asbestos-containing parging cement present under canvas jacketing on ducts in room 164.

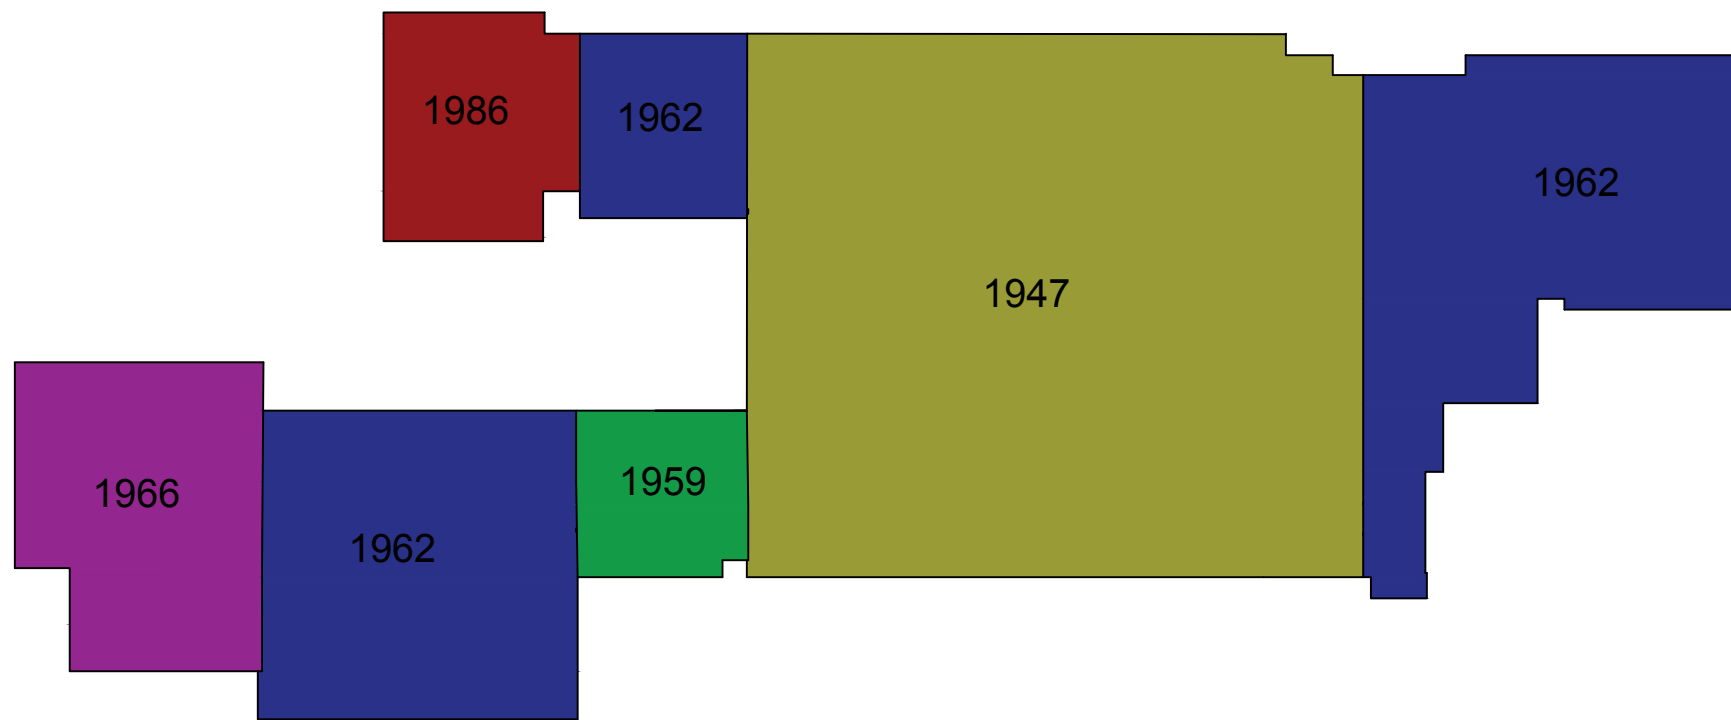
▨ SUSPECTED ASBESTOS-CONTAINING PIPE INSULATION WITHIN PIPE CHASE/ABOVE SOLID CEILING

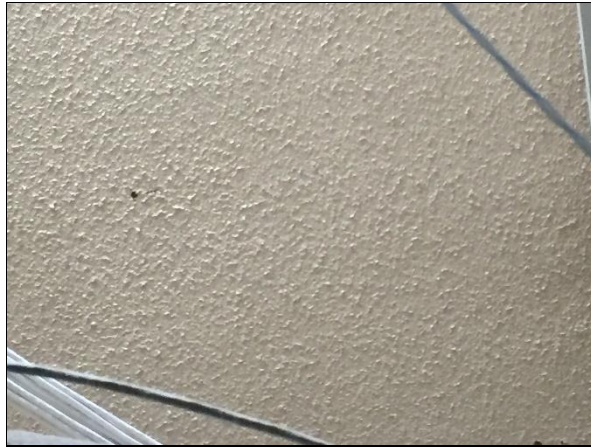
Asbestos-containing texture finish on the ceilings in Room 118B.

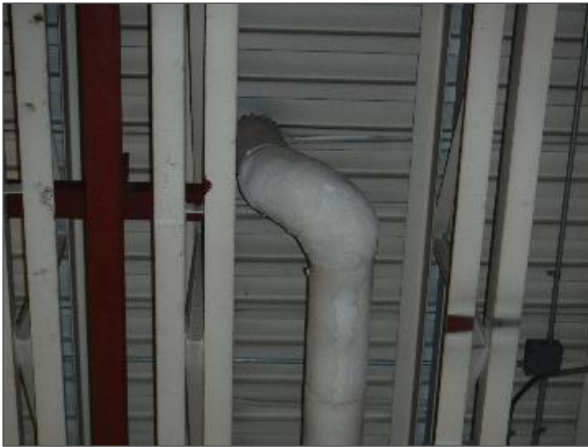
Asbestos-containing paring cement insulation present on pipe fitting, in good condition

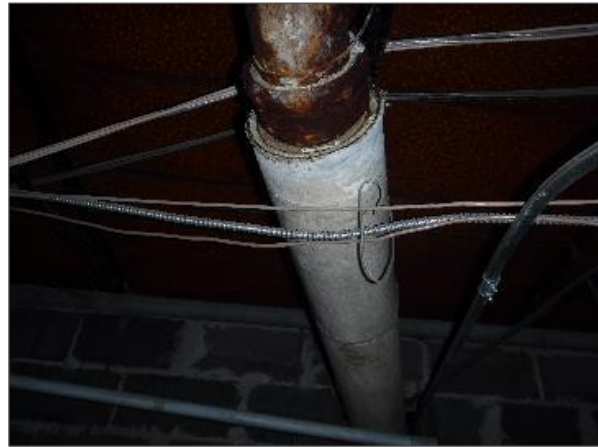
Asbestos-containing sweatwrap pipe insulation, in good condition.

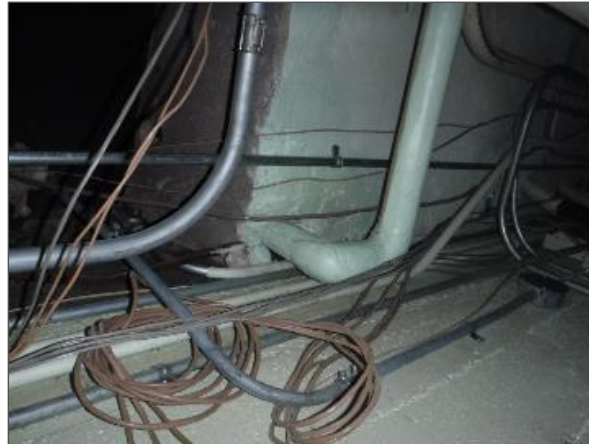
Asbestos-containing Aircell pipe present throughout the building

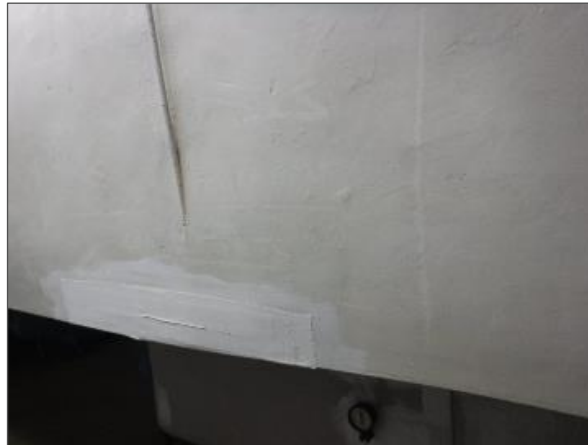
Asbestos-containing paring cement present under canvas jacketing on ducts in room 164.

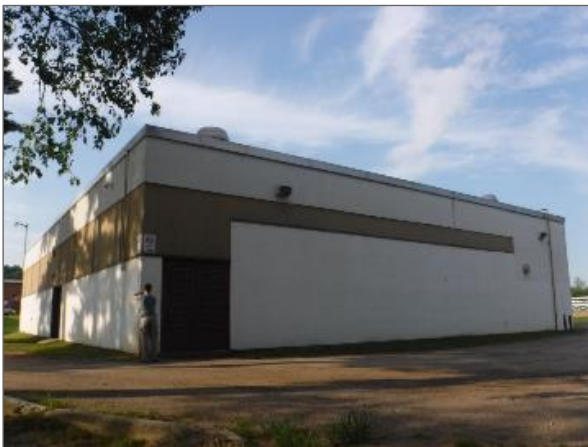
Asbestos-containing stucco present on the exterior walls of the 1959, 1962 and 1966 additions.

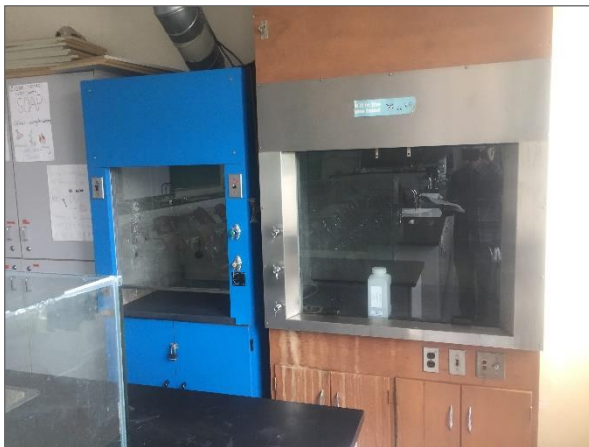
Fume hoods with presumed asbestos-containing Transite board in Room 201

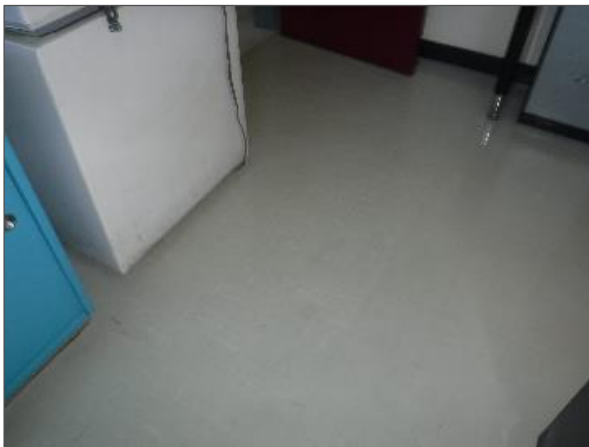
Asbestos-containing 9" light grey vinyl floor tiles with white streaks and mastic (VT1).

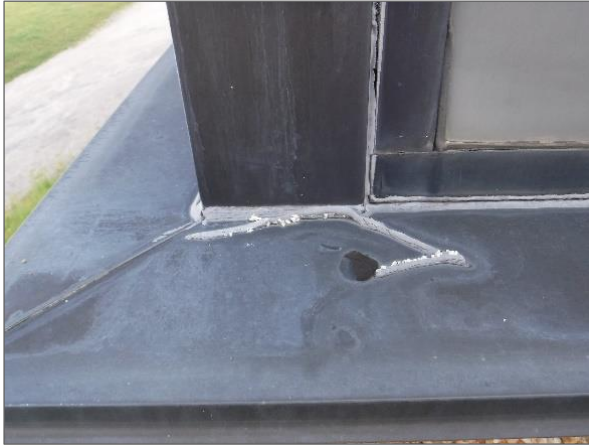
Asbestos-containing grey, soft exterior window caulking on the 1986 addition.

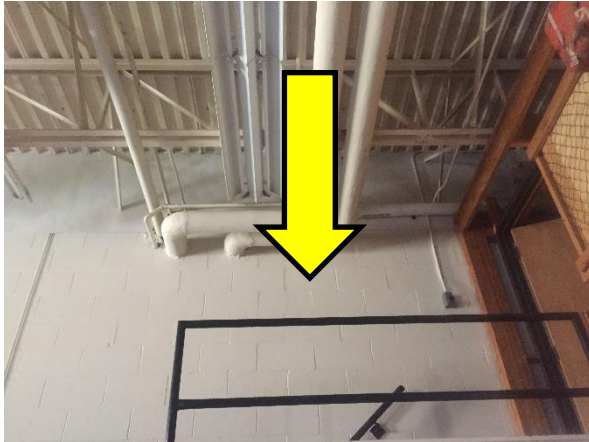
Asbestos-containing beige paint on concrete block walls.
