**DURHAM CATHOLIC
DISTRICT SCHOOL BOARD**
Learning and Living in Faith

**T26-08 Universal Washroom Additions Two (2) Schools - St. James and St. John the
Evangelist Catholic School
Addendum No 2**

Addendum Date: Wednesday, April 22, 2026
Issued by: Purchasing Services
Durham Catholic District School Board

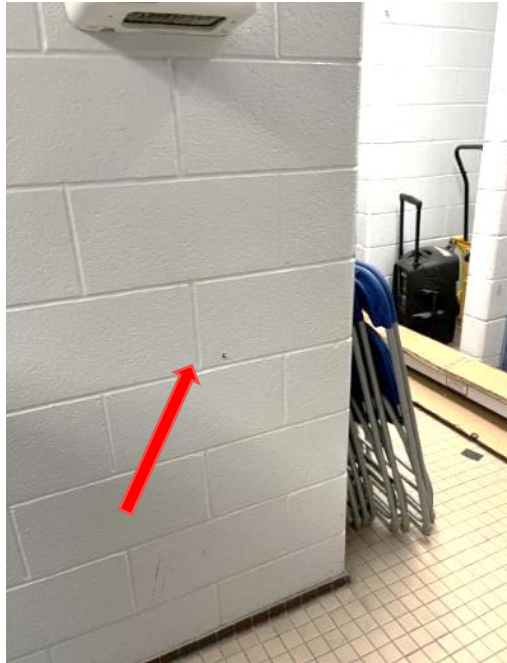
Photo 1. Representative view of low-level lead white paint applied to concrete block wall observed in Room 127.

Should disturbance to lead be required, follow appropriate lead safety precautions in accordance with the above-noted guideline.

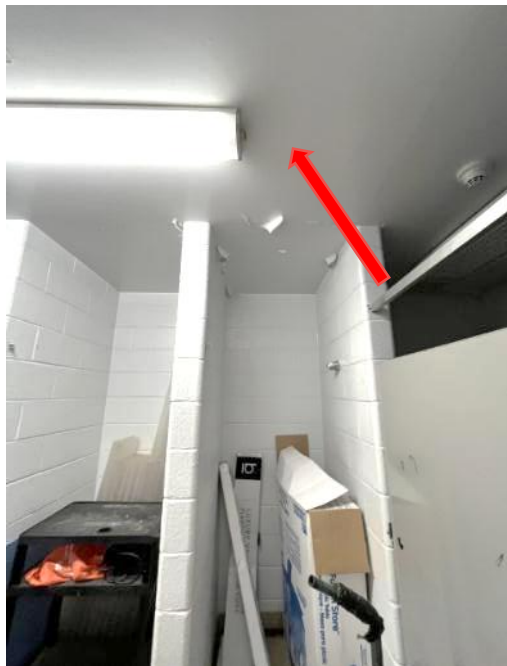
Photo 2. Representative view of low-level lead paint described as white applied to drywall ceiling observed in Room 127.

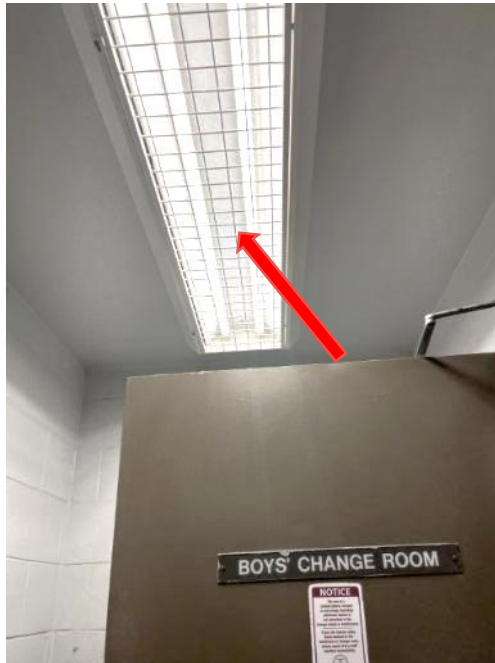
Light fixtures were noted to be equipped with LED light tubes which are not suspected to contain mercury vapour.

Light fixtures were noted to be equipped with LED light tubes. As such, associated ballasts are not suspected to contain PCBs.

Photo 3. Representative view of light fixture equipped with LED light tubes observed in Room 127.

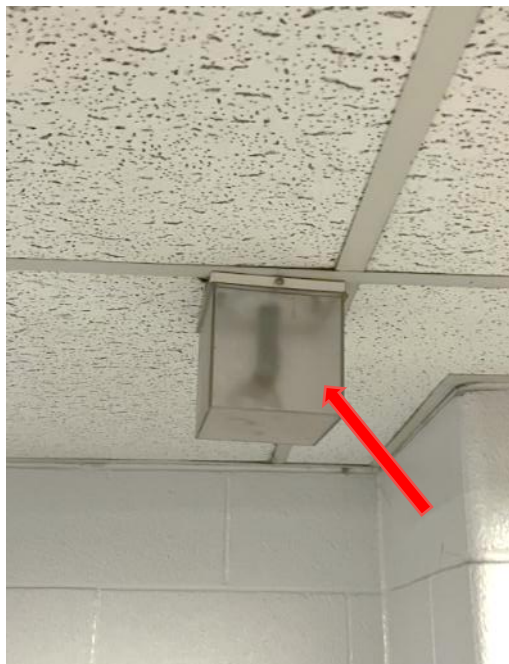
Photo 4. Representative view of assumed lead-containing batteries associated with emergency lighting system observed in Room 127.

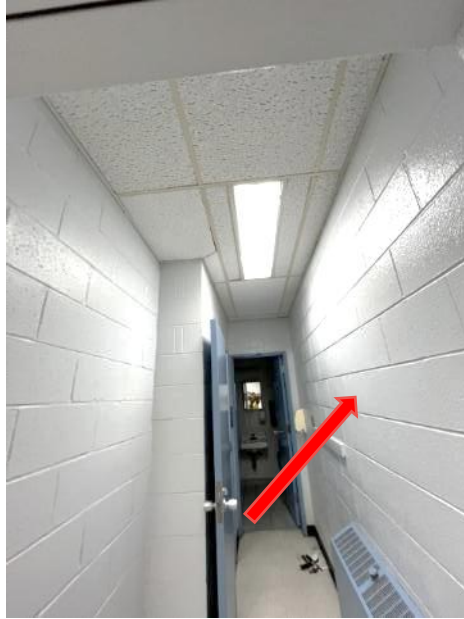
Photo 1. Representative view of low-level lead paint described as white applied to concrete block wall observed in the Corridor.

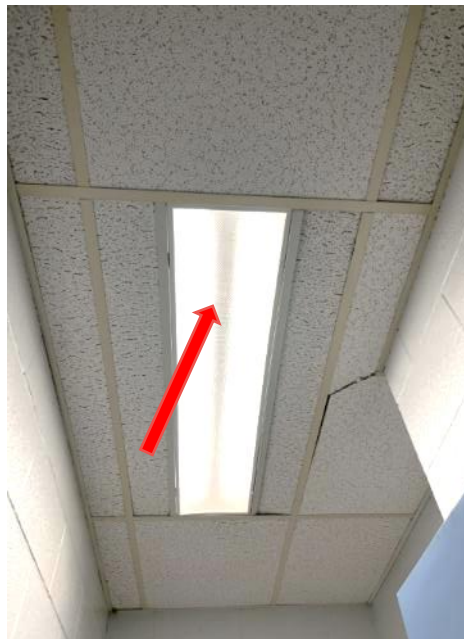
Photo 2. Representative view of assumed mercury-containing fluorescent light tubes and assumed PCB-containing light ballasts observed in the Corridor.
