Limited Designated Substance Survey Report

Ajax High School

105 Bayly Street East, Ajax, Ontario

February 25, 2026
Parasol Project No: 13367

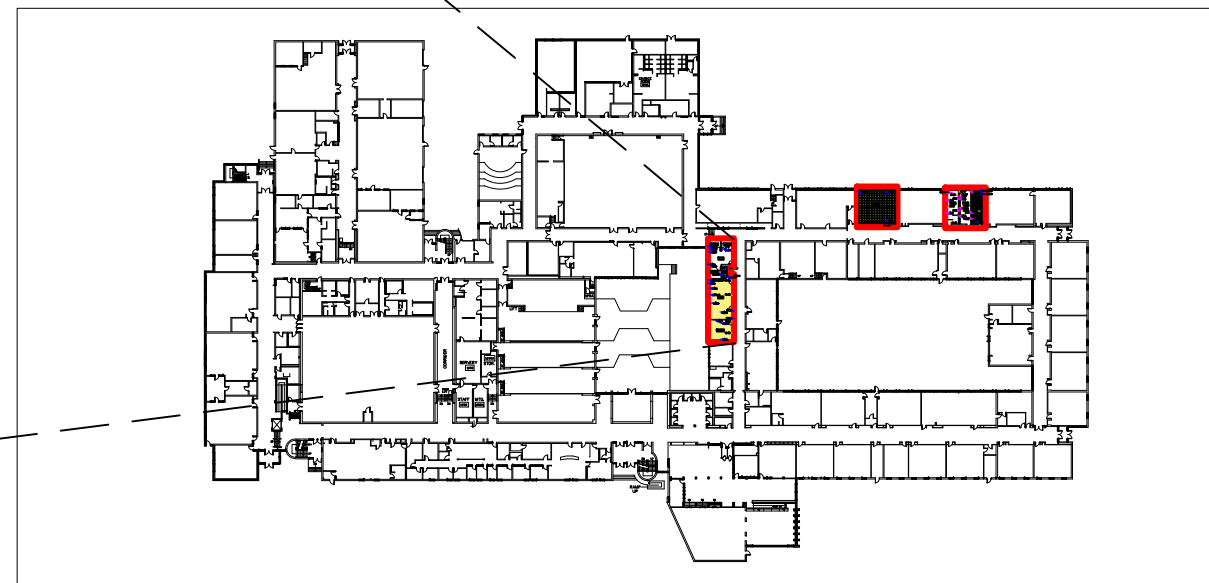
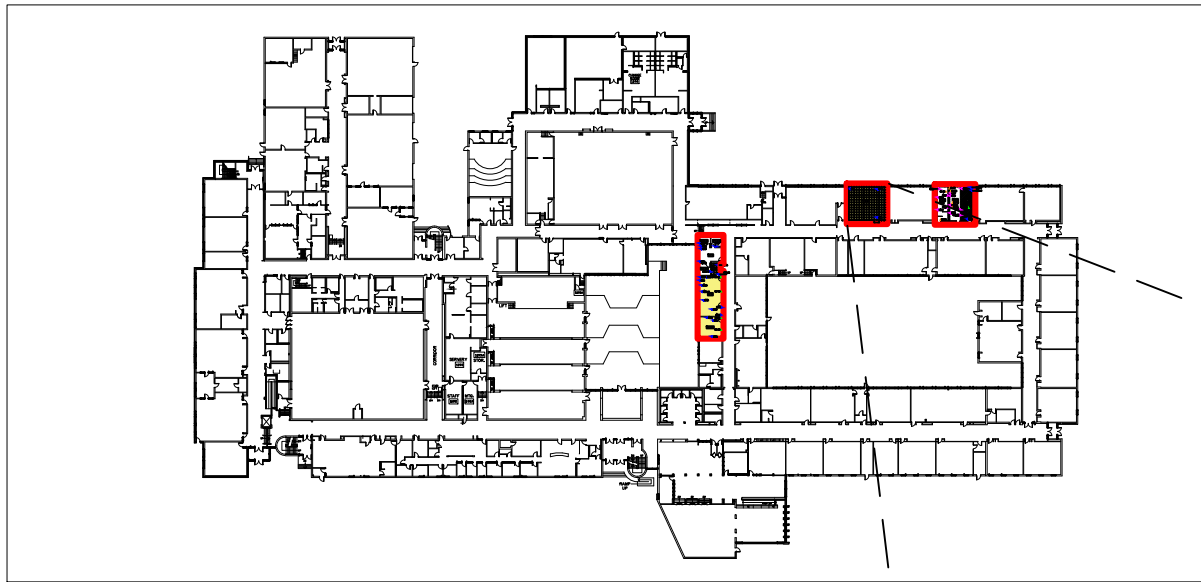
1) Primer applied to brick and masonry block finishes within the 1963 Building Addition Survey Area is confirmed to contain Chrysotile asbestos.
