January 31, 2013

## DESIGNATED SUBSTANCES AND CONTROLLED PRODUCTS SURVEY

# Airport New Terminal - 1200 Airport Boulevard, Oshawa, Ontario

**Report Number:** 12-1187-0086 (1003)

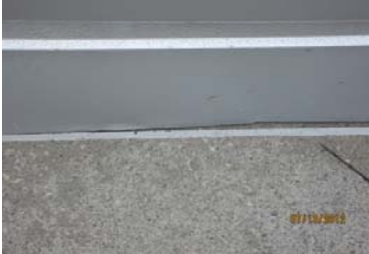
Location	Level	Material & Description	Est. Qty*	Units	Condition	Friable Yes/No	Accessibility	Sample #	% Asbestos and Type	Photographs	Recommended Actions/Comments
Perimeter of Exterior Windows & Doors	Ground Floor & 2nd Floor	Various Caulking Applications	450	Linear Feet	Good	No	High	01 A-C	None Detected

<p>Photograph 1</p>	No action required other than general dust suppression.

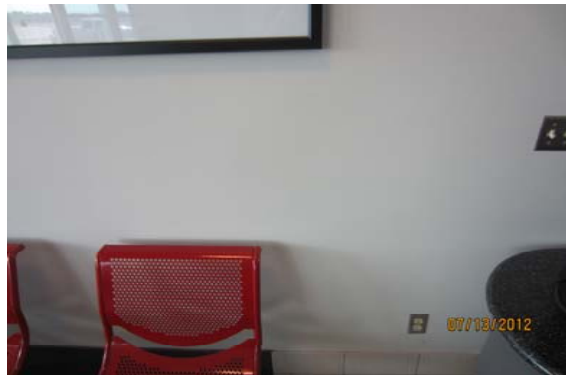
Area	Location / Surface	Colour & Description	Qty	Units	Condition	Accessibility	Sample #	% Lead	Photographs	Recommended Actions
Various Locations Throughout	Drywall Walls	White Paint	750	Square Feet	Good	High	LP-01	<0.0053% (by dry weight)

Photograph 1	Lead was not detected in the sample, therefore this paint is considered to be lead free. No recommended actions relative to control of exposure to lead apply to this paint.
First Floor - South East Offices	Drywall Walls	Light Purple Paint	1,400	Square Feet	Good	High	LP-02	<0.0067% (by dry weight)

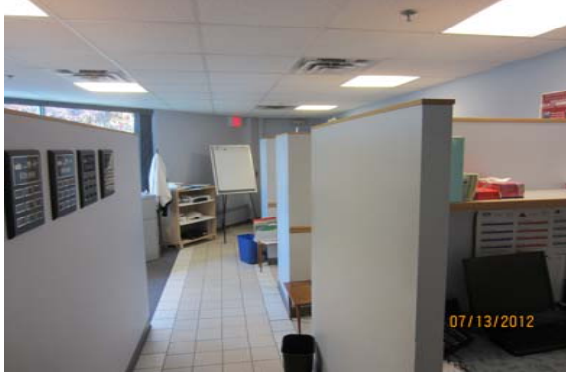
Photograph 2	Lead was not detected in the sample, therefore this paint is considered to be lead free. No recommended actions relative to control of exposure to lead apply to this paint.
Second Floor - West Offices	Drywall Walls	Yellow Paint	2,150	Square Feet	Good	High	LP-03	<0.0057% (by dry weight)

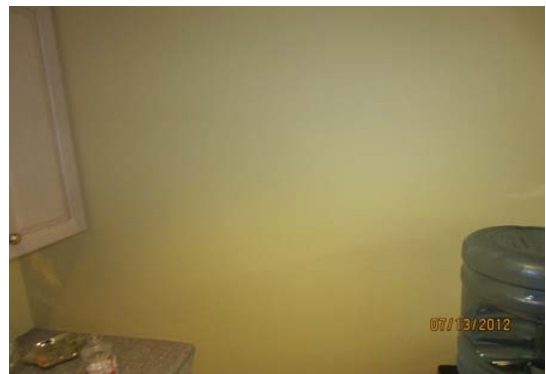
Photograph 3	Lead was not detected in the sample, therefore this paint is considered to be lead free. No recommended actions relative to control of exposure to lead apply to this paint.
