NORTH HASTINGS HIGH SCHOOL LIFT REPLACEMENT

Hazardous Building Materials Assessment North Hastings Secondary School

14 Monck Street, Bancroft,
Ontario

March 1, 2018

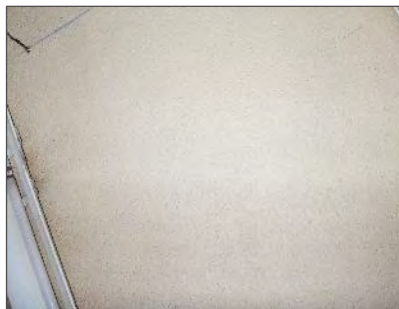
Texture finish, containing chrysotile asbestos, is present on the plaster ceiling in Rooms 118B, 118C and 118D (Samples 0045A-E). Texture finish is a friable materials and in good condition.

Asbestos-containing texture finish on the ceilings in Room 118B.

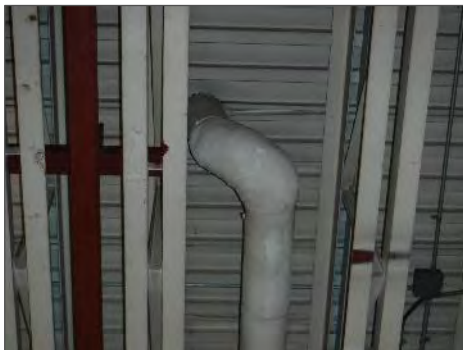
Parging cement, containing chrysotile asbestos, is present on pipe fittings (elbows, valves, tees, hangers etc.) on various pipe systems throughout the building (Samples 0019A-C). Parging cement is a friable insulation, unjacketed or jacketed with canvas and is in good condition.

Asbestos-containing parging cement insulation present on pipe fitting, in good condition

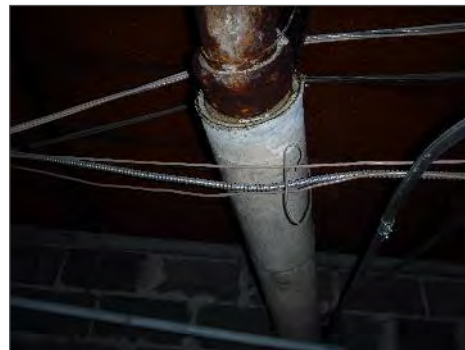
Sweatwrap insulation (brown layered paper), containing chrysotile asbestos, is present on straight sections of domestic cold water pipes, sanitary drains and rain water leaders (Samples 0018A-C). Sweatwrap is a friable insulation, unjacketed or jacketed with canvas or foil and is in good condition with the exception of 5 square feet of sweatwrap debris laying on top of the plaster ceiling at the north end of Corridor 162. The debris is not accessible and is only visible from above the suspended ceiling tiles in the adjacent corridor.

Asbestos-containing sweatwrap pipe insulation, in good condition.

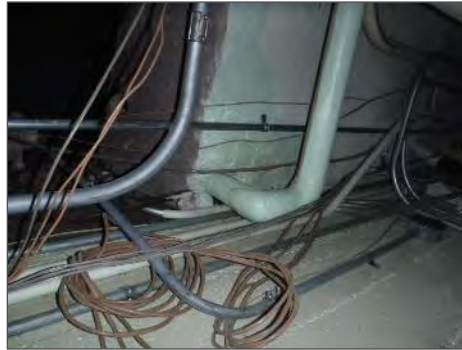
A white corrugated paper insulation (trade name Aircell), containing chrysotile asbestos, is present on straight sections of the hot water heating pipe system in isolated locations throughout the building (Samples 0021A-C). Aircell is a friable insulation, unjacketed or jacketed with canvas and is in good condition.

Asbestos-containing Aircell pipe present throughout the building

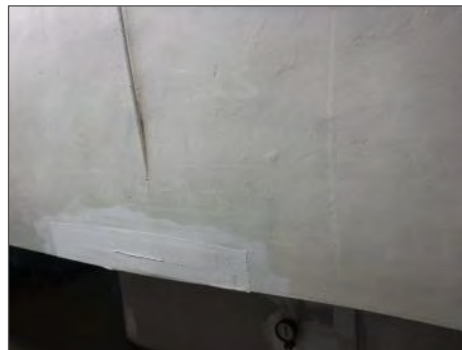
Parging cement, containing chrysotile asbestos, is present over the entire surface of the fibreglass insulation on ducts in the 2nd floor fan room 164 (Samples 0038A-C). Parging cement is a friable insulation, jacketed with canvas and approximately 750 square feet is present and in good condition.

Asbestos-containing parging cement present under canvas jacketing on ducts in room 164.

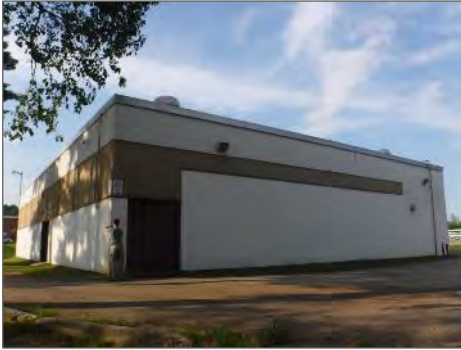
Asbestos-containing stucco present on the exterior walls of the 1959, 1962 and 1966 additions.

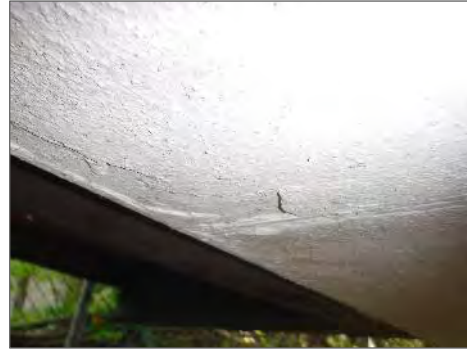
Asbestos-containing stucco panels present on the underside of the southeast entrance of the 1962 addition (under the music room 214).

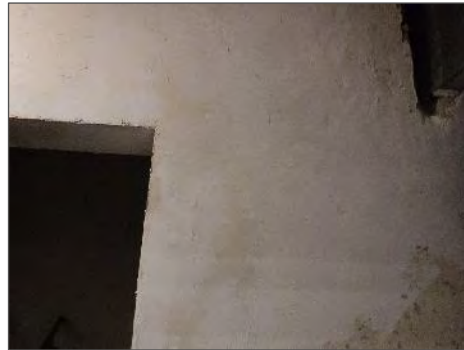
Plaster is non-friable material which may become friable during removal. All plaster is painted and is in good condition. Damage previously reported has been repaired.

Repaired, asbestos-containing plaster on the walls of Room 158A.

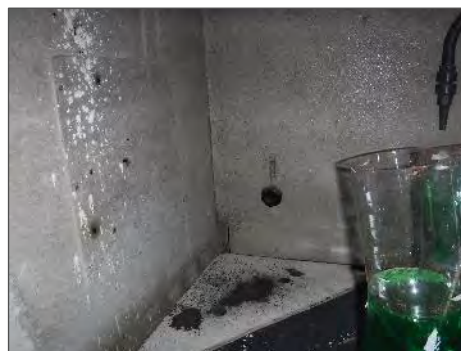
Transite board is present in 2 fume hoods in Room 201 and is presumed to contain asbestos based on visual observation. Transite is a non-friable material and approximately 80 SF is present and in good condition.

Transite panels present in the fumehood in Room 201, in good condition.

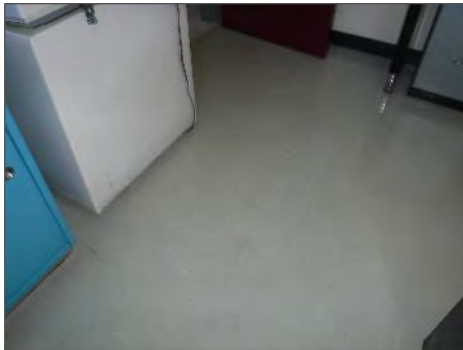
Asbestos-containing 9" light grey vinyl floor tiles with white streaks (VT1)

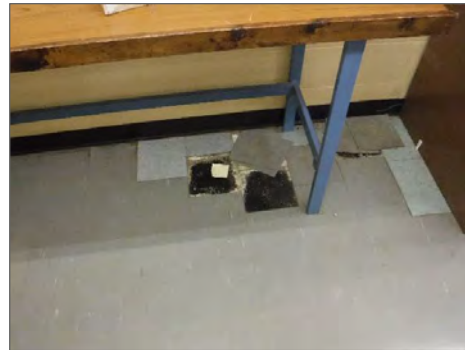
The vinyl floor tiles and mastic are non-friable and are in good condition with the exception of four loose floor tiles (VT3) in Room 114A.

Loose and delaminating asbestos-containing 9" dark grey vinyl floor tiles with white streaks (VT3) in room 114A.

Material, Quantity & Condition	Location	Recommended Procedure
9" Vinyl floor tiles, 4 loose tiles	Room 114A	Type 1 asbestos procedures
Sweatwrap pipe insulation, 5 SF debris	North end of corridor 162 above plaster ceiling; no access and not reachable, visible from above suspended ceiling tiles in adjacent corridor.	Restrict access until Type 2 asbestos abatement is performed (when required for renovation/demolition/maintenance).
Peeling and flaking lead-containing mint paint, 10 SF	Room 101A	Type 2a lead procedures

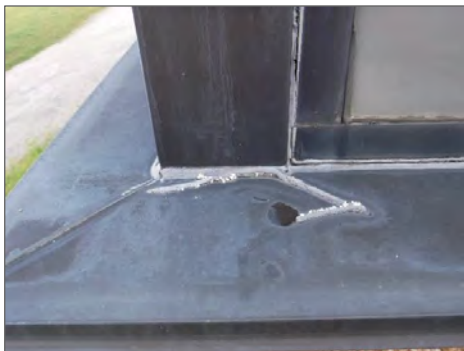
Asbestos-containing grey, soft exterior window caulking on the 1986 addition.

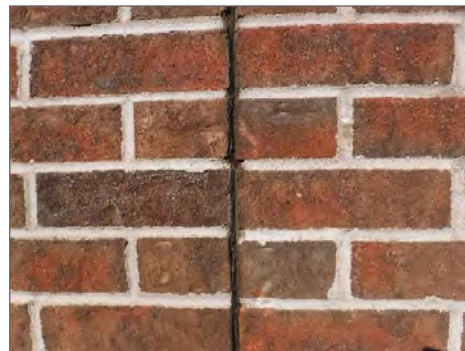
Asbestos-containing black, soft exterior expansion joint caulking on the 1947 original building.

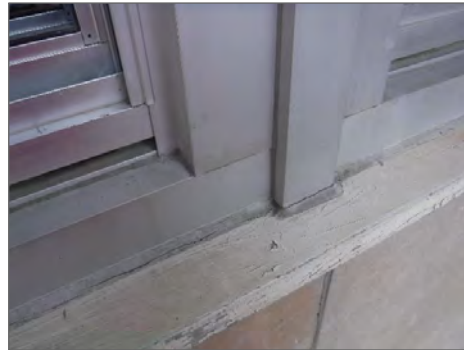
Asbestos-containing grey, soft exterior window caulking on the 1947 original building and 1962 addition.

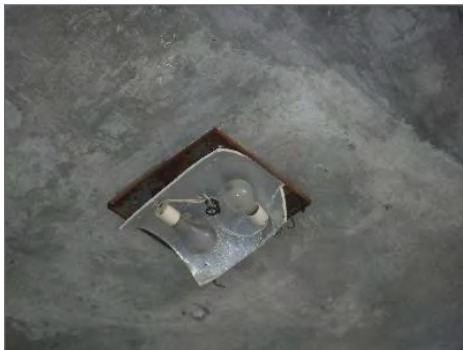
Paper heat shields, containing chrysotile asbestos, are present within two exterior incandescent light fixtures at the entrance to Corridor 163 (Samples 0042A-C). Paper heat shields are non-friable and are in good condition.

Asbestos-containing paper heat shield present within two exterior incandescent light fixtures at the entrance to Corridor 163.

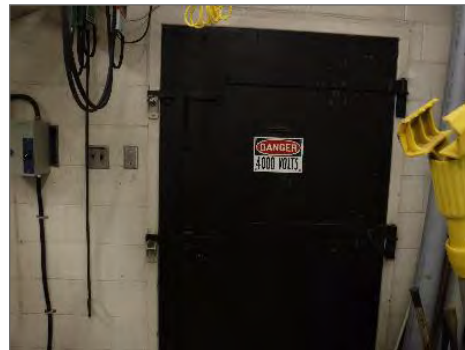
Insulation in the core of one fire rated door in Room 140 is suspected to contain asbestos. The insulation is typically friable and is in good condition.

Suspected asbestos-containing insulation within the core of the fire rated door for room 140.

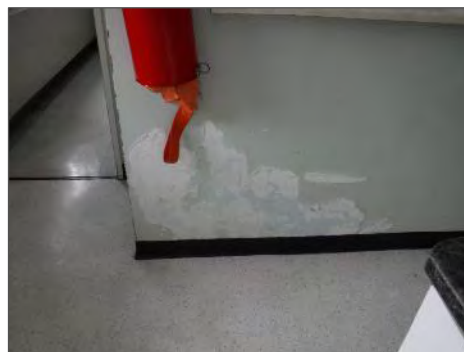
- 10 SF of peeling and flaking mint paint on plaster wall is present in Room 101A.

Peeling and flaking mint paint present in Room 101A.

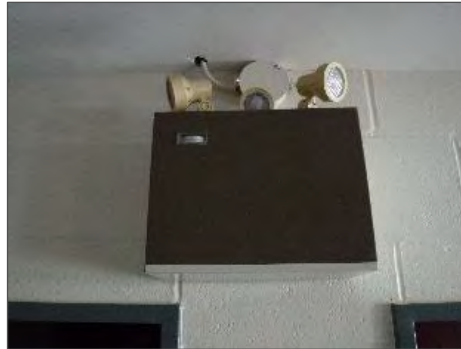
Lead-containing batteries are present in emergency lighting and fire alarm control panels.

Emergency light containing lead-acid batteries.

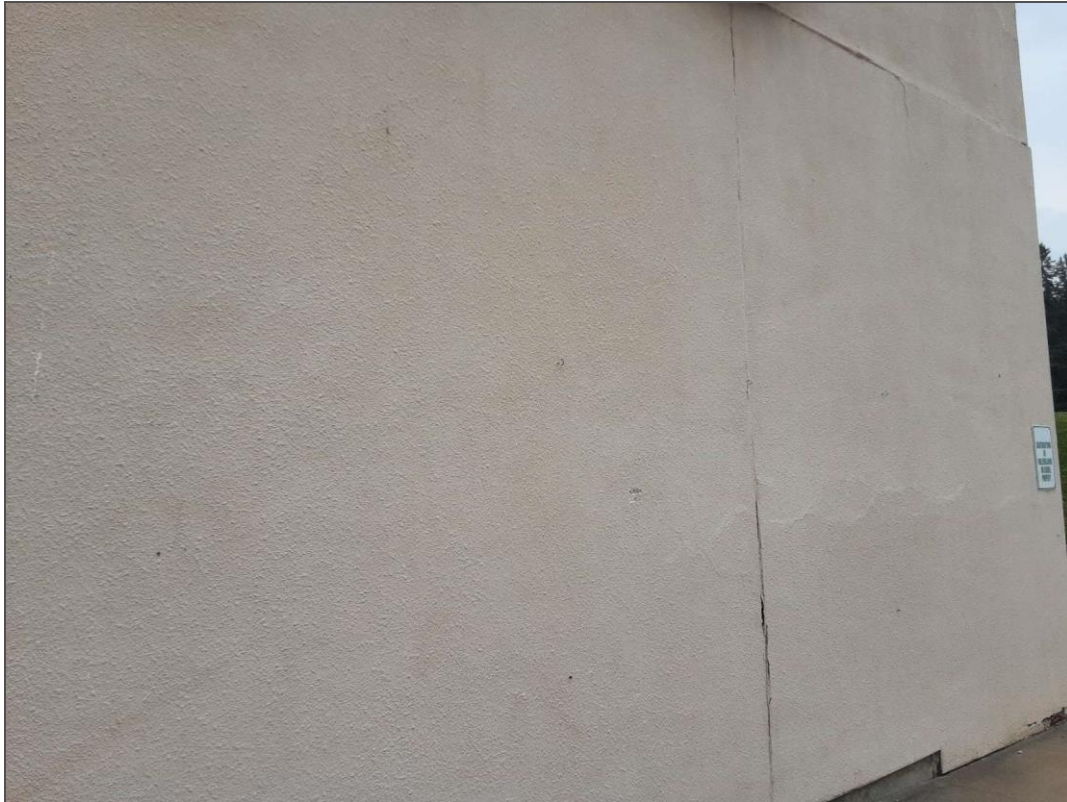
S0002 – Asbestos-Containing Stucco, Exterior - 1959 Addition (Location #: 501).

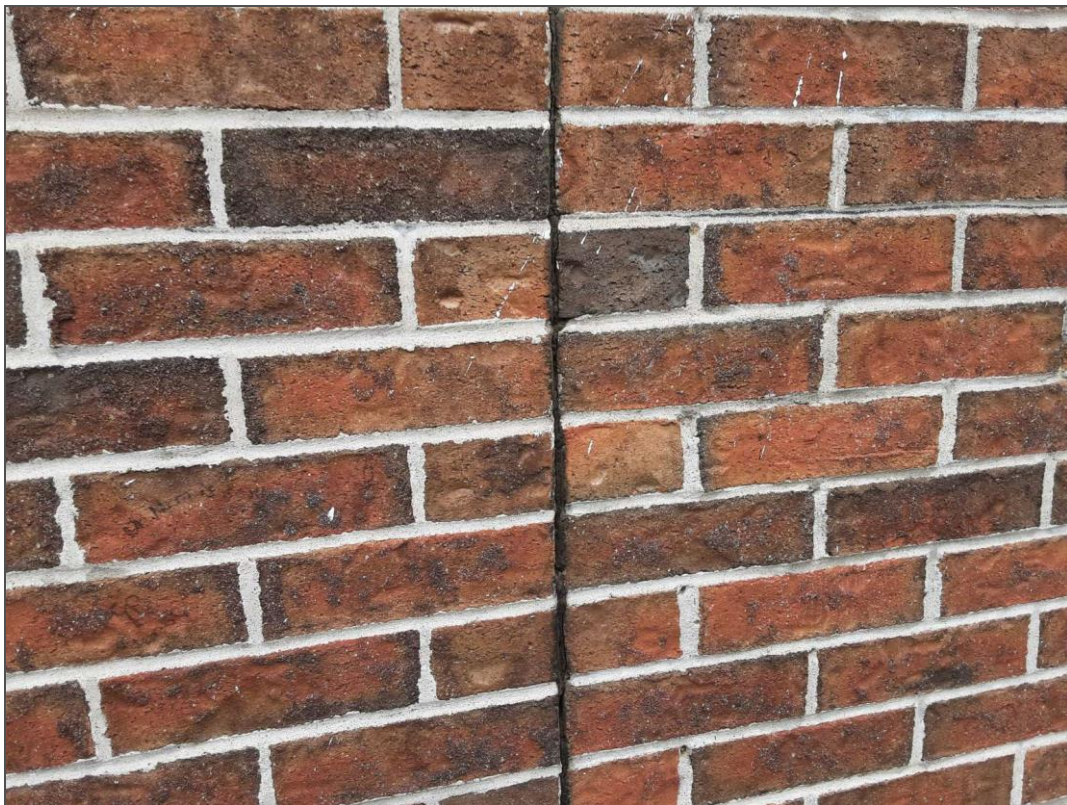
S0009 – Asbestos-Containing Soft Black Expansion Joint Caulking, Exterior - Original Building (Location #: 500).

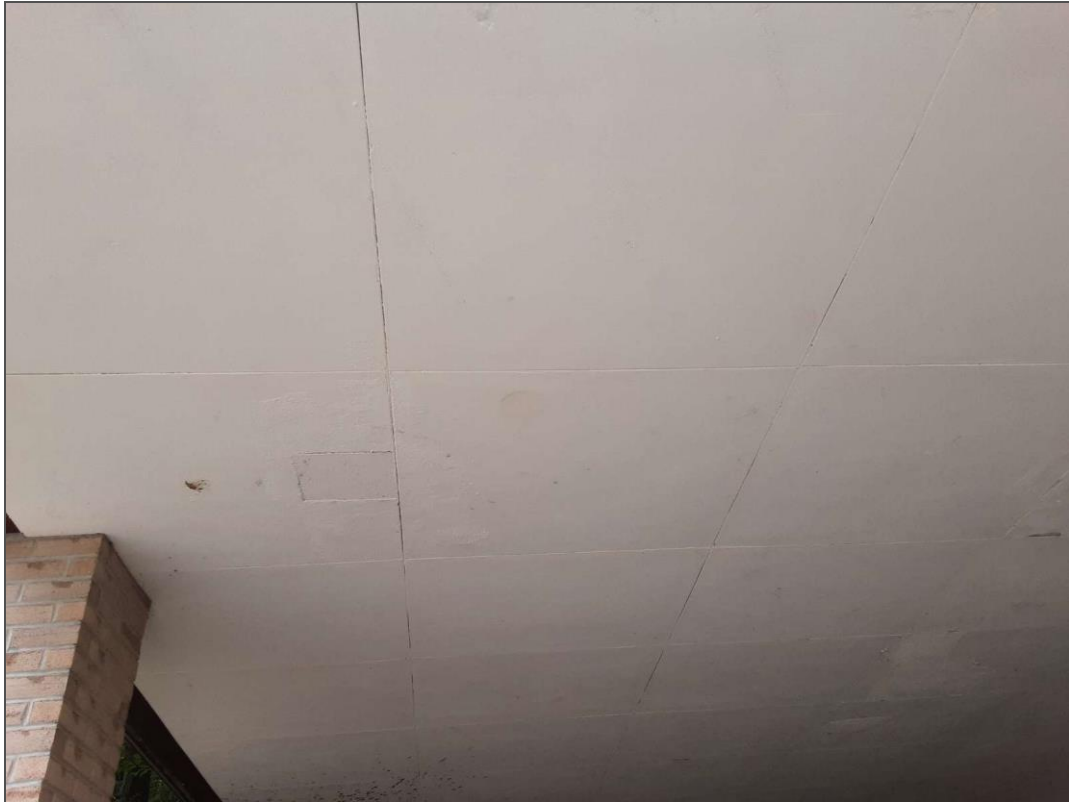
S0012 – Asbestos-Containing Stucco Canopy, Exterior - 1962 Addition (Location #: 502).

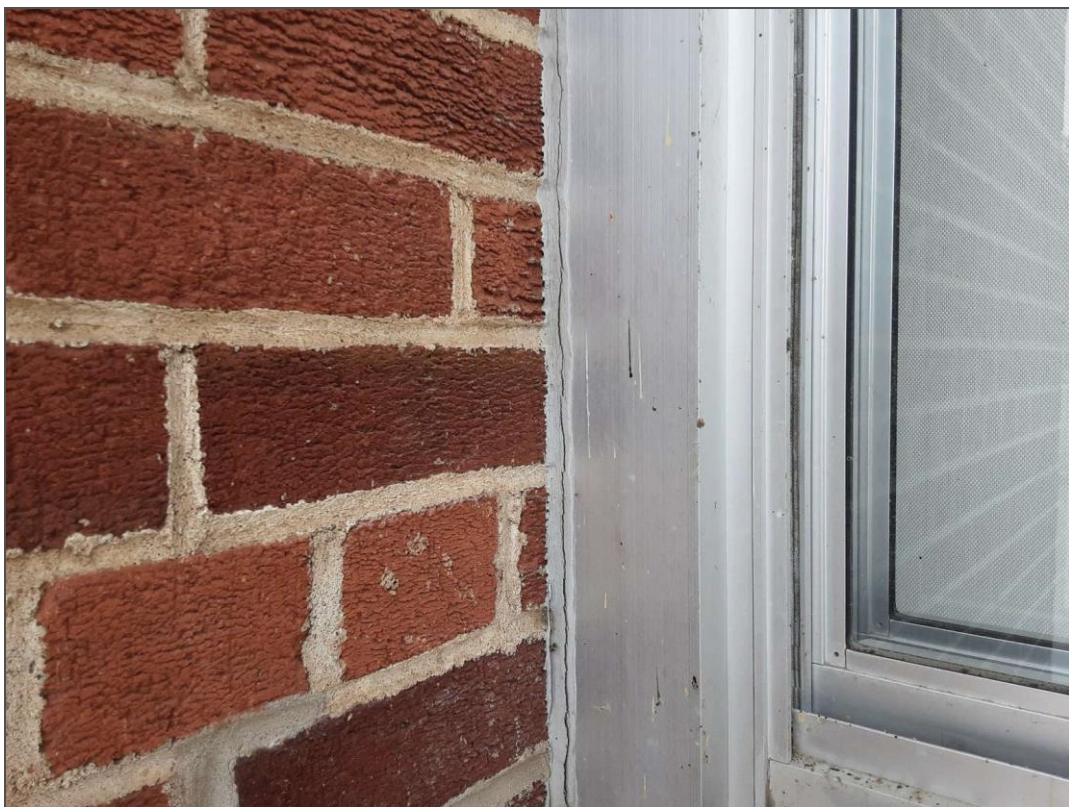
S0013 – Asbestos-Containing Soft Grey Window Caulking, Exterior - Original Building (Location #: 500).

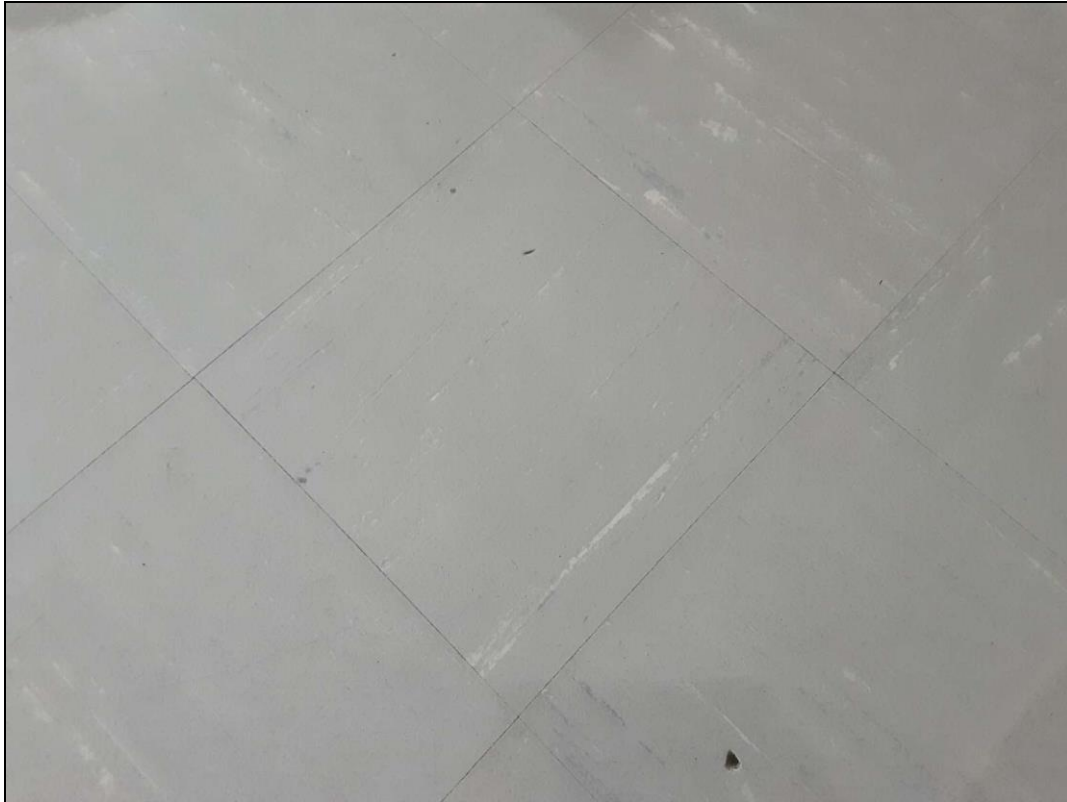
S0017 – Asbestos-Containing 9"x9" Light Grey Vinyl Floor Tiles with White Streaks and Mastic, Classroom (Location #: 120).

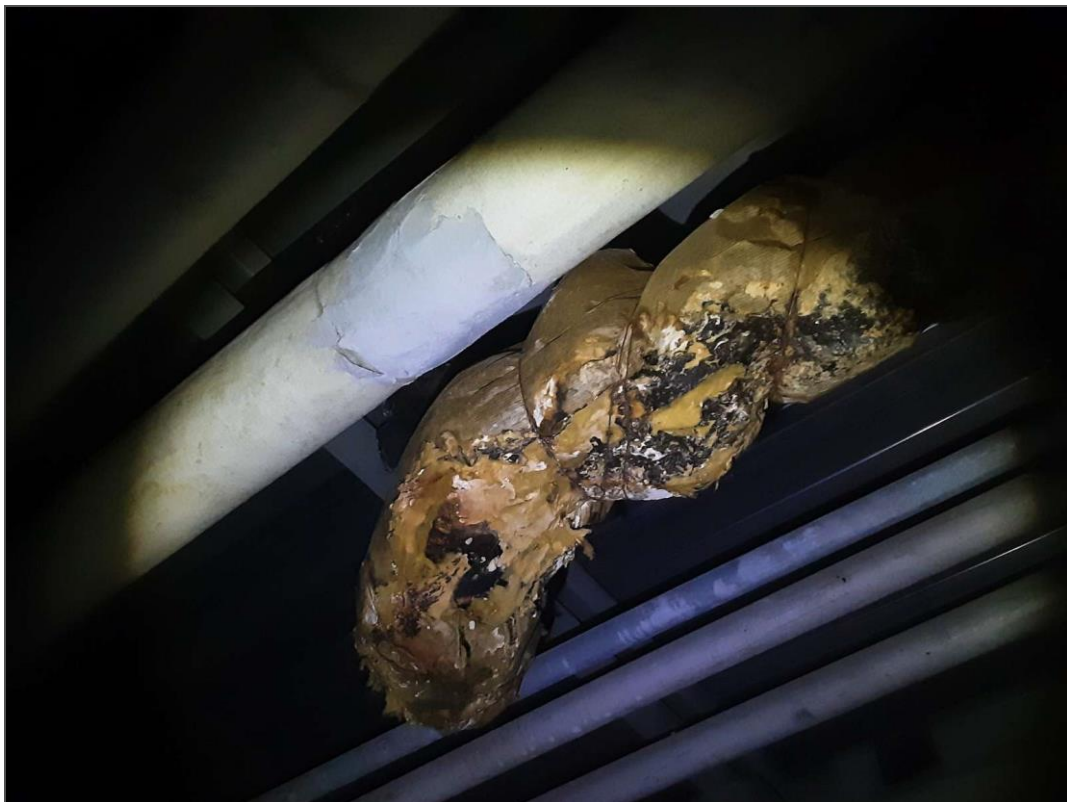
S0018 - Asbestos-Containing Sweatwrap Insulation in Poor Condition, Fan Room (Location #: 264).

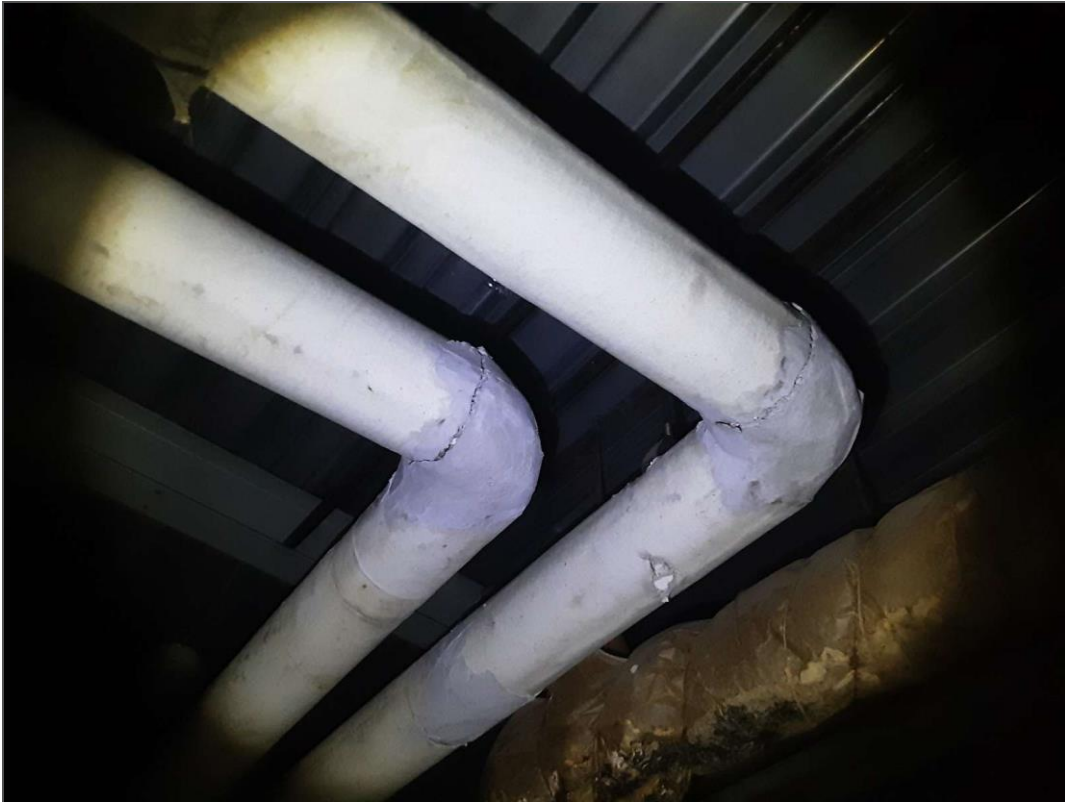
S0019 - Asbestos-Containing Parging Cement Insulation in Poor Condition, Fan Room (Location #: 264).

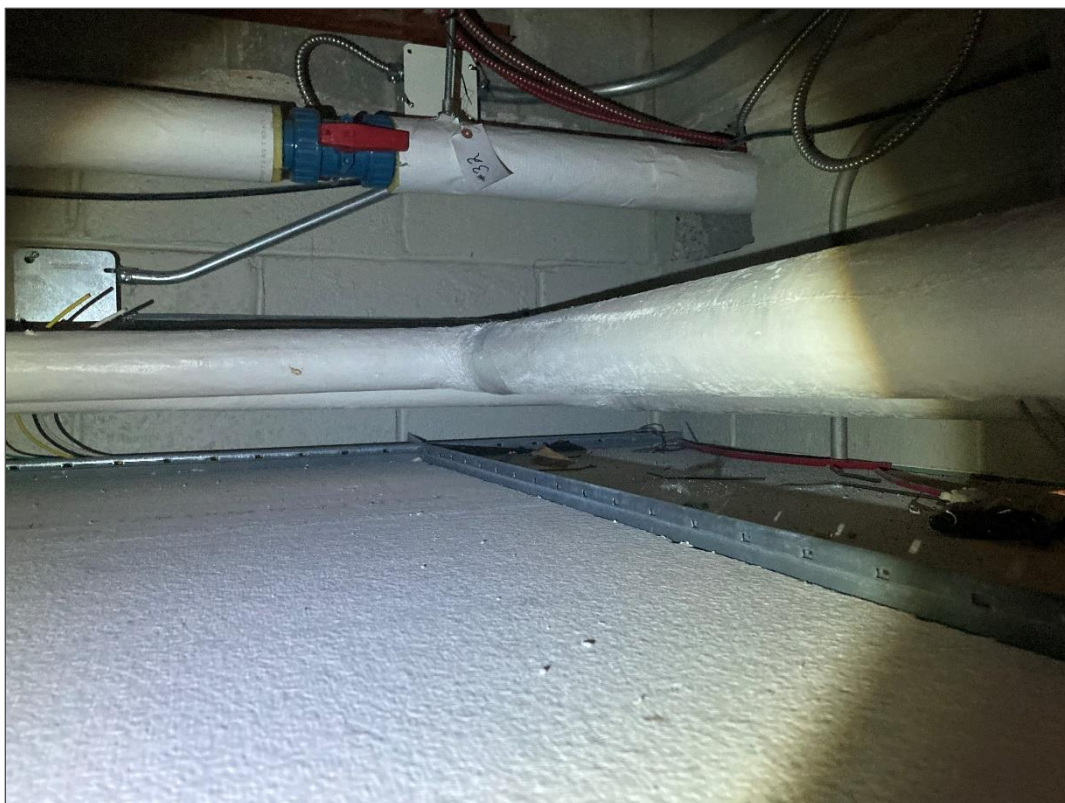
S0021 - Asbestos-Containing Aircell Insulation, Corridor (Location #: 162).

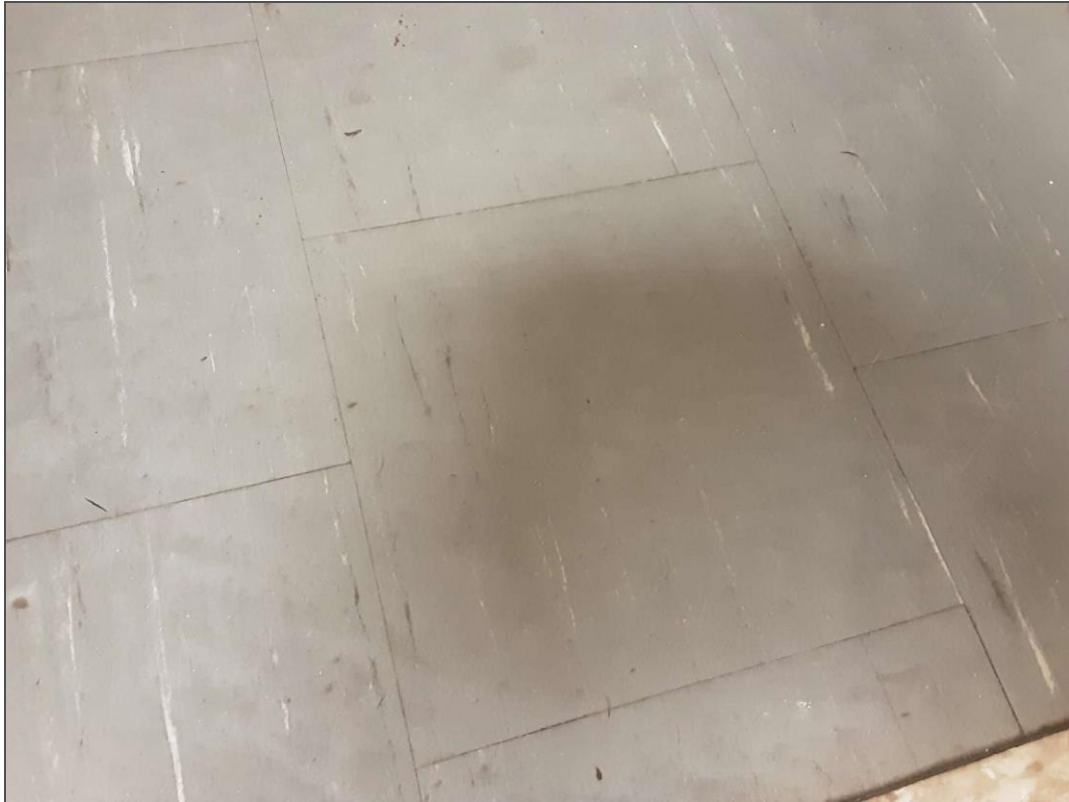
S0024 - Asbestos-Containing 9"x9" Dark Grey Vinyl Floor Tiles with White Streaks and Mastic, Closet (Location #: 1141).

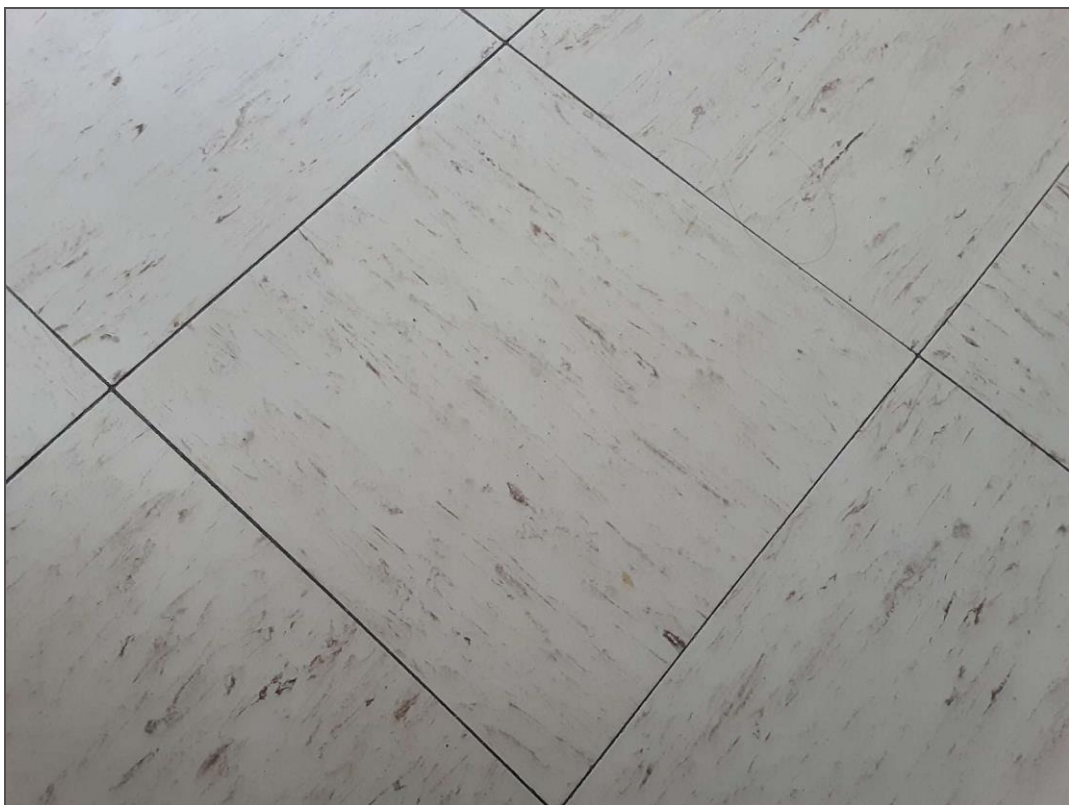
S0028 - Asbestos-Containing 12"x12" Beige Vinyl Floor Tiles with Burgundy Streaks, Classroom (Location #: 101).

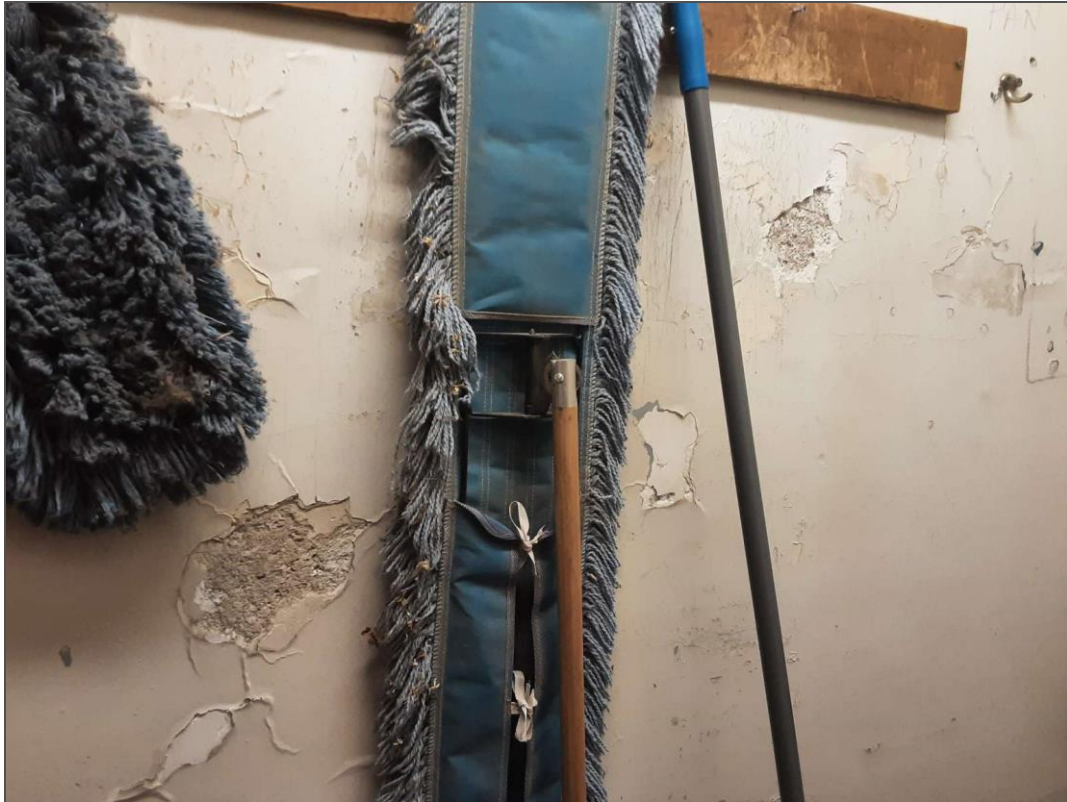
S0029 - Asbestos-Containing Smooth Plaster in Poor Condition, Closet (Location #: 133).

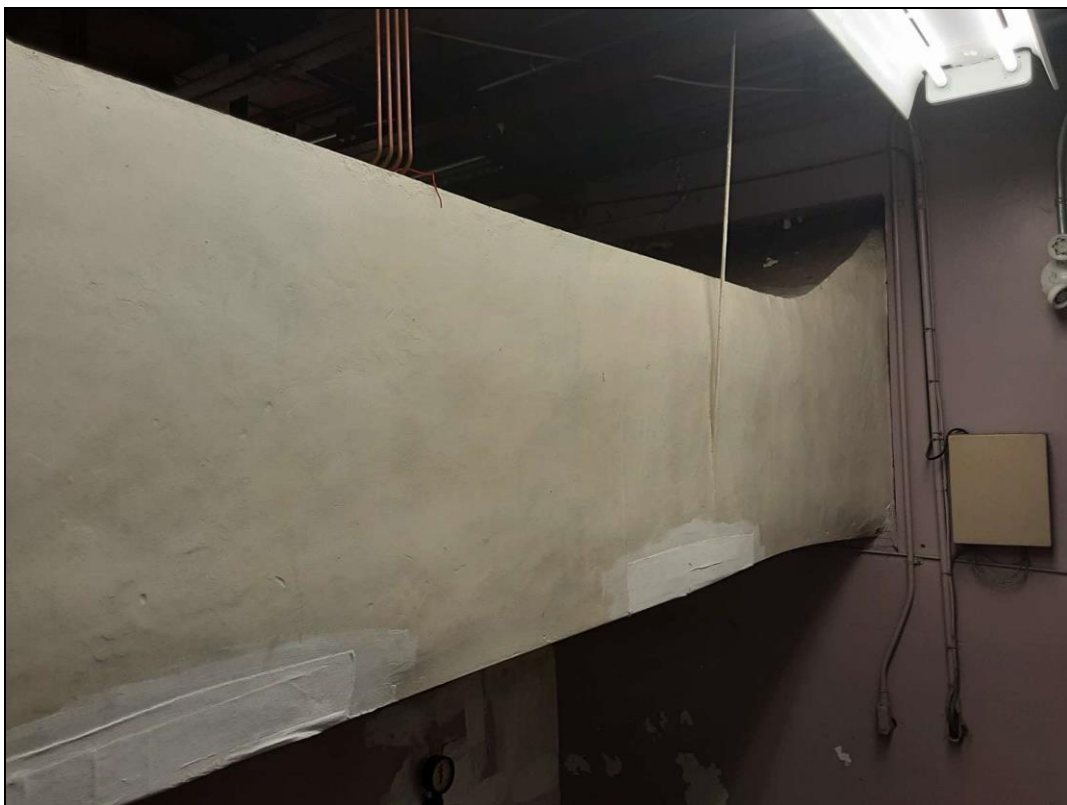
S0038 - Asbestos-Containing Parging Cement Duct Insulation, Fan Room (Location #: 264).

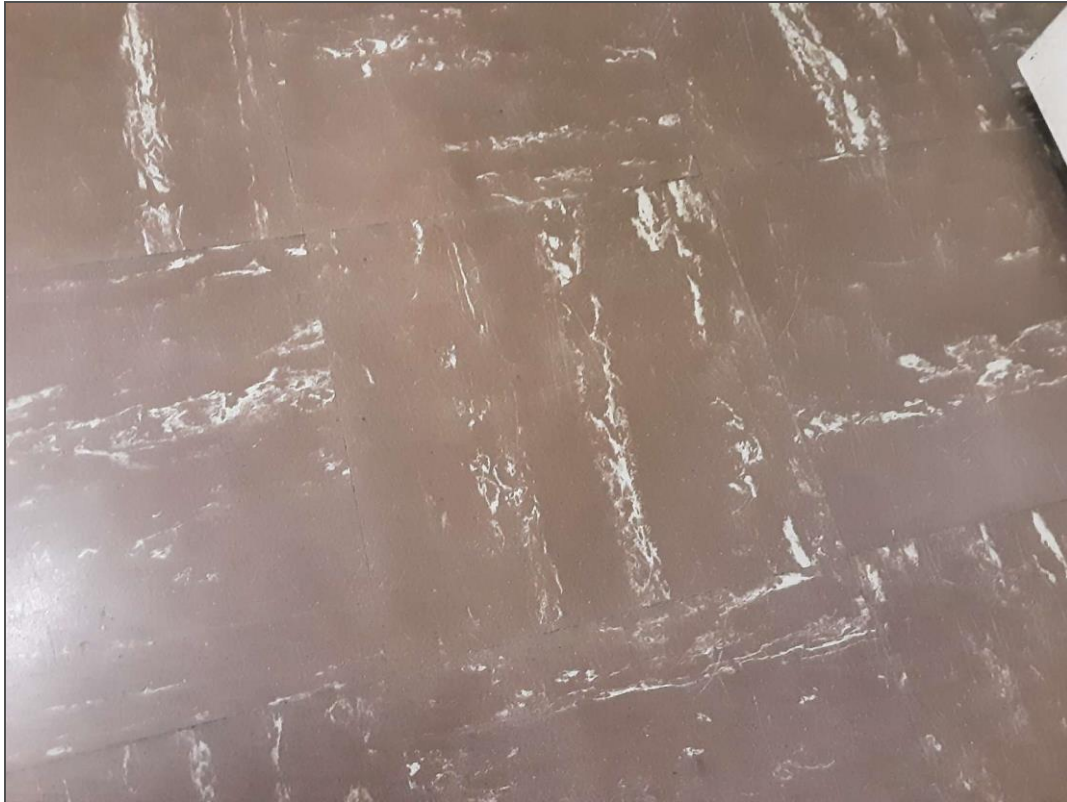
S0041 - Asbestos-Containing 9"x9" Brown Vinyl Floor Tiles with White Streaks and Mastic, Classroom (Location #: 130).

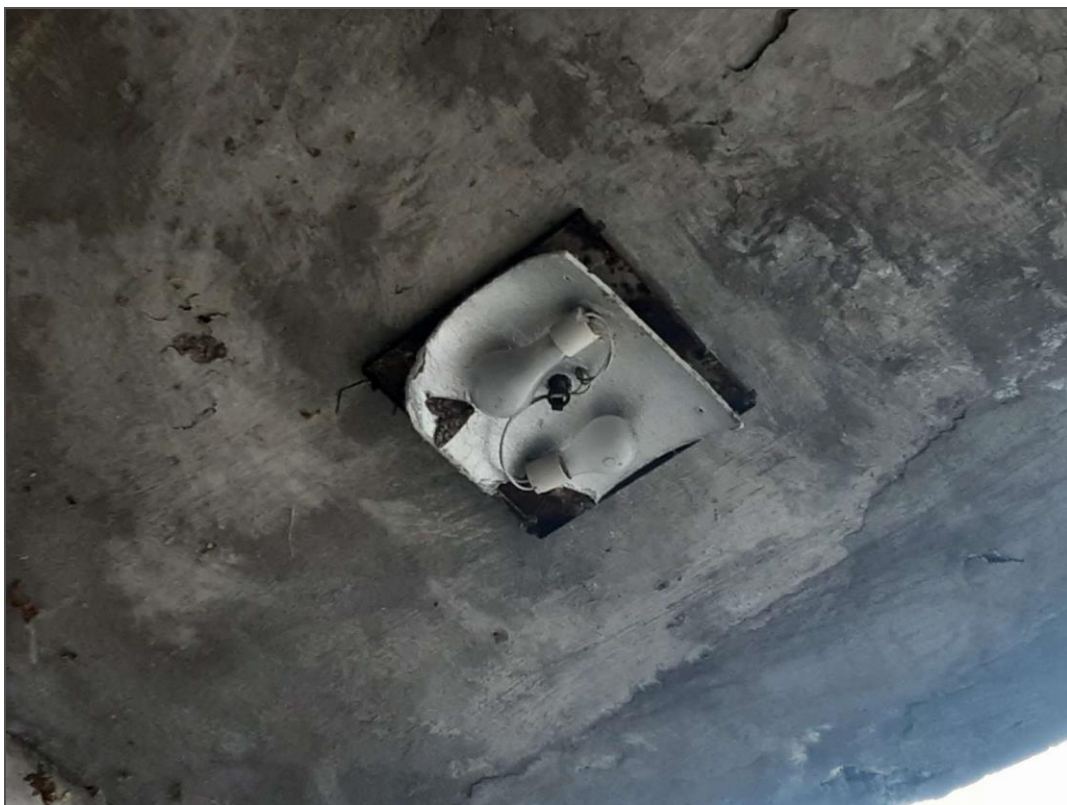
S0042 - Asbestos-Containing Paper Heat Shield, Corridor (Location #: 163).

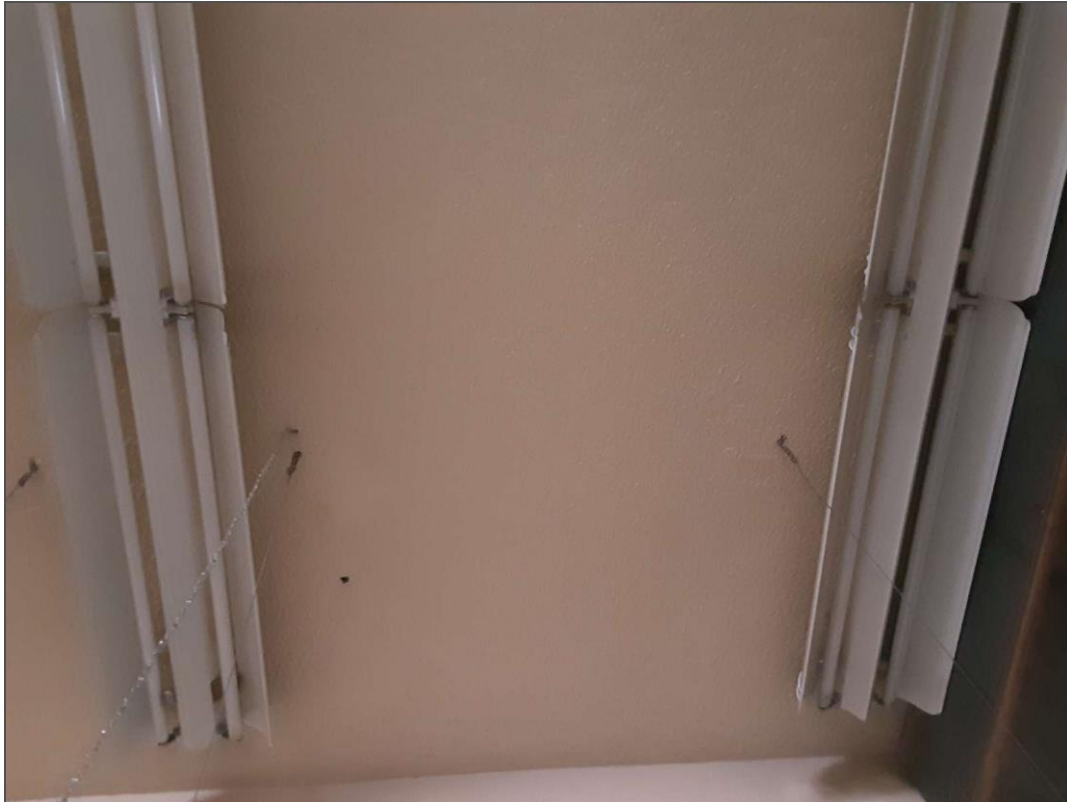
S0045 - Asbestos-Containing Texture Coat Ceiling, Classroom (Location #: 1182).

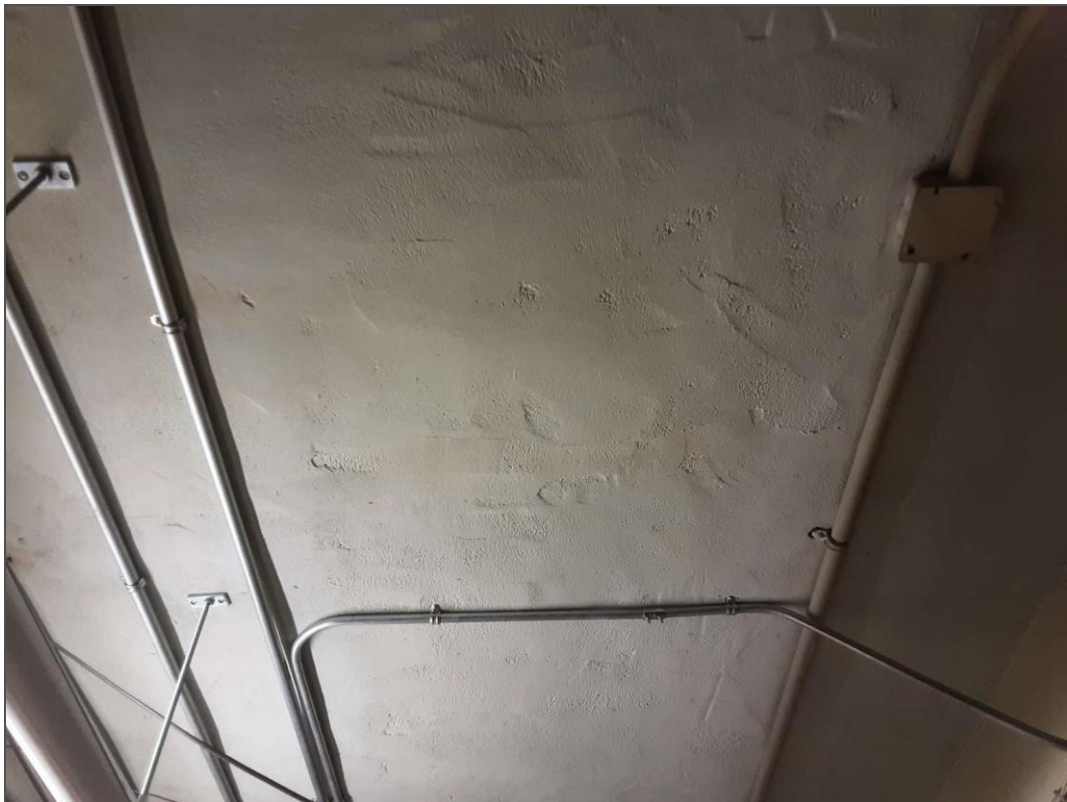
S0048 - Asbestos-Containing Rough Plaster Ceiling, Basement (Location #: 18).

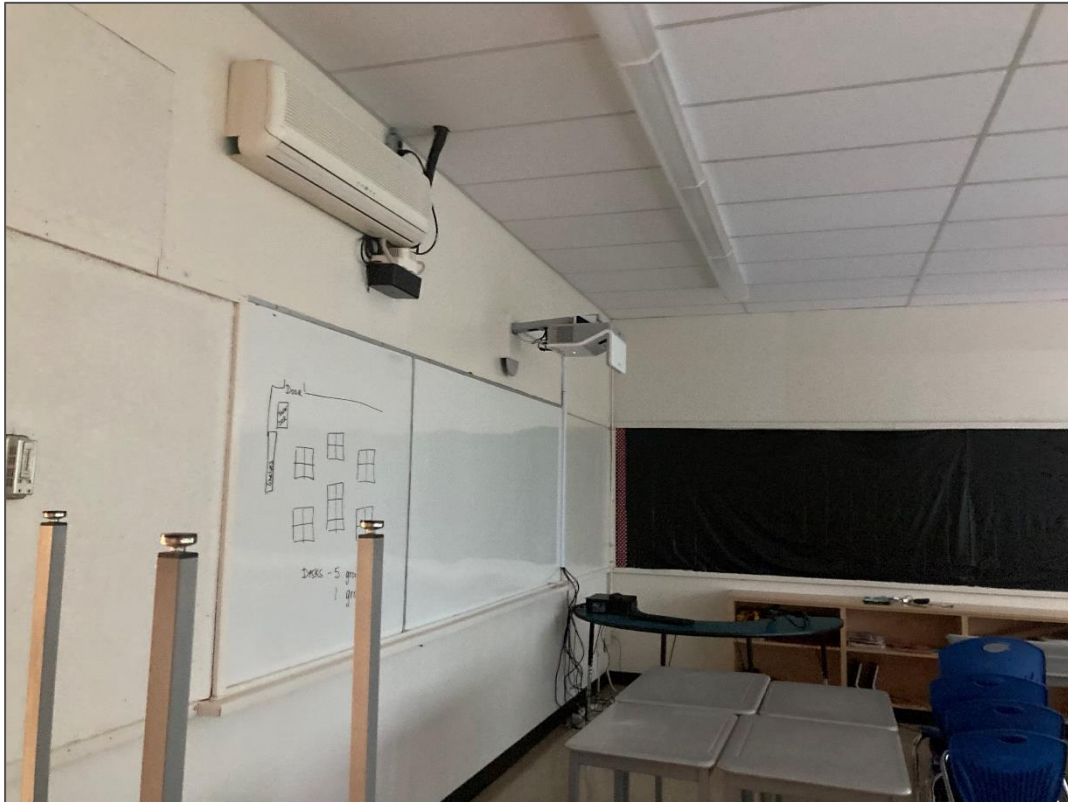
S0050 – Asbestos-Containing Plaster, Classroom (Location #: 202).

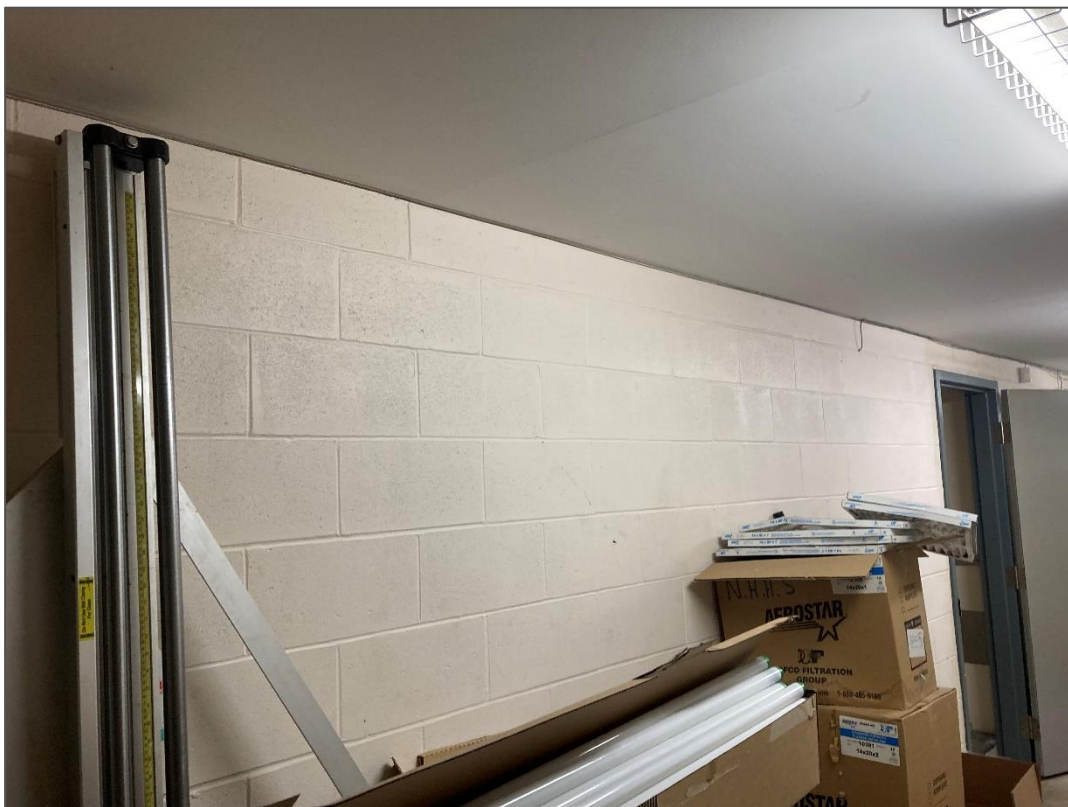
S0056 – Asbestos-Containing Beige Paint on Concrete Block, Classroom (Location #: 204).

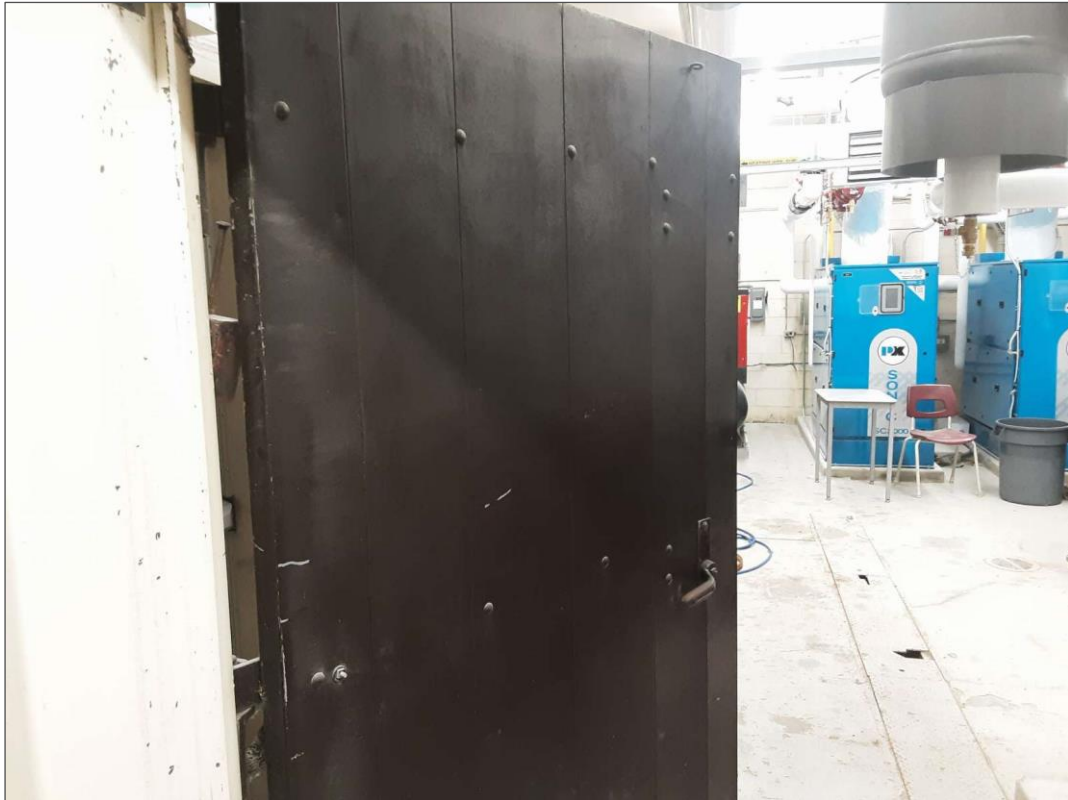
V9500 – Presumed Asbestos-Containing Insulation within Fire Rated Door, Electrical Room (Location #: 140).

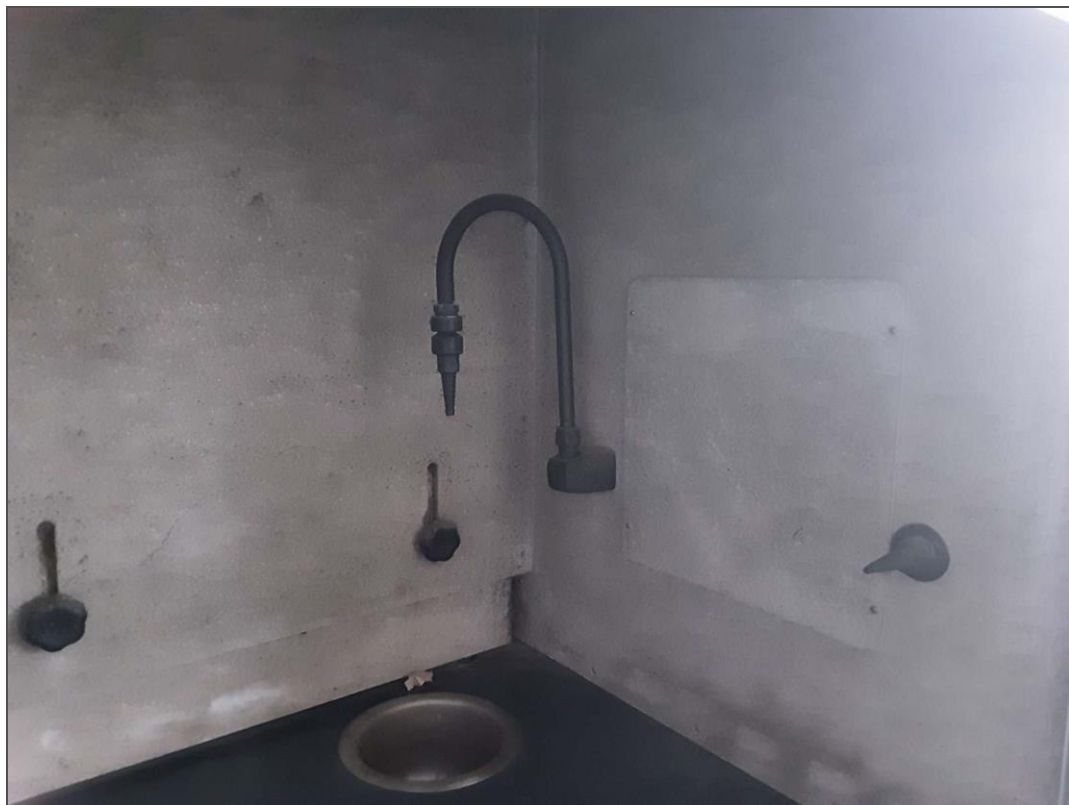
V9500 – Presumed Asbestos-Containing Transite Board within Fume Hood, Classroom (Location #: 201).
