### Hazardous Building Materials Assessment (Pre-construction)

Classroom Refresh and HVAC Upgrade Project Chemong Public School 1029 Gore Street, Bridgenorth, Ontario

### Kawartha Pine Ridge District School Board

May 7, 2021

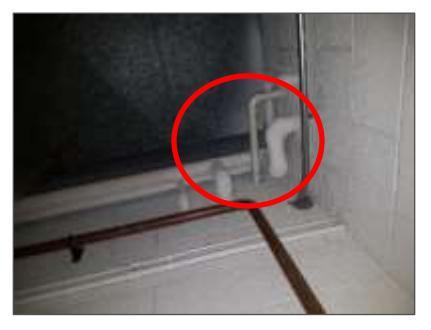
Asbestos-containing parging cement in Storage S4 (Location 44).

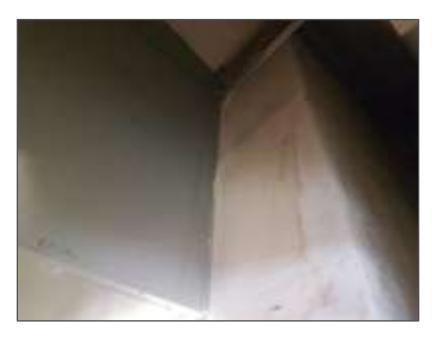
in Storage S4 (Location 44).

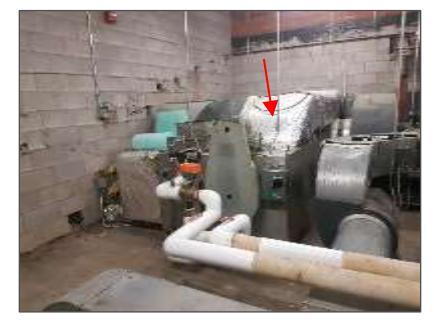
Ducts insulated with fibreglass insulation jacketed with canvas Ducts insulated with fibreglass insulation jacketed with foil-face in Mechanical Room M1 (Location 6).

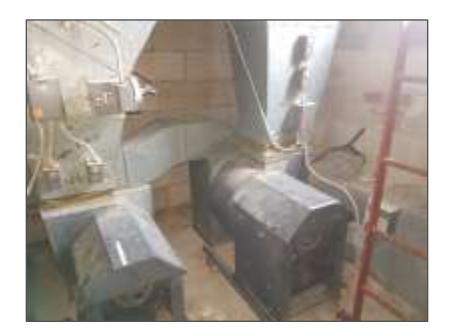
Uninsulated fan units in Upper Mechanical Room 2 (Location 5).

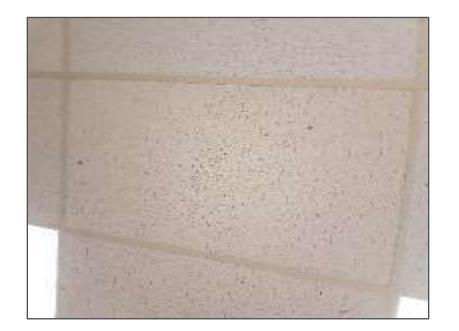
Non-asbestos 24" x 48", lay-in, beige fissure and pinhole ceiling tile.

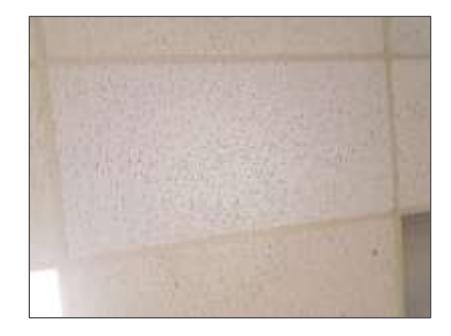
Non-asbestos 24" x 48", lay-in, fissure and pinhole ceiling tile.

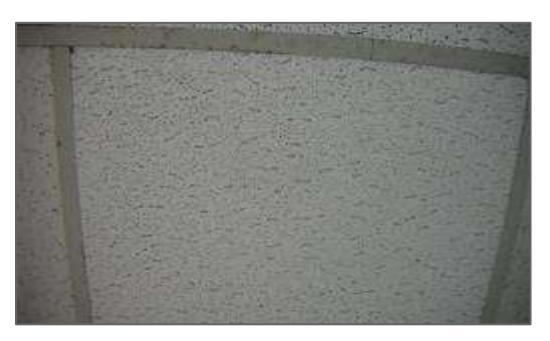
Non-asbestos 24" x 48", lay-in, lareg fissure and large pinhole ceiling tile.

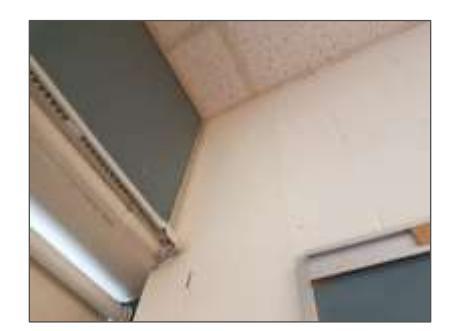
Drywall joint compound, containing chrysotile asbestos, is present on walls and ceilings in isolated locations in the assessed area (samples 0001A-C, 0016A-C, and 0038A-C). Drywall joint compound is a non-friable material.

Asbestos-containing drywall joint compound present in Science Lab 307 (Location 64).

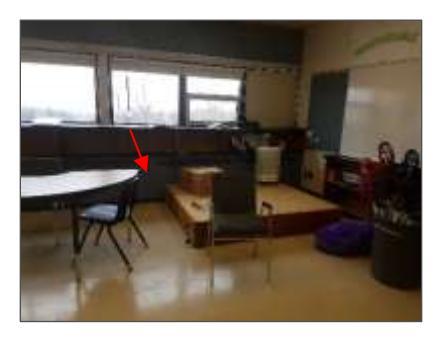
Presumed asbestos Transite panels behind radiator.

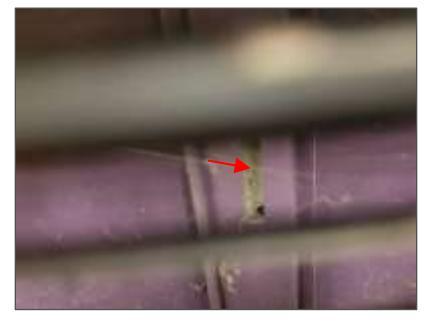
Presumed asbestos Transite panels behind radiator.

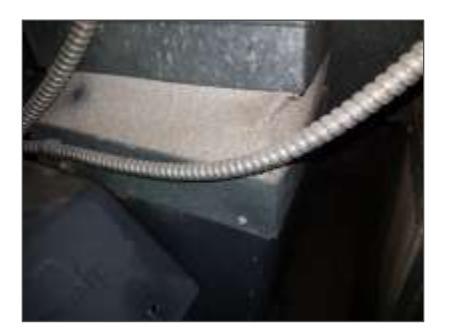
Asbestos-containing textile vibration damper in Upper Mechanical Room 2 (Location 5).

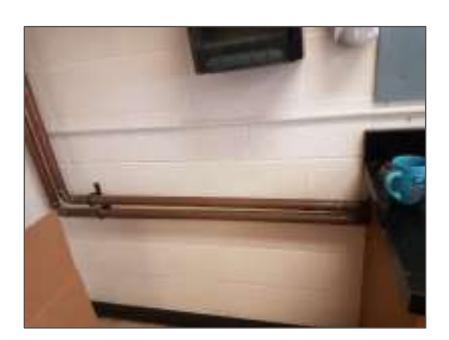
Non-asbestos white paint on block wall in Science Lab 307 (Location 64).

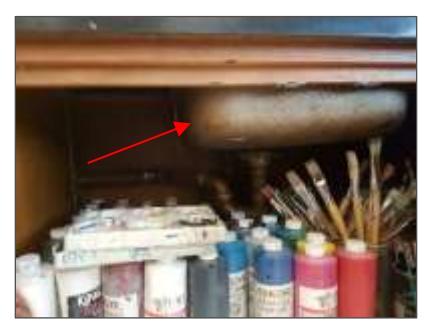
Gold mastic, containing chrysotile asbestos, is present on the underside of the sinks in Science Lab 307 (Location 64) (samples 0037A-C). Mastic is non-friable.

Asbestos-containing gold mastic on sink in Science Lab 307 (Location 64).

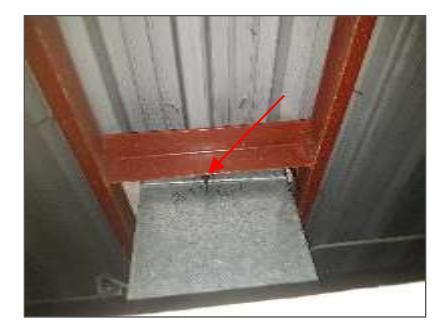
Black duct mastic present at the exhaust duct roof penetration in Corridor (Location 41) does not contain asbestos (samples 0039A-C).

Non-asbestos black duct mastic at exhuast roof penetration.
