TOWNSHIP OF UXBRIDGE

TENDER U18-29

30'x 34' Storage Shed at the Goodwood Community Park

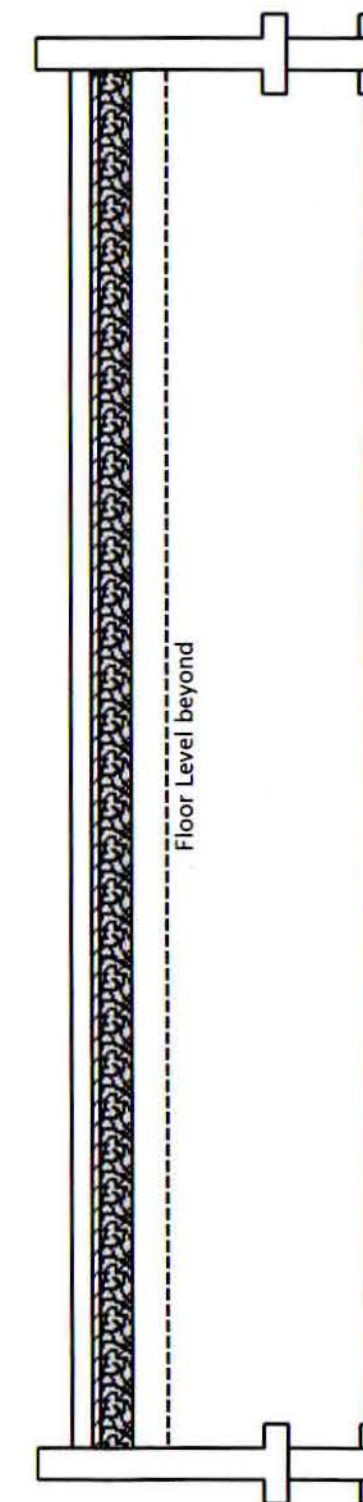
Foundation Plan

Concrete floors shall be even, smooth and level, sloping as indicated.
Provide sawcuts 3/16" x 1" deep as soon as possible after pour at a max.
of 40 times the slab thickness in both directions

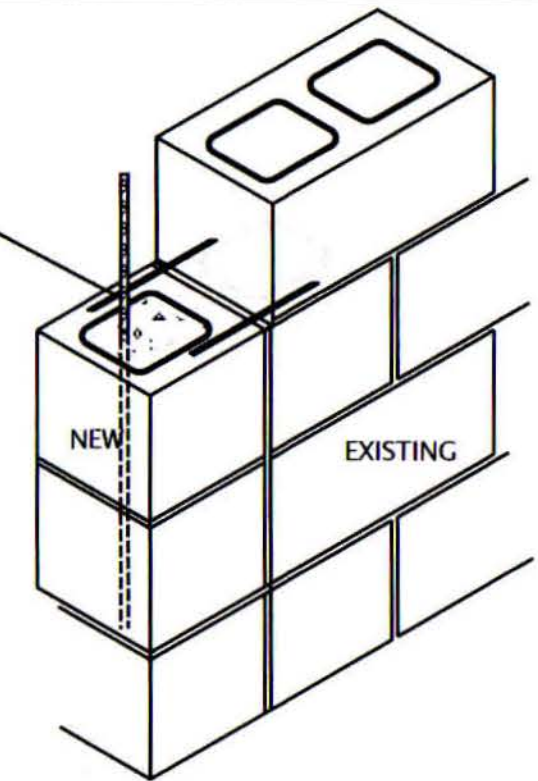
MASONRY TIED TO EXISTING WALL

Spira-Lok Front
and rear shell
every course in
Mortar Bed

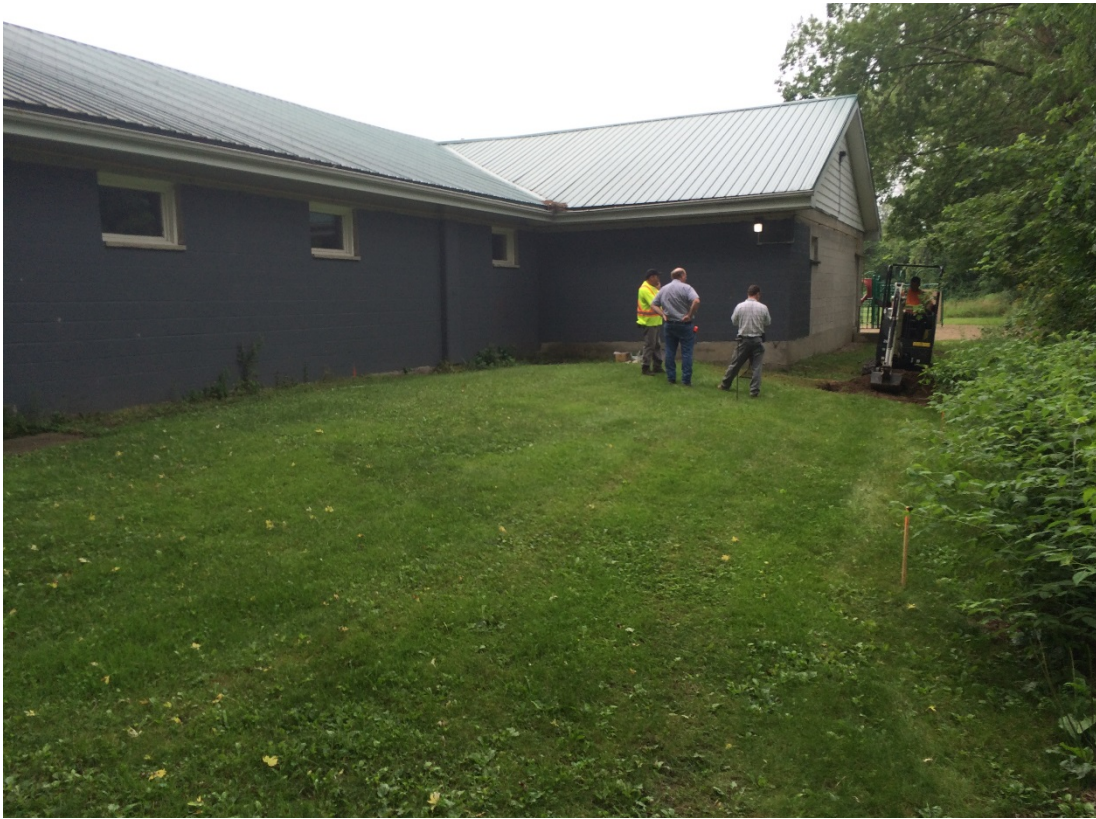
Photo No. 1: Location of Test Pit #1 being excavated (facing east).
