# Designated Substances Survey - Beavermead Gatehouse Building - 2011 Ashburnham Drive, Peterborough, Ontario

2021-08-06

Prepared for:  
City of Peterborough

© Cambium Reference No.: 13516-001

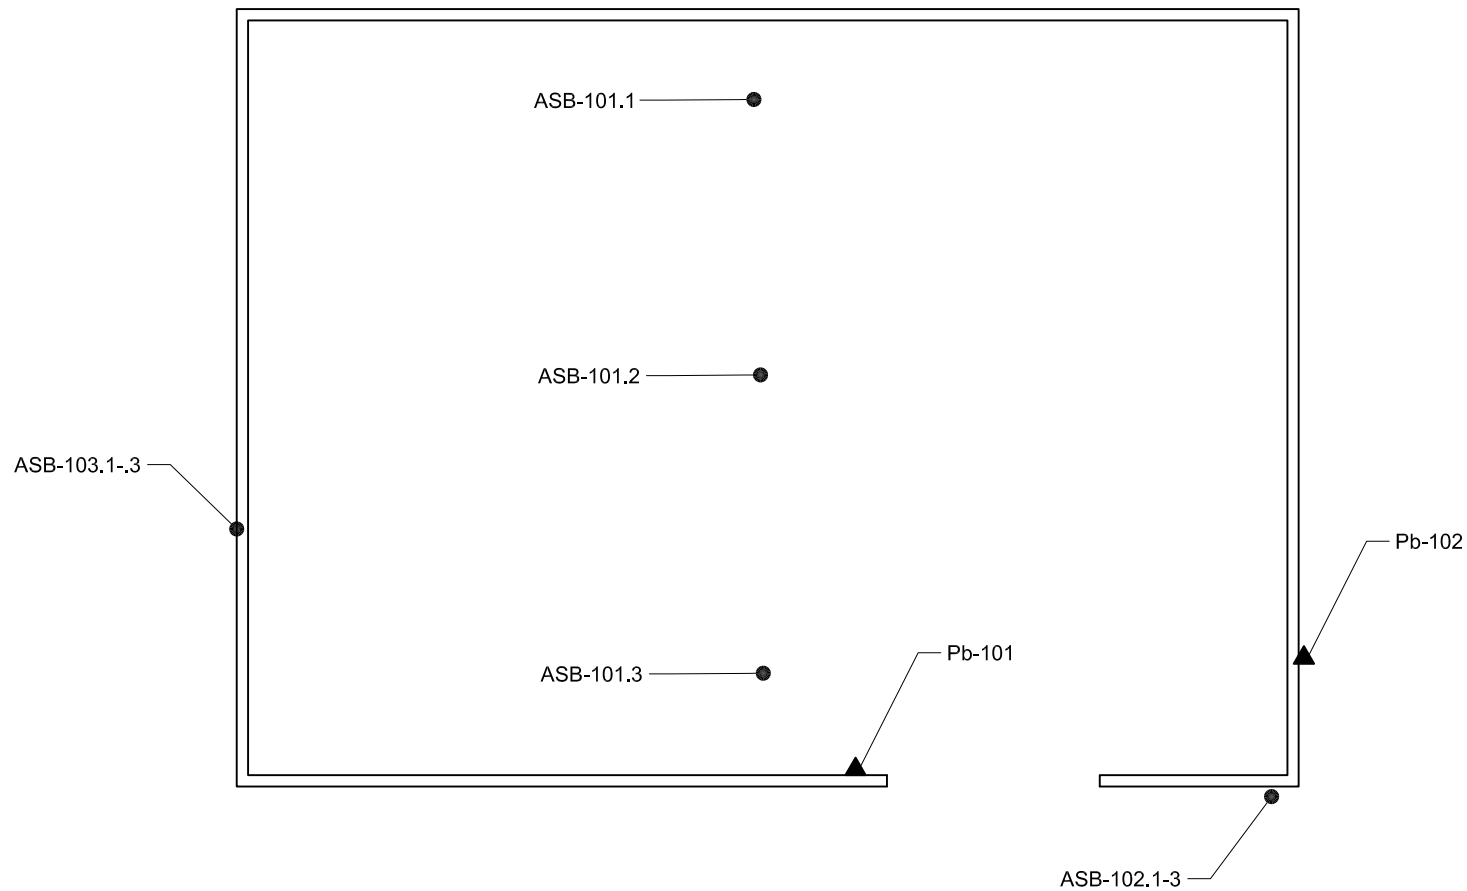
Project No.:	13516-001	Date:	August 2021
Horizontal Scale:	N.T.S.	Rev.:	N/A
Vertical Scale:	N/A	Drawn By:	MAT
Checked By:	CM	Figure:	1

Below is a brief summary of building materials identified during the assessment that were suspected of being asbestos-containing. Photographs are included in Appendix A. The laboratory certificate of analysis report for asbestos is included in Appendix B. A drawing with the locations of samples is present in Figure 1.

## GATEHOUSE BUILDING - SITE PLAN

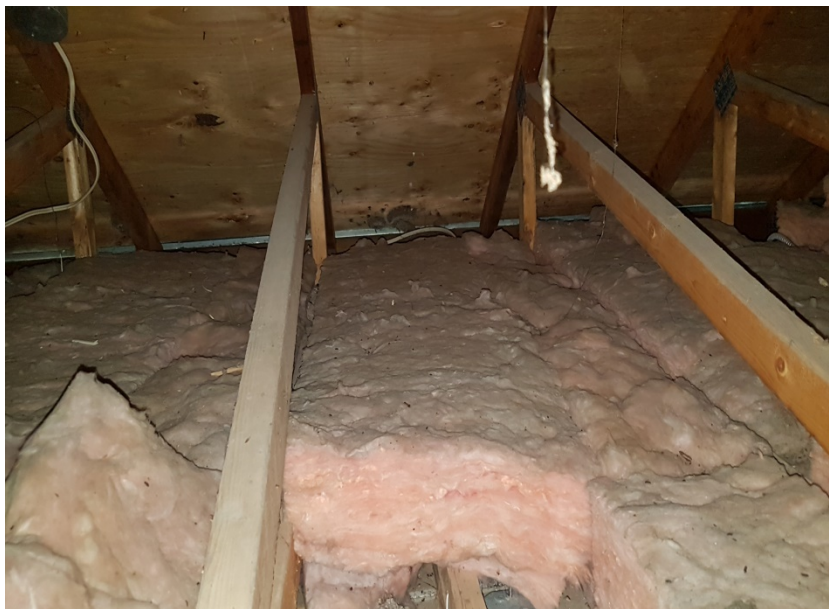
Insulation in the attic was observed to be non-asbestos fibreglass batt.

***Photo 1 – Non-asbestos fibreglass insulation in the attic.***

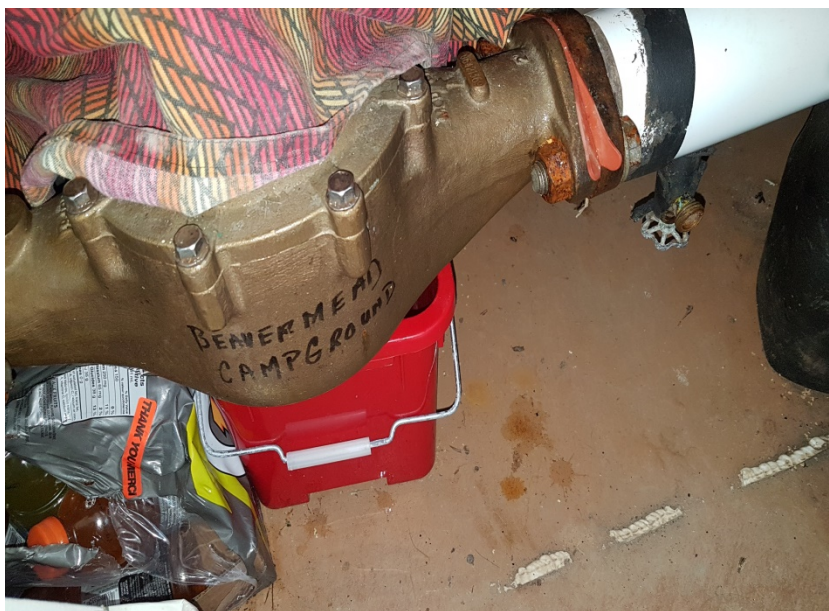
Pipes were observed to be insulated with non-asbestos fibreglass or uninsulated.

***Photo 2 – Non-asbestos fibreglass insulation on pipes.***

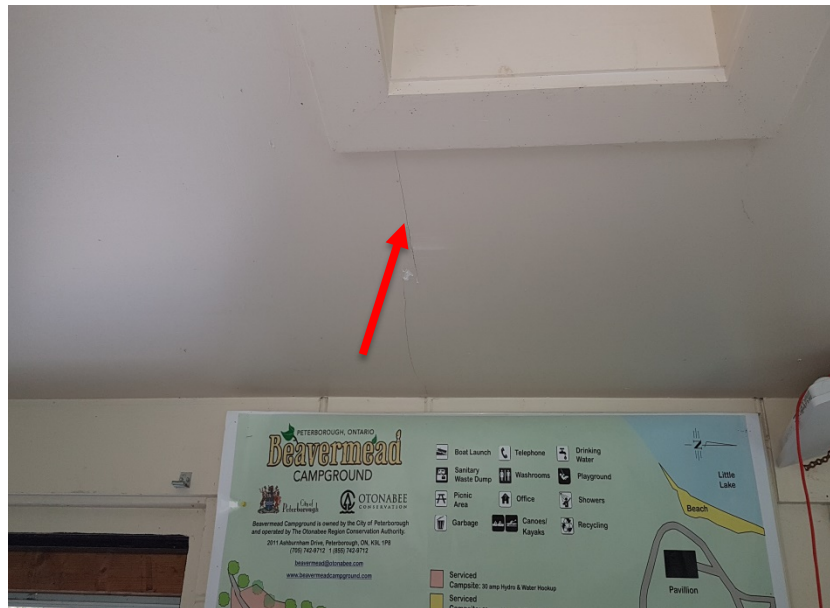
Non-asbestos drywall joint compound is present on the gypsum ceiling in the building (samples ASB-101.1 to ASB-101.3).

***Photo 3 – Non-asbestos drywall joint compound.***

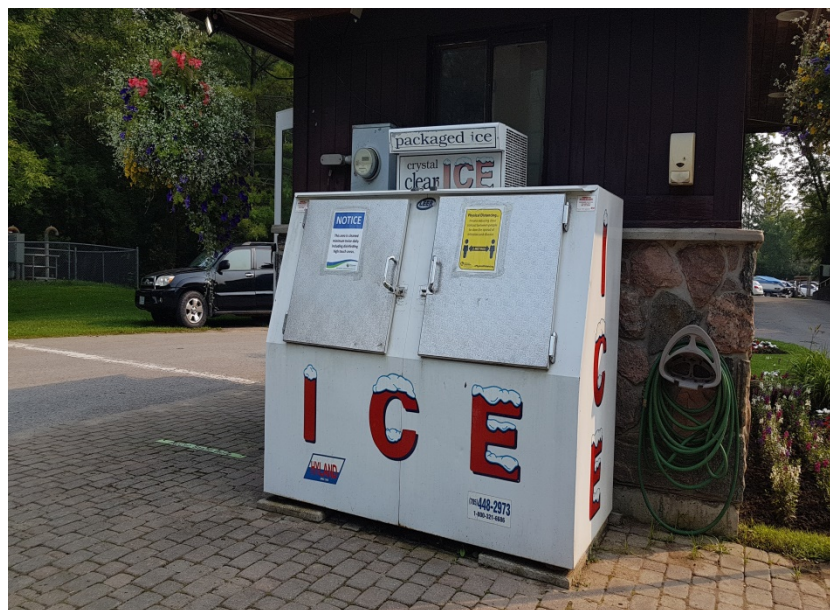
Ozone depleting substances are presumed to be present as refrigerants in the ice freezer. Remove and recover refrigerants from the freezer prior to disposal.

***Photo 4 – Freezer adjacent to building.***

- Remove and recover refrigerants from the freezer prior to disposal.
