CORONATION HALL EXTERIOR CONSERVATION

01 KING STREET WEST, OMEMEE, ON

ISSUED FOR TENDER: APRIL 22, 2025

DRAWING TITLE:
TITLE PAGE & LOCATION PLAN

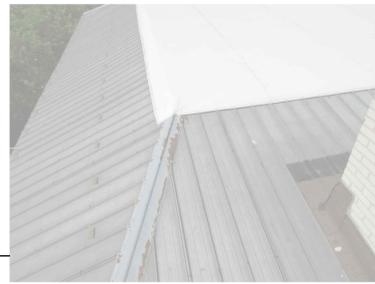
- 2 MAIN ROOF REPAIR**
A1.5 NTS
- MAIN ROOF REPAIRS:
1. INSPECT HIP ROOF METAL ANGLES FOR SEVERE DETERIORATION. REVIEW CONDITION WITH CONSULTANT
 2. SCRAPE & SAND ALL SURFACES TO REMOVE LOOSE PAINT & RUST TO BASE METAL.
 3. PRIME WITH RUST INHIBITIVE PRIMER & PAINT ALL METAL SURFACES TO MATCH EXISTING.
 4. UNDERTAKE REPAIRS AS DETERMINED DURING REVIEW. CHANGES TO SCOPE TO BE ADDRESSED BY CHANGE ORDER.

- INSPECT HIP ROOF METAL ANGLES FOR SEVERE DETERIORATION. REVIEW CONDITION WITH CONSULTANT
- SCRAPE & SAND ALL SURFACES TO REMOVE LOOSE PAINT & RUST TO BASE METAL.
- PRIME WITH RUST INHIBITIVE PRIMER & PAINT ALL METAL SURFACES TO MATCH EXISTING.
- UNDERTAKE REPAIRS AS DETERMINED DURING REVIEW. CHANGES TO SCOPE TO BE ADDRESSED BY CHANGE ORDER.
