JVN-FSOW Visual Verification Report Requirements

Instructions to Complete FSOW Visual Verification Report

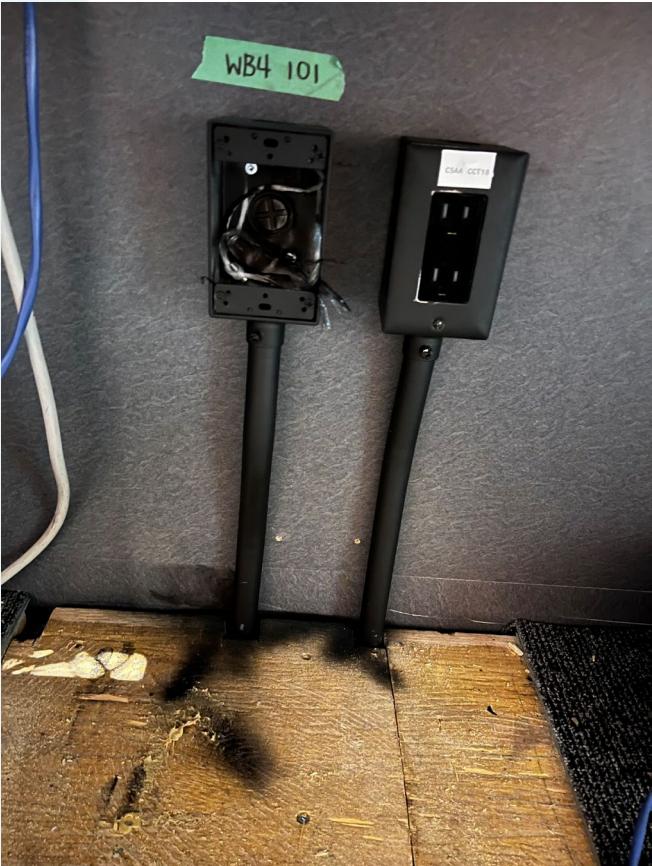
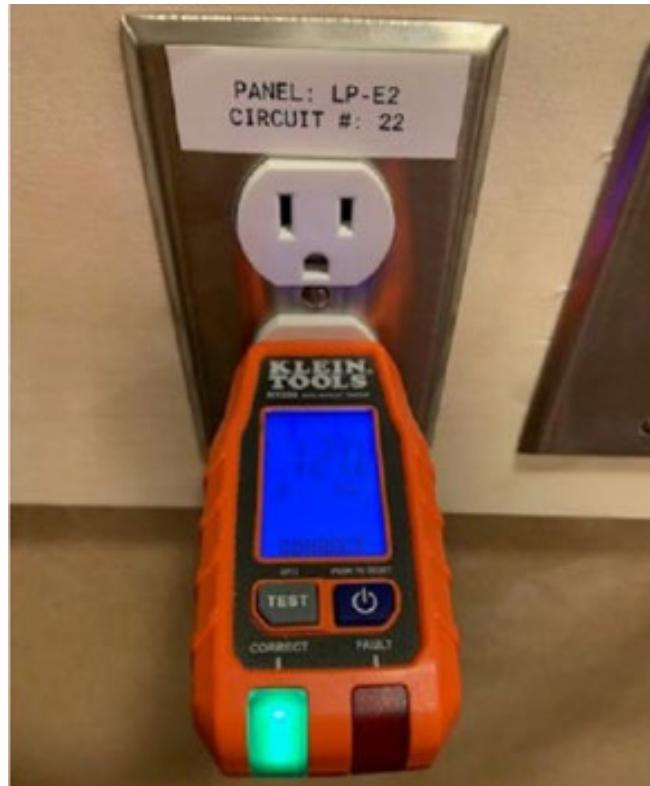
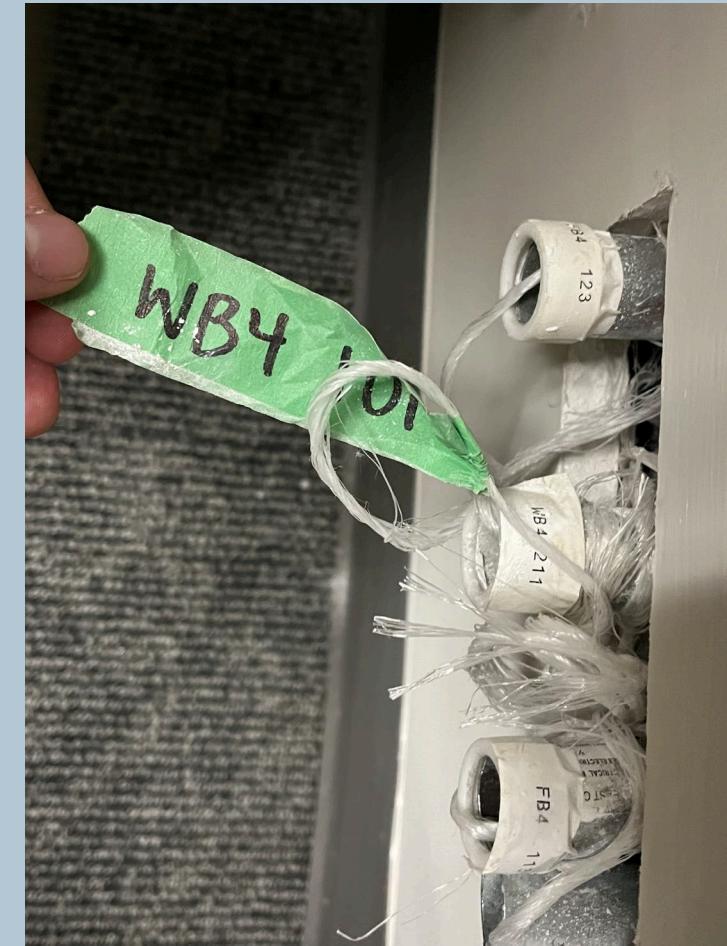
Judge Location

Reminder: Photos must show the completed receptacle installation with an outlet tester in place showing the circuit is live and wired correctly-at the judge's bench, along with conduit work stubbed into a floor/wall box with pull strings at both ends.

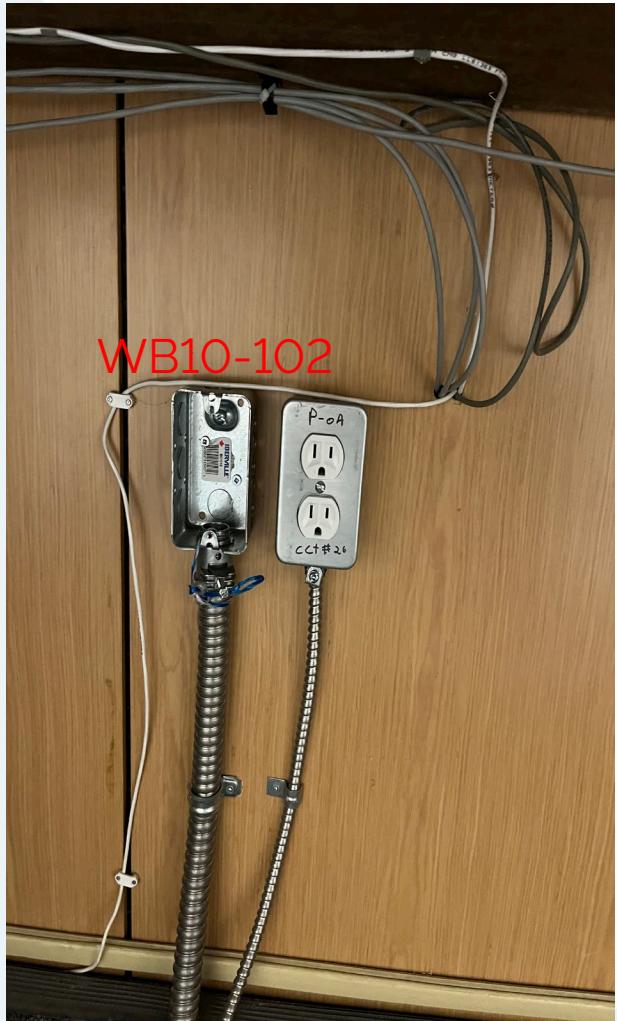
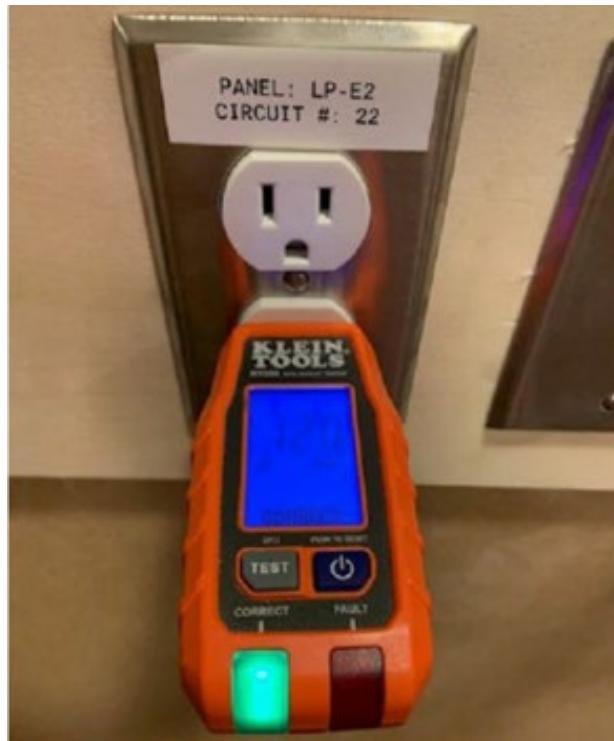
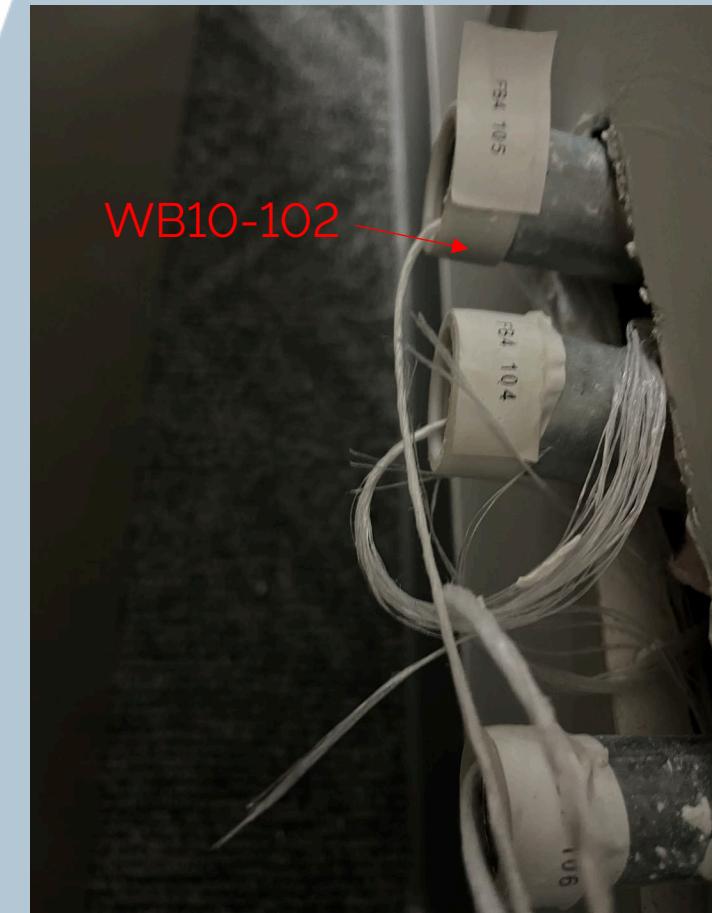
Clerk Location

Reminder: Photos must show the completed receptacle installation with an outlet tester in place showing the circuit is live and wired correctly at the Clerk Location, along with conduit work stubbed into a floor/wall box with pull strings at both ends.

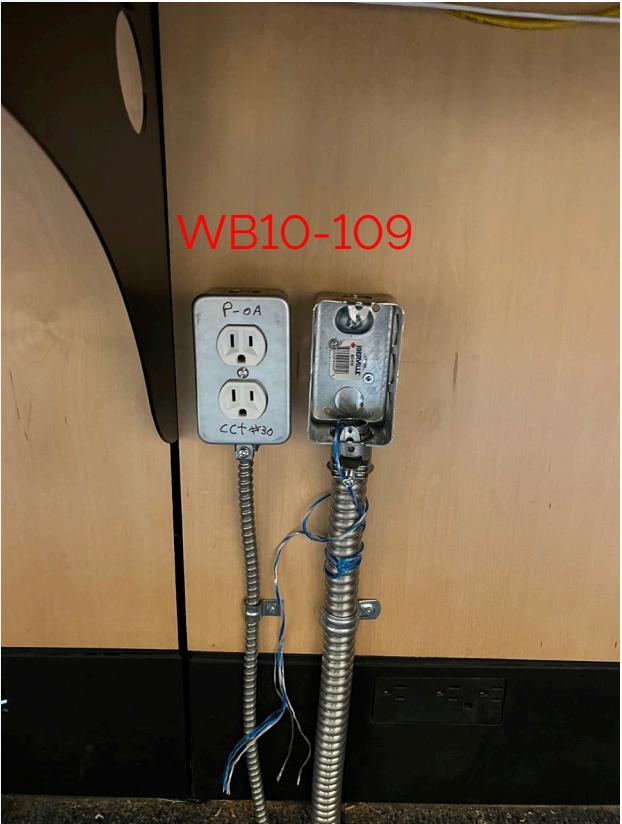
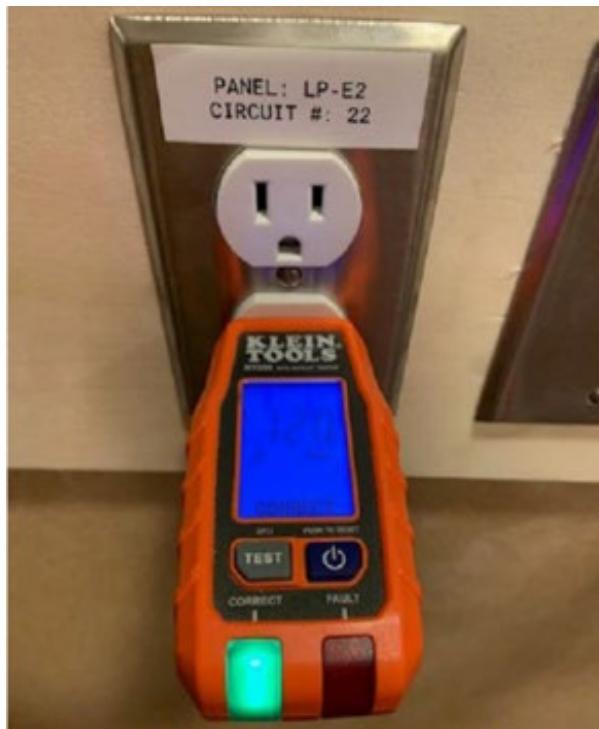
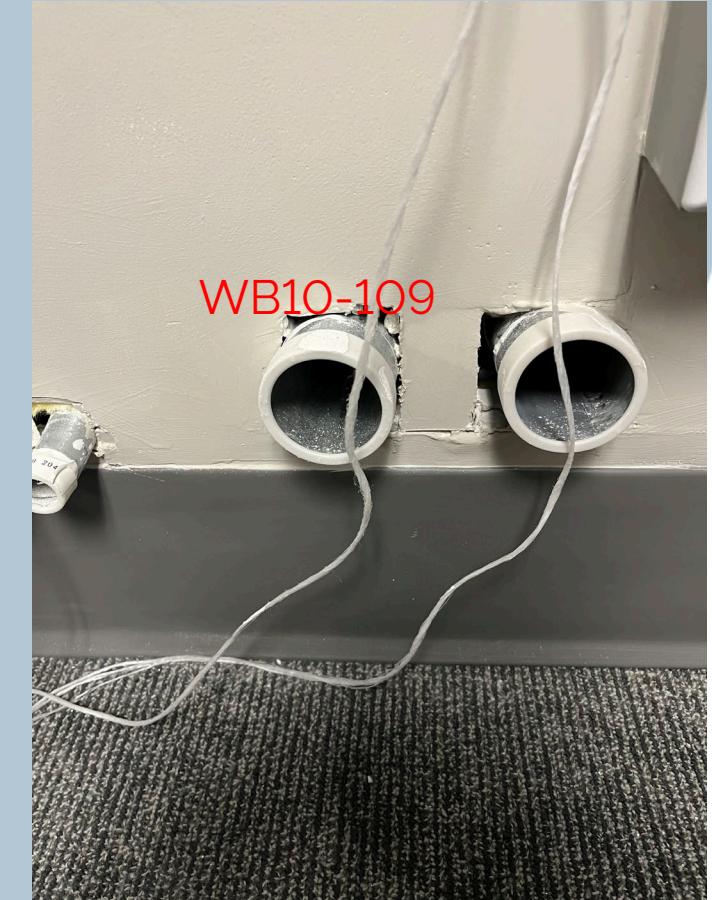
Reminder: Photos must show the completed receptacle installation with an outlet tester in place showing the circuit is live and wired correctly-at the Reporter Location , along with conduit work stubbed into a floor/wall box with pull strings at both ends.

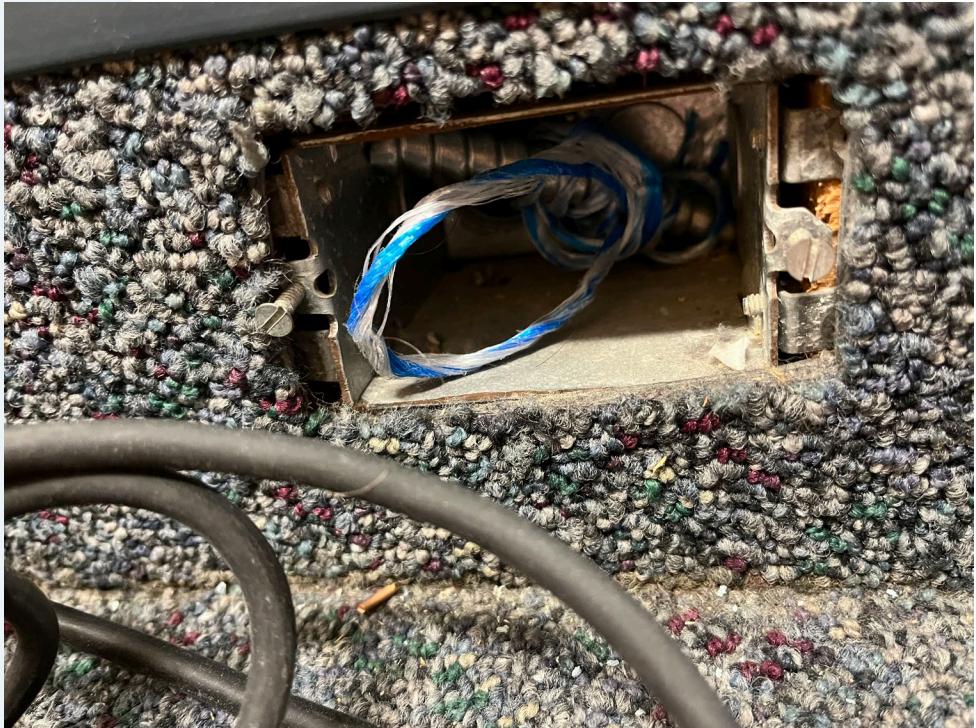
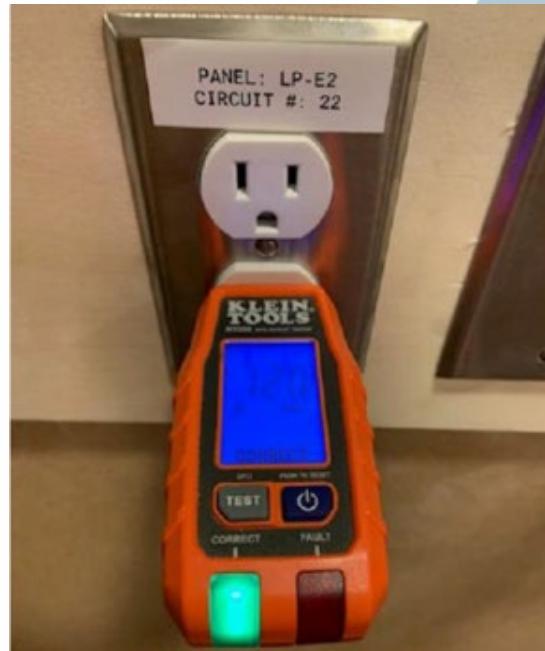
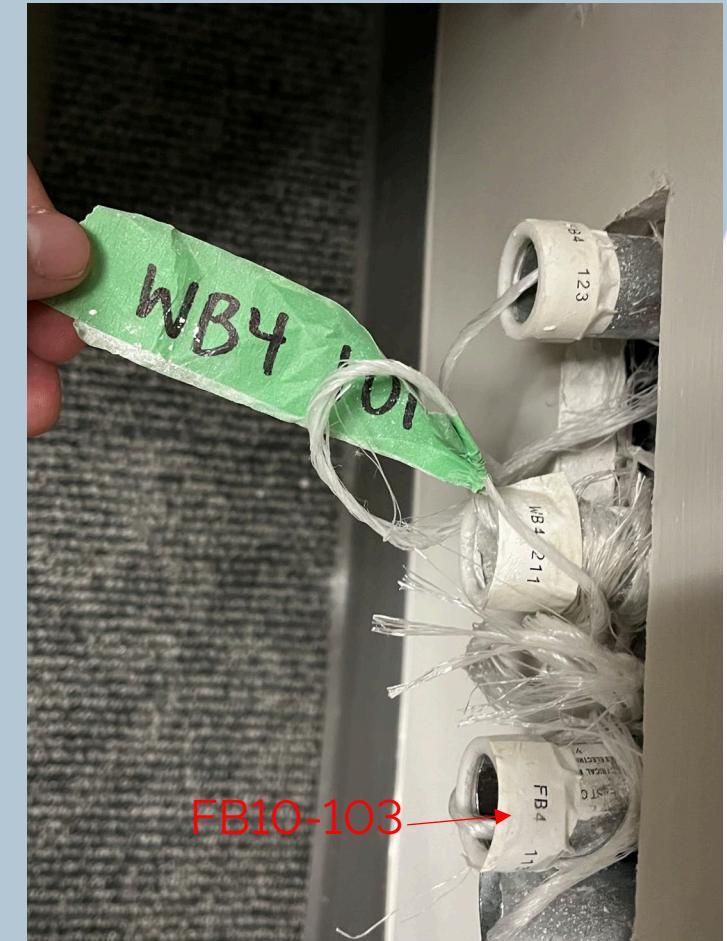
Witness Location

Reminder: Photos must show the completed receptacle installation with an outlet tester in place showing the circuit is live and wired correctly-at the Witness Location, along with conduit work stubbed into a floor/wall box with pull strings at both ends.

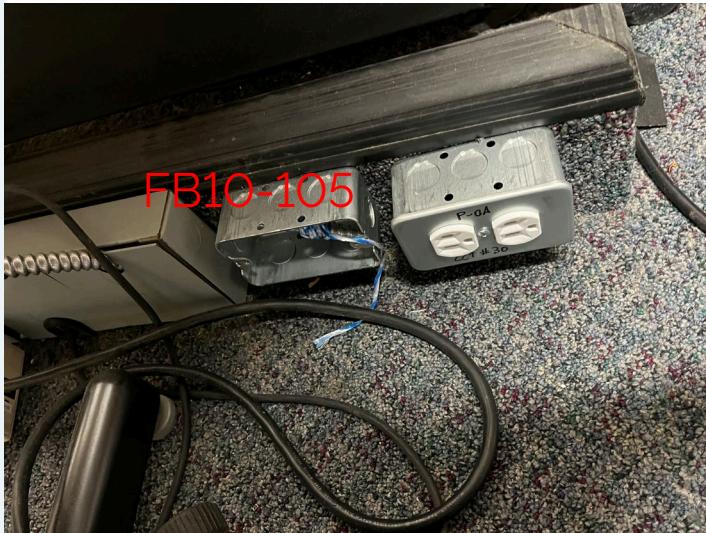
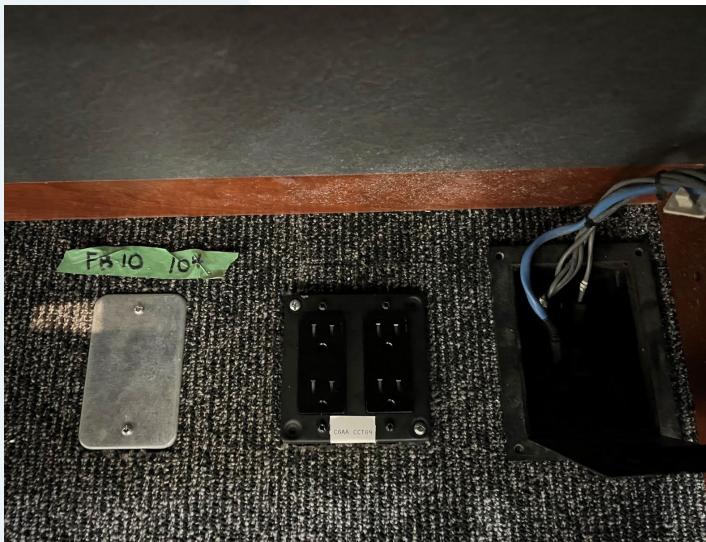
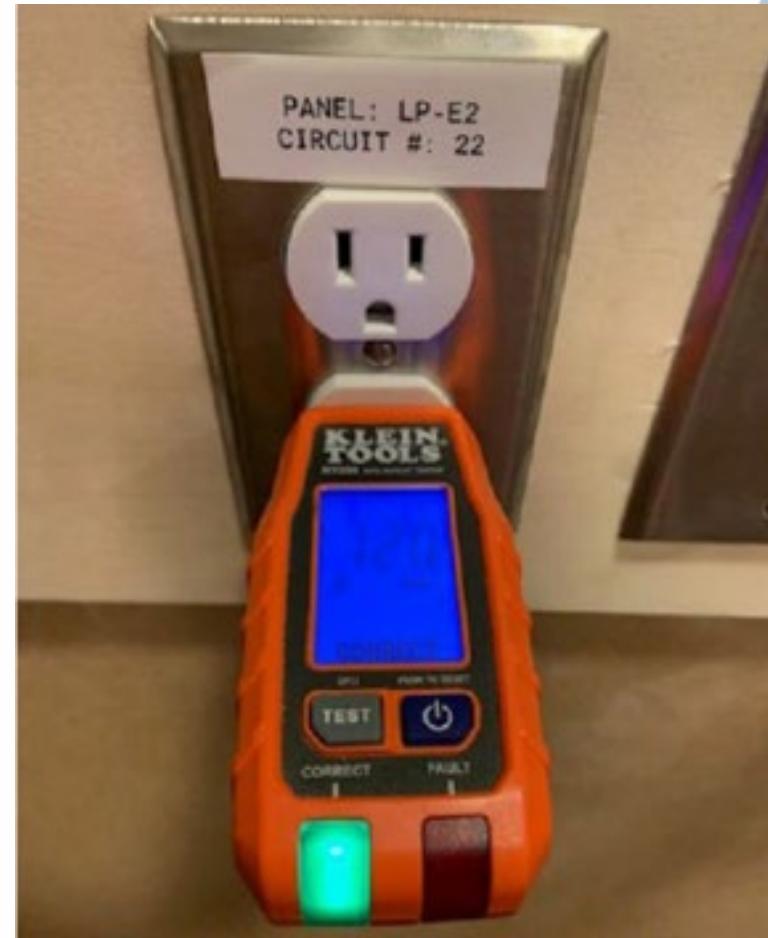
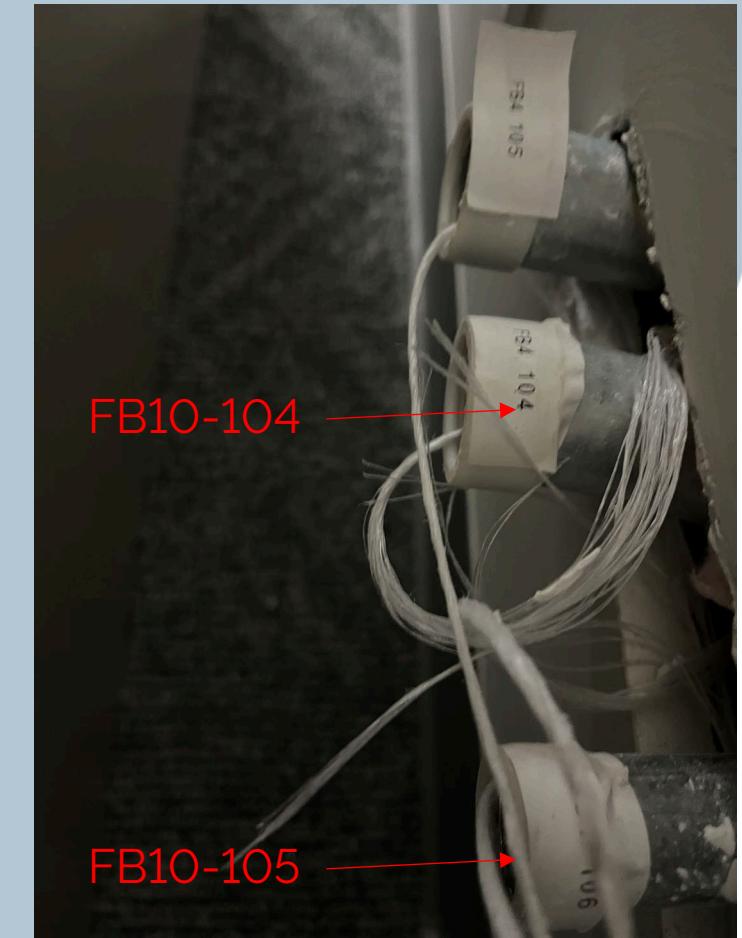
Counsel Locations

Reminder: Photos must show the completed receptacle installation with an outlet tester in place showing the circuit is live and wired correctly-at the Counsel Left & Right Location, along with conduit work stubbed into a floor/wall box with pull strings at both ends.

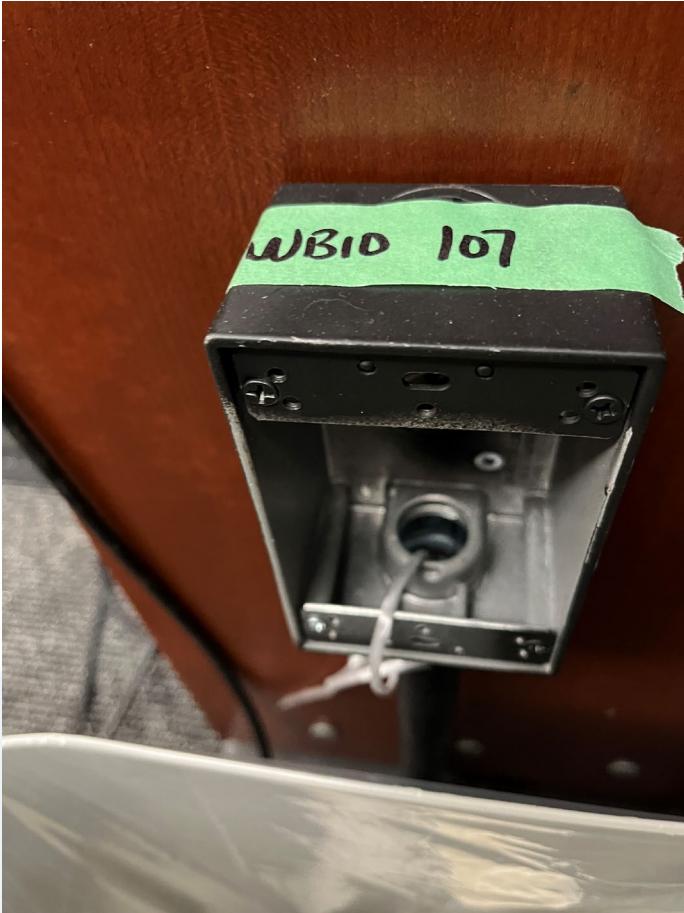
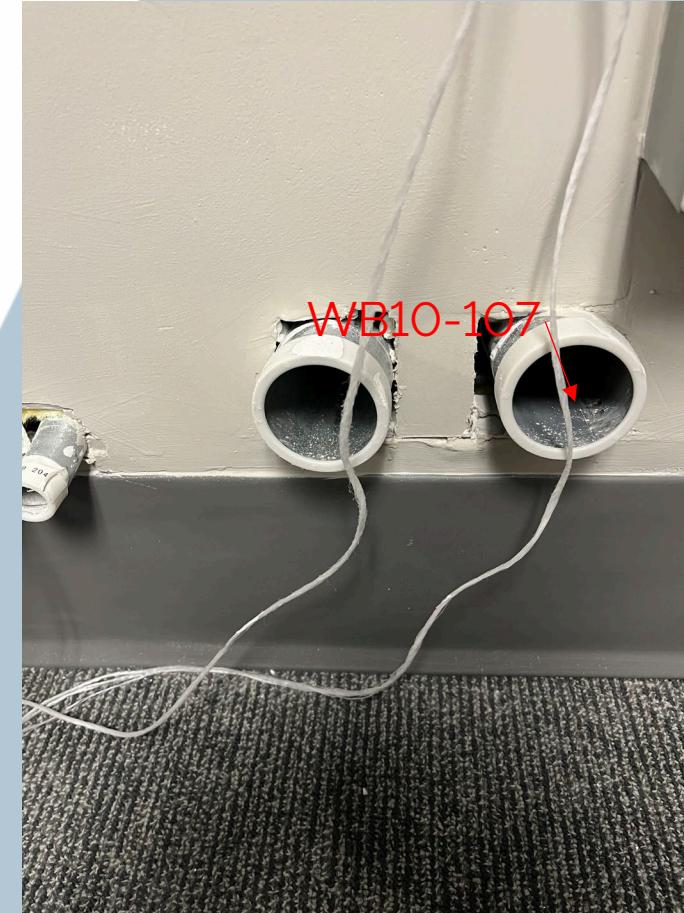
Lectern Location

Reminder: Photos must show the completed receptacle installation with an outlet tester in place showing the circuit is live and wired correctly-at the Lectern, along with conduit work stubbed into a floor/wall box with pull strings at both ends.

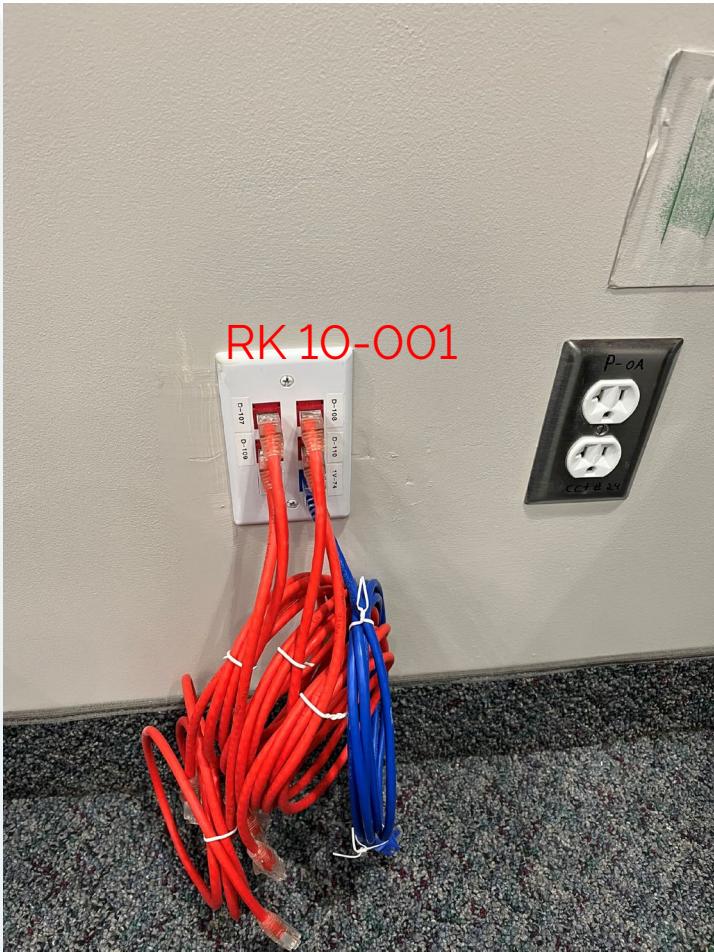
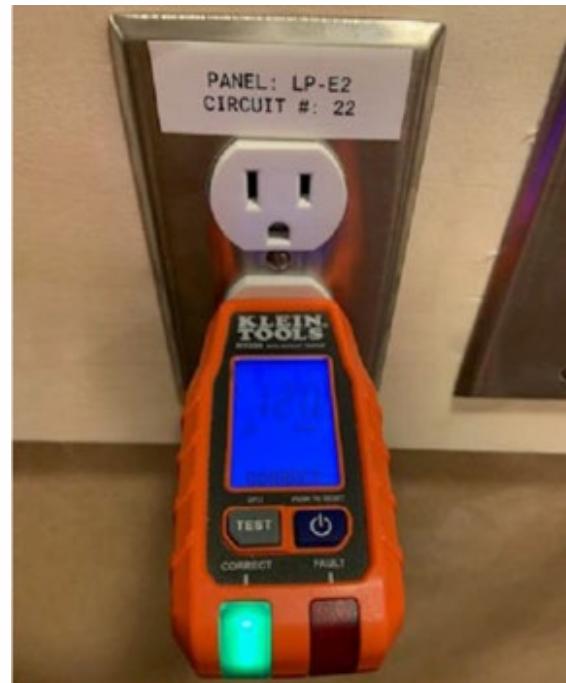
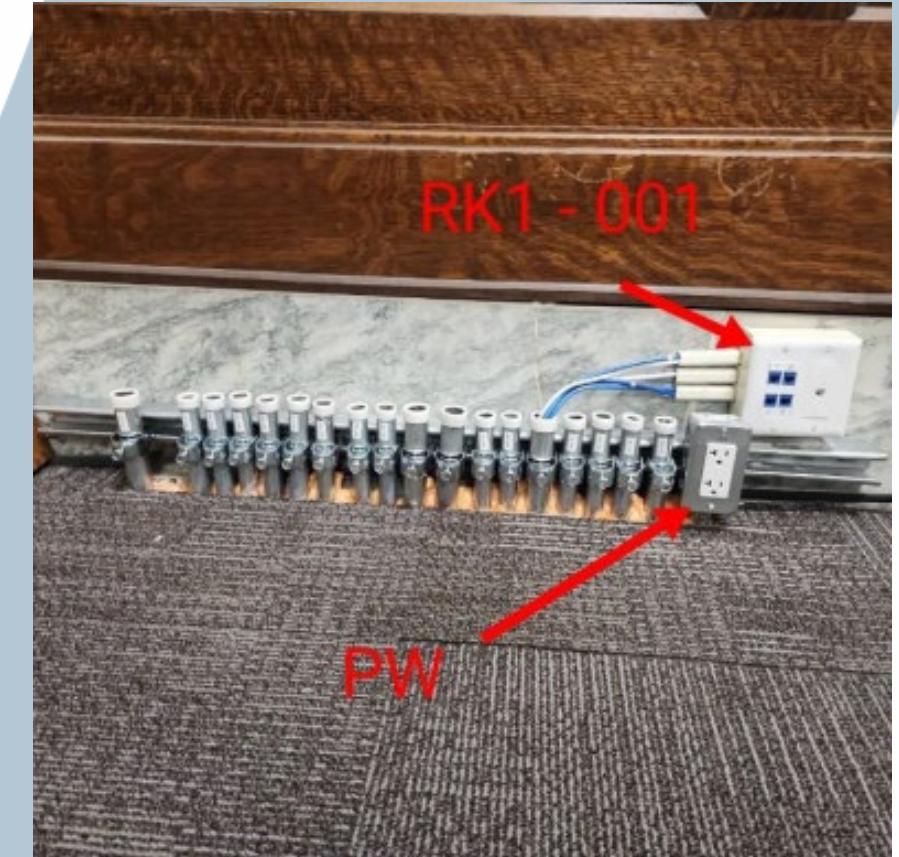
AV Rack Location

Reminder: Photos must show the completed receptacle installation with an outlet tester in place showing the circuit is live and wired correctly-at the Rack Location, along with conduit work stubbed into a floor/wall box with pull strings at both ends.

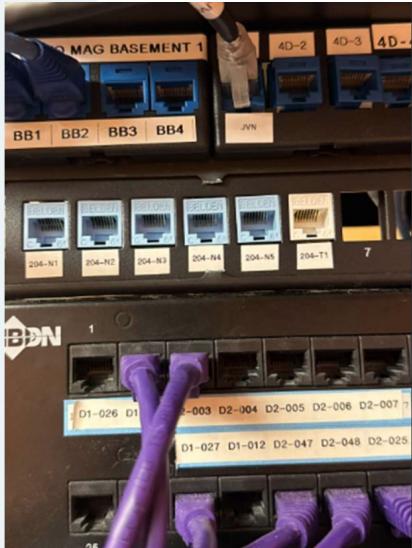
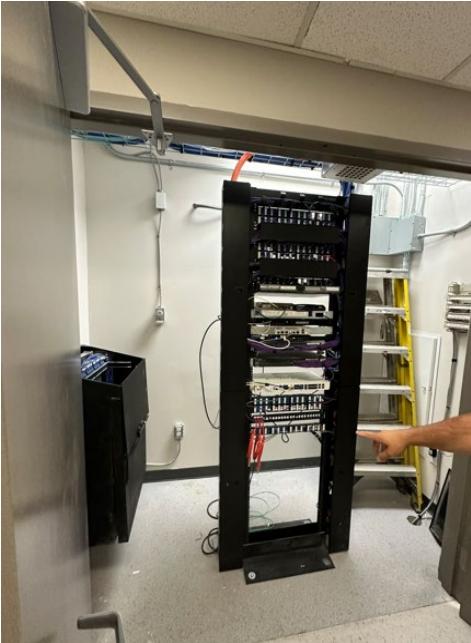
Cat6 data and voice keystone termination into the patch panel

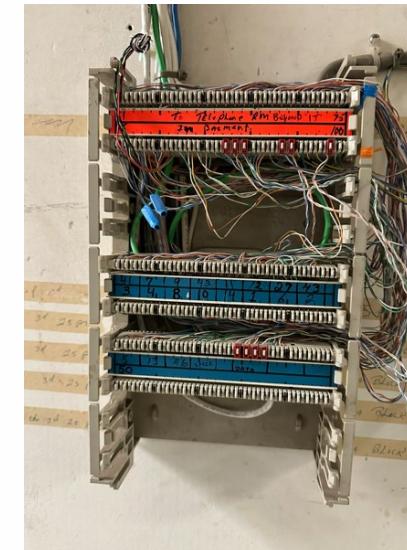
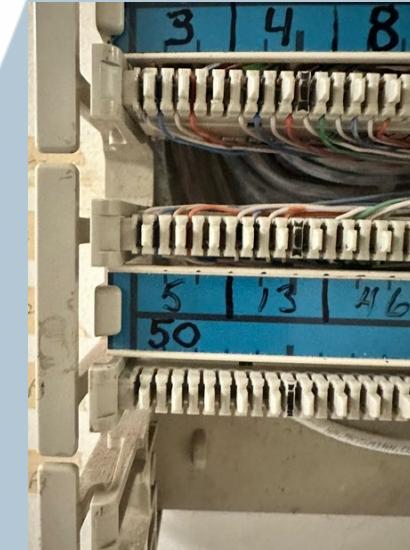
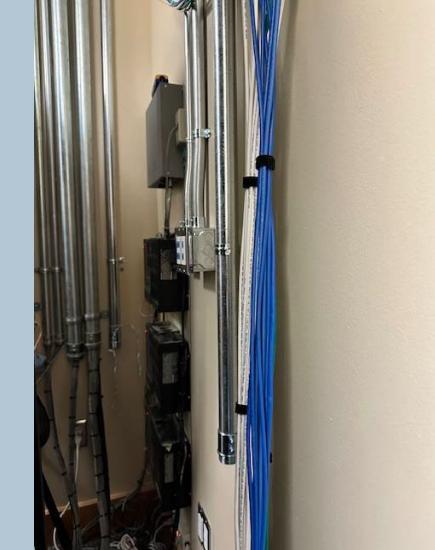
Cat6 voice termination into the Bell Bix block

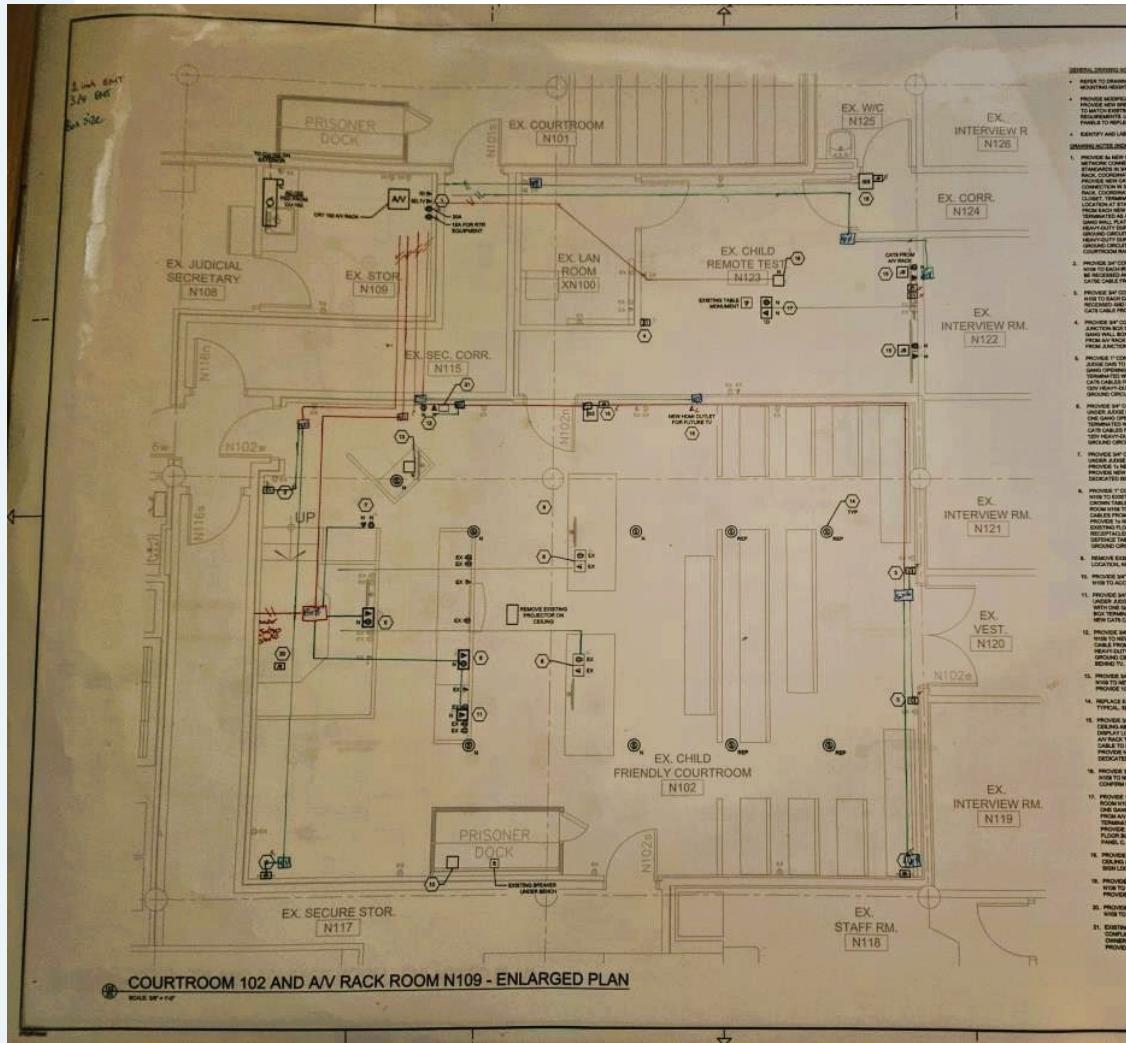
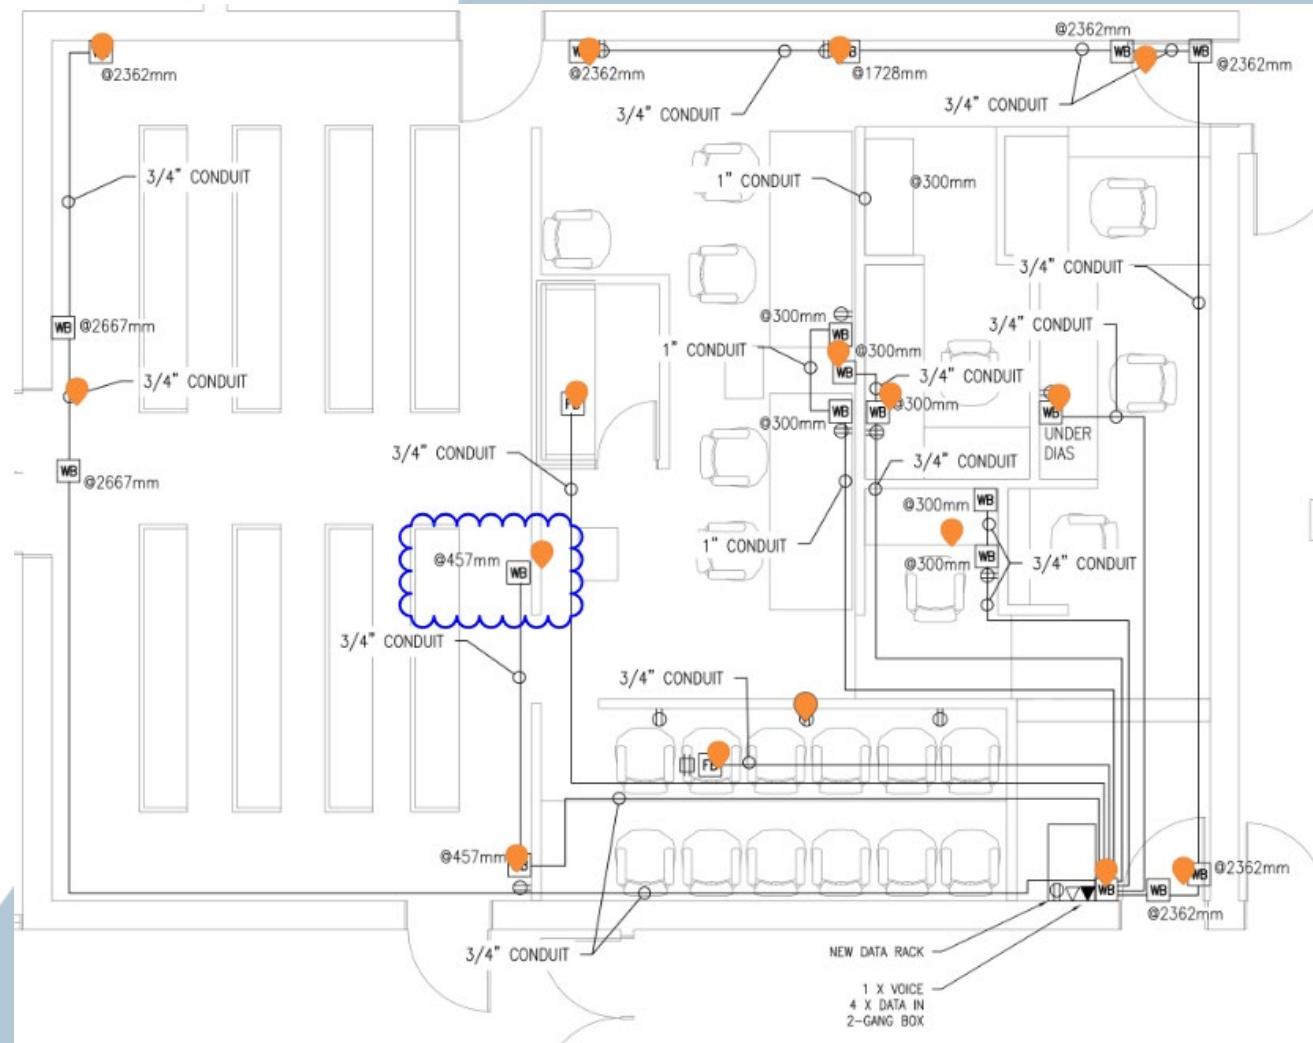
Appendix A – On Site as-Built Conduit Layout

Please submit either the As Built Drawings OR the Conduit Drawings

Provide red-line or marked-up drawings as Appendix A that clearly identify the locations of all conduits, junction boxes and pull box access hatches.
