Project Specific Designated Substances Survey – Room 207, 1720 West Bank Drive, Peterborough, Ontario

March 31, 2026

Trent University

Cambium Reference: 02601244.000

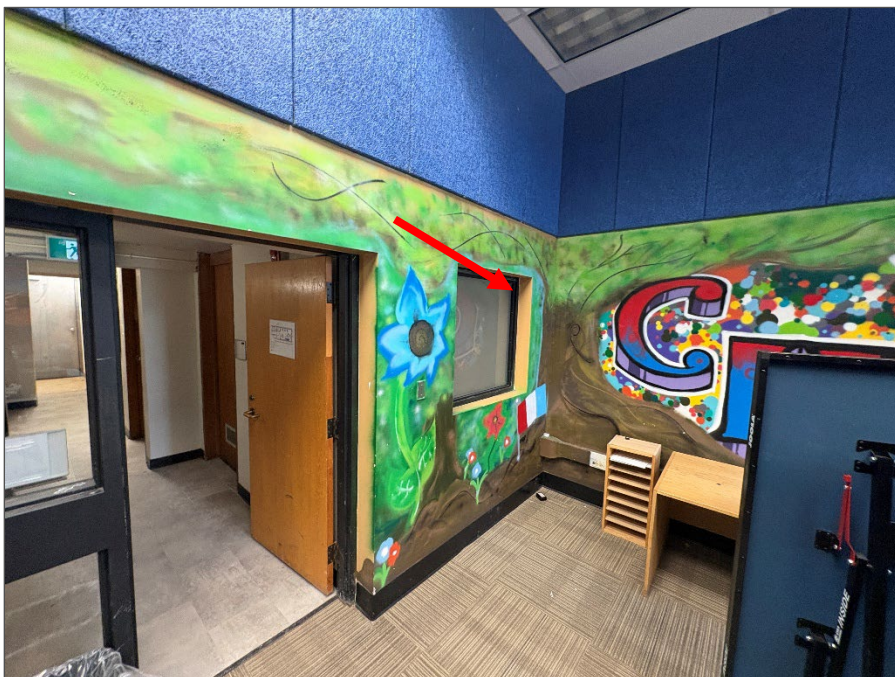
Sample ID	Location	Paint Colour/Substrate	Lead Content (%)	Lead-Based? Yes/No
PB-101	Walls	White / drywall	0.0023	No
PB-102	Walls	Blue / fibreboard	0.0022	No
PB-103	Interior window	Black / metal	0.0172	No
PB-104	Walls	Biege / drywall	0.0043	No

Photo 2: Non-lead based black paint on interior window frame.

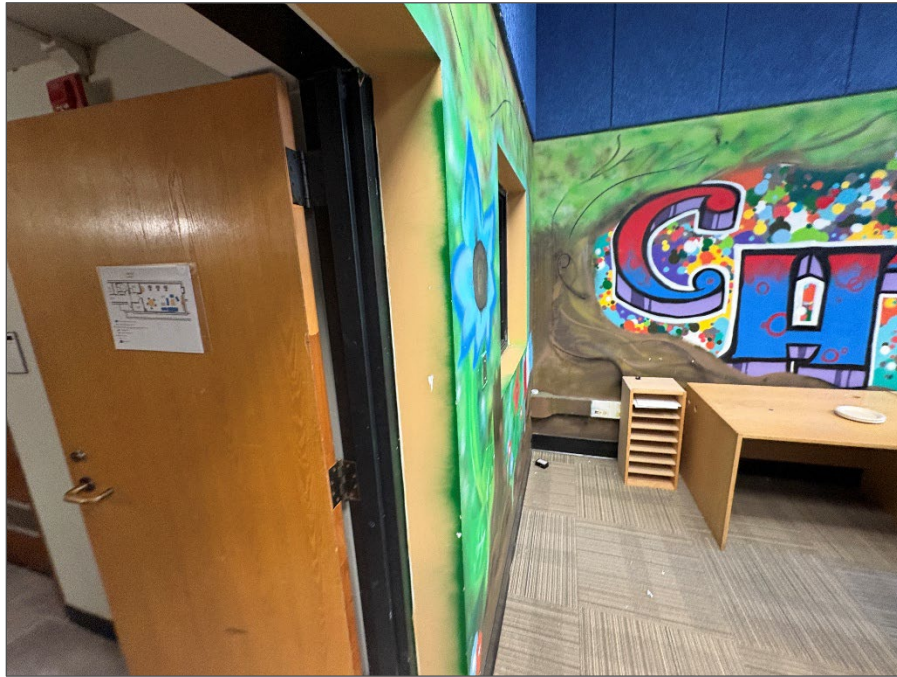
Photo 3: Non-lead based beige paint on drywall.

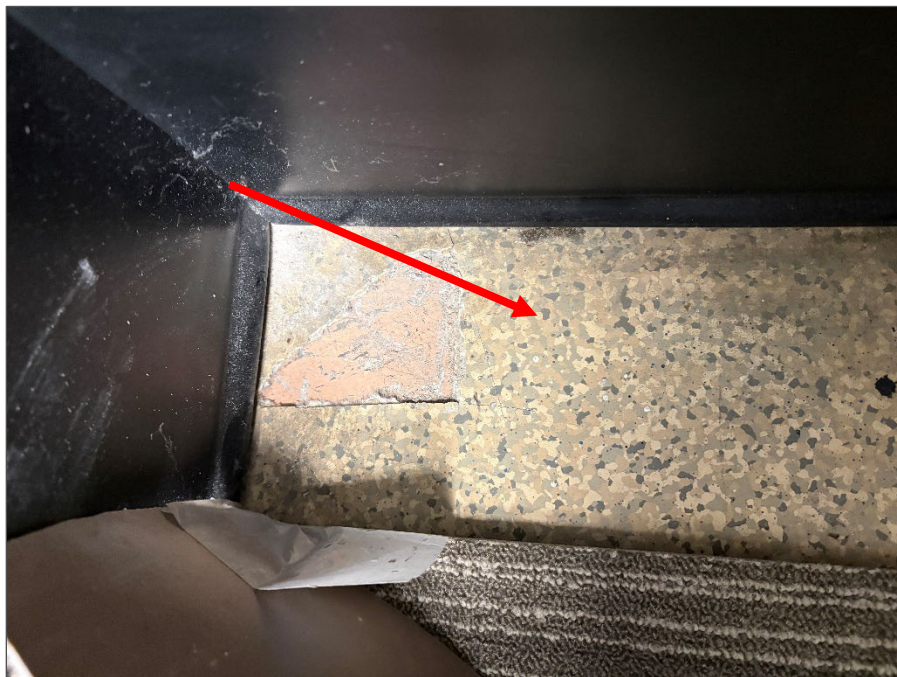
Non-asbestos vinyl sheet flooring (as well as mastic) is present beneath carpeting throughout the assessed area (samples ASB-103.1 to ASB-103.3).

Photo 4: Non-asbestos vinyl sheet flooring, concealed beneath the carpet.
