CRESTWOOD SECONDARY SCHOOL MECHANICAL UPGRADES - 2021

Hazardous Building Materials Assessment (Pre-construction)

HVAC Update Program and
Walk-in Cooler Replacement
Crestwood Secondary School
1885 Sherbrooke Street West,
Peterborough, Ontario

May 11, 2021

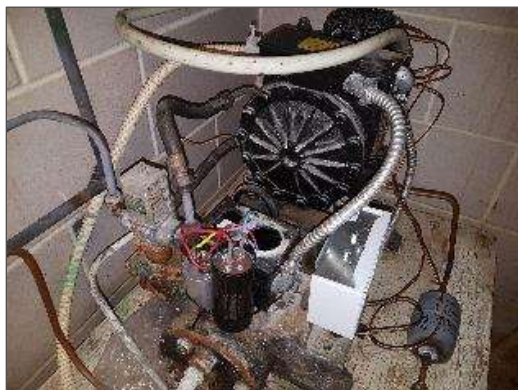
Mechanical equipment (e.g. compressor, coolers) is either uninsulated or insulated with non-asbestos fibreglass.

Uninsulated compressor.

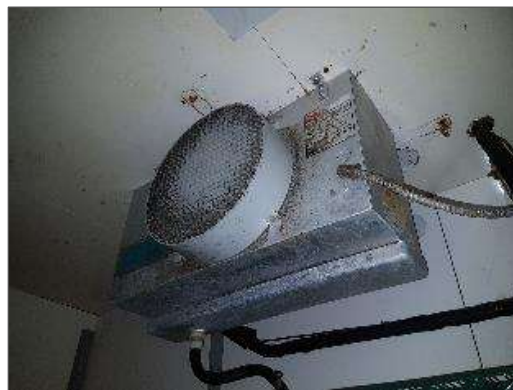
Cooling unit.

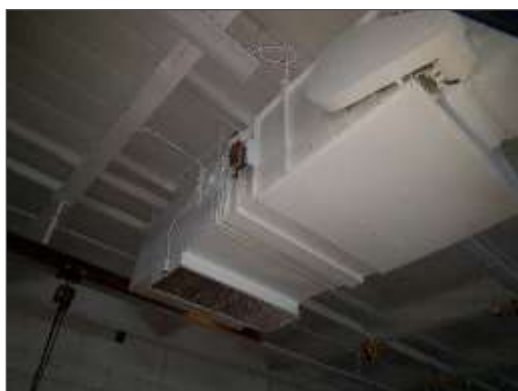
Fan units present in the assessed area uninsulated.

Uninsulated fan unit.

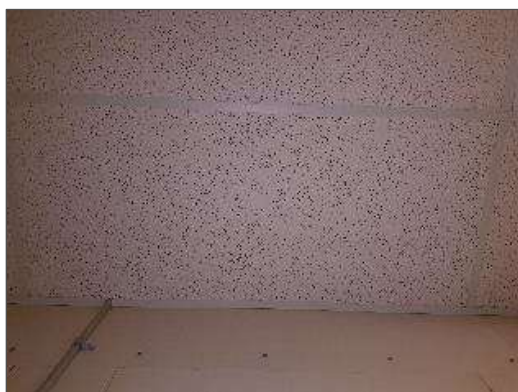
Ceiling tiles are presumed to be non-asbestos based on the date of manufacture determined from the date stamp applied to the top of the tiles. The tiles were manufactured after asbestos stopped being used in acoustic ceiling tiles.

Non-asbestos 24" x 48", lay-in, fleck and pinhole ceiling tile in Kitchen 126 (Location 34).

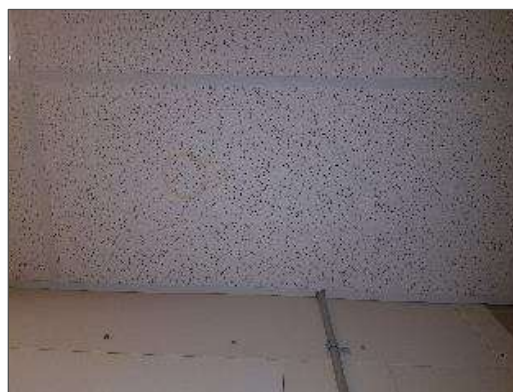
Non-asbestos 24" x 48", lay-in width wise fissure and pinhole ceiling tile in Kitchen 126 (Location 34).

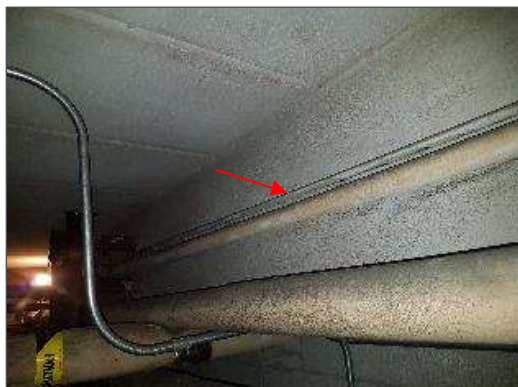
Plaster present as a bulkhead in Mechanical Room (Location 84) does not contain asbestos (samples 0060A-C).

Non-asbestos plaster bulkheads in Mech Room (Location 84).

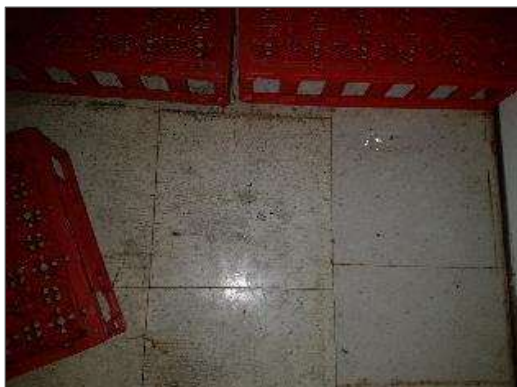
Non-asbestos 12" x 12" beige with brown splotch vinyl floor tiles (left) and 12" x 12" white with beige splotch vinyl floor tiles (right).

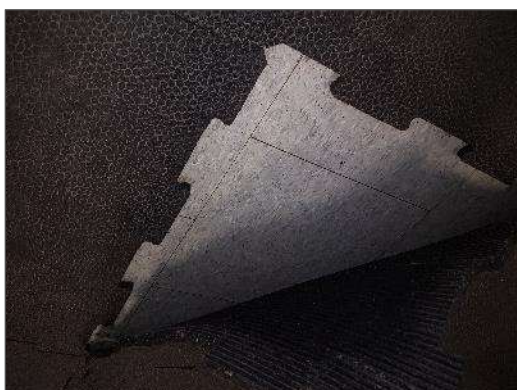
The 12" x 12" grey and white splotch replacement tiles are presumed to be non-asbestos based on historical knowledge of the date of installation. The tiles were replaced after 1993.

Non-asbestos grey and white splotch replacement tiles.
