Designated Substances Survey -12 Queen Street, Lakefield, Ontario

June 6, 2022

Prepared for:
Township of Selwyn

Cambium Reference: 15392-001

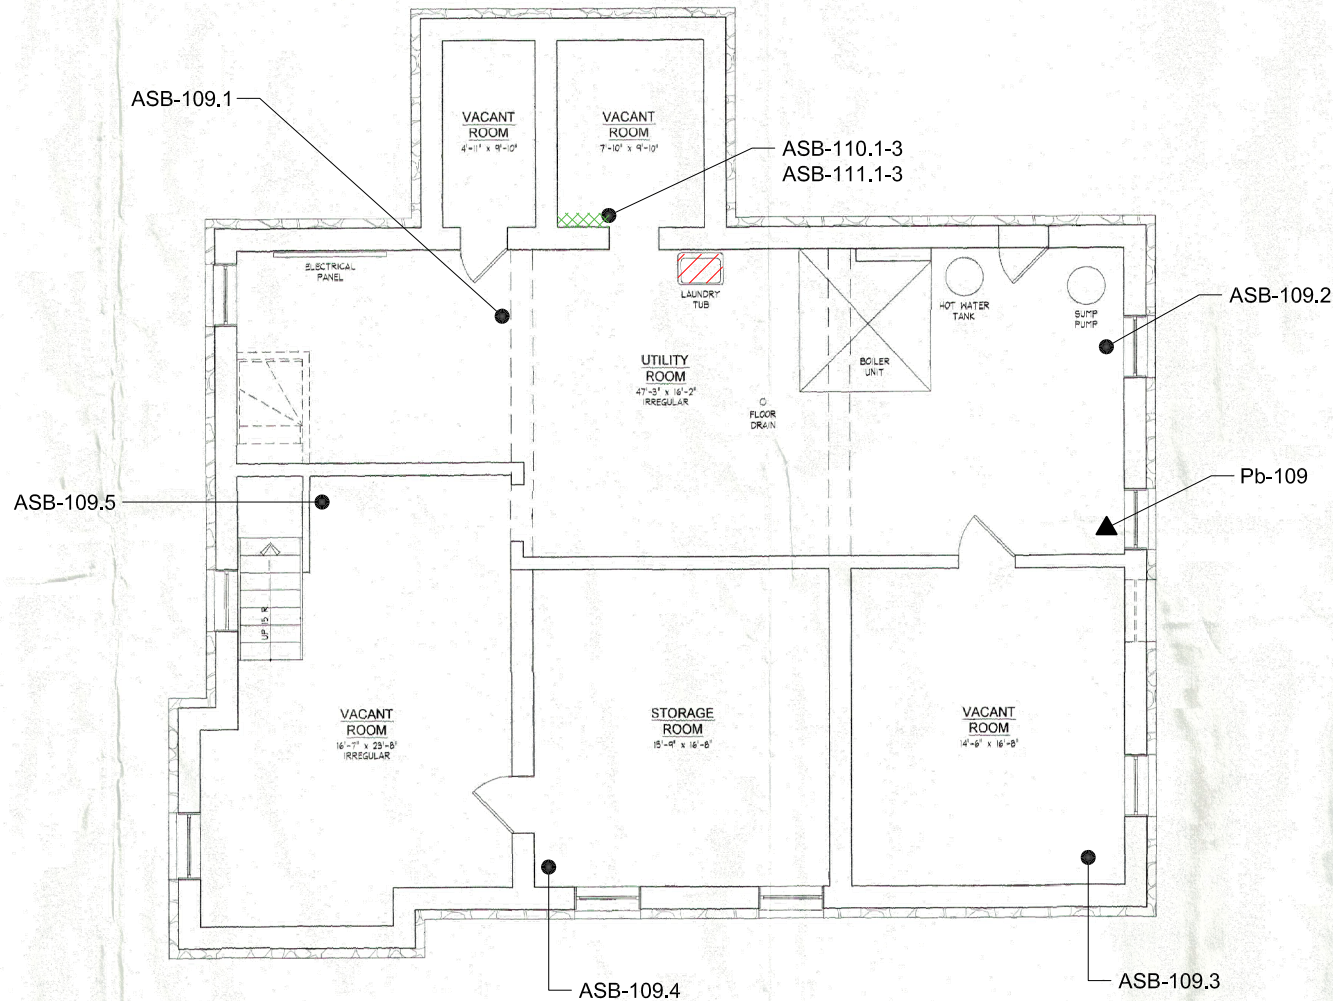
BASEMENT SITE PLAN

Below is a brief summary of building materials identified during the assessment that were suspected of being asbestos-containing. Photographs are included in Appendix A. The laboratory certificate of analysis report for asbestos is included in Appendix B. A drawing with hatching showing the locations of all asbestos-containing materials and the locations of samples is present in Figure 1 to Figure 3.
