Designated Substances Survey

**St. Paul Catholic
Elementary School**

**1101 Hilliard Street,
Peterborough, Ontario**

January 22, 2026

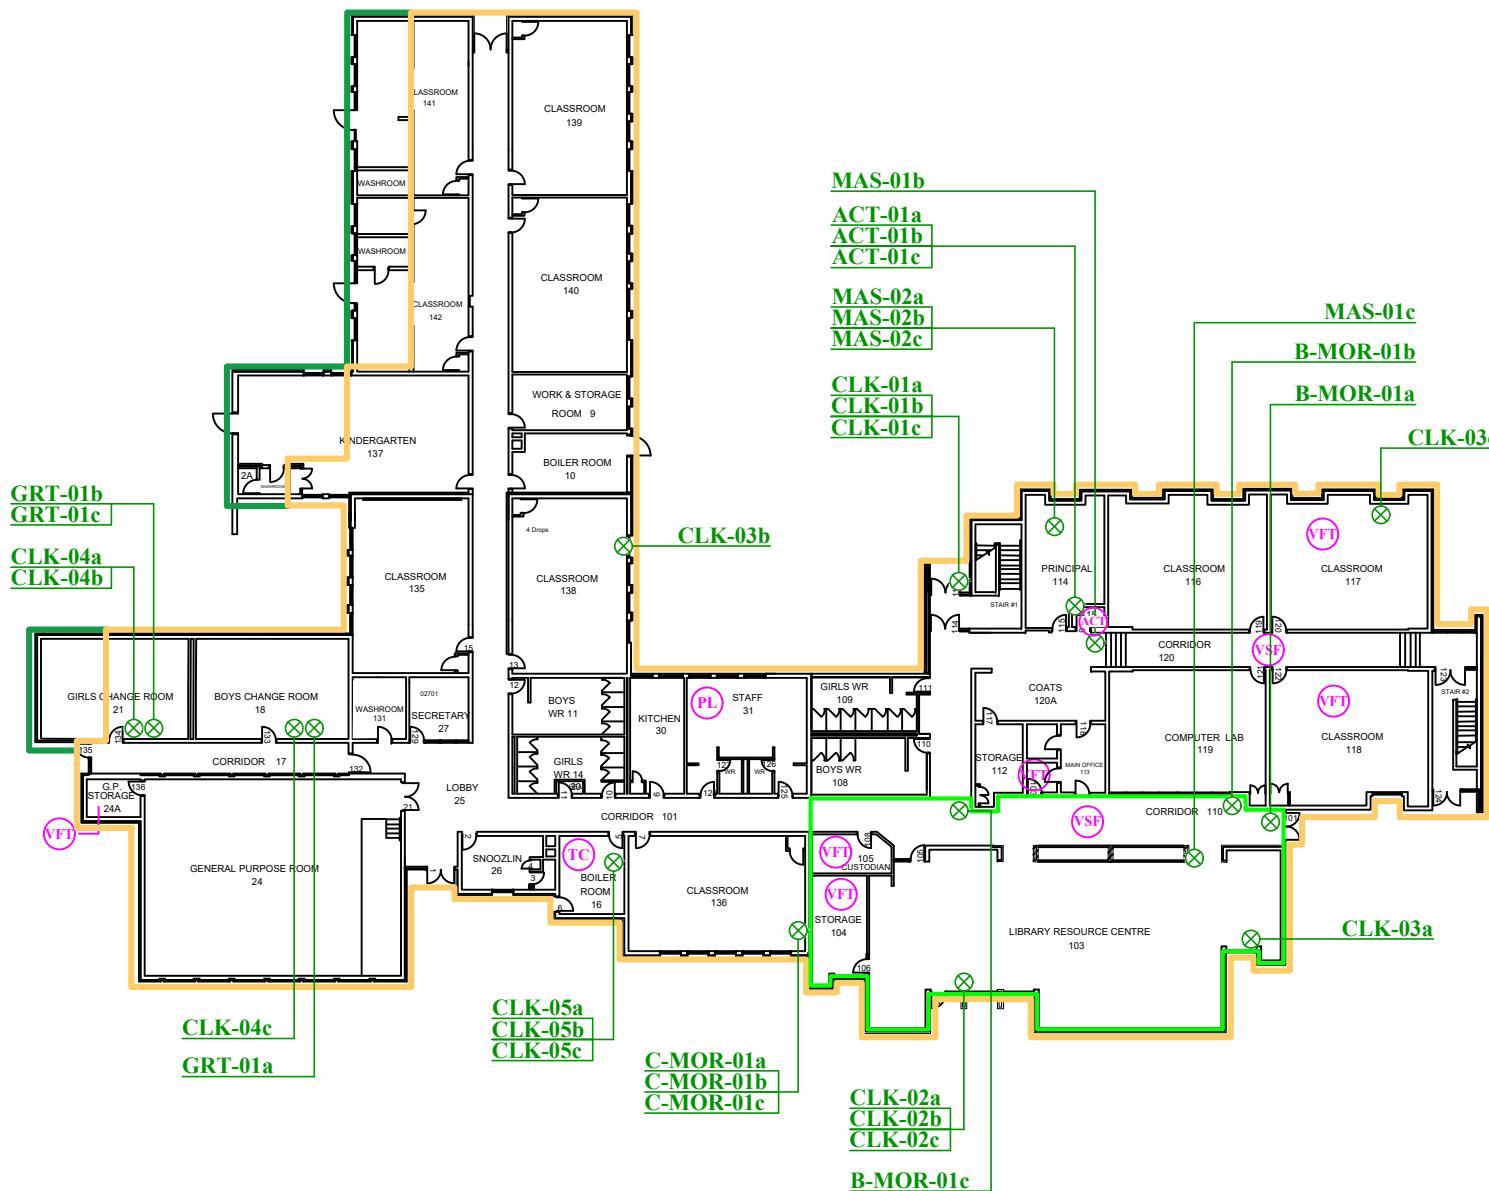
DESIGNATED SUBSTANCES SURVEY

ALTHOUGH NOT SHOWN ON DRAWING DRYWALL JOINT COMPOUND AND INSULATING CEILING PANELS ON LIGHT FIXTURES, WERE PREVIOUSLY IDENTIFIED TO BE ASBESTOS CONTAINING BY PREVIOUS CONSULTANTS.
