**ASBESTOS-CONTAINING MATERIALS**

OTHER DESIGNATED SUBSTANCES

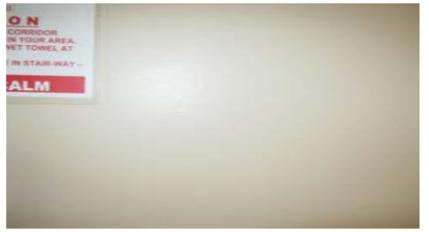
Light sanding of surfaces containing low levels of lead is classified as a Type 1 Lead Operation, provided the airborne concentration of lead is maintained below <math>0.05 \text{ mg/m}^3</math> of air. Applying paint causes no disturbance to the lead-containing paint that is present in good condition. Lead Awareness Procedures are recommended.
Tenant Spaces and Common Areas	Throughout	All	All	N/A	Good	High	LP-02 to LP-04	All remaining paint samples collected were found to contain low levels of lead ranging from 0.06% to <math>0.02\%</math>

Light sanding of surfaces containing low levels of lead is classified as a Type 1 Lead Operation, provided the airborne concentration of lead is maintained below <math>0.05 \text{ mg/m}^3</math> of air. Applying paint causes no disturbance to the lead-containing paint that is present in good condition. Lead Awareness Procedures are recommended.
