**REVISED**  
**Hazardous Building**  
**Materials Assessment**  
**(Pre-construction)**

Eastside Secondary School  
275 Farley Avenue, Belleville,  
Ontario

July 12, 2023

Pinchin File: 200584.061

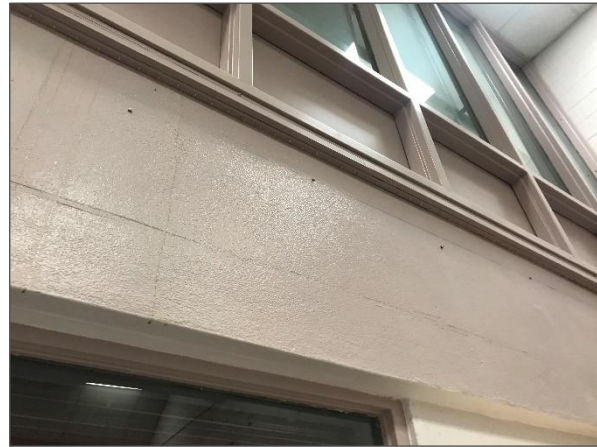
Non-asbestos textured plaster on wall.

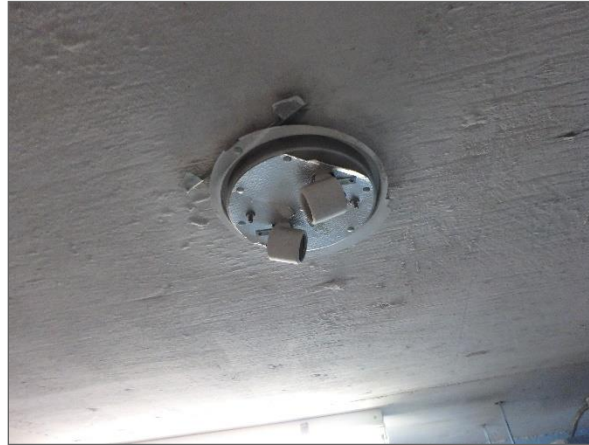
A paper heat shield, containing chrysotile asbestos, is present within an incandescent light fixture in Basement Room 002 (previous samples 0017A-C).

Asbestos-containing heat shield.

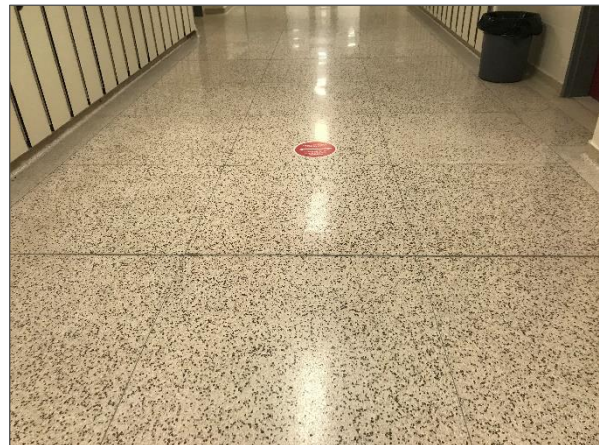
Non-asbestos terrazzo floor.
