Re: Asbestos Reassessment

Susanna Moodie Elementary School, 376 Avonlough Road, Belleville, ON
Pinchin File: 0200584.085

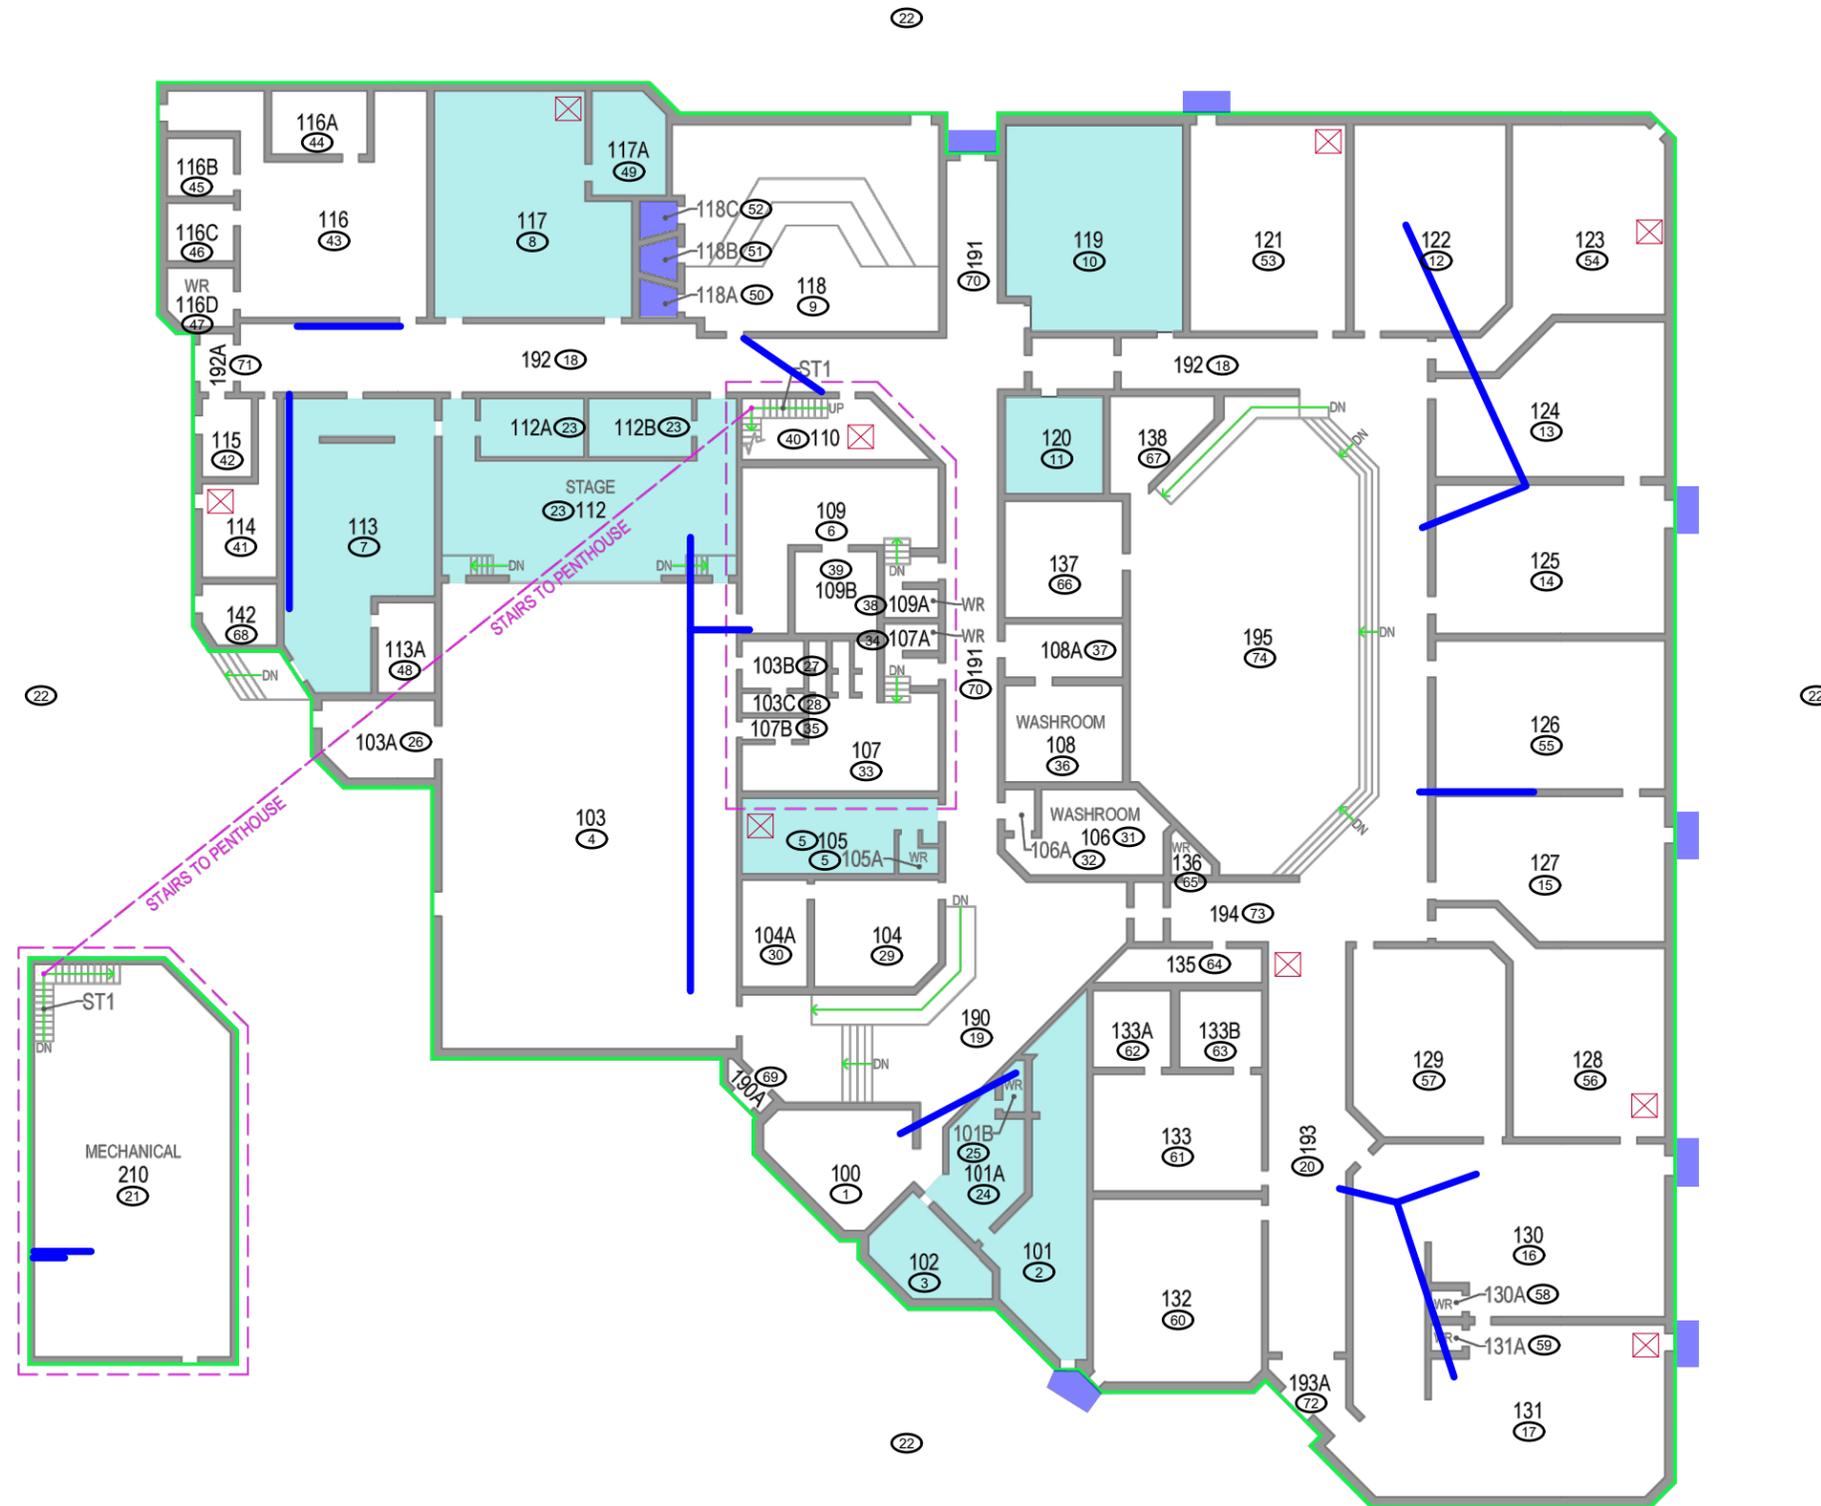
FIGURE NAME:
GROUND FLOOR

- ASBESTOS-CONTAINING MATERIALS:**
- VINYL FLOOR TILES
 - TRANSITE PANELS (PRESUMED)
 - TRANSITE RAIN WATER LEADERS (PRESUMED)
