Designated Substances Survey

**Immaculate Conception
Catholic Elementary
School**

**76 Robinson Street,
Peterborough, Ontario**

January 21, 2026

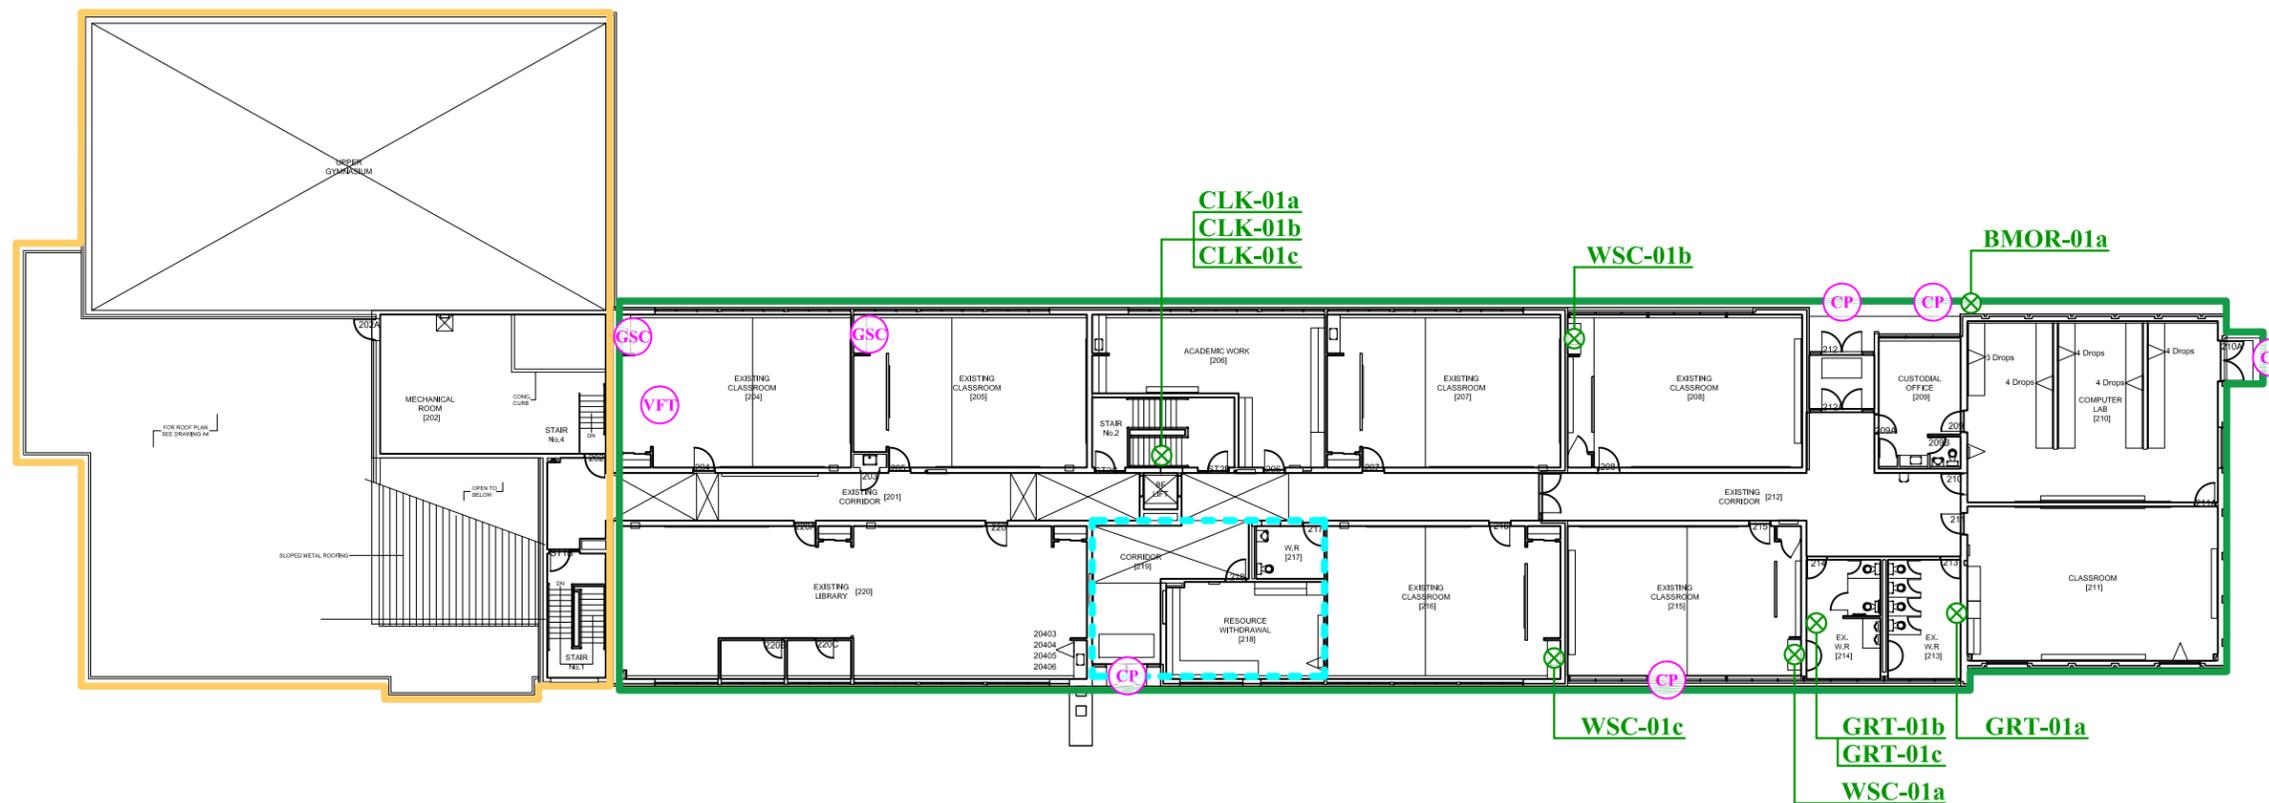
ALTHOUGH NOT SHOWN ON THE DRAWING, THE BUILT-UP ROOFING SYSTEM (ROOF SECTIONS C TO H) ARE TO BE PRESUMED ASBESTOS CONTAINING UNTIL FURTHER SAMPLING PROVES OTHERWISE.
