Limited Designated Substance Survey Report

Waverly Public School

100 Waverly Street South, Oshawa, Ontario

March 6, 2026
Parasol Project No: 13370

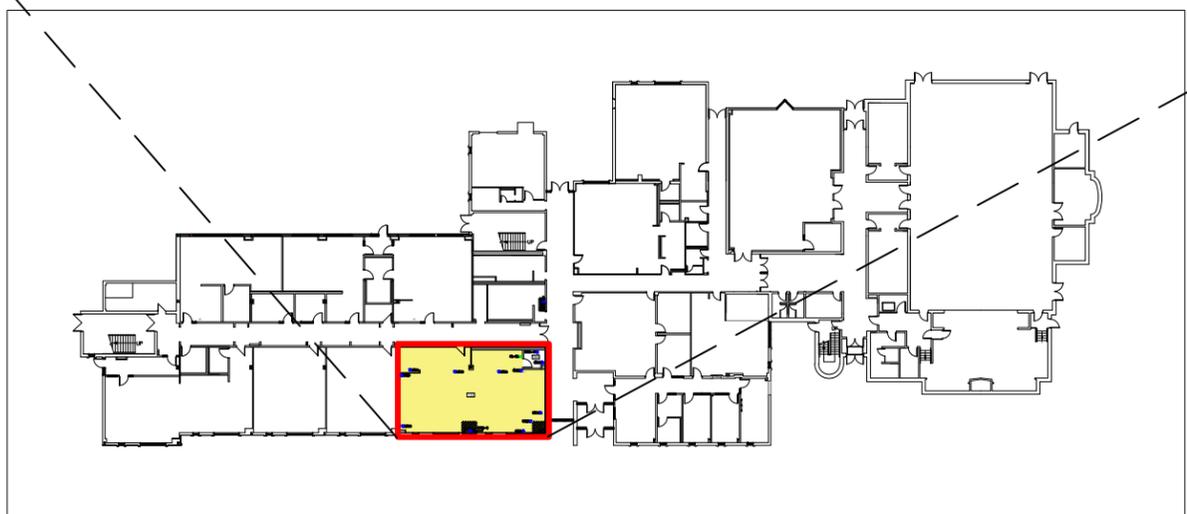
TITLE
**Limited Designated Substance Survey
 First Floor Plan**

- 1) Drywall finishes where present with joint compound applied are confirmed to contain Chrysotile asbestos. Sampling is required in specific areas to prove non-ACM.
- 2) Loose fill insulation (Vermiculite) is confirmed to contain Amphibole asbestos and is suspected to be present within the voids of the masonry block within the surveyed area. Specific locations of the material are not known.
- 3) Asbestos-containing sprayed fireproofing may be concealed behind non-asbestos sprayed fireproofing or within wall and ceiling cavities.

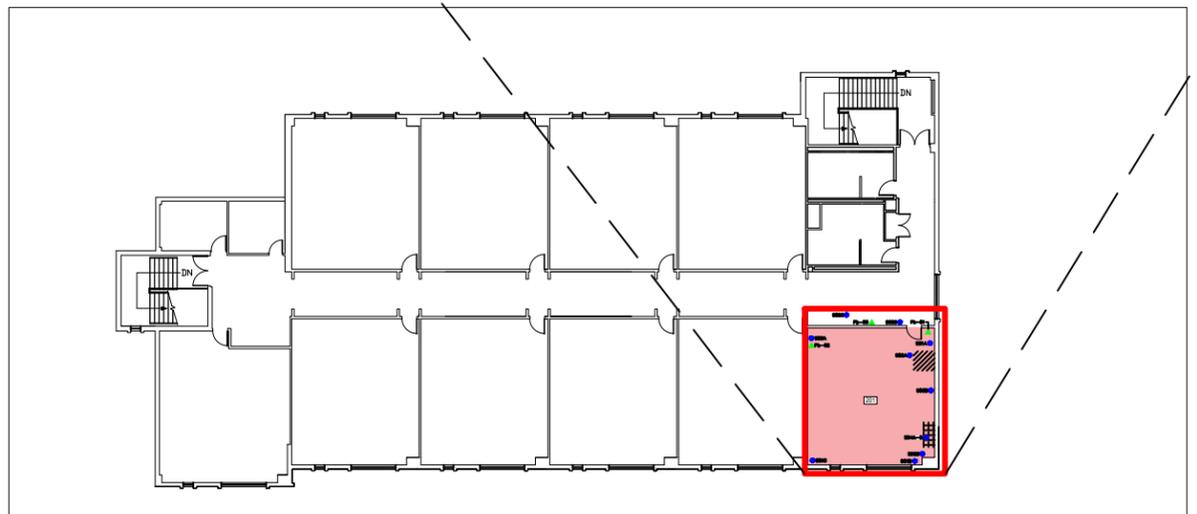
TITLE	Limited Designated Substance Survey Second Floor Plan
CLIENT	Durham District School Board
LOCATION	Waverly Public School 100 Waverly Street South Oshawa, Ontario

- 1) Drywall finishes where present with joint compound applied are confirmed to contain Chrysotile asbestos. Sampling is required in specific areas to prove non-ACM.
 - 2) Loose fill insulation (Vermiculite) is confirmed to contain Amphibole asbestos and is suspected to be present within the voids of the masonry block within the surveyed area. Specific locations of the material are not known.
 - 3) Asbestos-containing sprayed fireproofing may be concealed behind non-asbestos sprayed fireproofing or within wall and ceiling cavities.
- Refer to Main Report.
