Limited Designated Substance Survey Report

Ajax High School

105 Bayly Street East, Ajax, Ontario

February 25, 2026
Parasol Project No: 13367

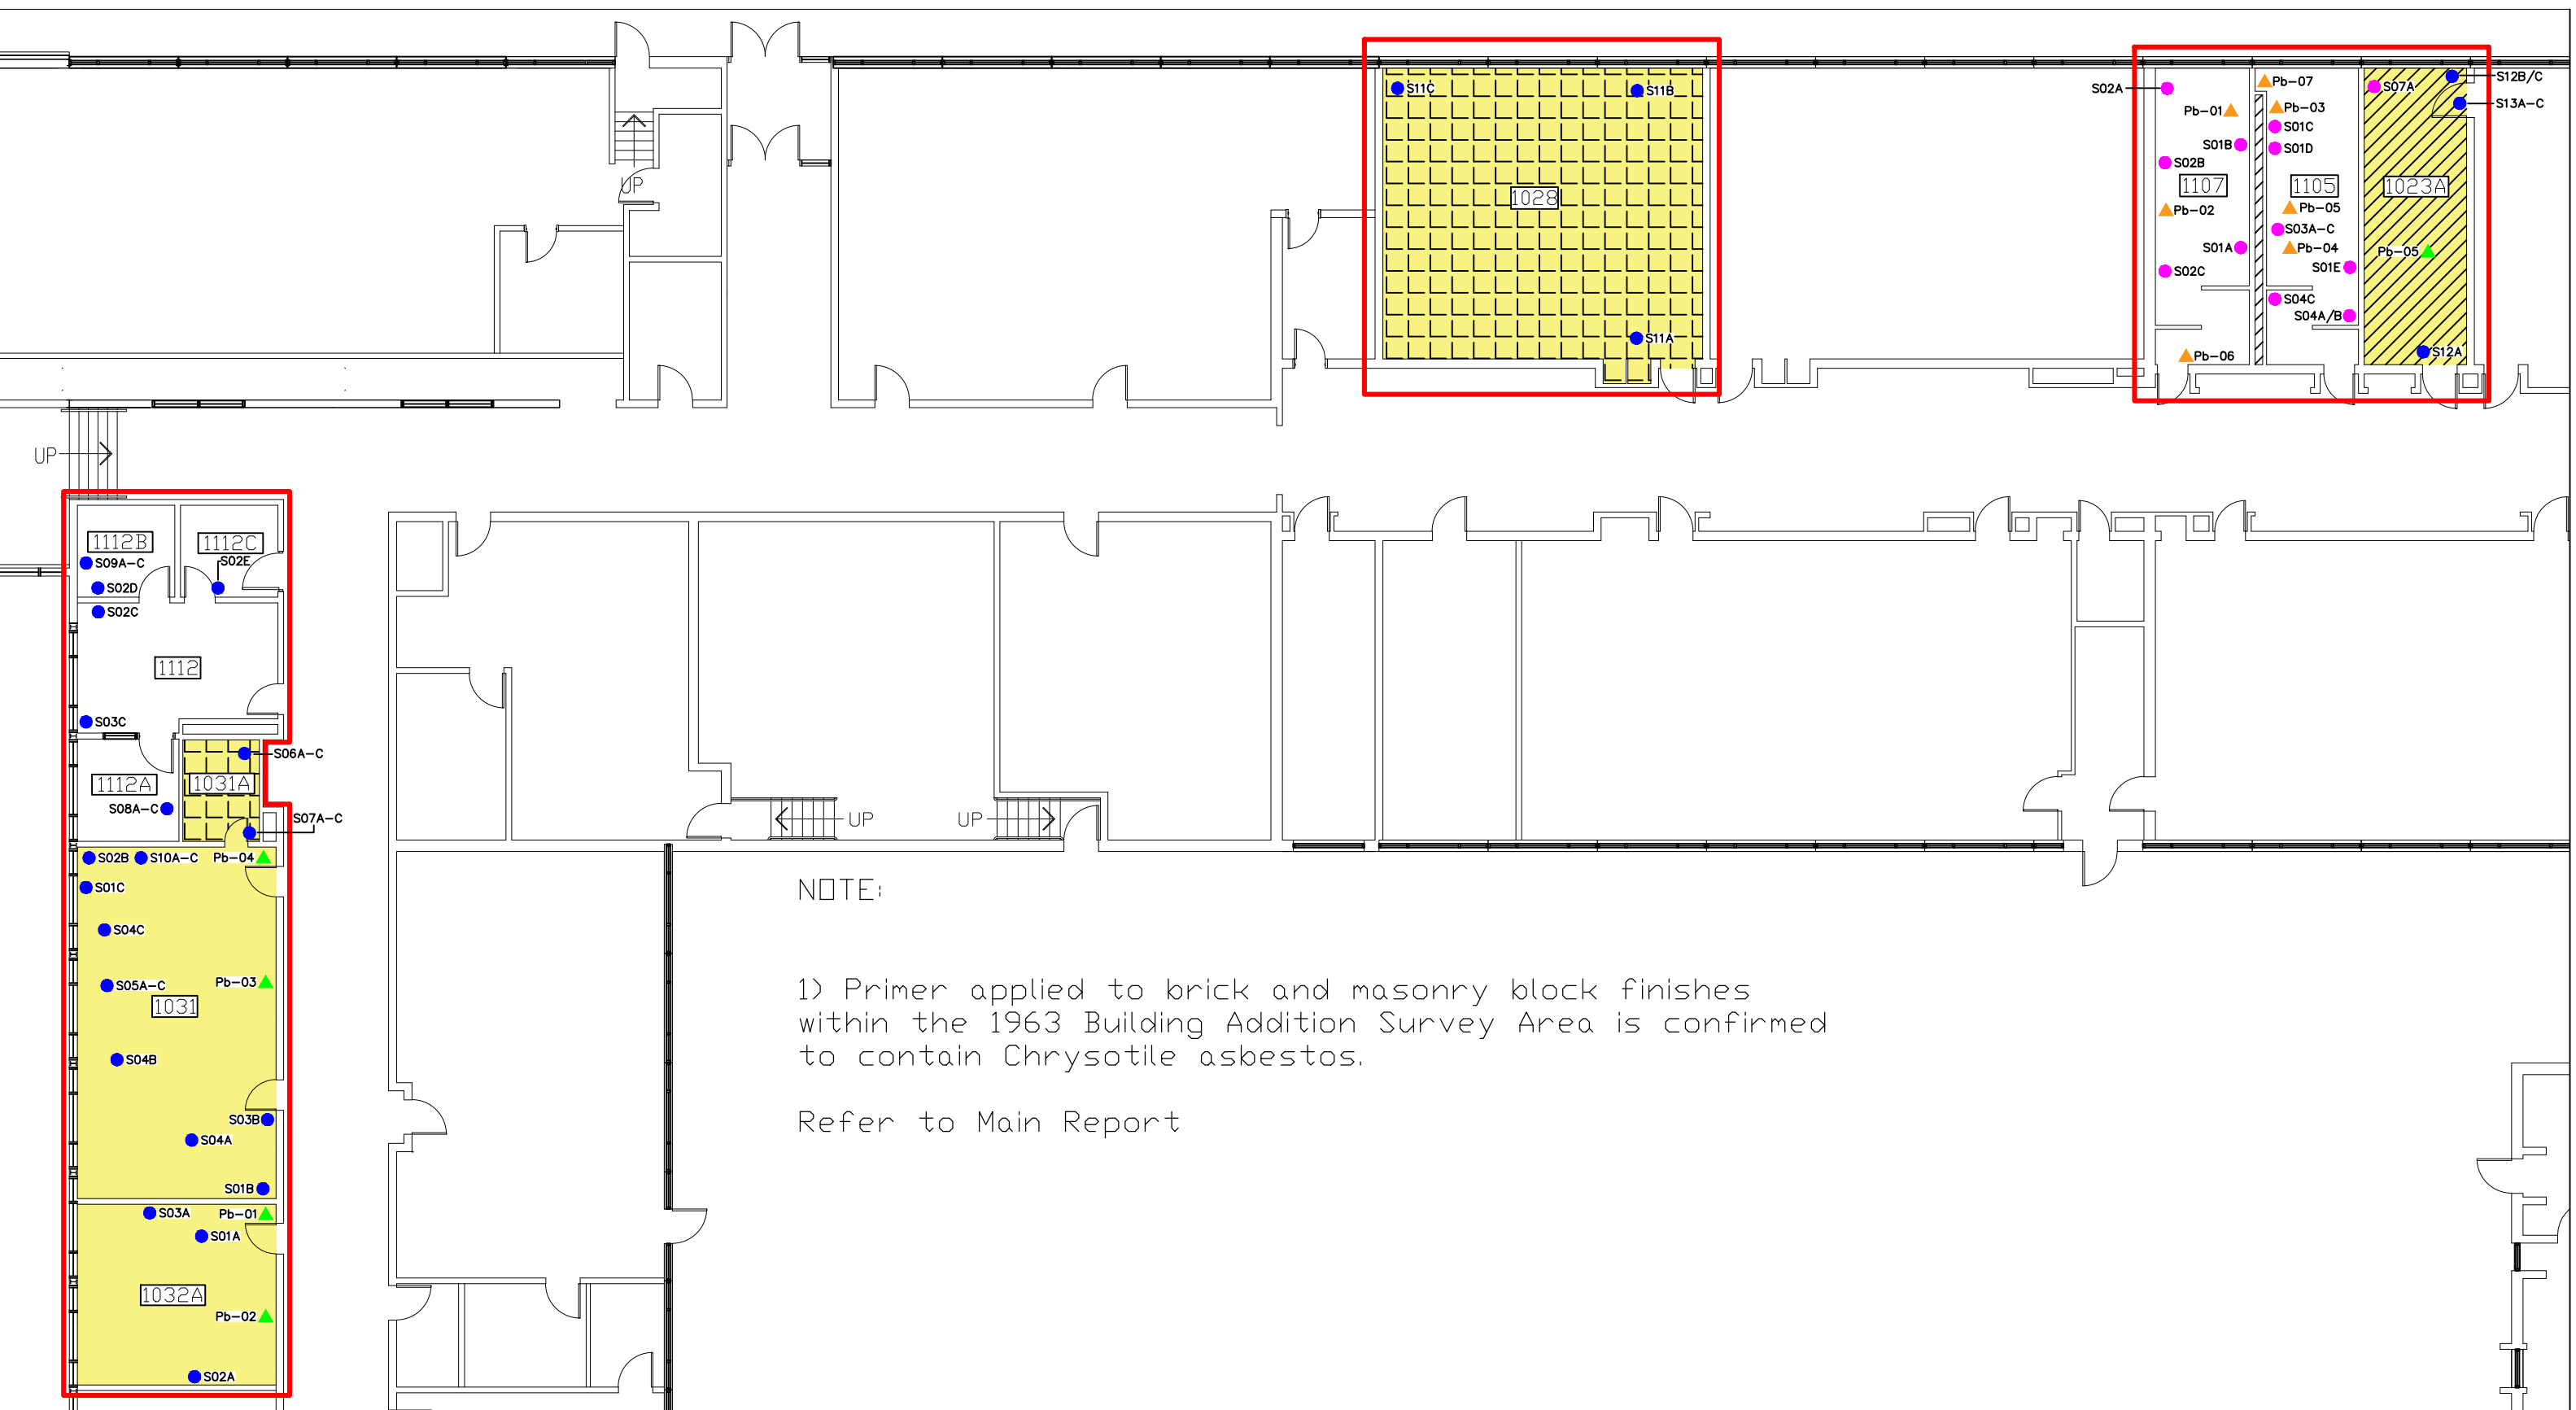
1) Primer applied to brick and masonry block finishes within the 1963 Building Addition Survey Area is confirmed to contain Chrysotile asbestos.

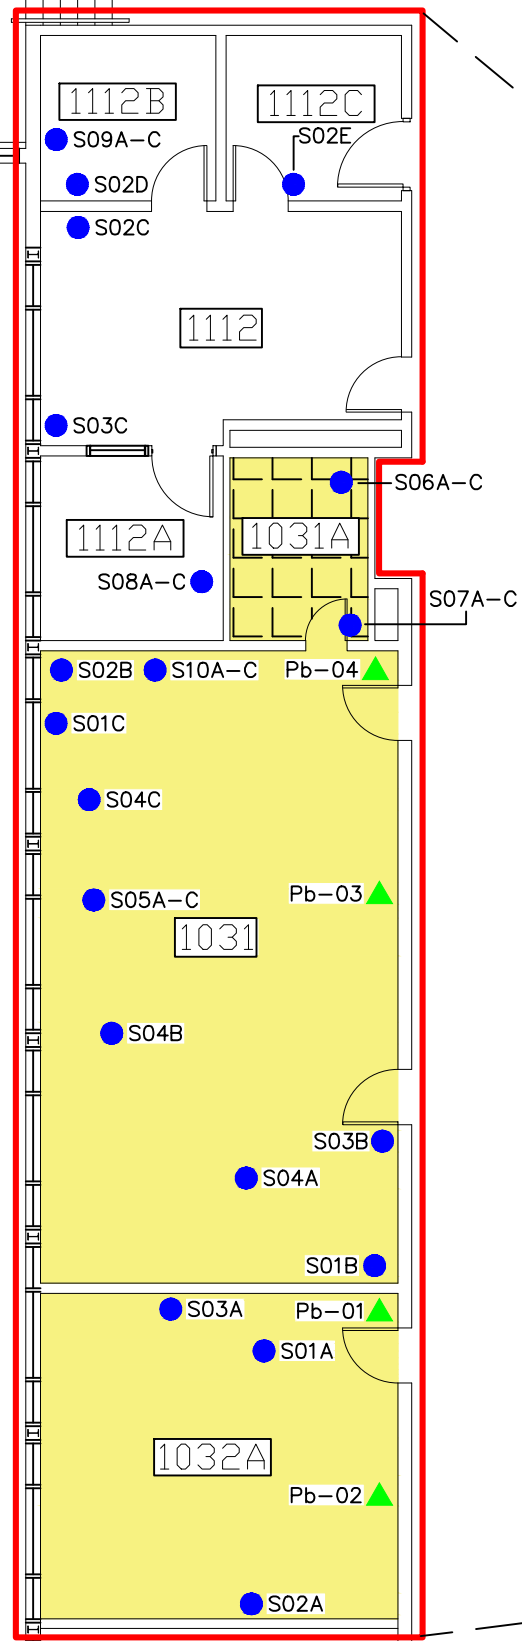
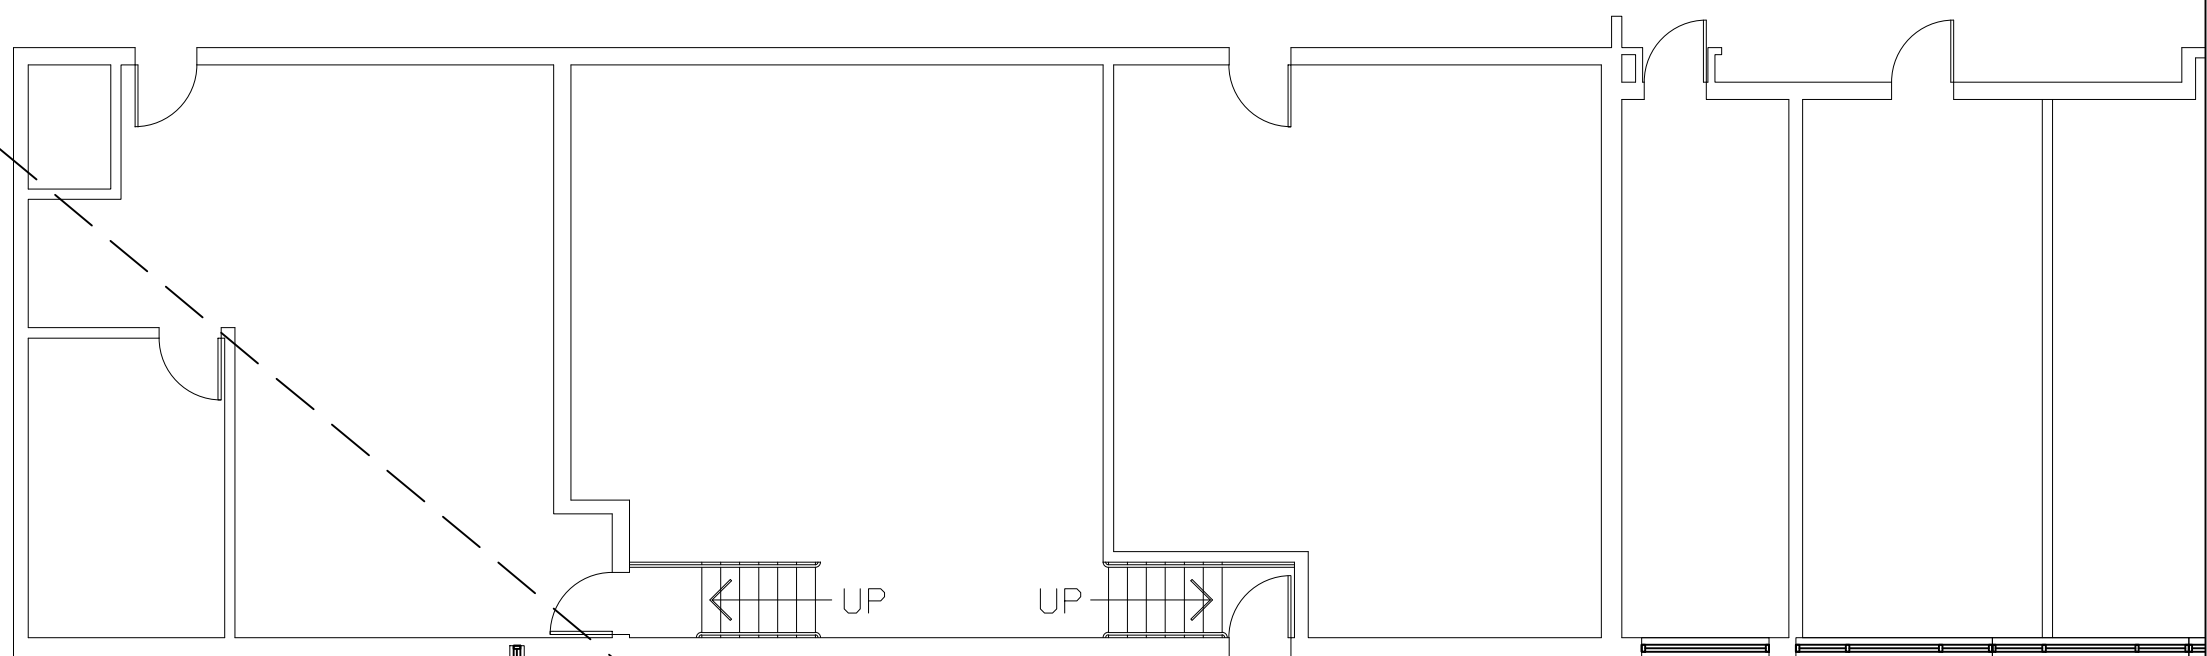
1) Primer applied to brick and masonry block finishes within the 1963 Building Addition Survey Area is confirmed to contain Chrysotile asbestos.

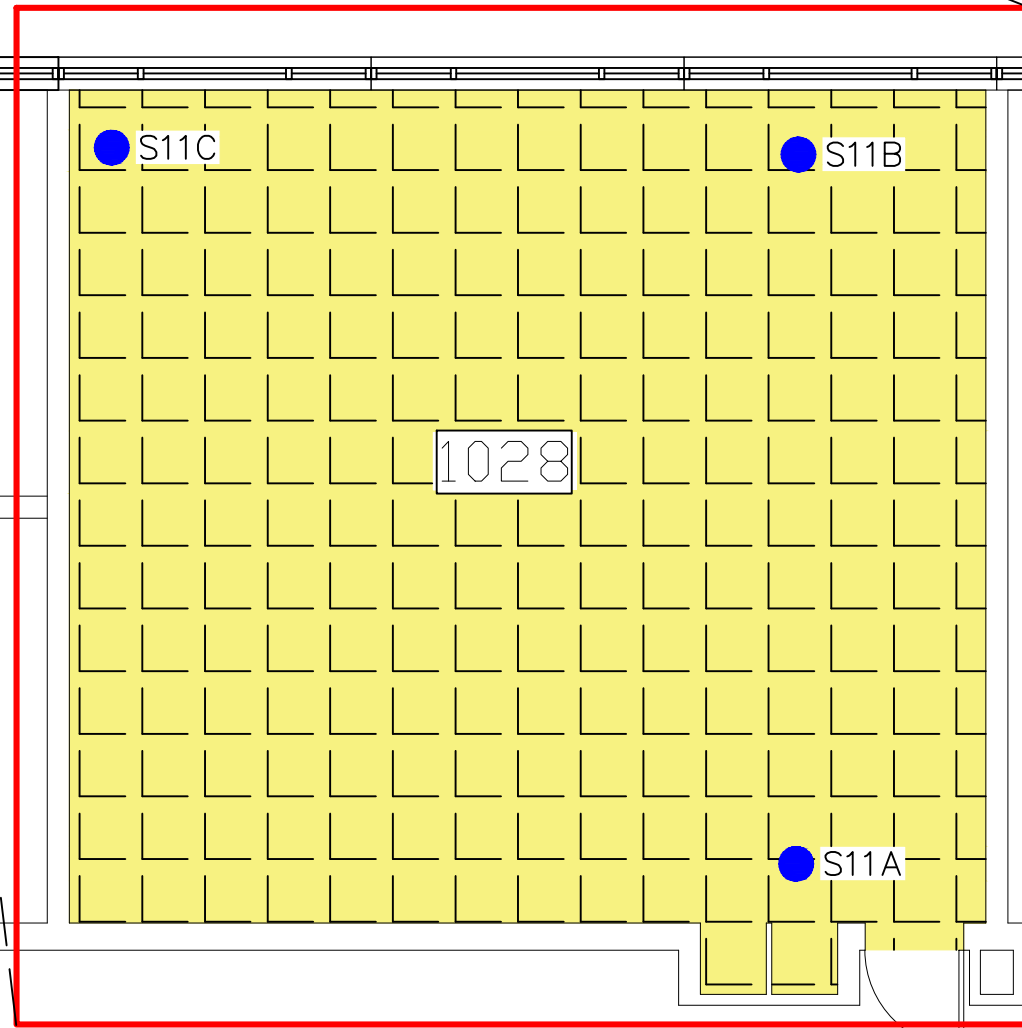
TITLE	Limited Designated Substance Survey First Floor Plan
CLIENT	Durham District School Board
LOCATION	Ajax High School 105 Bayly Street East Ajax, Ontario

1) Primer applied to brick and masonry block finishes within the 1963 Building Addition Survey Area is confirmed to contain Chrysotile asbestos.

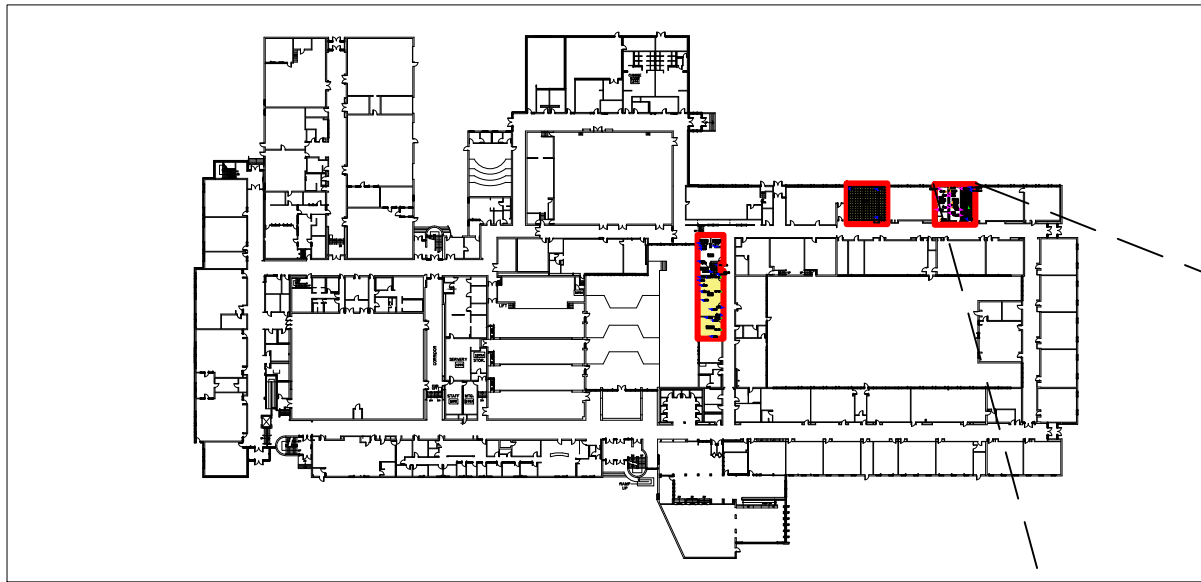
1) Primer applied to brick and masonry block finishes within the 1963 Building Addition Survey Area is confirmed to contain Chrysotile asbestos.
