ASBESTOS-CONTAINING BUILDING MATERIALS RE-ASSESSMENT REPORT

King Albert Public School

49 Glenelg Street West
Lindsay, Ontario
K9V 2T9

Maple Project No. 18736-35

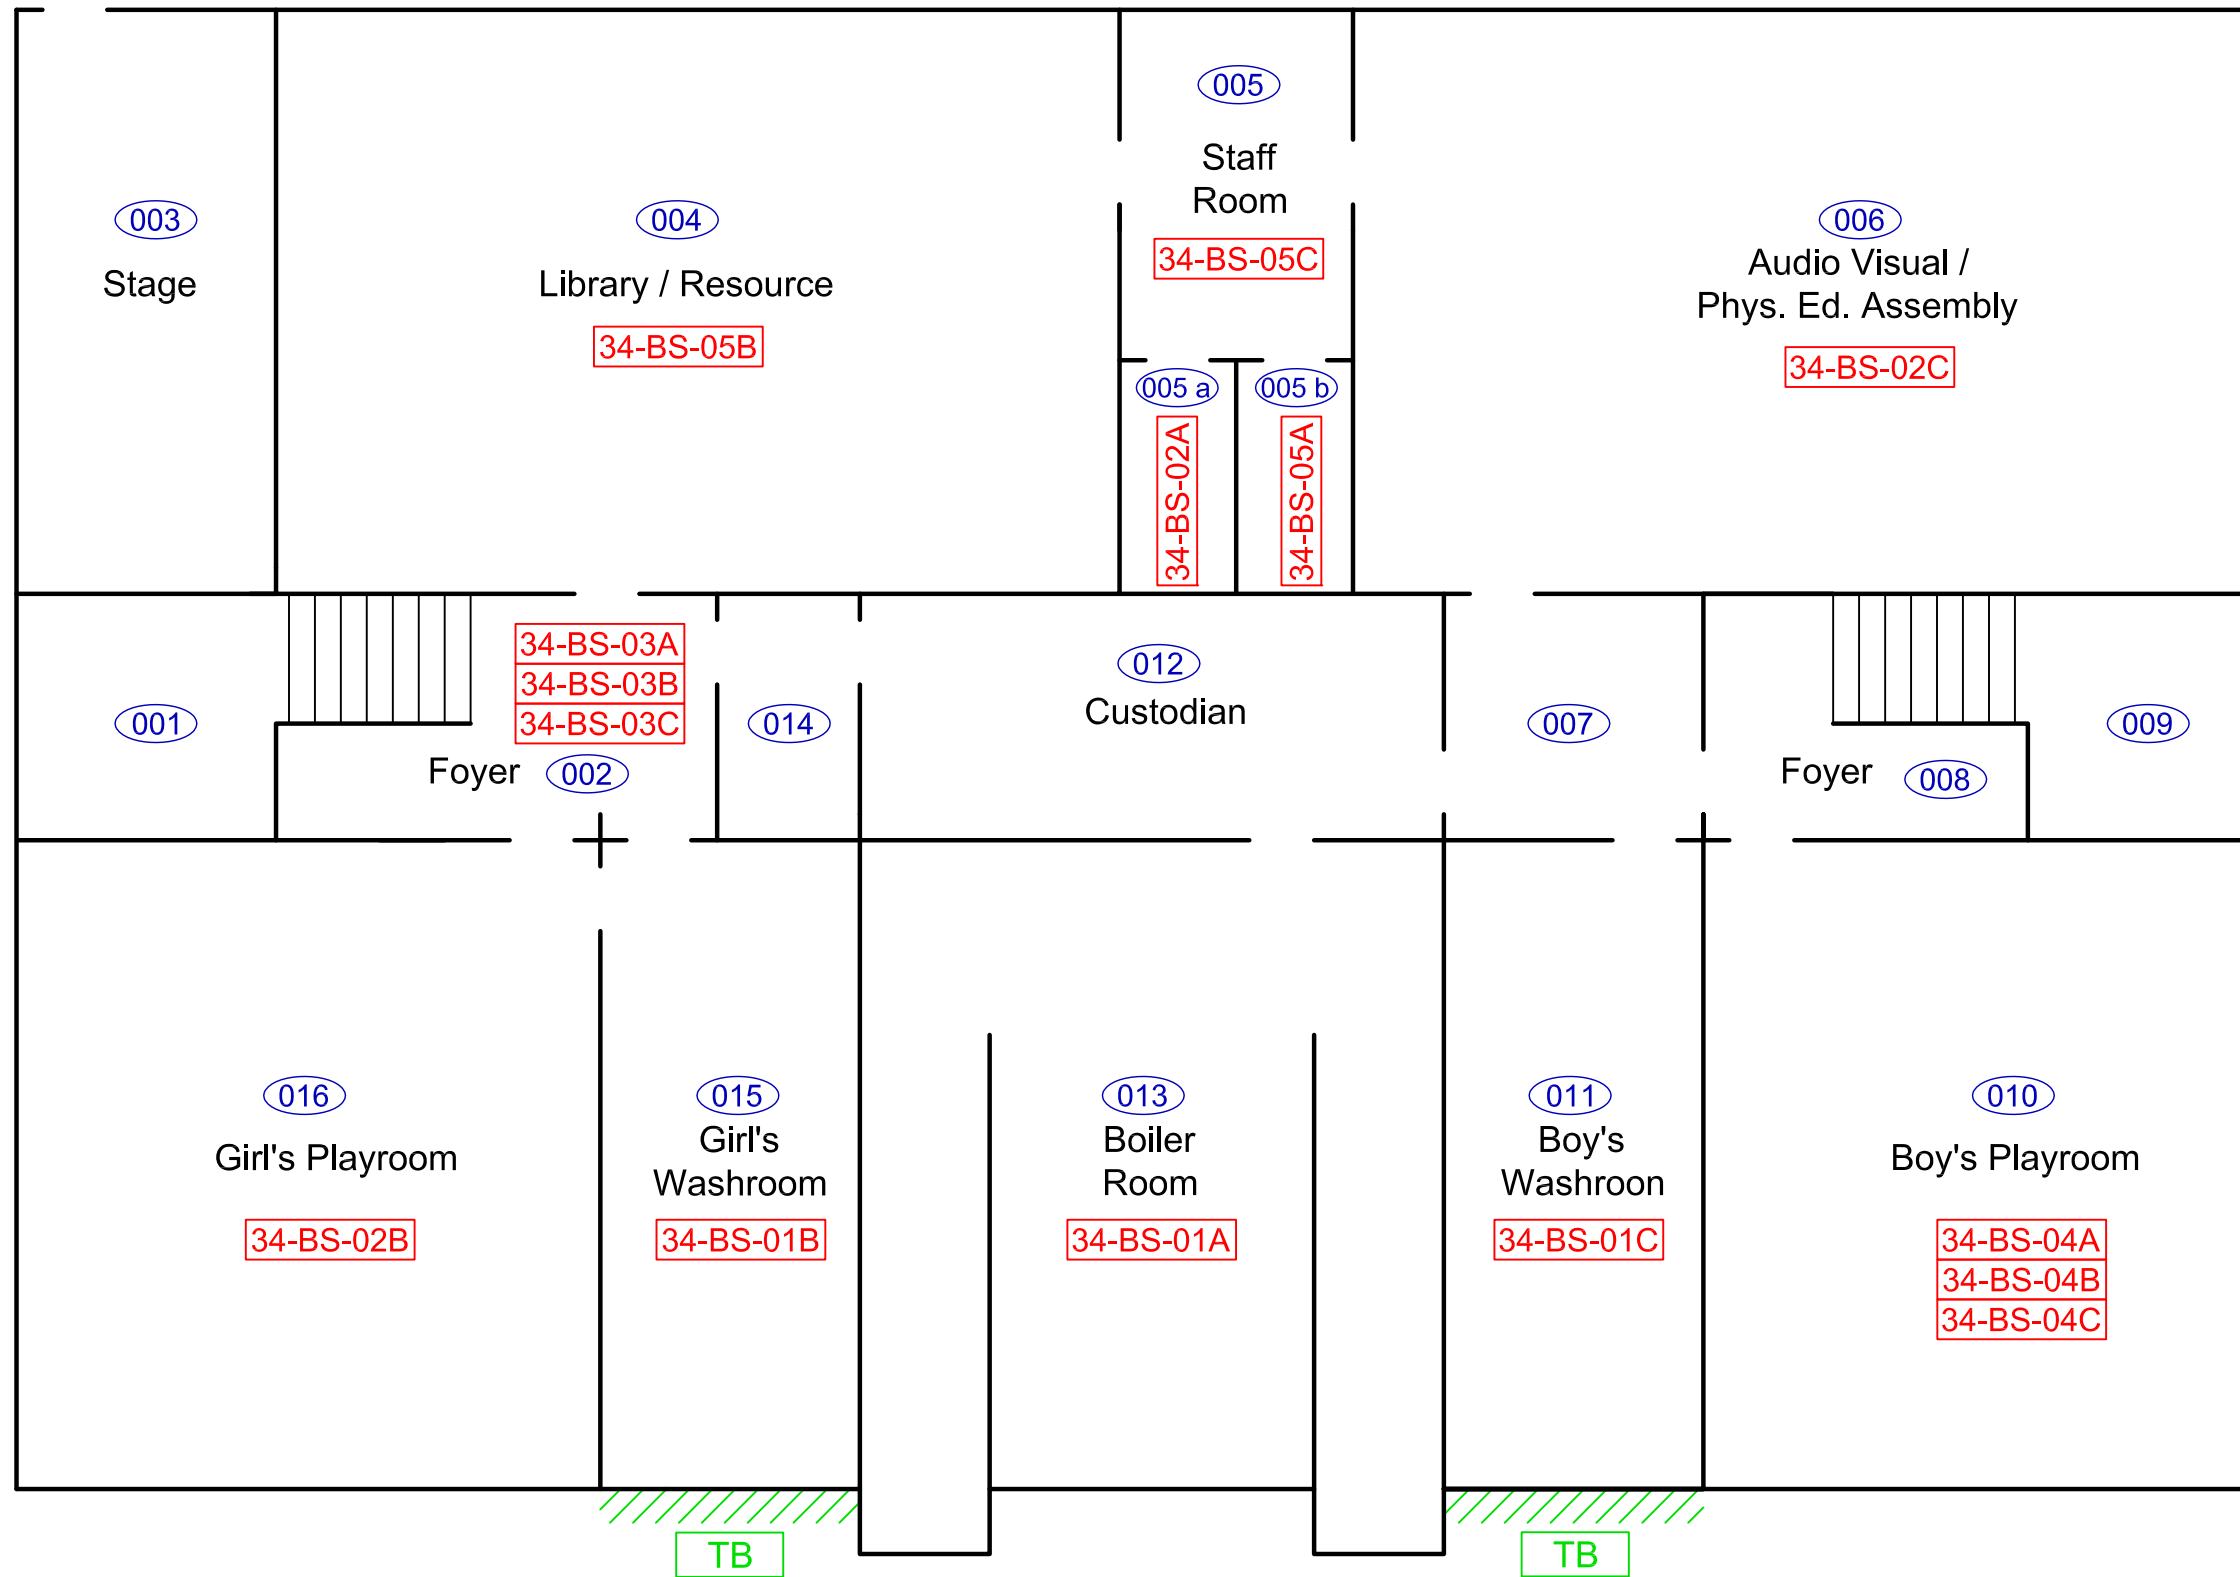
LEGEND

- 01-BS-01A Jacques Whitford Sample Locations
- # Ebase Number

For Detailed Information as to Location, Type, Quantity, Condition and Access to ACM, Please Refer to the Room-by-Room Sheets Provided in the Report.

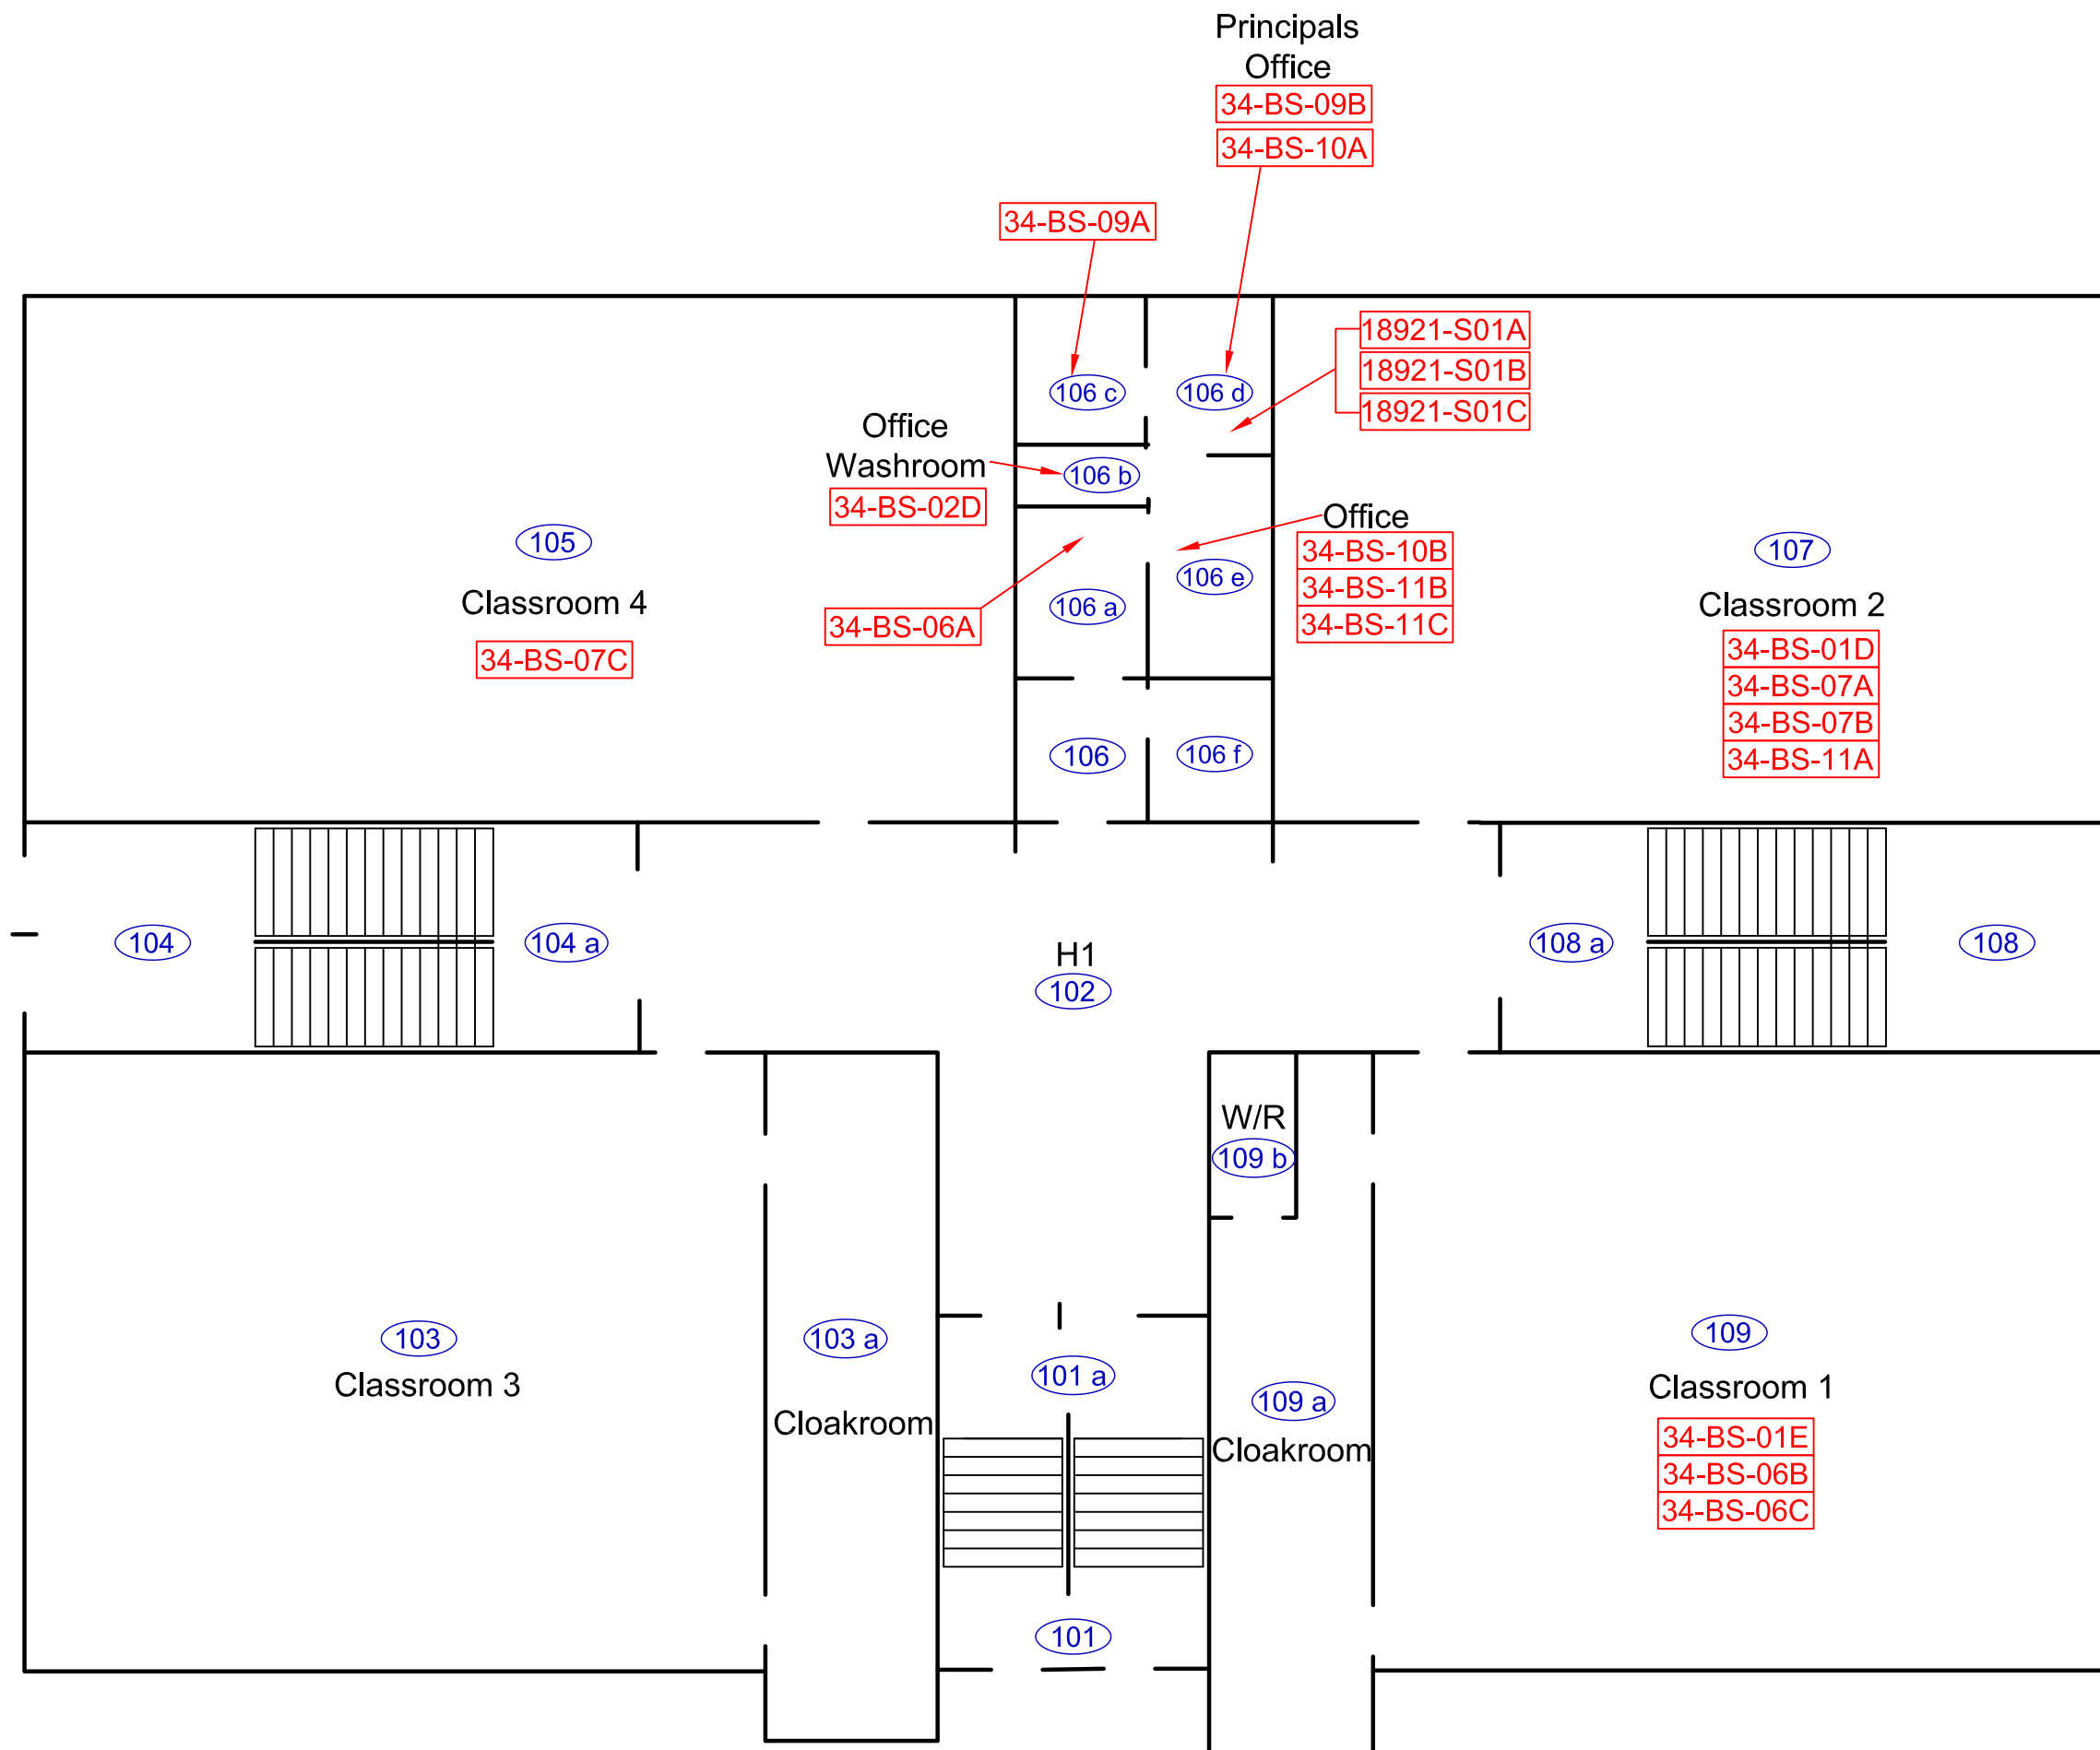
LEGEND

- 01-BS-01A Jacques Whitford Sample Locations
- # Ebase Number

For Detailed Information as to Location, Type, Quantity, Condition and Access to ACM, Please Refer to the Room-by-Room Sheets Provided in the Report.

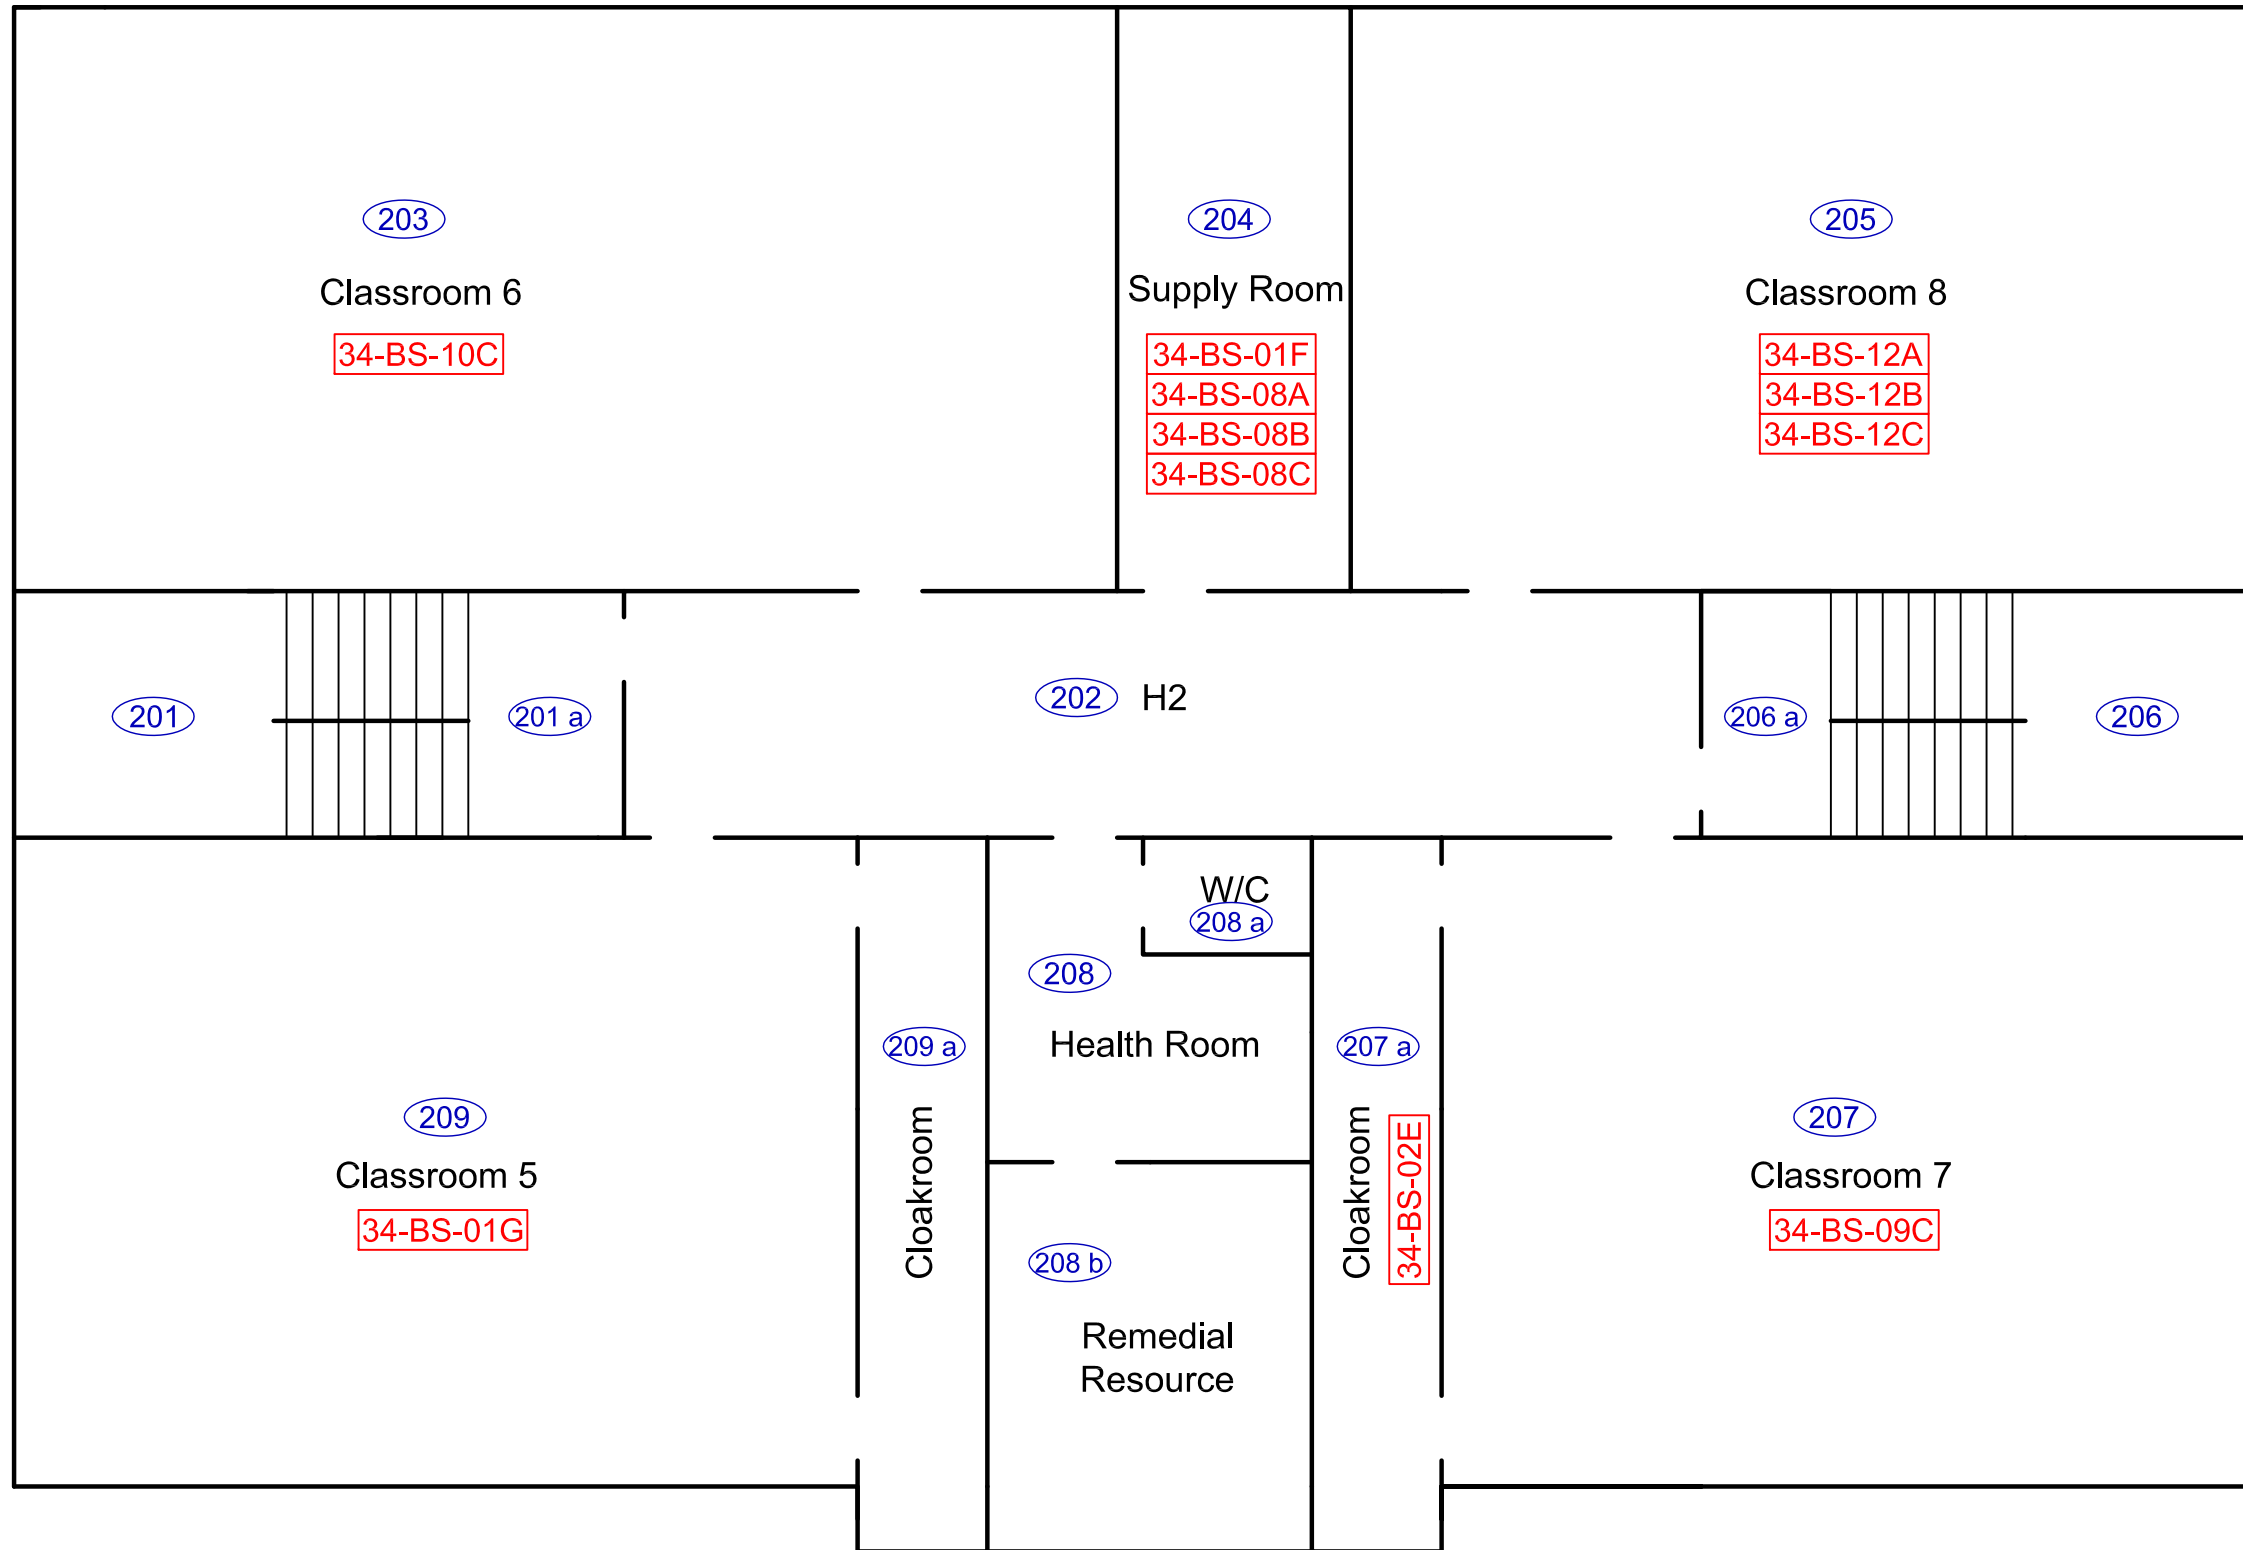
LEGEND

- 01-BS-01A Jacques Whitford Sample Locations
- # Ebase Number

For Detailed Information as to Location, Type, Quantity, Condition and Access to ACM, Please Refer to the Room-by-Room Sheets Provided in the Report.
