Drawing Title:
GENERAL NOTES AND PERSPECTIVE

Drawing Title:
PLANS

Drawing Title:
SECTIONS

Limited Designated Substance Survey Report

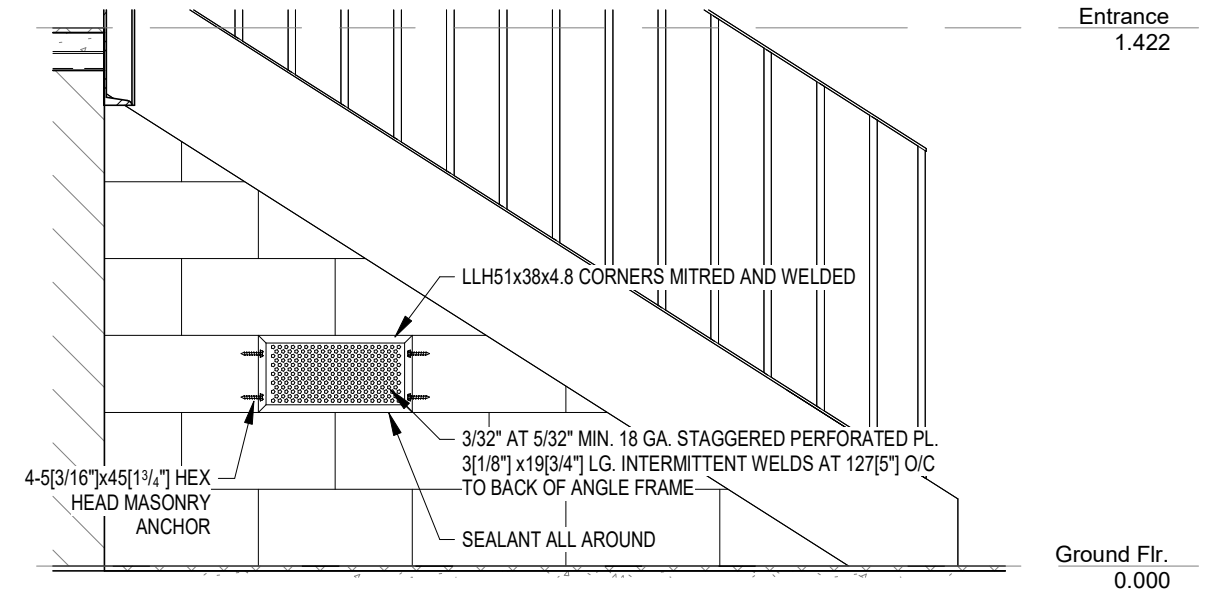
5 Wall/Vent Detail
1 : 20
NOTES:
- NO ROUGH/SHARP EDGES
- OUTER DIMENSIONS TO ALLOW FOR FUTURE REMOVALS
- TO BE PAINTED TO MATCH WALL COLOUR

1. STAIRS/TREADS/STRINGERS (GYPSUM BOARD PREVIOUSLY ABATED)
 - A. 4 STAIR PANS TO BE REPLACED PER DETAILS. REMOVE AND REPLACE CMU TO ACCESS UNDERSIDE OF LOWER STAIR. REPLACEMENT INCLUDES VENT AS DETAILED.

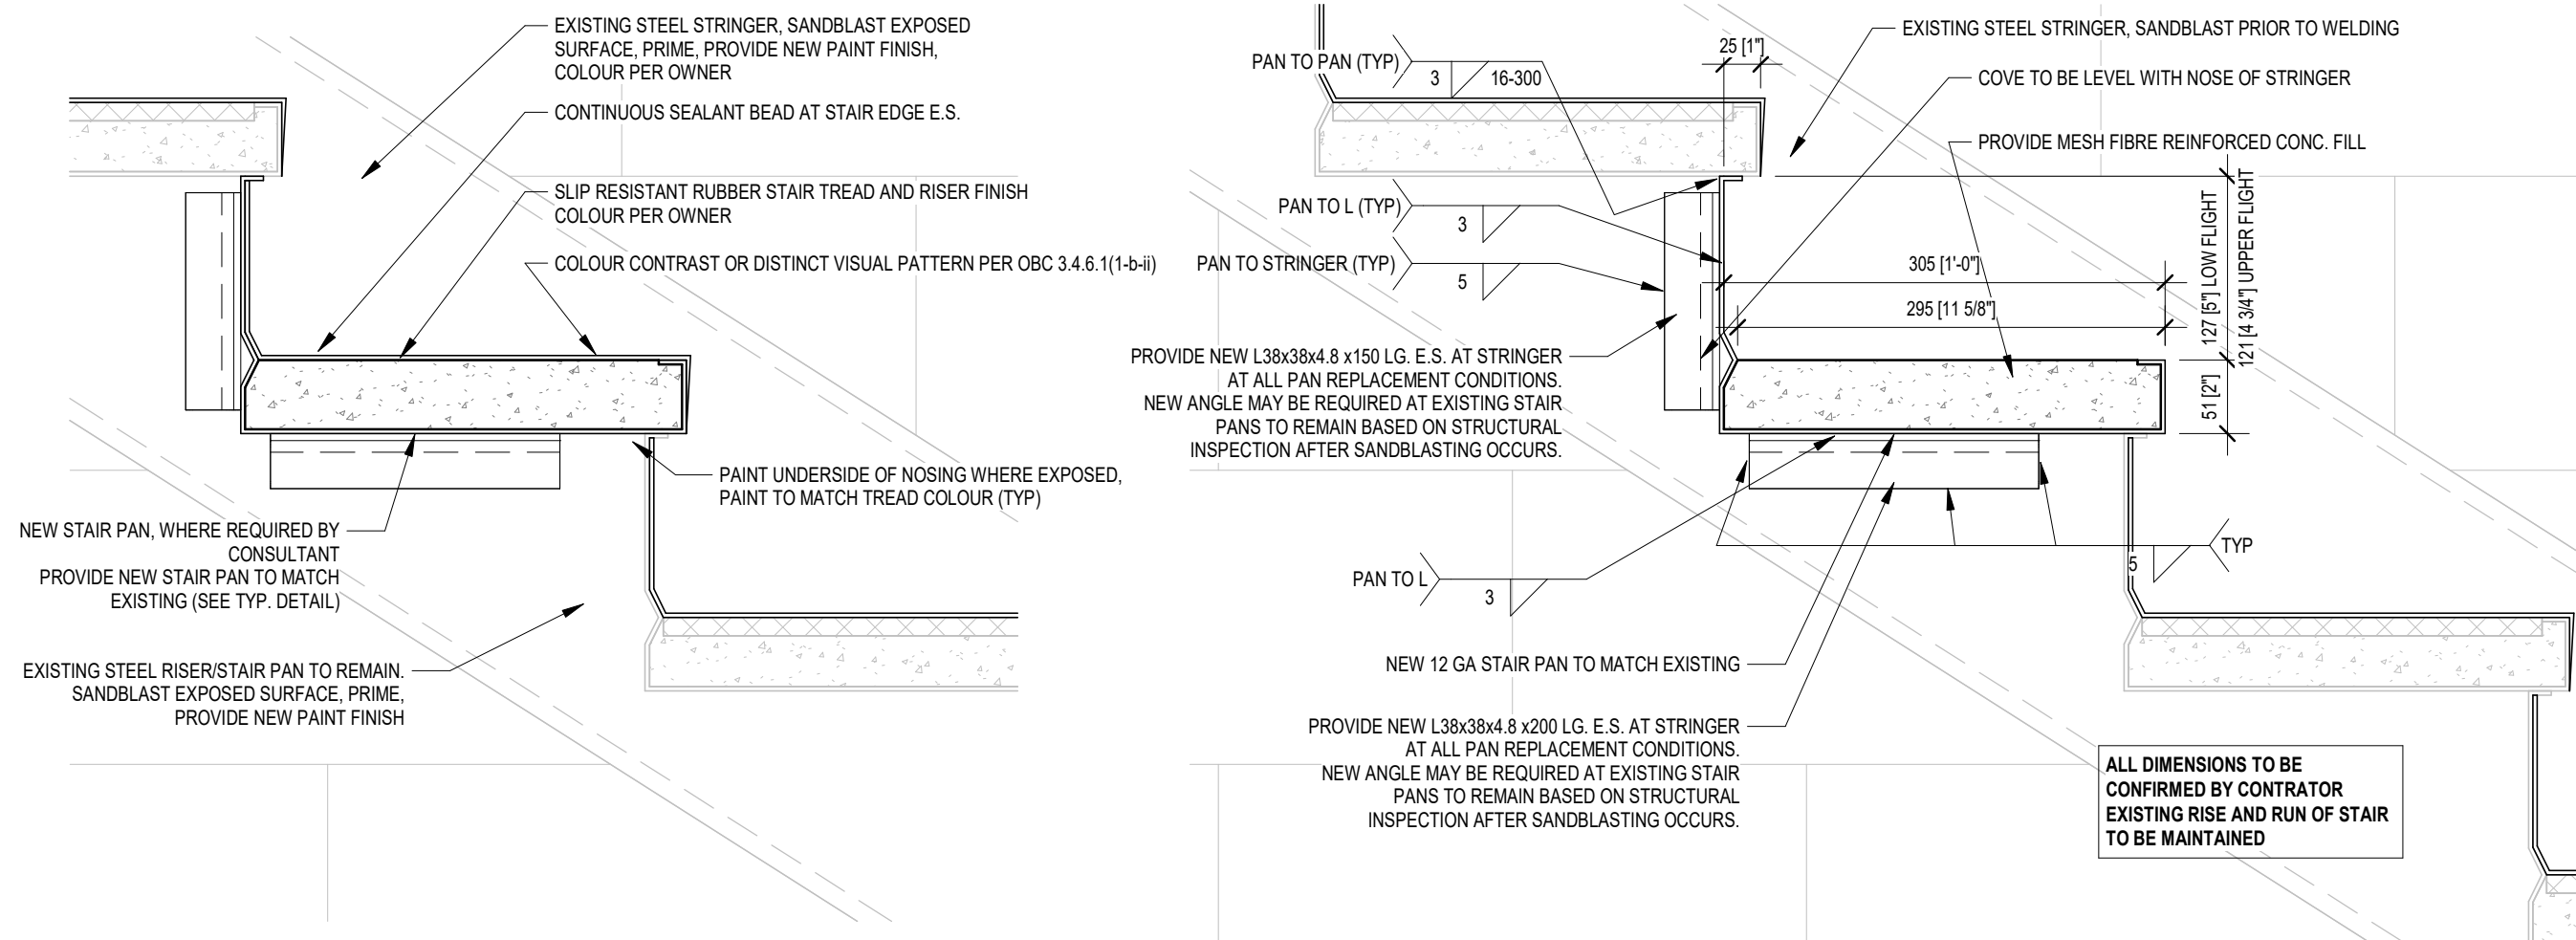
1 Typ Stair Covering
1 : 5

2 Typ Stair Pan Replacement
1 : 5

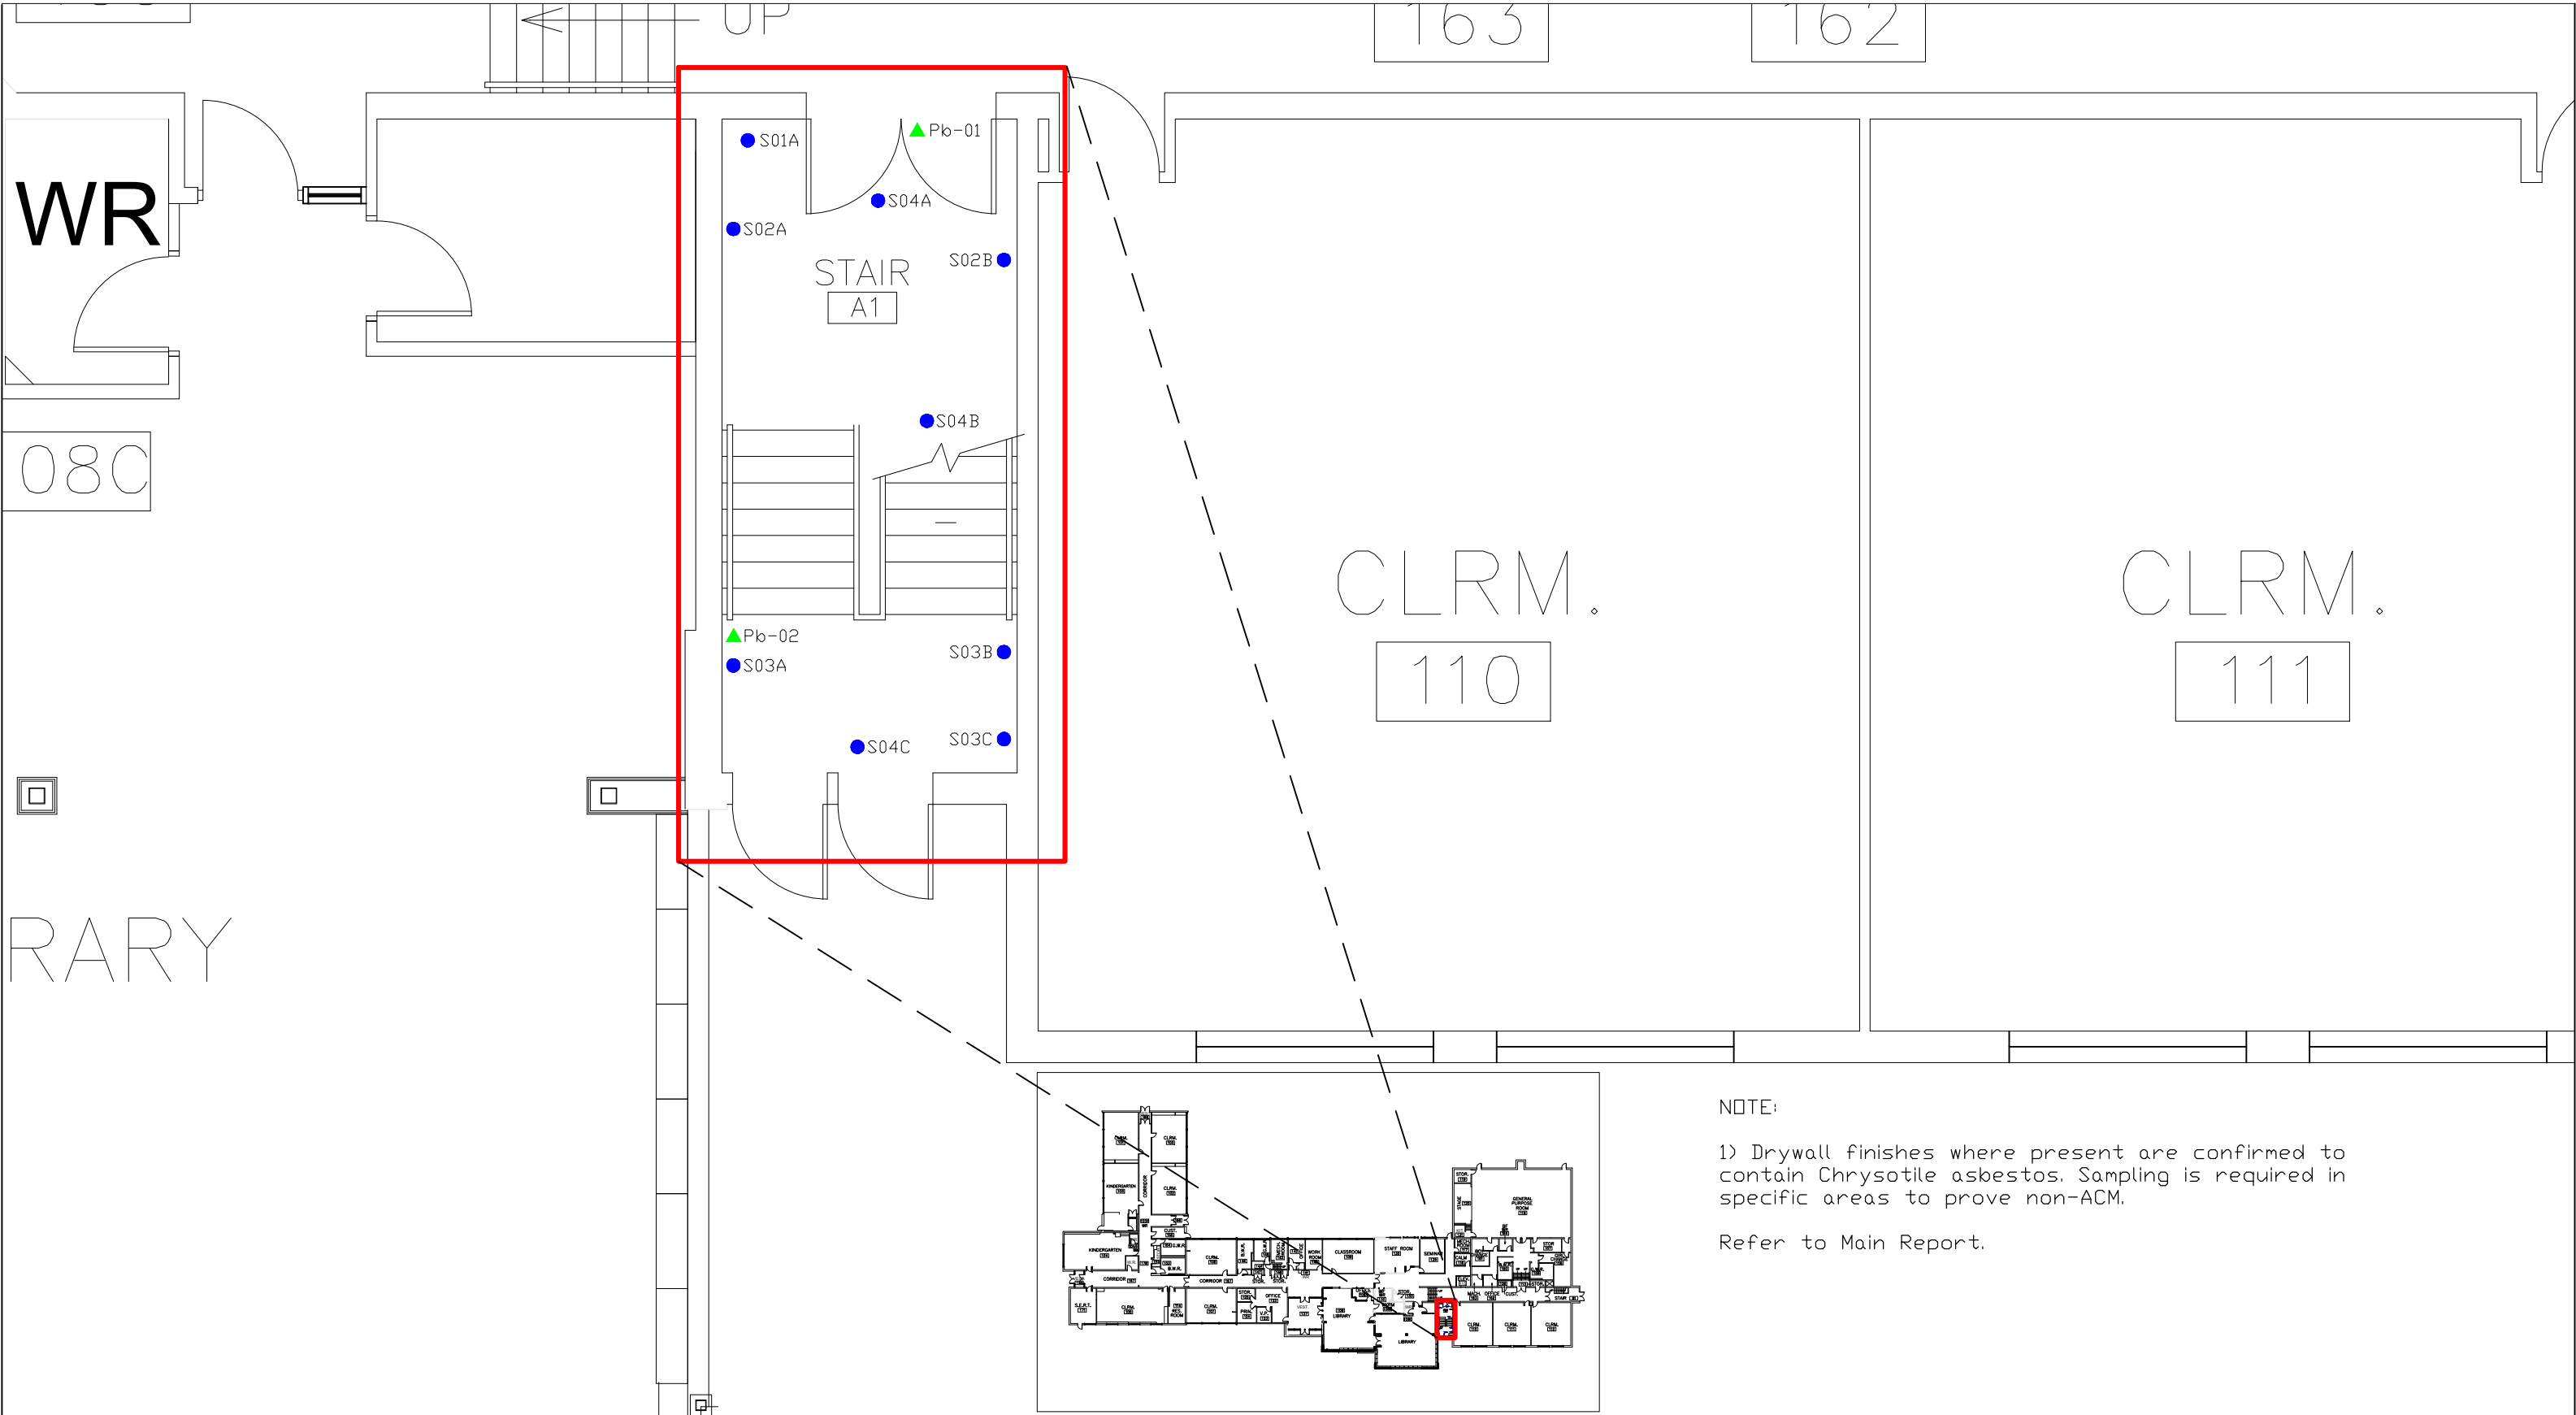
Site Drawing

1) Drywall finishes where present are confirmed to contain Chrysotile asbestos. Sampling is required in specific areas to prove non-ACM.
