ASBESTOS-CONTAINING BUILDING MATERIALS RE-ASSESSMENT REPORT

Haliburton Highlands Secondary School

5358 County Road #21
Haliburton, Ontario

September 2024

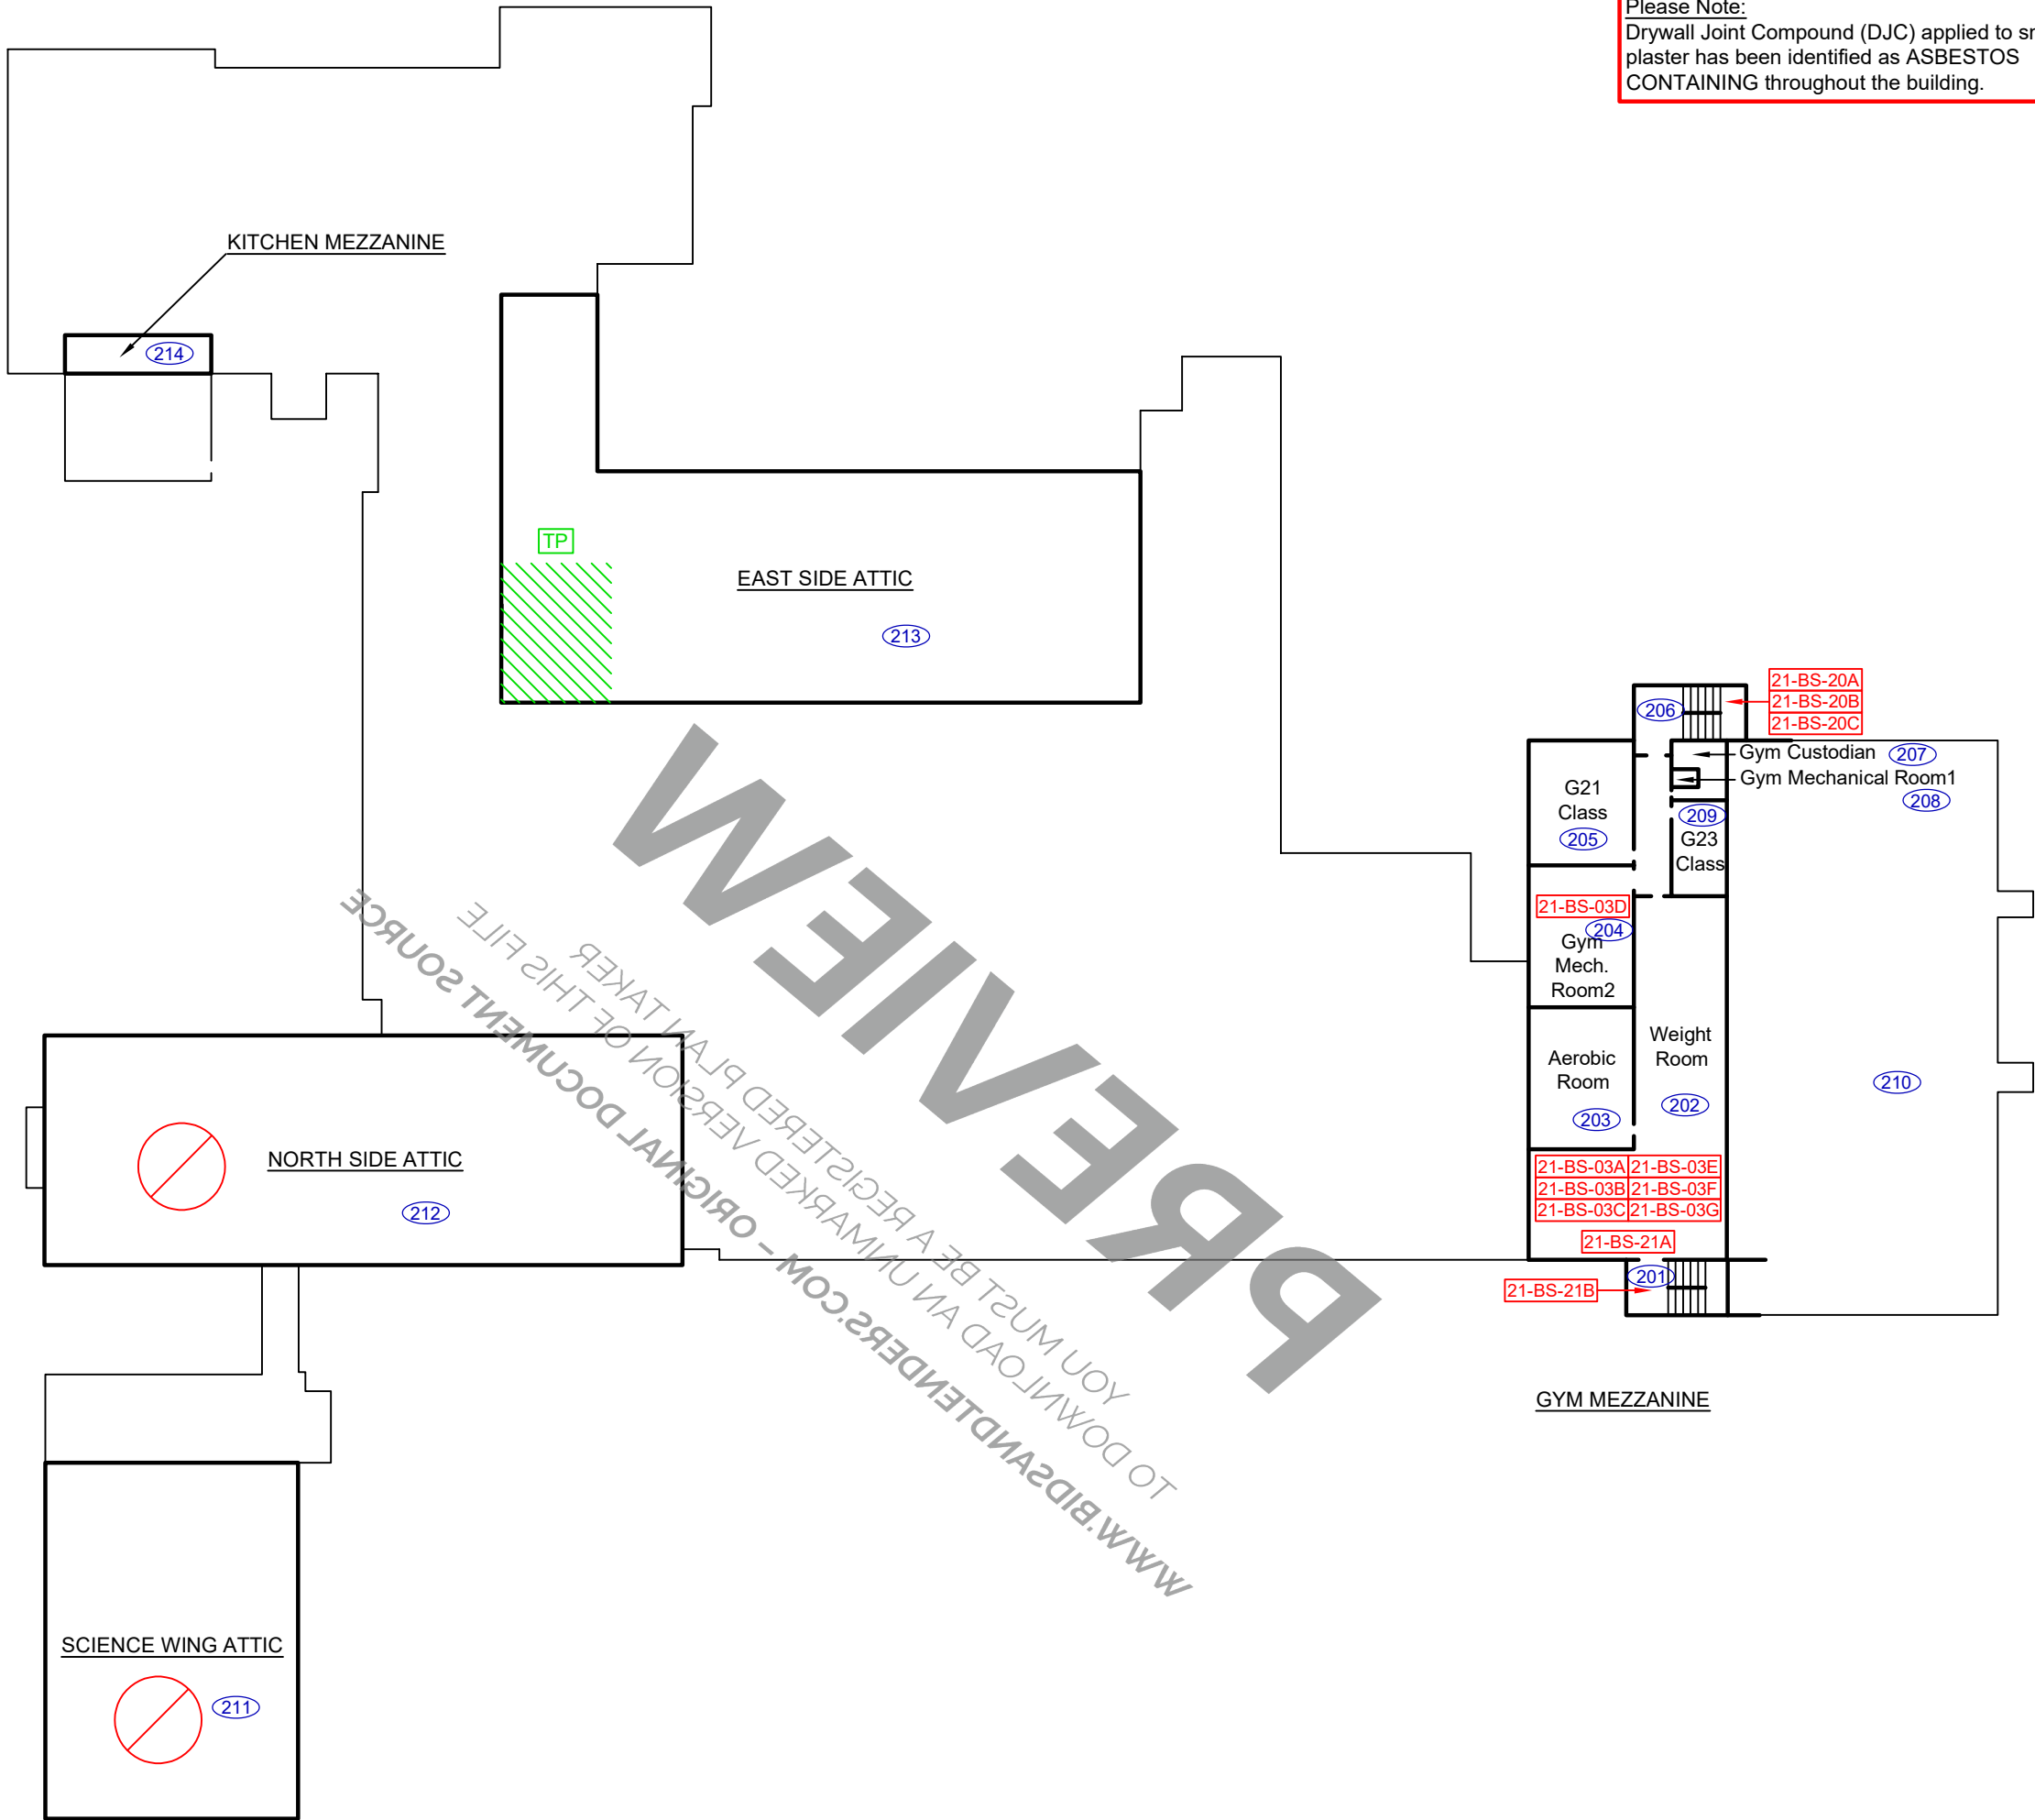
Please Note:
Drywall Joint Compound (DJC) applied to smooth
plaster has been identified as ASBESTOS
CONTAINING throughout the building.

- 01-BS-01A Jacques Whitford Sample Locations
- # Ebase Number
- ⊘ No Access

For Detailed Information as to Location, Type, Quantity, Condition and Access to ACM, Please Refer to the Room-by-Room Sheets Provided in the Report.
