DETAILED ASBESTOS-CONTAINING BUILDING MATERIALS SURVEY REPORT

**DURHAM DISTRICT SCHOOL BOARD
VAUGHAN WILLARD PUBLIC SCHOOL
1911 DIXIE ROAD NORTH
PICKERING, ONTARIO**

Maple Project No. 16312-096

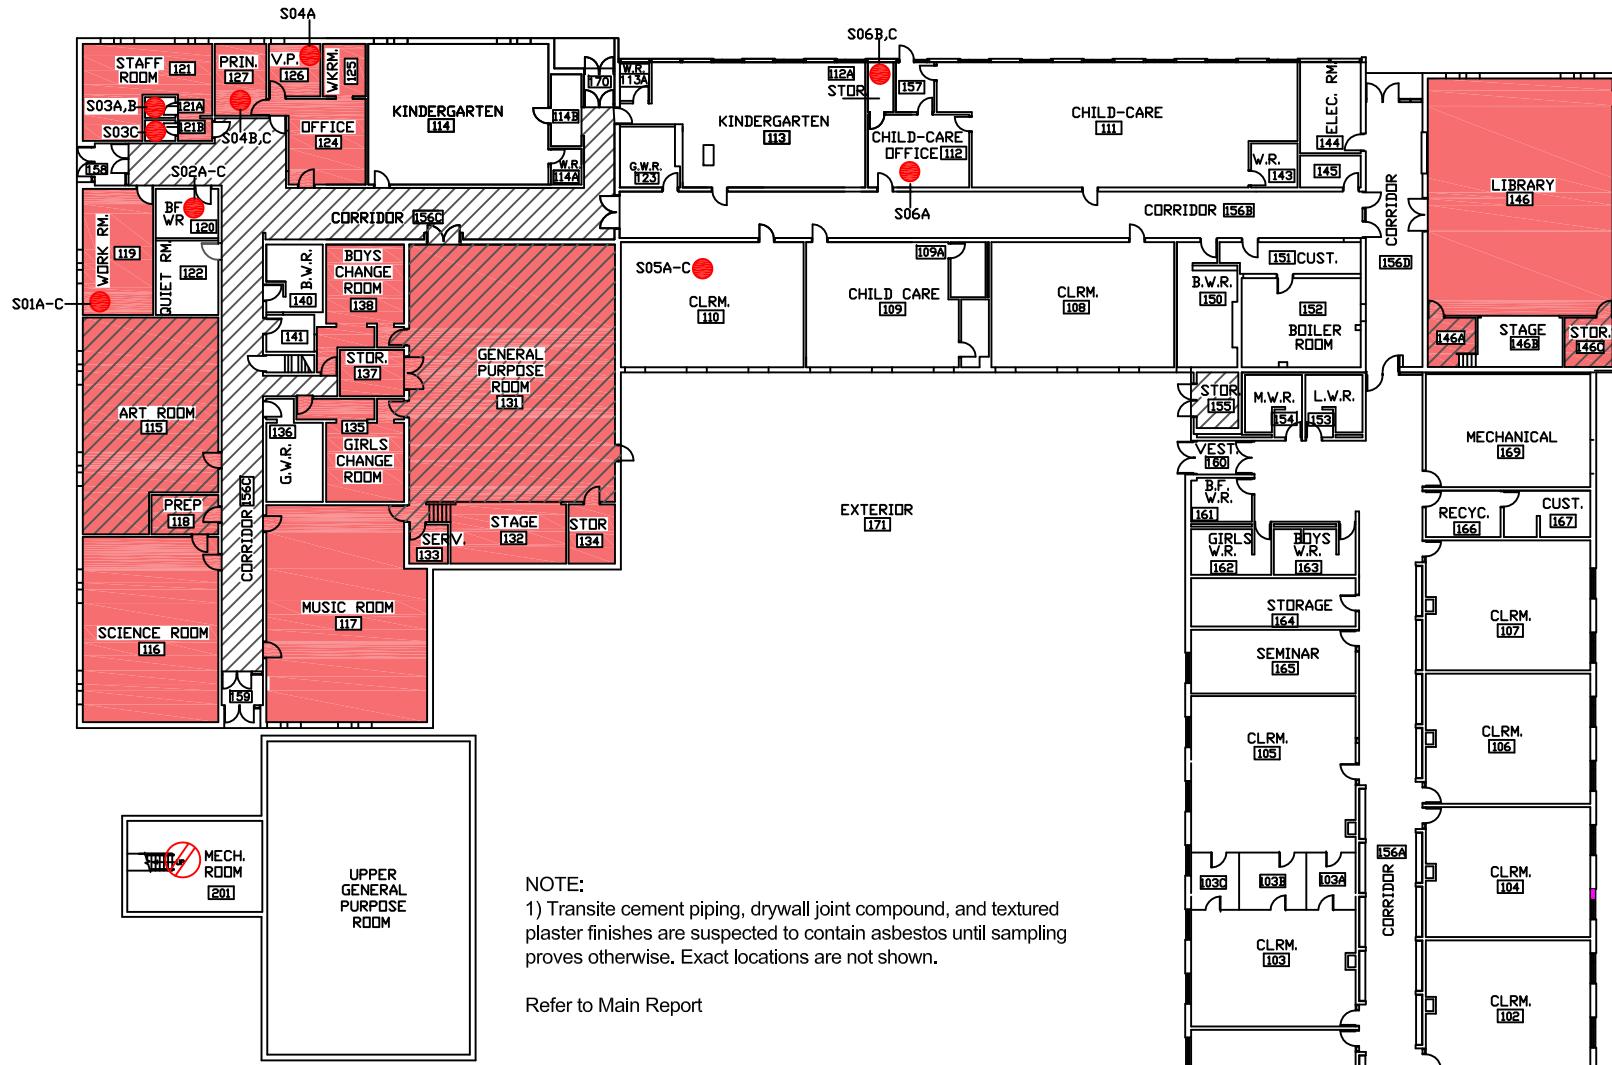
SAMPLE LOCATIONS		CONFIRMED & SUSPECTED ACM	
SYMBOL	DESCRIPTION	SYMBOL	DESCRIPTION
●	ASBESTOS BULK SAMPLE: 16312-096 S-##	■	VINYL FLOOR TILE
■	NO ACCESS	■	MECHANICAL INSULATIONS
●		■	TRANSITE, DRYWALL JOINT COMPOUND, & TEXTURED PLASTER
■			NOTE
