## Addendum No. 1

| <b>Project Name:</b> | <b>DDSB Dunbarton HS</b> | <b>Date:</b> | <b>January 23, 2026</b> |
| <b>Description:</b> | <b>Steam Decommissioning</b> | <b>From:</b> | <b>Brad Timson<br/>Sabastien Snow</b> |

# Limited Designated Substance Survey Report

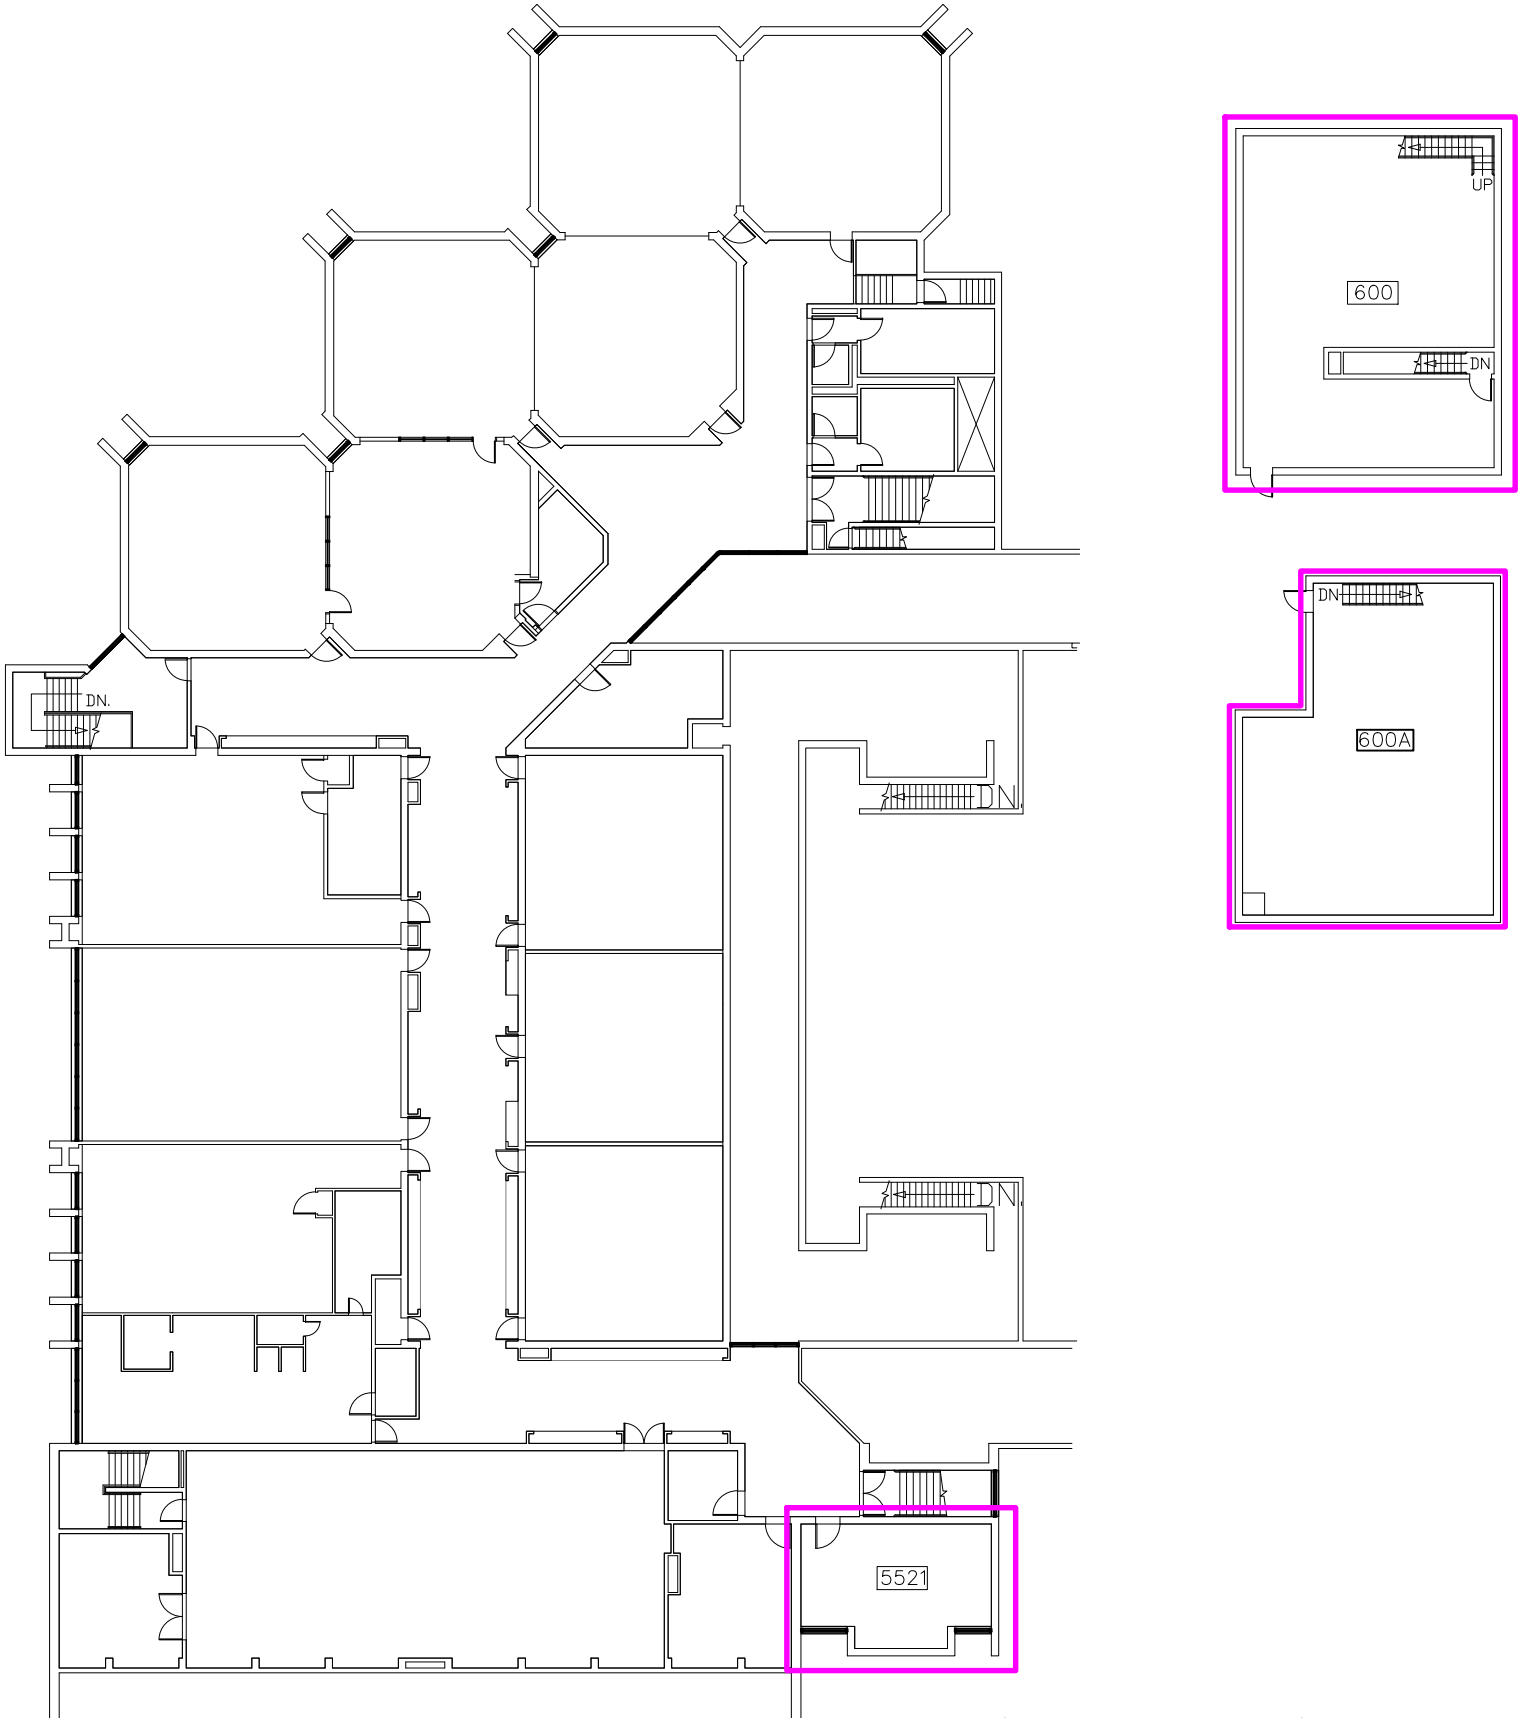
- 1) Drywall finishes where present within the 1959 Original Building Survey Area, 1962 & 1968 Building Addition Survey Areas are confirmed to contain Chrysotile asbestos. Sampling is required in specific areas to prove non-ACM.
- 2) Primer applied to masonry block and brick finishes within the 1959 Original Building Survey Area and 1962 Building Addition Survey Area is confirmed to contain Chrysotile asbestos. Sampling is required in specific areas to prove non-ACM.
- 3) Caulking applied to concrete deck panels where present is confirmed to contain Chrysotile asbestos.
- 4.) Flexible duct connectors are suspected to contain asbestos. Sampling of the materials is required to prove them non-ACM.
- 5) Flooring finishes were not included as part of the current assessment. Should flooring finishes require disturbance, it is recommended to sample the materials to prove non-ACM.

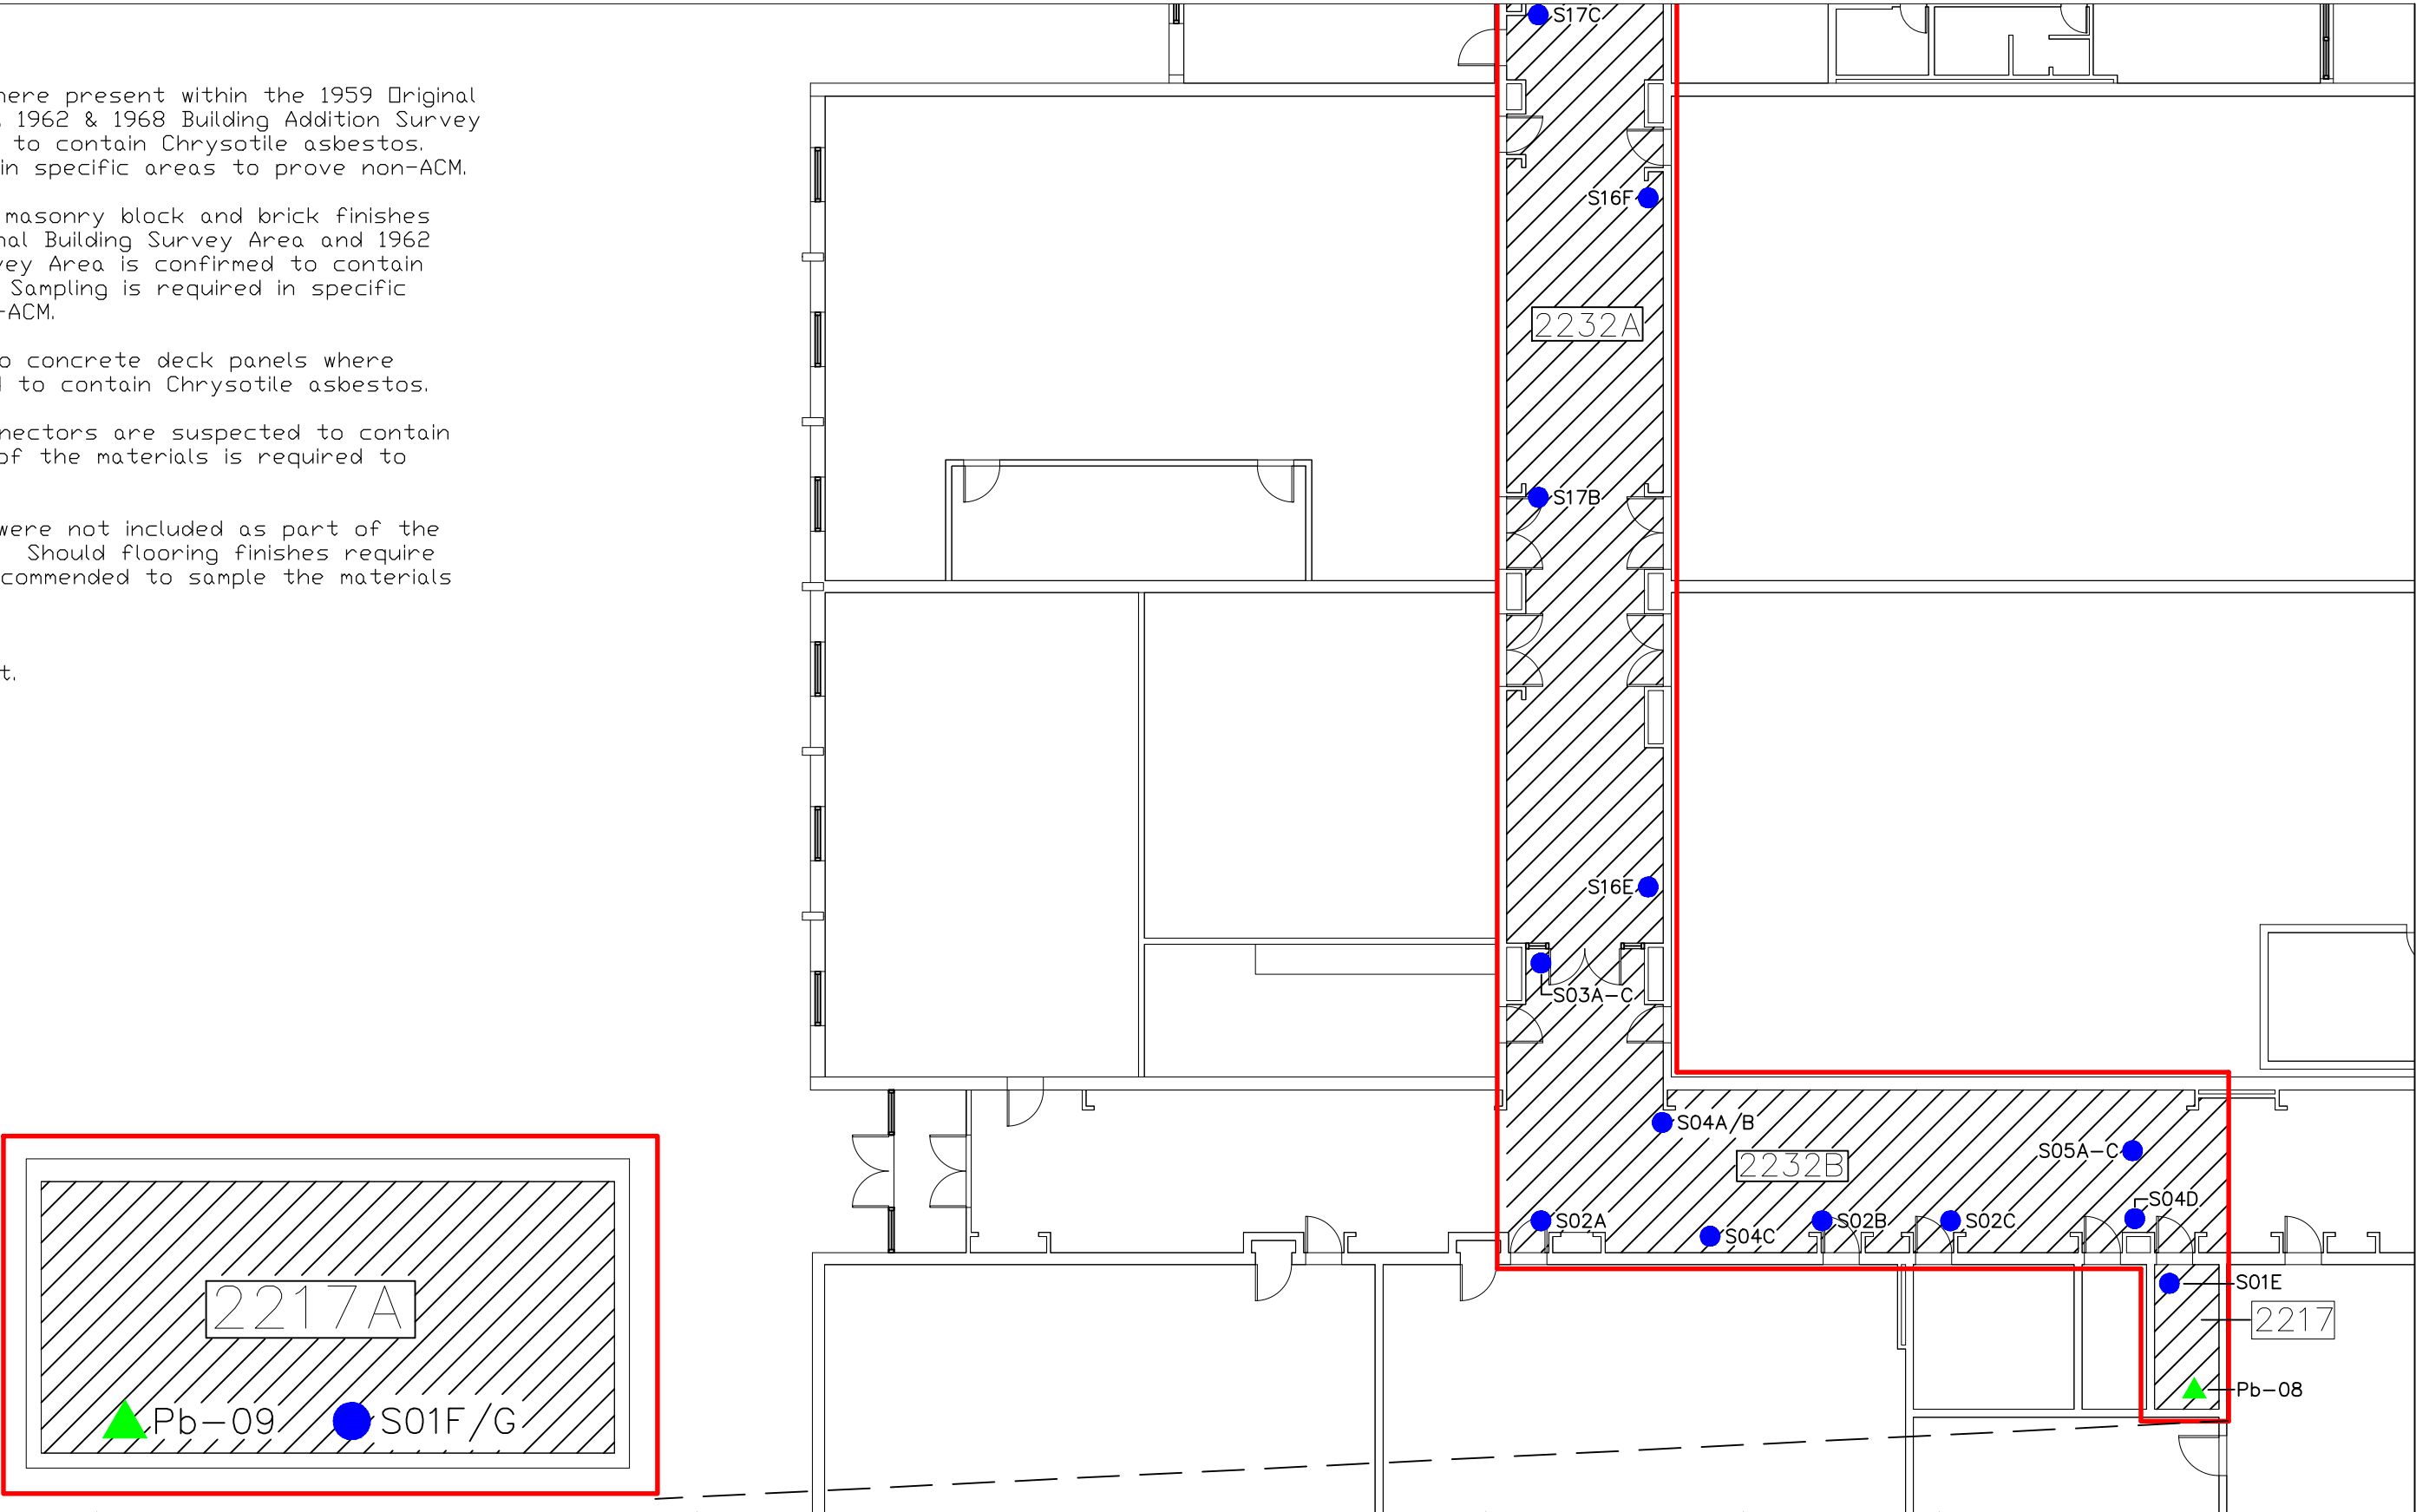
NOTE:

1) Drywall finishes where present within the 1959 Original Building Survey Area, 1962 & 1968 Building Addition Survey Areas are confirmed to contain Chrysotile asbestos. Sampling is required in specific areas to prove non-ACM.

5) Flooring finishes were not included as part of the current assessment. Should flooring finishes require disturbance, it is recommended to sample the materials to prove non-ACM.

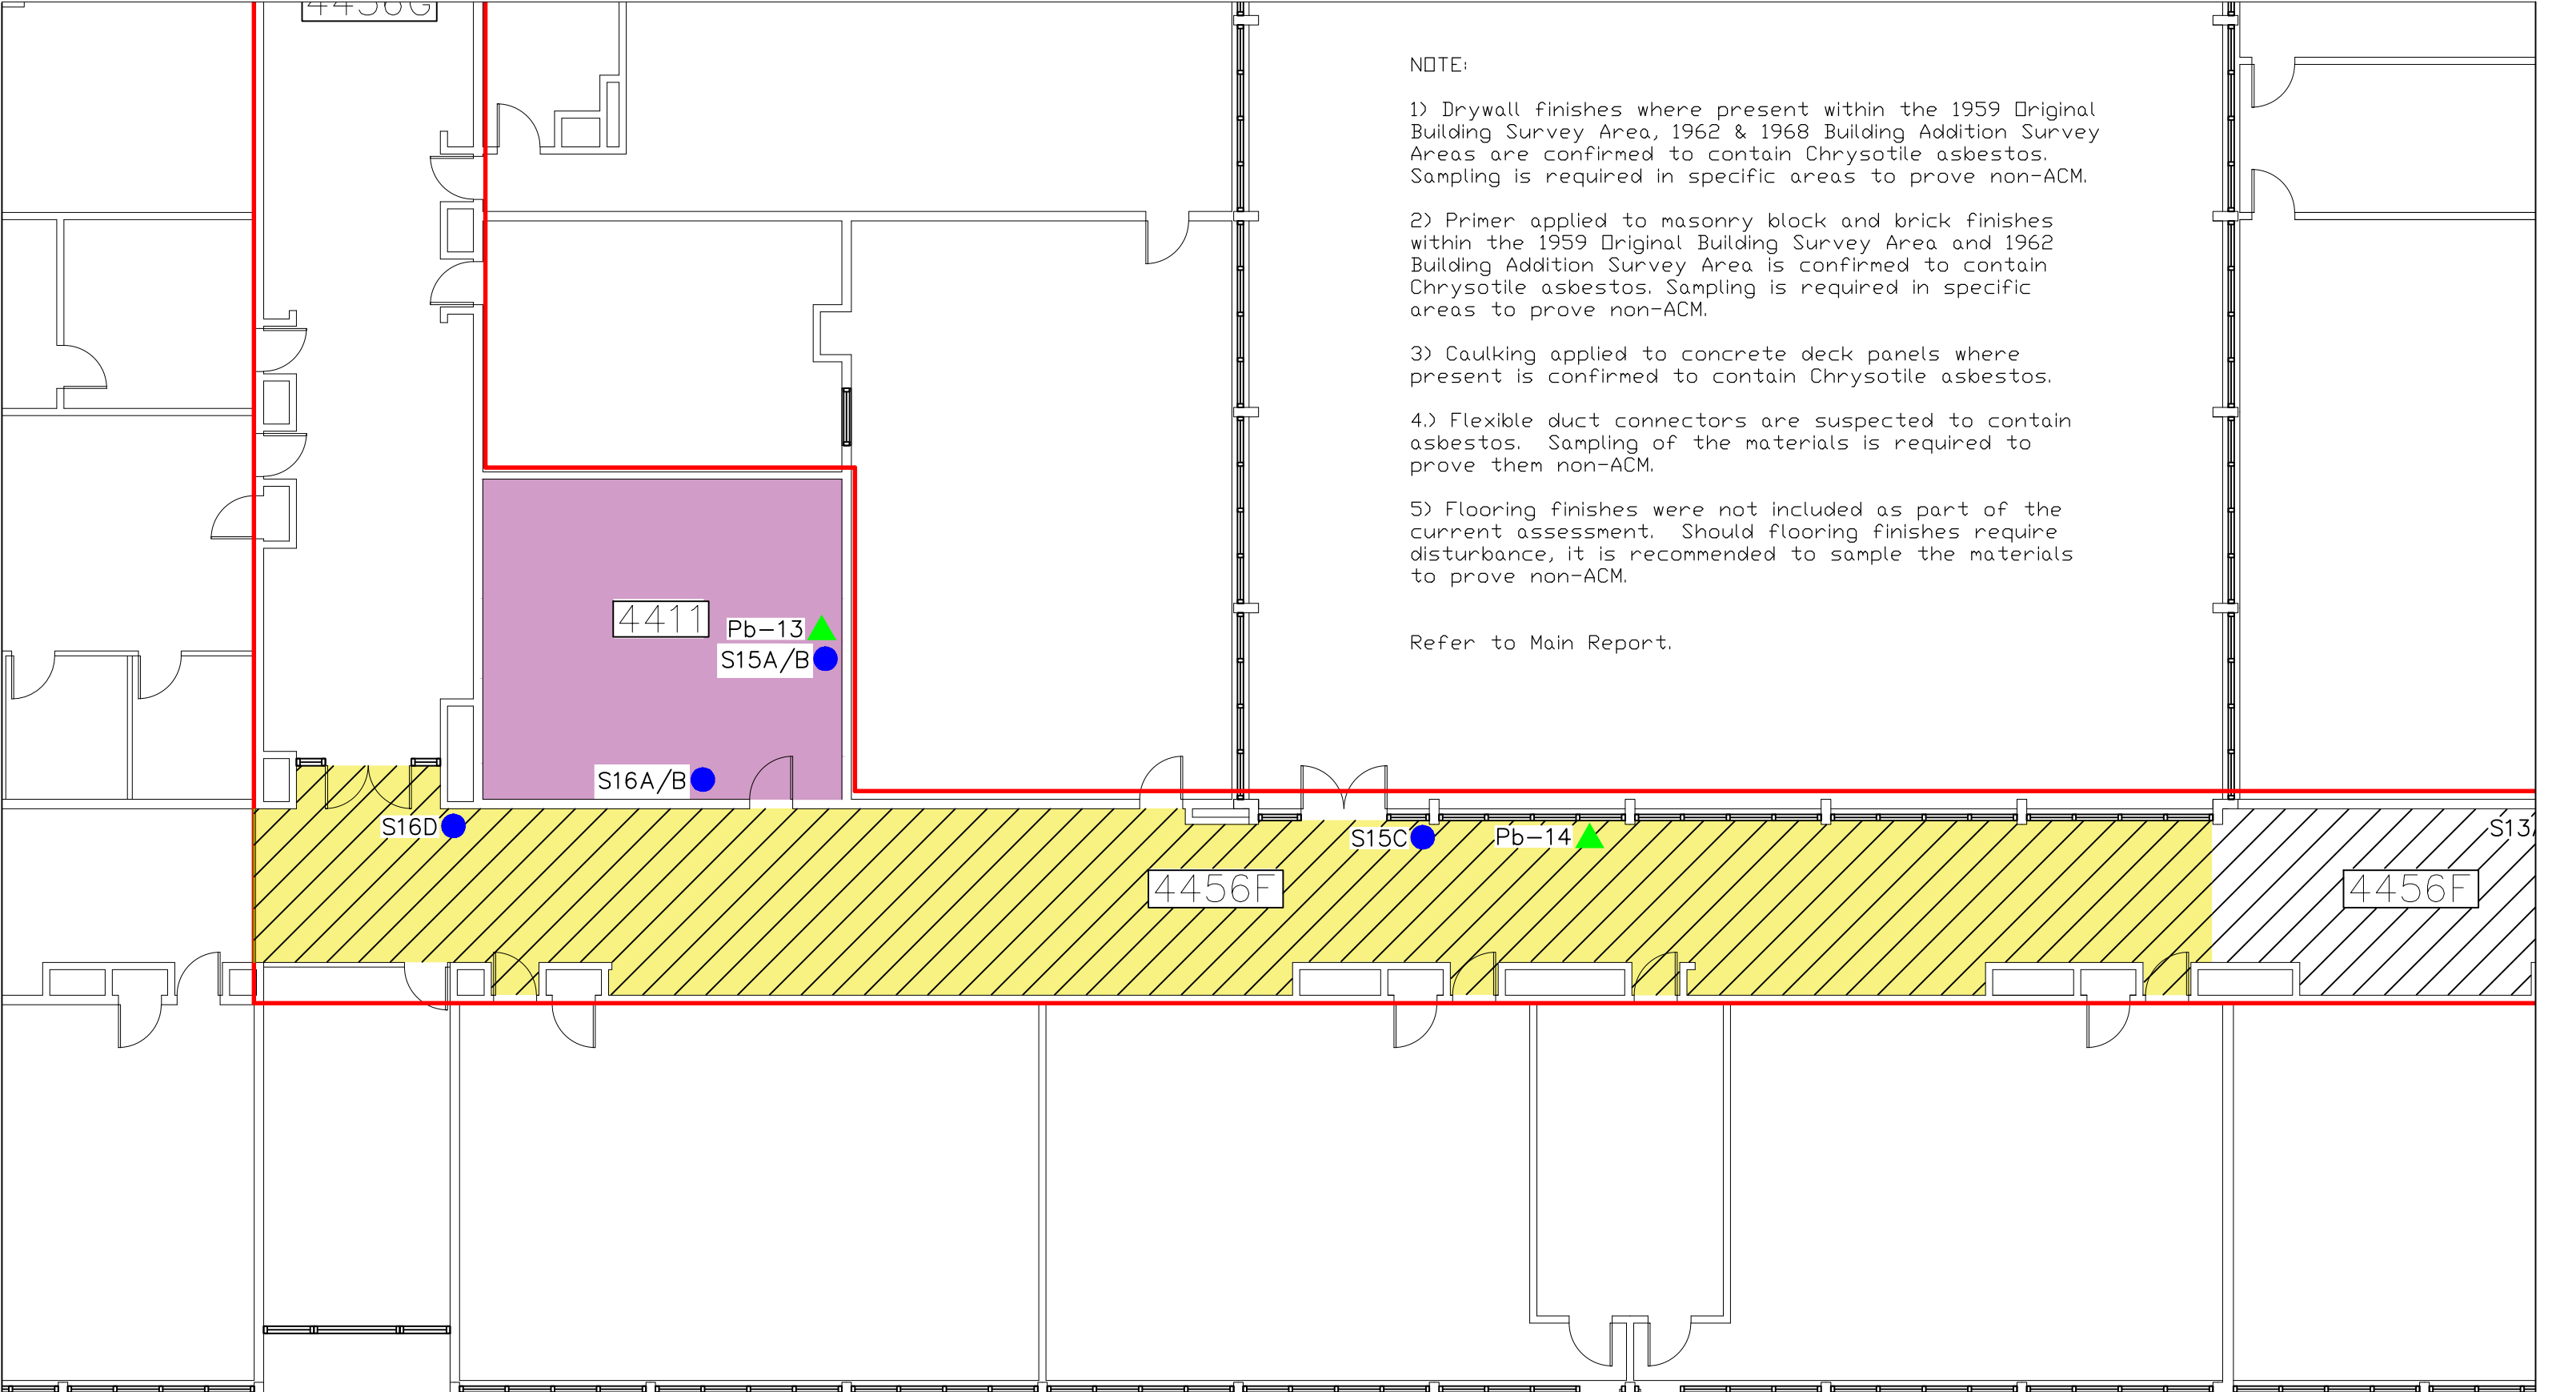
NOTE:

- 1) Drywall finishes where present within the 1959 Original Building Survey Area, 1962 & 1968 Building Addition Survey Areas are confirmed to contain Chrysotile asbestos. Sampling is required in specific areas to prove non-ACM.
- 2) Primer applied to masonry block and brick finishes within the 1959 Original Building Survey Area and 1962 Building Addition Survey Area is confirmed to contain Chrysotile asbestos. Sampling is required in specific areas to prove non-ACM.
- 3) Caulking applied to concrete deck panels where present is confirmed to contain Chrysotile asbestos.
- 4.) Flexible duct connectors are suspected to contain asbestos. Sampling of the materials is required to prove them non-ACM.
- 5) Flooring finishes were not included as part of the current assessment. Should flooring finishes require disturbance, it is recommended to sample the materials to prove non-ACM.

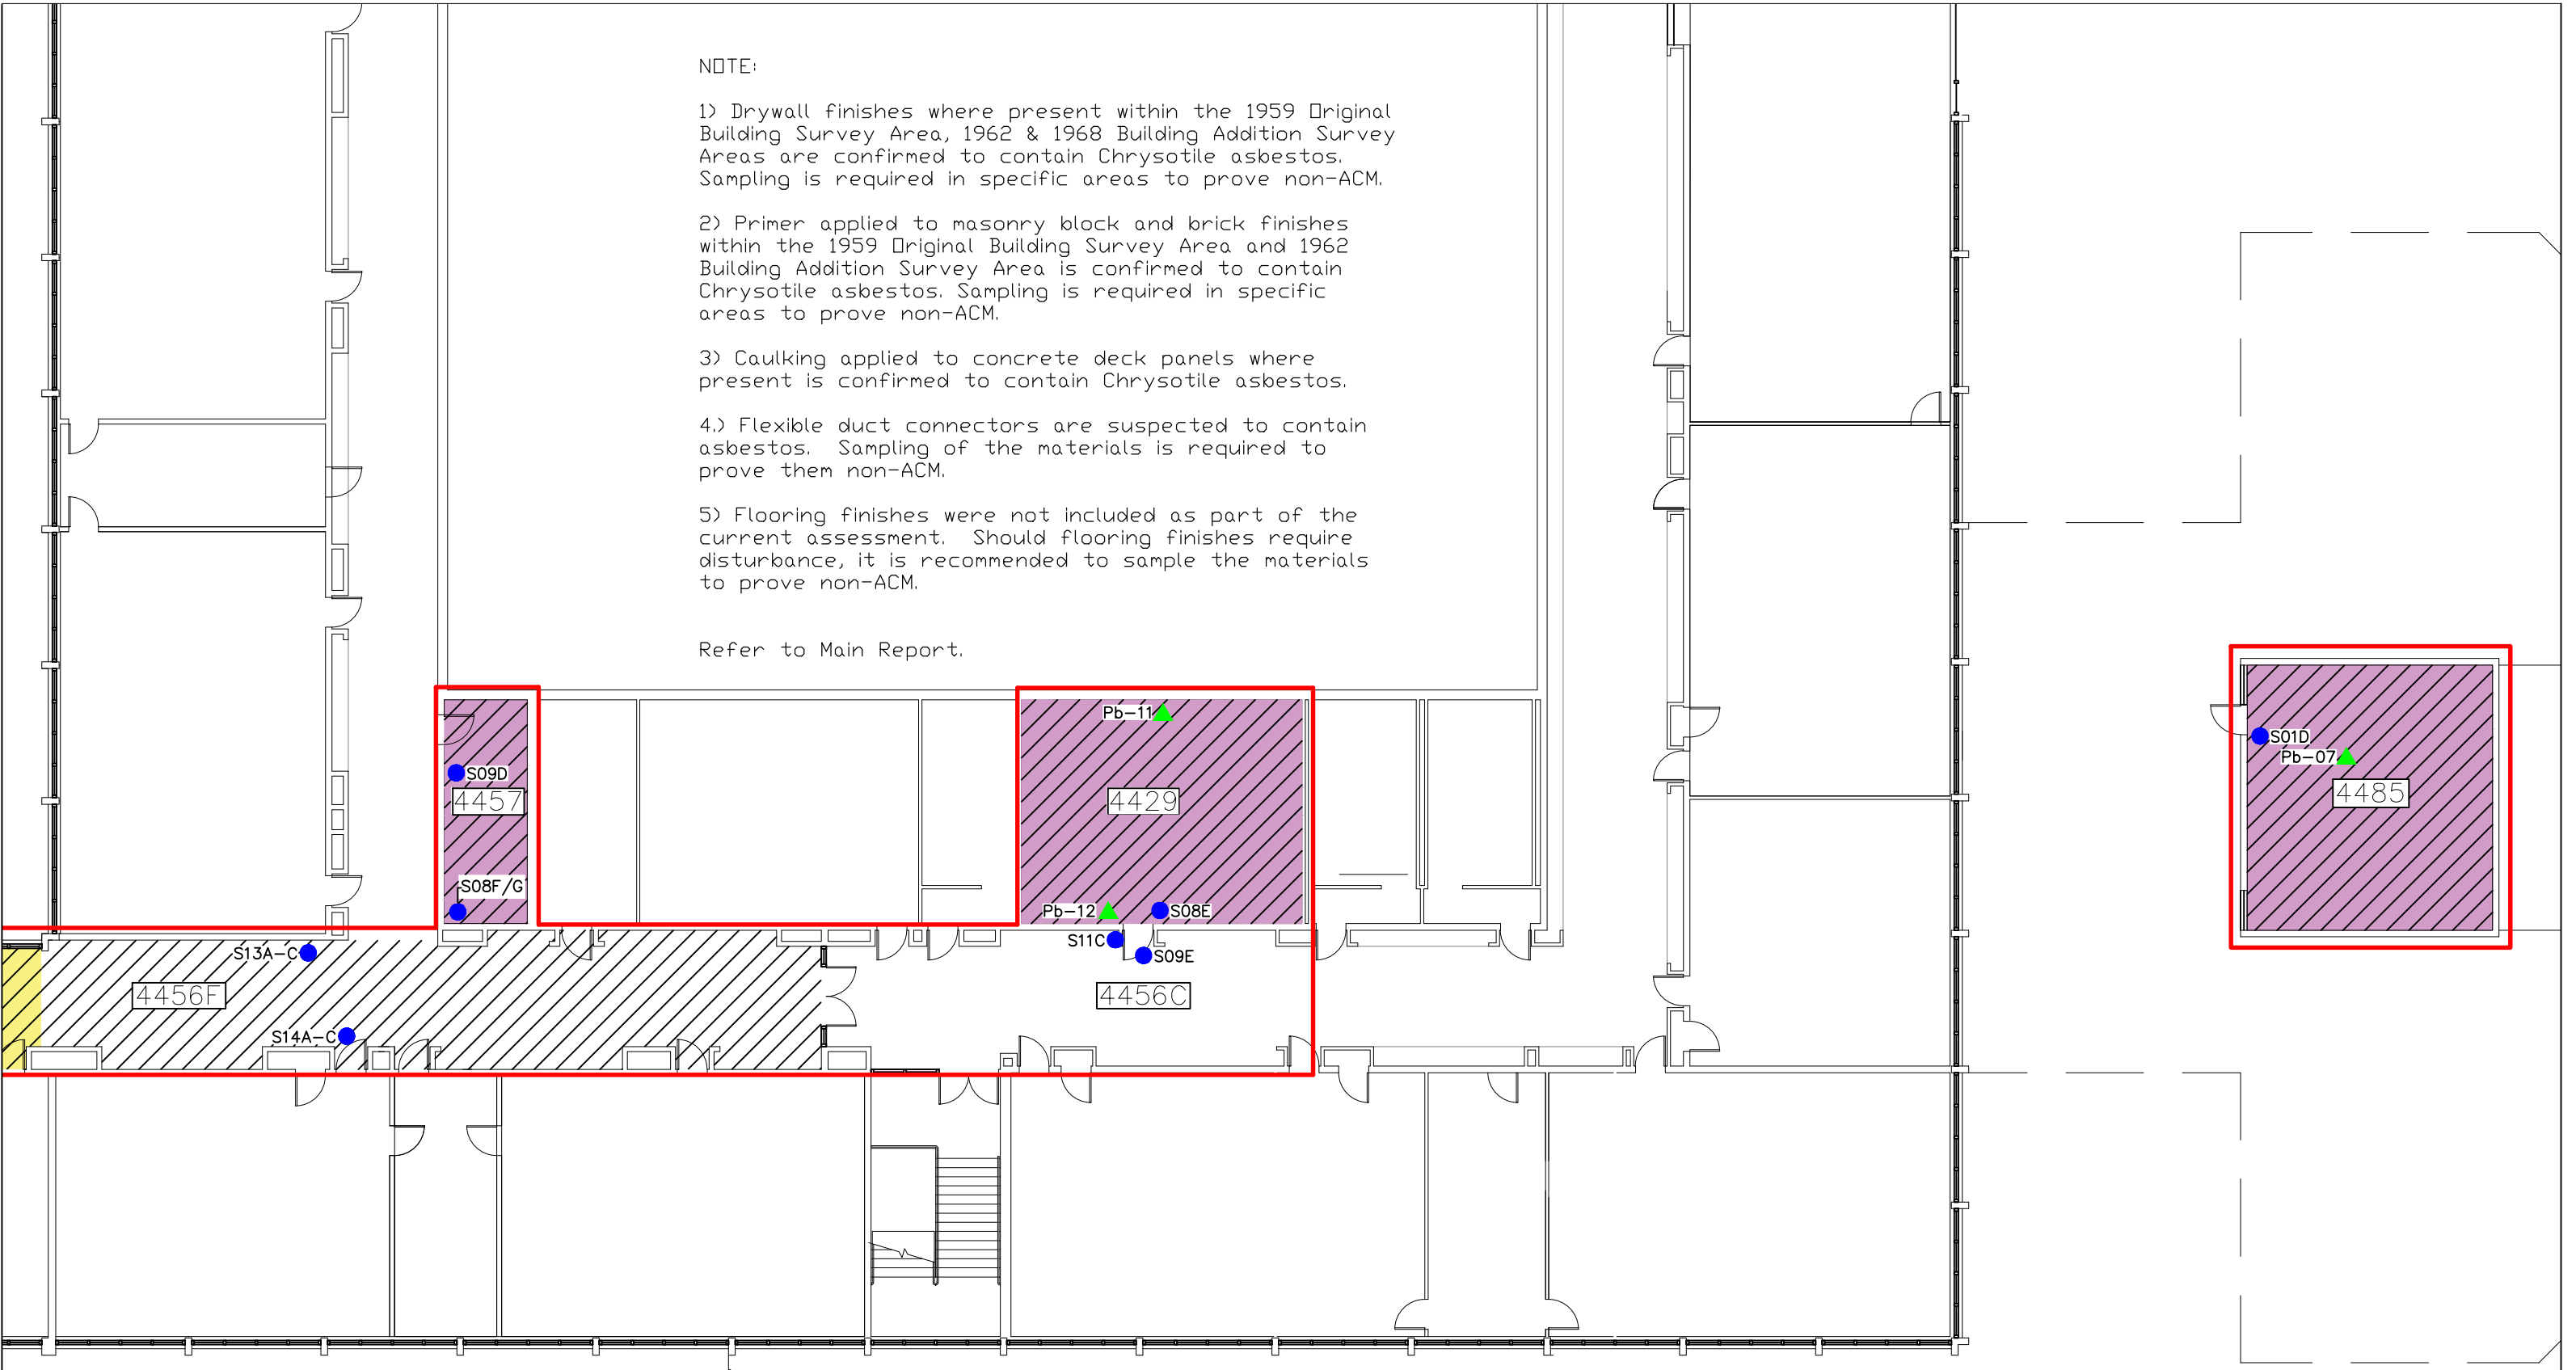
- 1) Drywall finishes where present within the 1959 Original Building Survey Area, 1962 & 1968 Building Addition Survey Areas are confirmed to contain Chrysotile asbestos. Sampling is required in specific areas to prove non-ACM.
- 2) Primer applied to masonry block and brick finishes within the 1959 Original Building Survey Area and 1962 Building Addition Survey Area is confirmed to contain Chrysotile asbestos. Sampling is required in specific areas to prove non-ACM.
- 3) Caulking applied to concrete deck panels where present is confirmed to contain Chrysotile asbestos.
- 4.) Flexible duct connectors are suspected to contain asbestos. Sampling of the materials is required to prove them non-ACM.
- 5) Flooring finishes were not included as part of the current assessment. Should flooring finishes require disturbance, it is recommended to sample the materials to prove non-ACM.

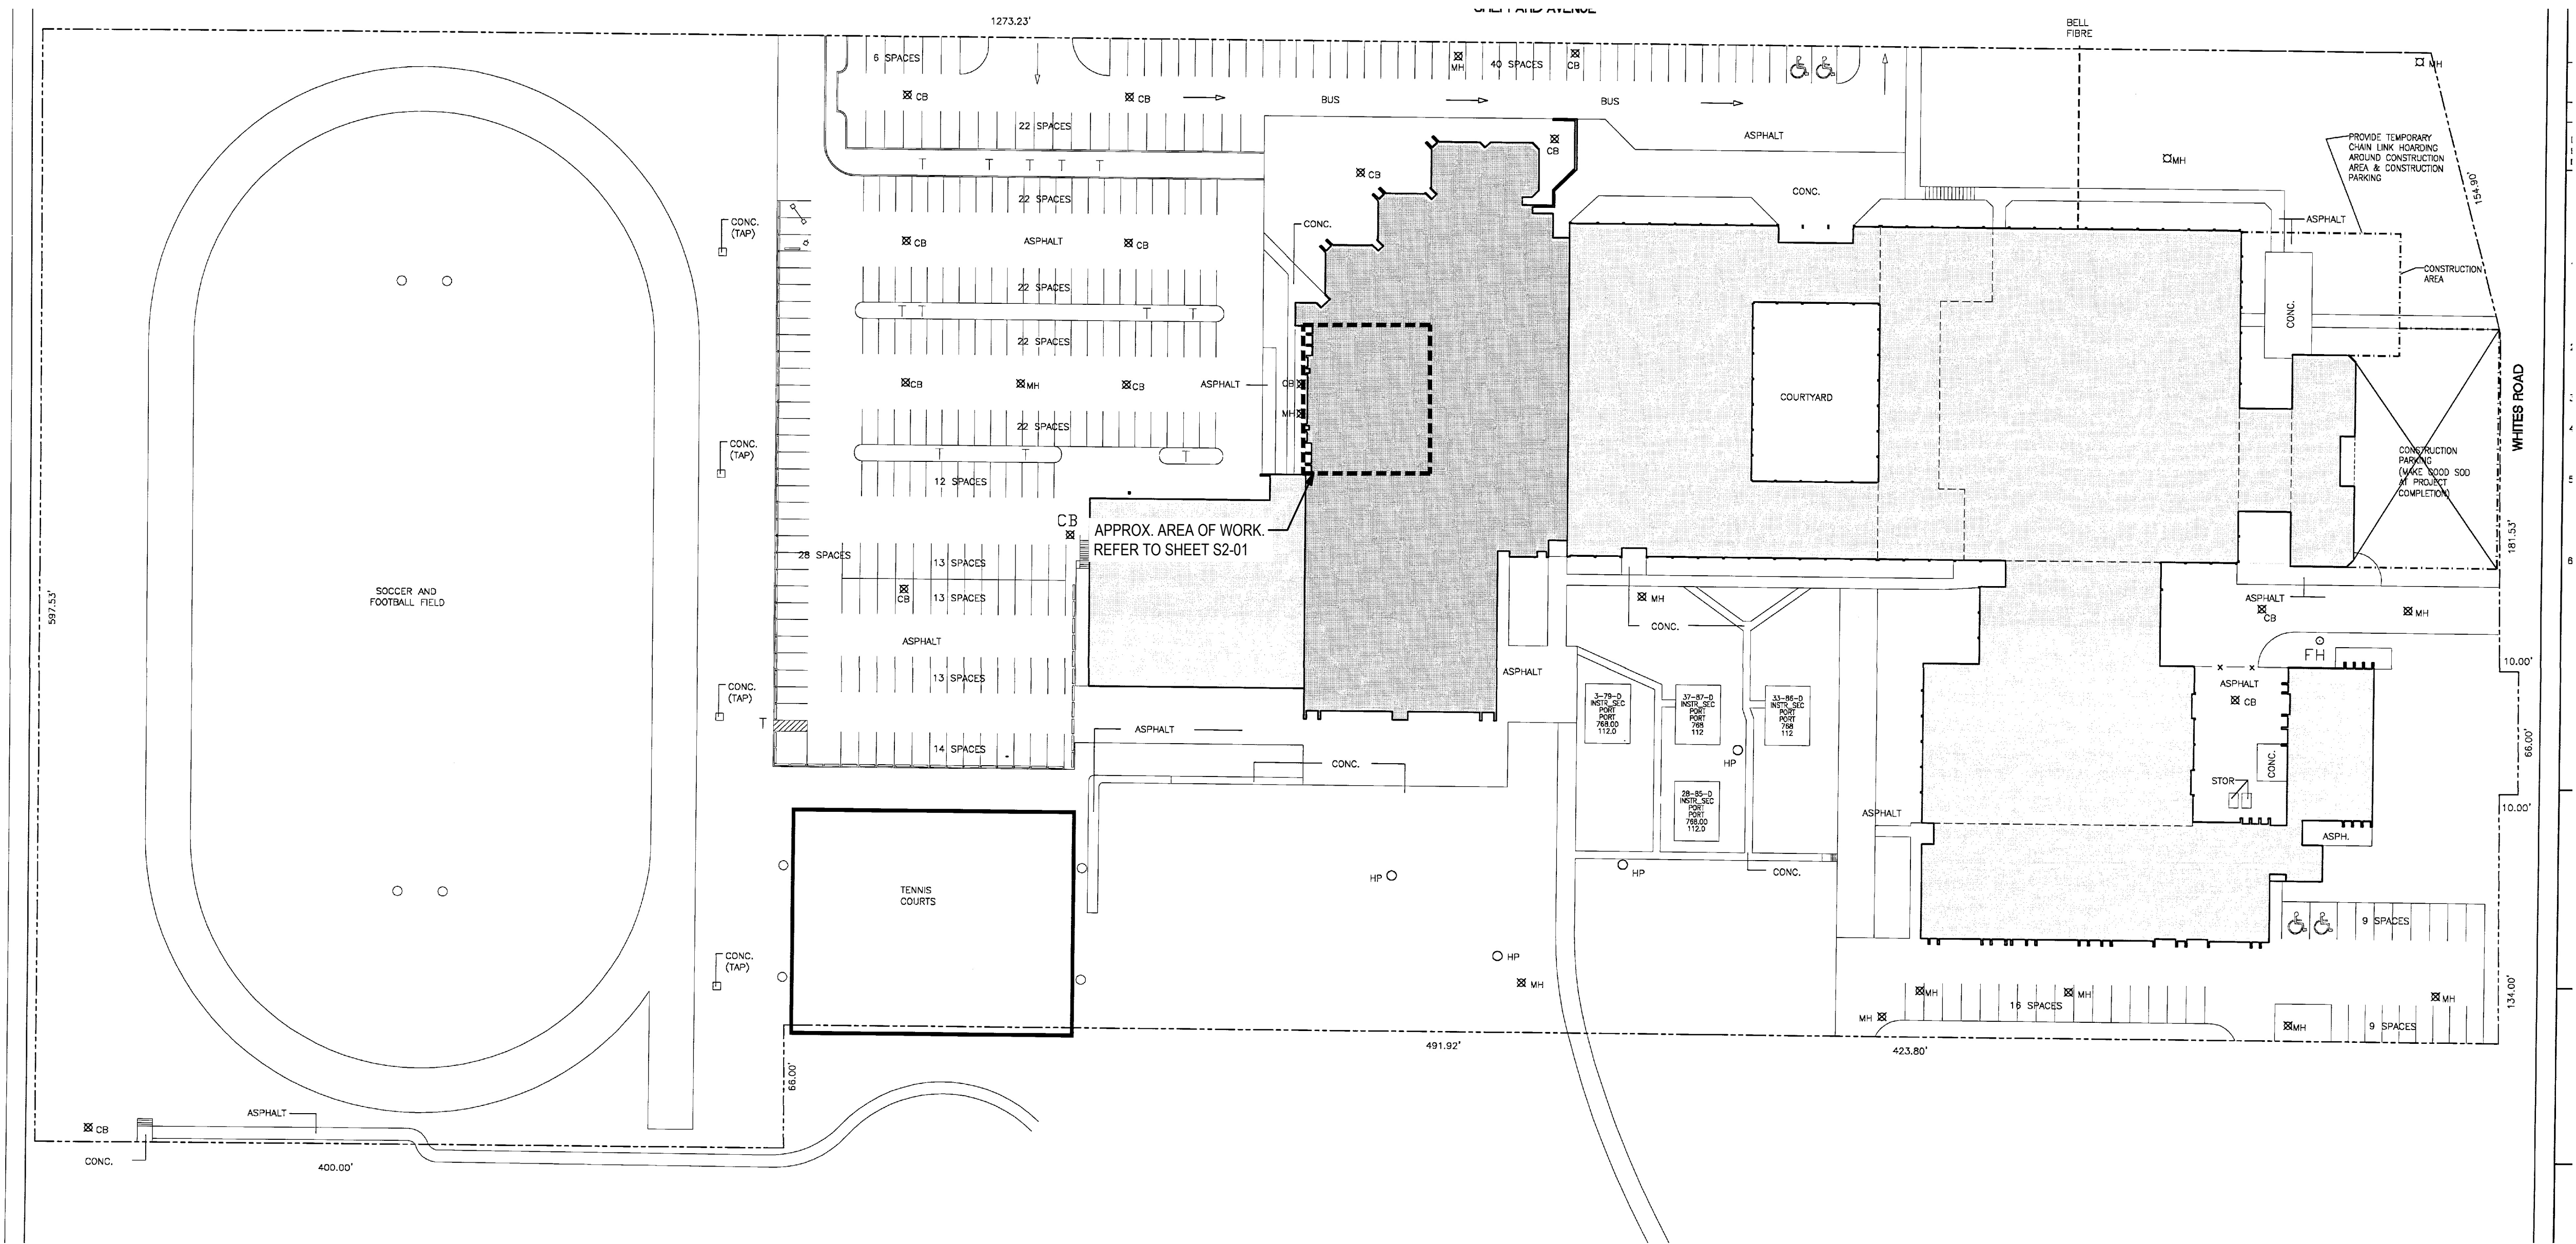
1. SITE PLAN FROM ARCHITECTURAL DRAWING A1-0 "OVERALL SITE PLAN" PREPARED BY KINGSLAND + ARCHITECTS INC DATED MAY 12, 2008 PROVIDED FOR REFERENCE PURPOSES ONLY.

- **Structural Drawing S1-01 Site Plan (1 - 24x36")**
- **Structural Drawing S2-01 Upper-Level Precast Double-Tee Slab Restoration Plan and Details (1 - 24x36")**

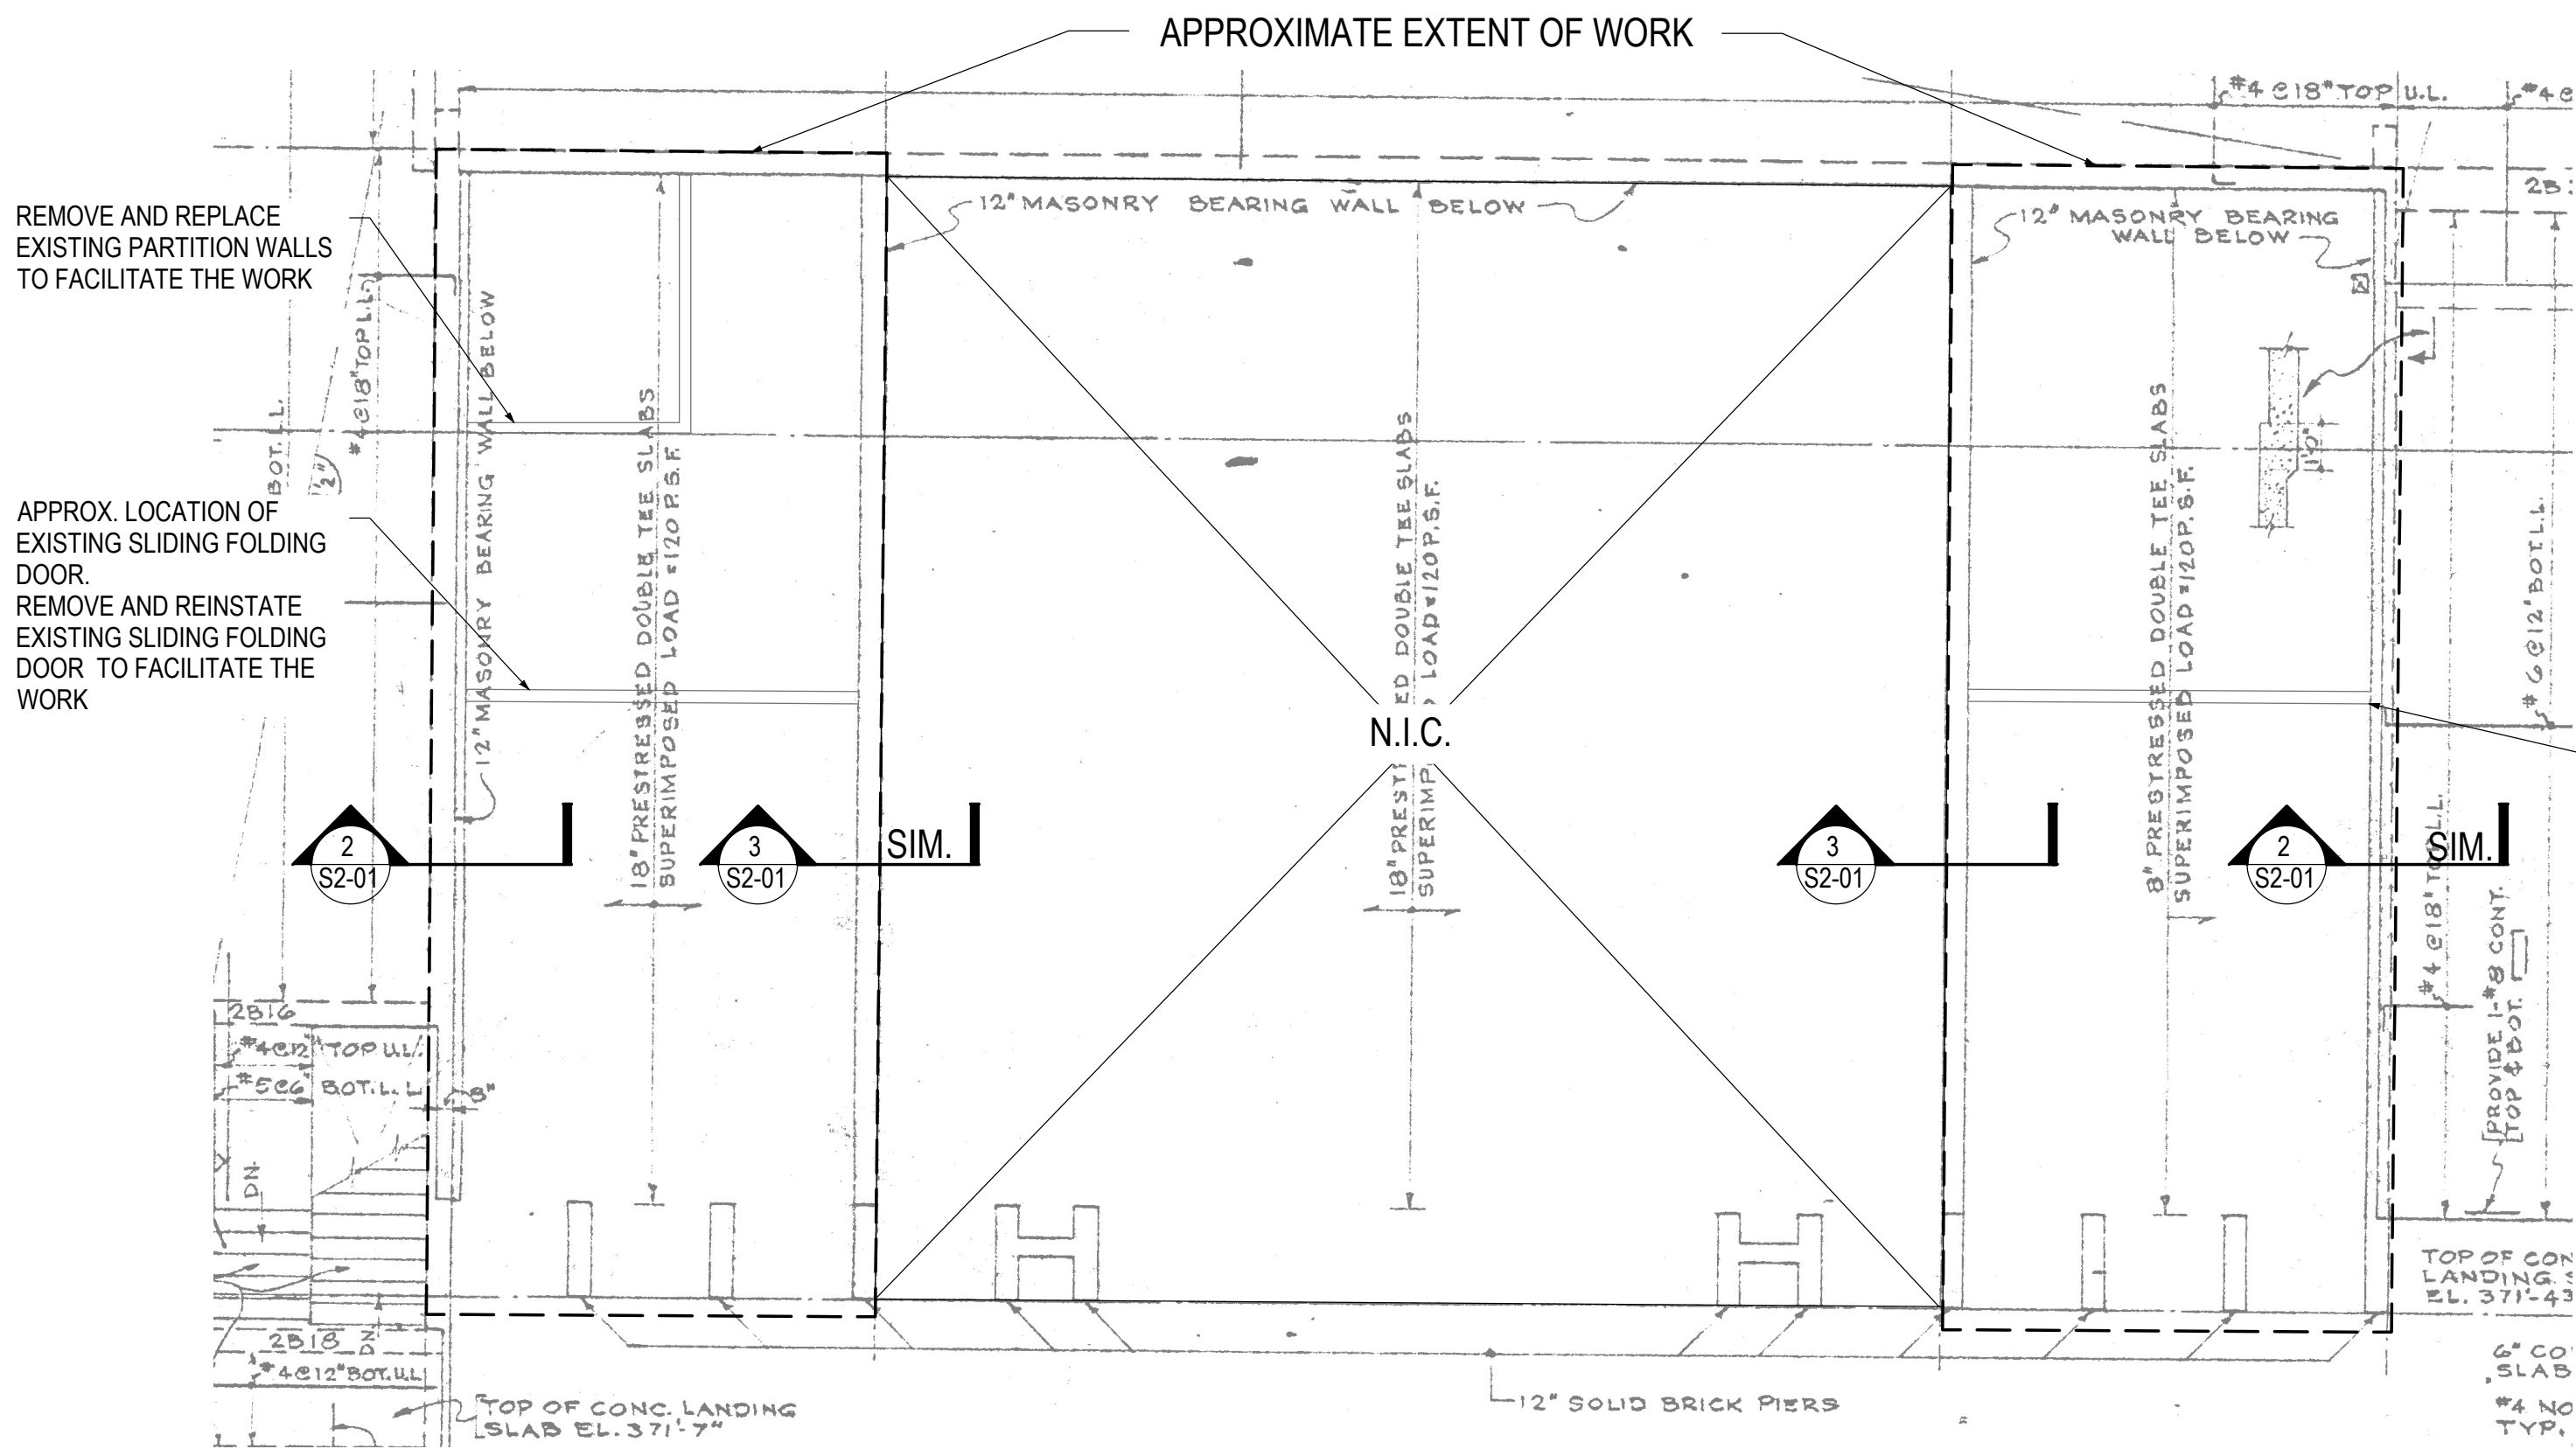
1 UPPER-LEVEL COMPUTER ROOMS PRECAST DOUBLE-TEE RESTORATION PLAN  
N.T.S.

**RESTORATION SCOPE:**

- REMOVAL AND REPLACEMENT OF EXISTING PARTITION WALLS AS WELL AS REMOVAL AND REINSTATEMENT OF EXISTING SLIDING FOLDING DOOR AND SCREEN WITHIN THE WORK AREA TO FACILITATE CONCRETE REPAIRS AT BEARING STEM OF PRECAST DOUBLE-TEE SLAB.
- LOCALIZED CONCRETE REPAIR AT BEARING STEM OF PRECAST DOUBLE-TEE SLAB, COMPLETE WITH SUPPLY AND INSTALL NEW REINFORCEMENT (E.G. HOOK AND LONGITUDINAL REINFORCEMENT) AS PER PROJECT SPECIFICATIONS AND DRAWINGS AND AS DIRECTED BY THE CONSULTANT.
- REPAINT ALL NEW/REPAIRED CONCRETE SURFACES TO MATCH EXISTING AS PER PROJECT SPECIFICATIONS.
