## Addendum No. 1

| <b>Project Name:</b> | <b>DDSB Dunbarton HS</b> | <b>Date:</b> | <b>January 23, 2026</b> |
| <b>Description:</b> | <b>Steam Decommissioning</b> | <b>From:</b> | <b>Brad Timson<br/>Sabastien Snow</b> |

# Limited Designated Substance Survey Report

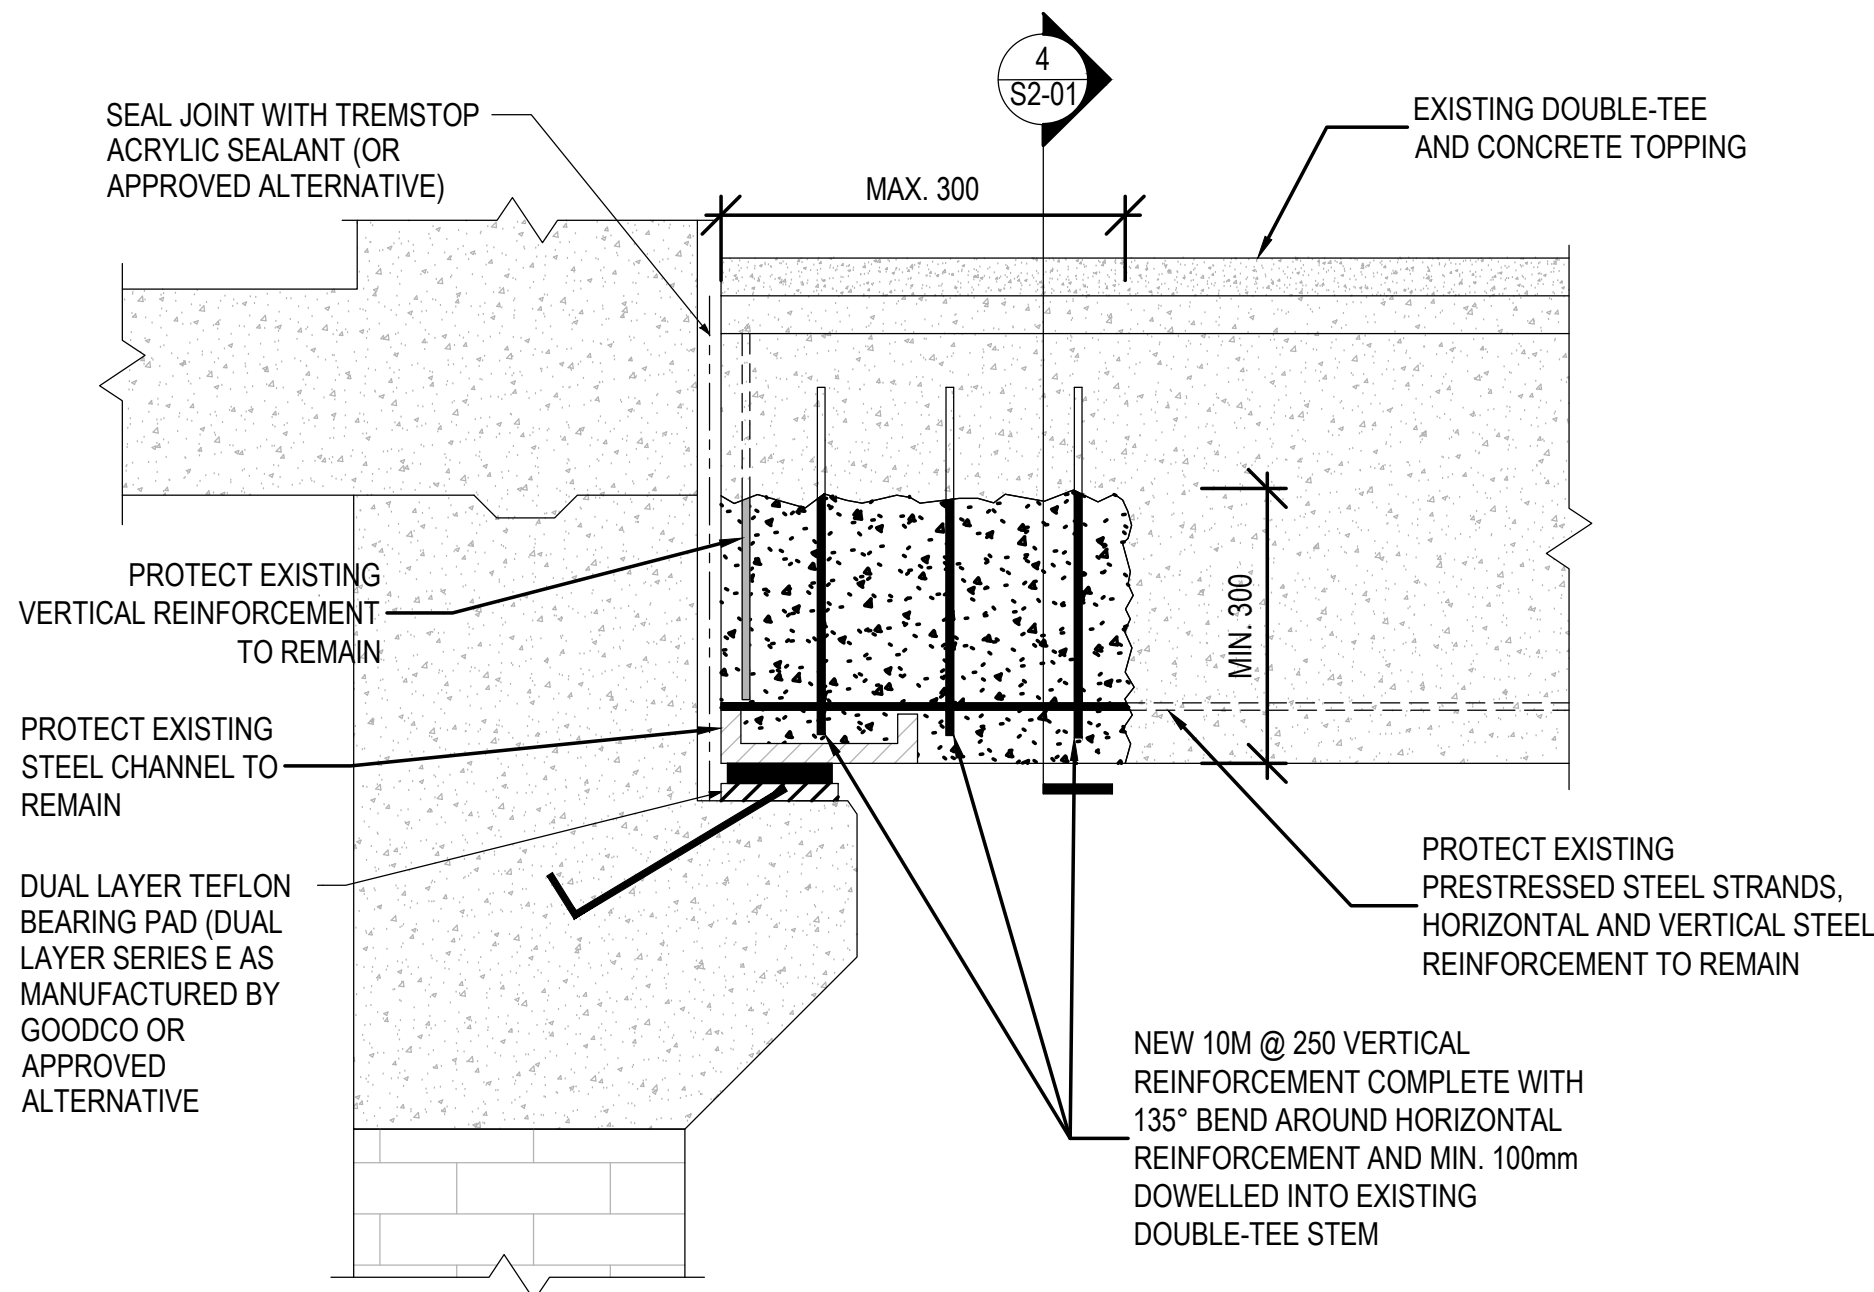
2 PRECAST DOUBLE-TEE BEARING STEM REPAIR (PERPENDICULAR TO STEM)  
N.T.S.

**NOTES:**

- SUBMIT ENGINEERED STAMP SHORING DESIGN AND PROVIDE TEMPORARY SHORING TO SAFELY SUPPORT SLAB AS PER CONTRACTOR SUBMITTED ENGINEERED SHORING DESIGN. **SHORE ADJACENT DOUBLE TEES AS REQUIRED TO PREVENT DETERIORATION DUE TO VIBRATIONS.**
- PERCUSSIVE CONCRETE REMOVALS TO BE COMPLETED WITH MAX. 7 kg CHIPPING HAMMERS.
- SAWCUT SURFACE PERIMETER (MAX. 12mm, DO NOT CUR BARS).
- ABRASSIVELY BLAST PARENT CONCRETE AND EXISTING REINFORCING.
- WET DOWN CONCRETE FOR MIN. 12 HOURS PRIOR TO PLACING CONCRETE.
- COAT PARENT CONCRETE WITH CEMENTITIOUS SLURRY.
- SUPPLY AND PLACE CONCRETE.
- CONTRACTOR SHALL FINISH AND WET CURE NEW CONCRETE MIN. 7-DAYS.

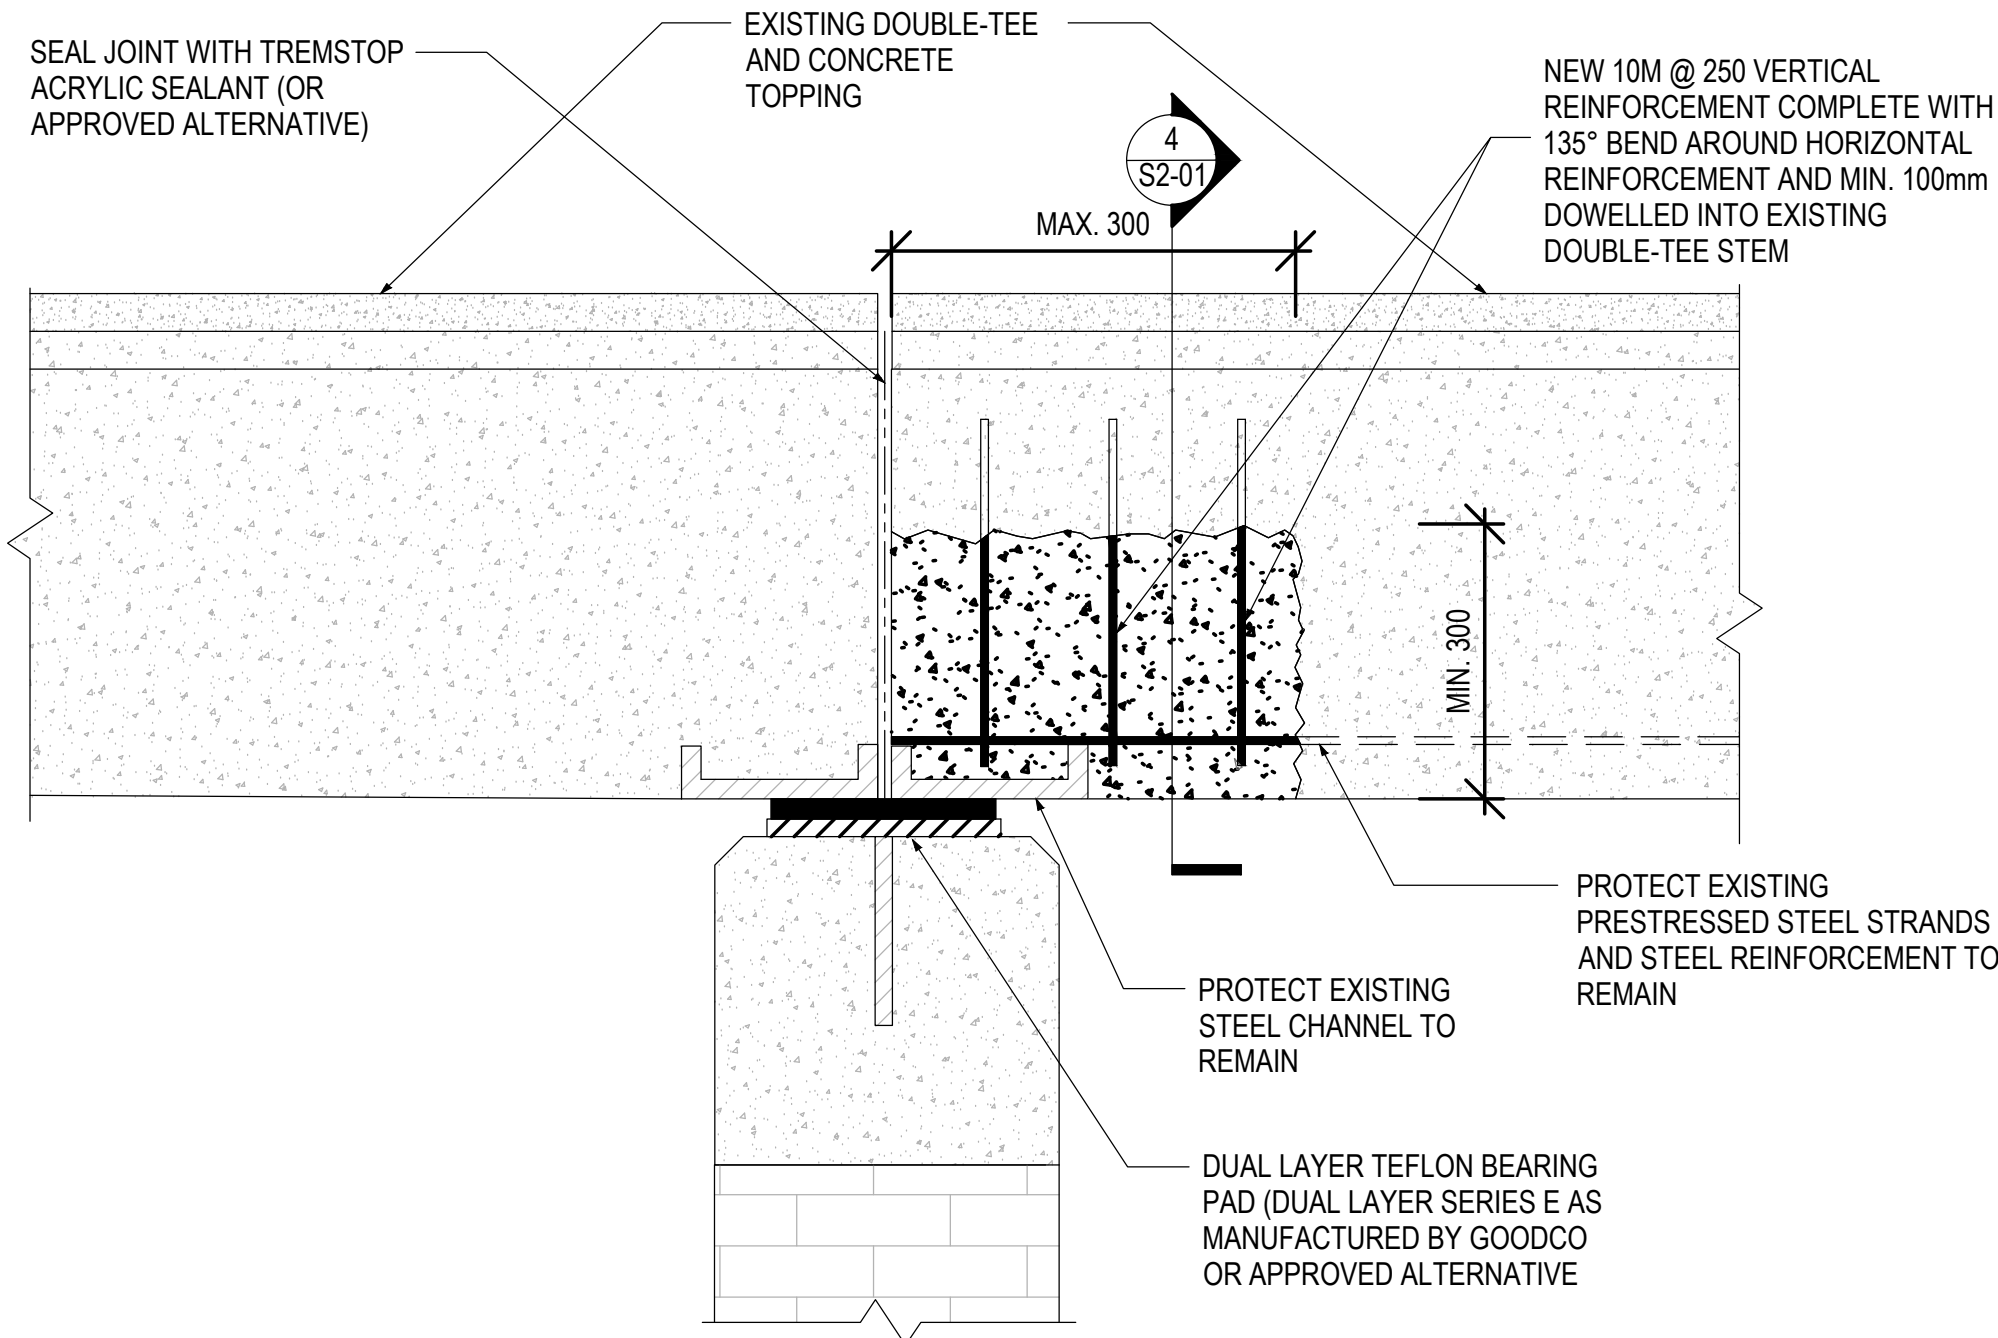
3 PRECAST DOUBLE-TEE BEARING STEM REPAIR (PERPENDICULAR TO STEM)  
N.T.S.

- REFER TO NOTES IN 2/S2-01.
