Designated Substance and Hazardous Materials Survey – Pre-Renovation

**École élémentaire Micheline-Saint-Cyr
85 Forty First St, Etobicoke, Ontario**

March 6, 2026

Arcadis Project No. 30305976

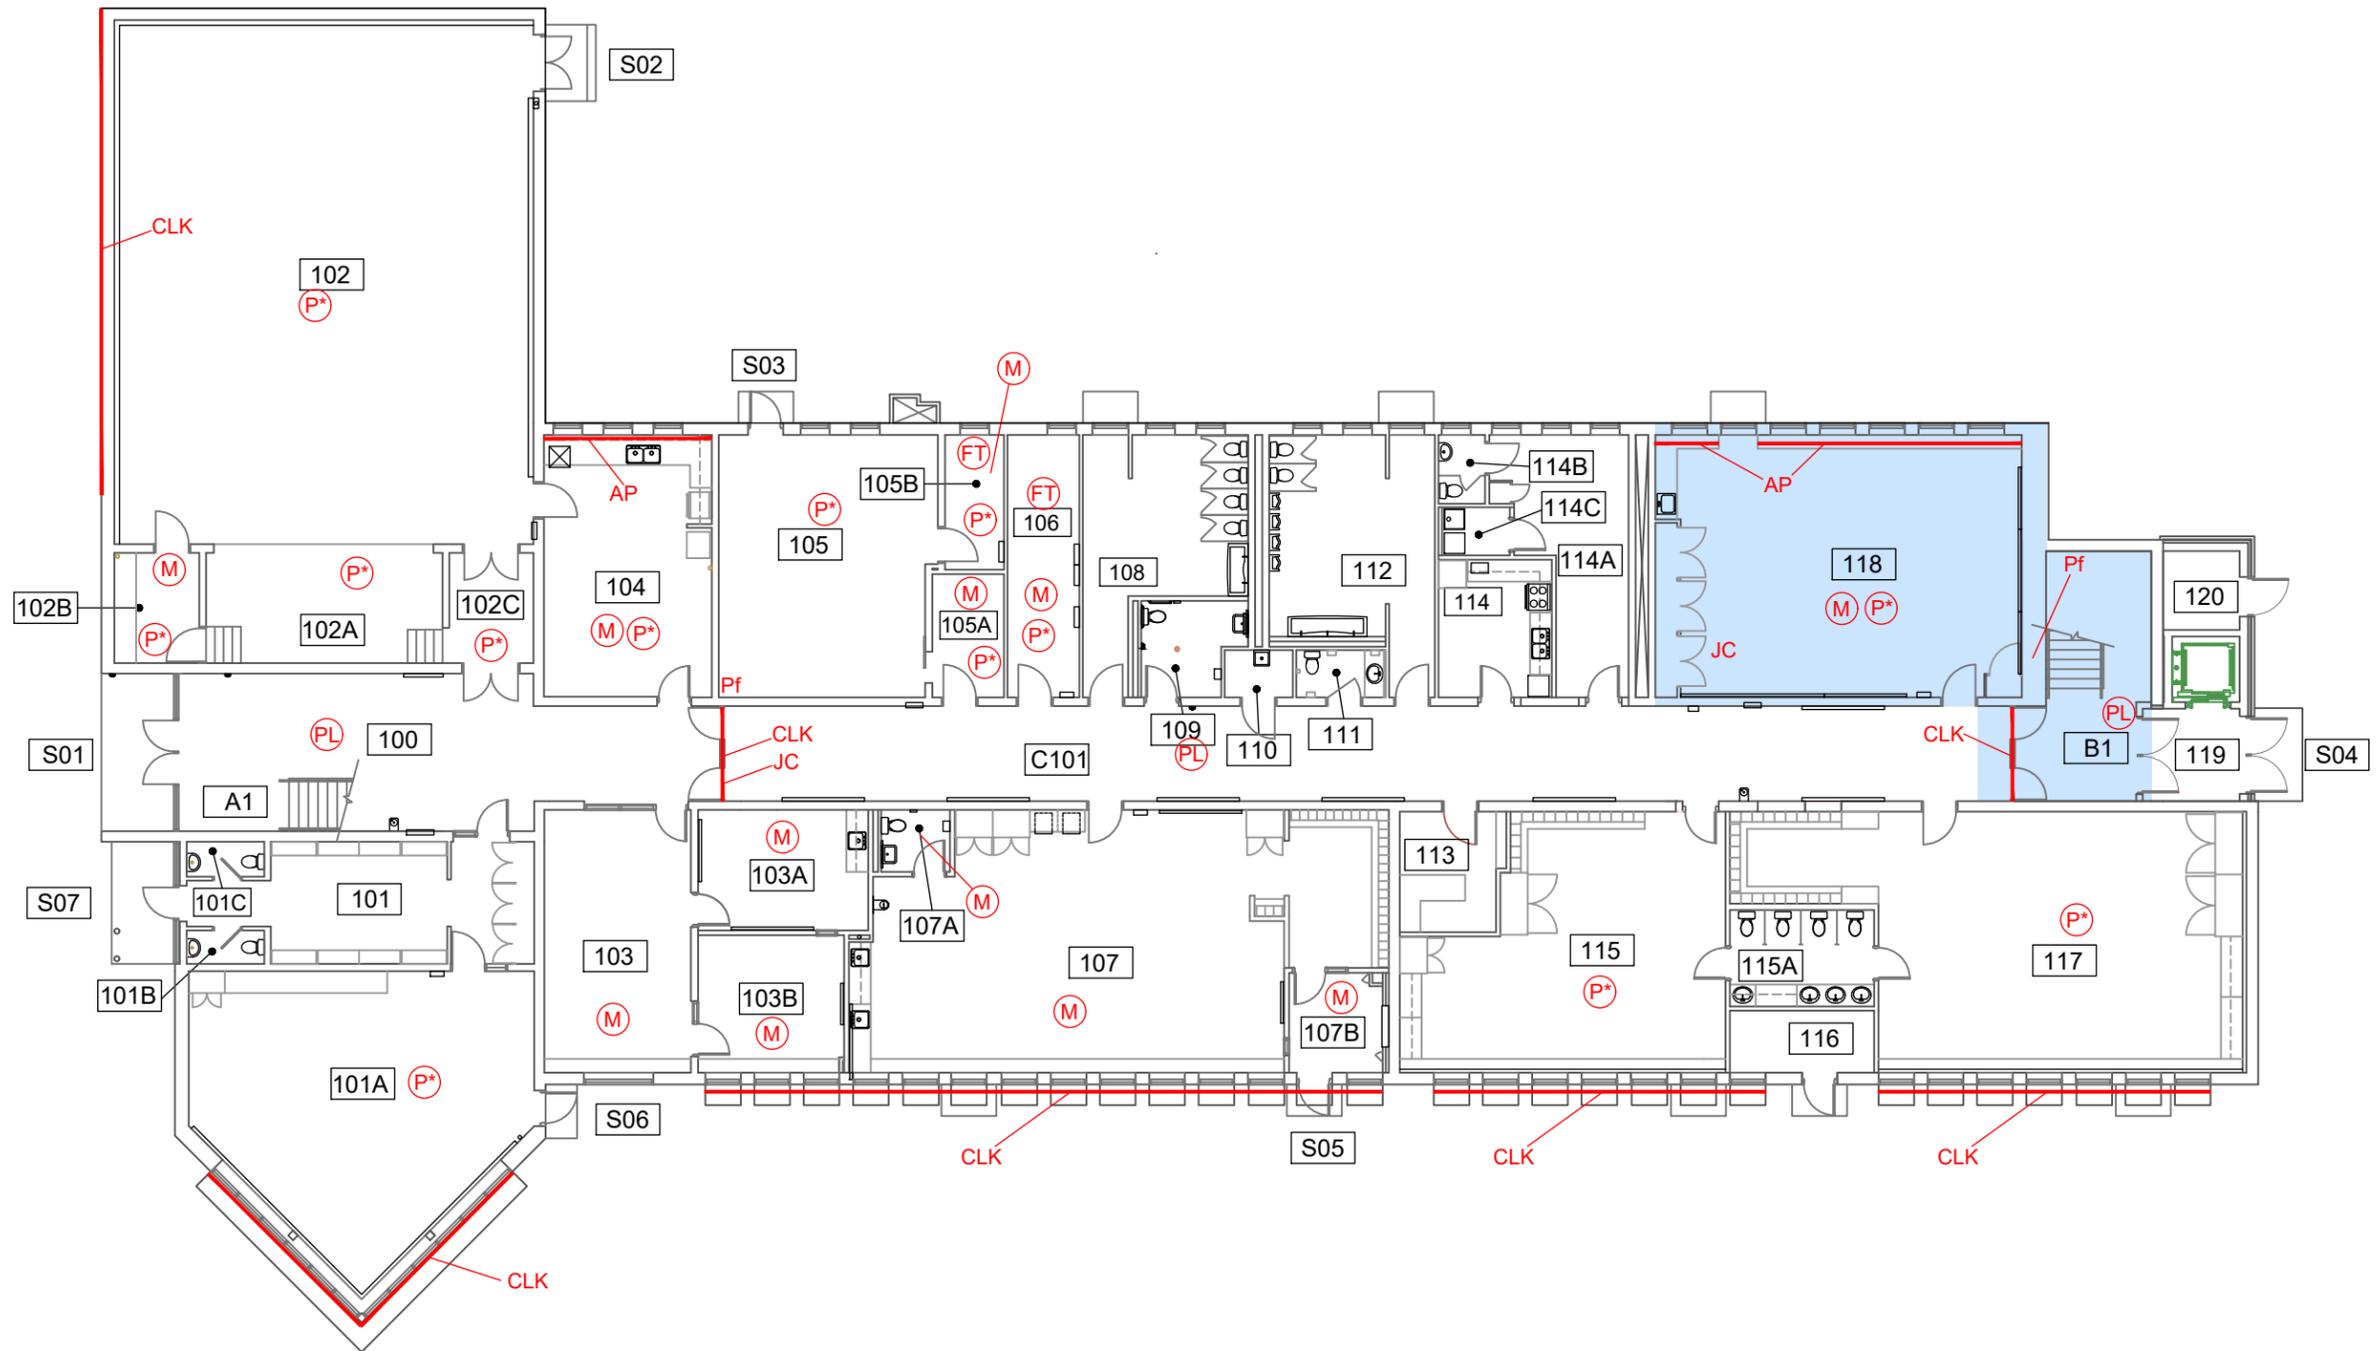
Floor Plans

- LEGEND:**
- 124 FUNCTIONAL SPACE
 - THROUGHOUT FUNCTIONAL SPACE
 - * ABOVE CEILING ASSEMBLY
 - P ASBESTOS ON STRAIGHT SECTIONS OF PIPING AND PIPE FITTINGS
 - Pf ASBESTOS ON PIPE FITTINGS ONLY
 - FT ASBESTOS FLOORING
 - M ASBESTOS FLOORING MASTIC
 - PL ASBESTOS PLASTER
 - JC ASBESTOS DRYWALL JOINT COMPOUND
 - CLK ASBESTOS CAULKING
 - AP ASBESTOS PAPER
 - STUDY AREA
