Limited Designated Substance Survey Report

Woodcrest Public School

506 Woodcrest Avenue, Oshawa, Ontario

October 16, 2025
Parasol Project No: 13337

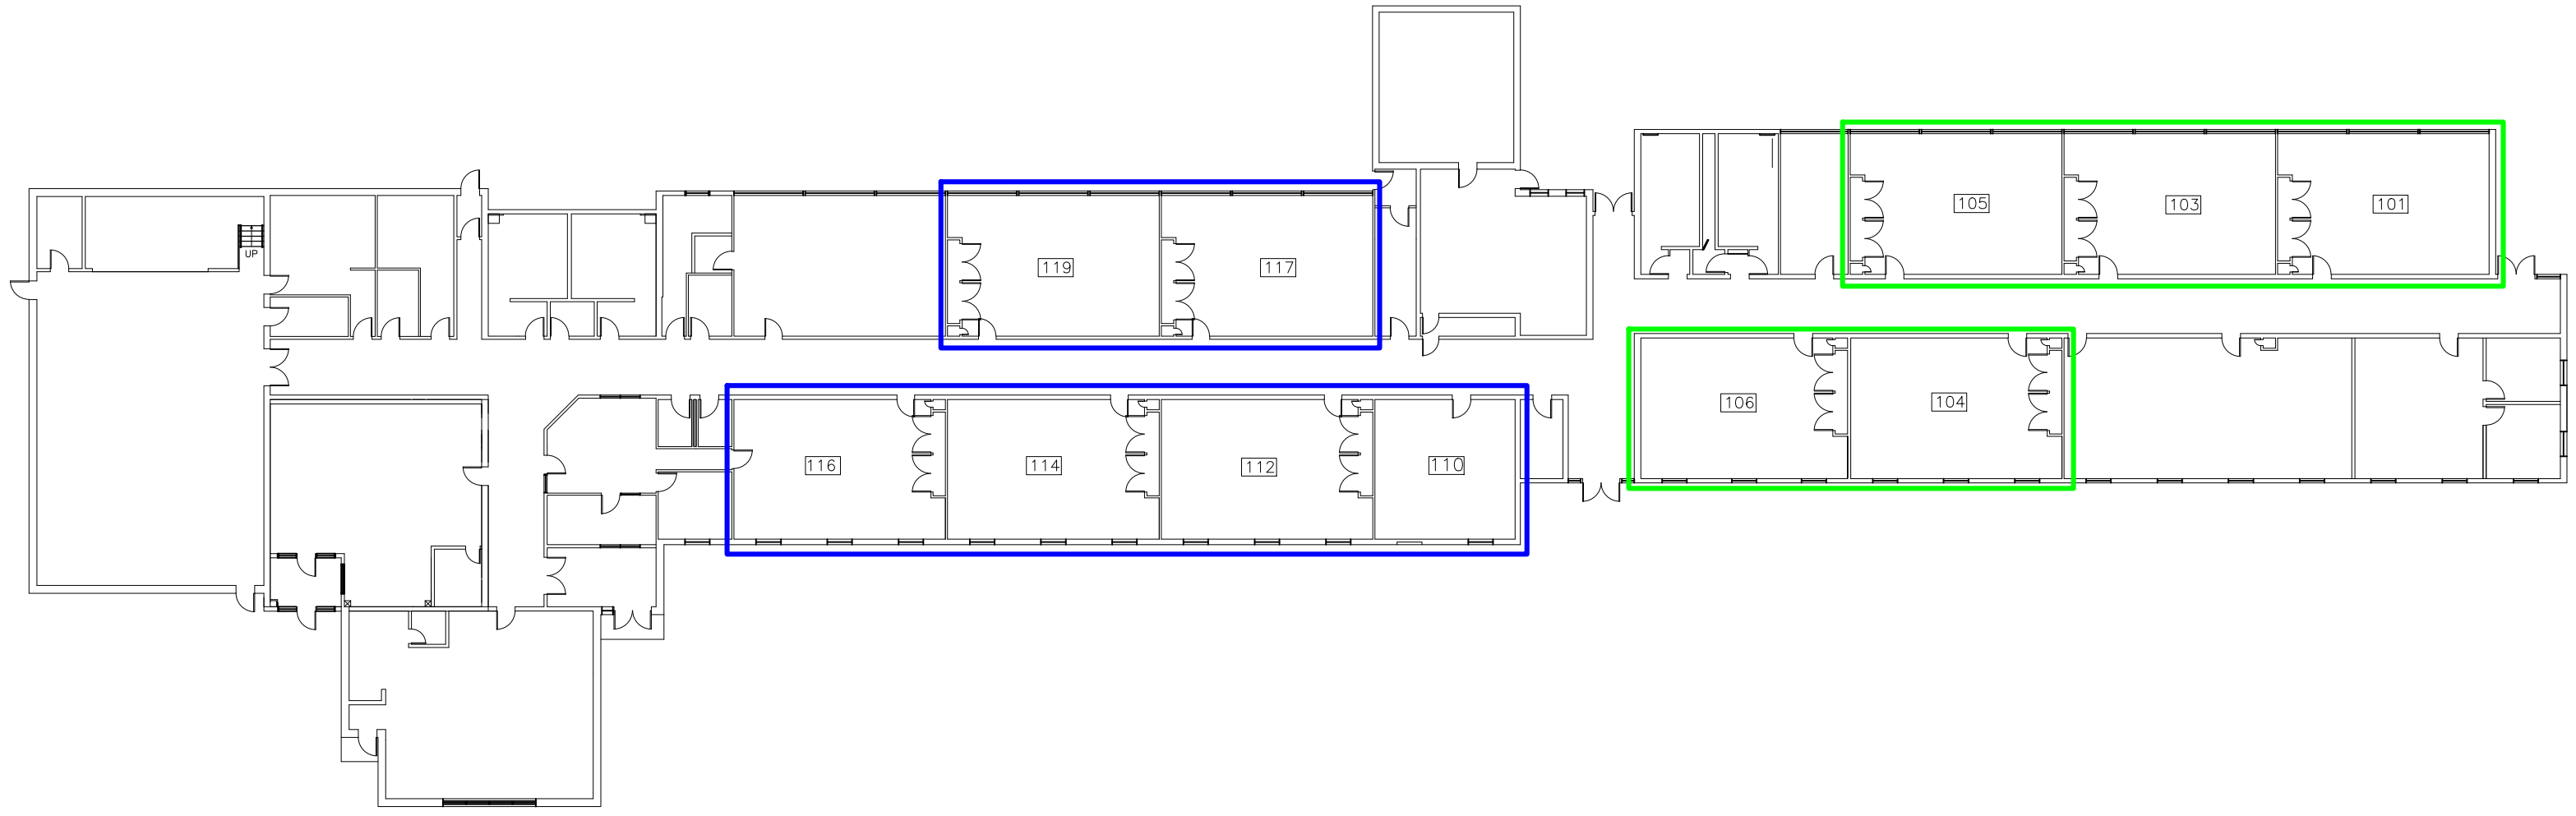
TITLE		LEGEND		DRAWING NO		DRAWN BY:	
Limited Designated Substance Survey First Floor Plan (Building Vintages)				DSR-01		B. PANZER	
CLIENT		SYMBOL		SCALE		PARASOL PROJECT NO	
Durham District School Board		1953 ORIGINAL BUILDING SURVEY AREA		NTS		13337	
LOCATION		1955 BUILDING ADDITION SURVEY AREA		DATE

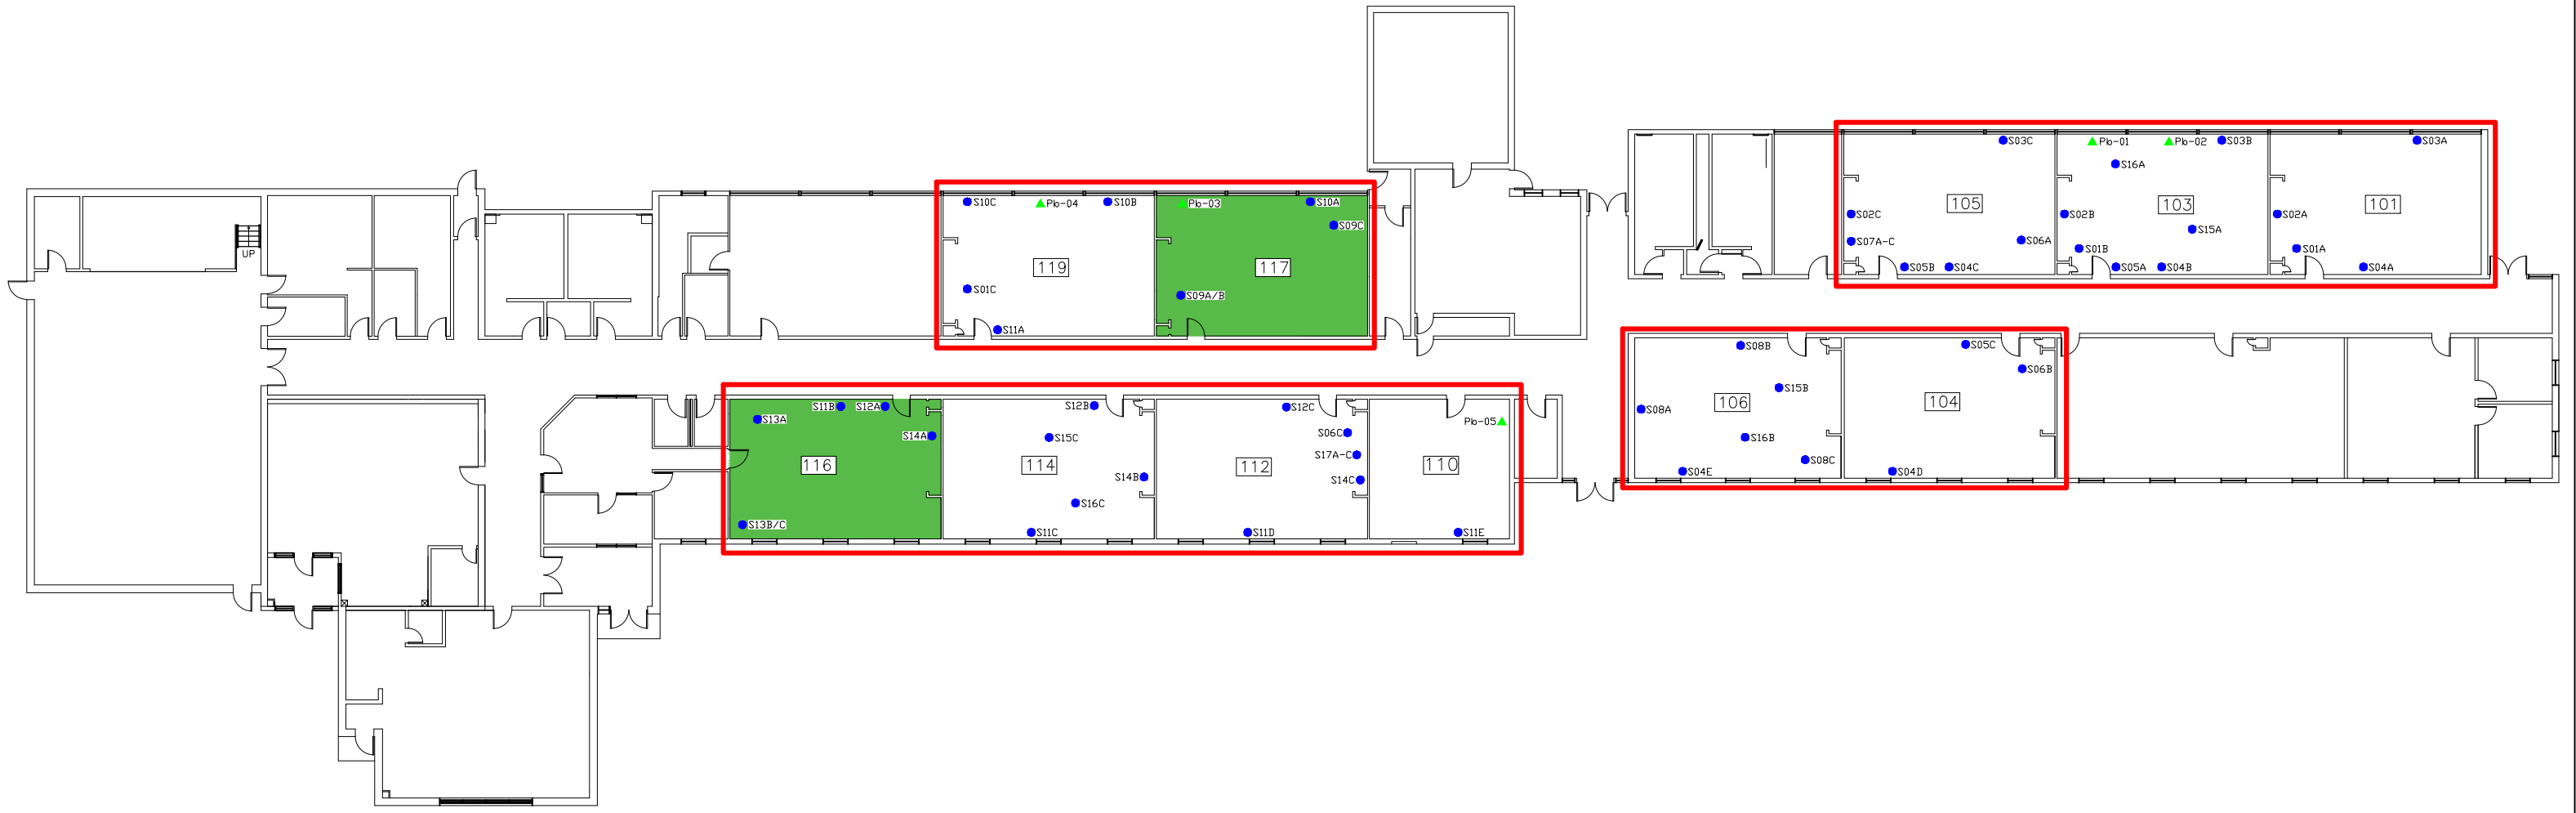
DRAWING NO	DSR-02
SCALE	NTS
DATE	October 16, 2025

TITLE
Limited Designated Substance Survey
First Floor Plan
 CLIENT
 Durham District School Board
 LOCATION
 Woodcrest Public School
 506 Woodcrest Avenue
 Oshawa, Ontario

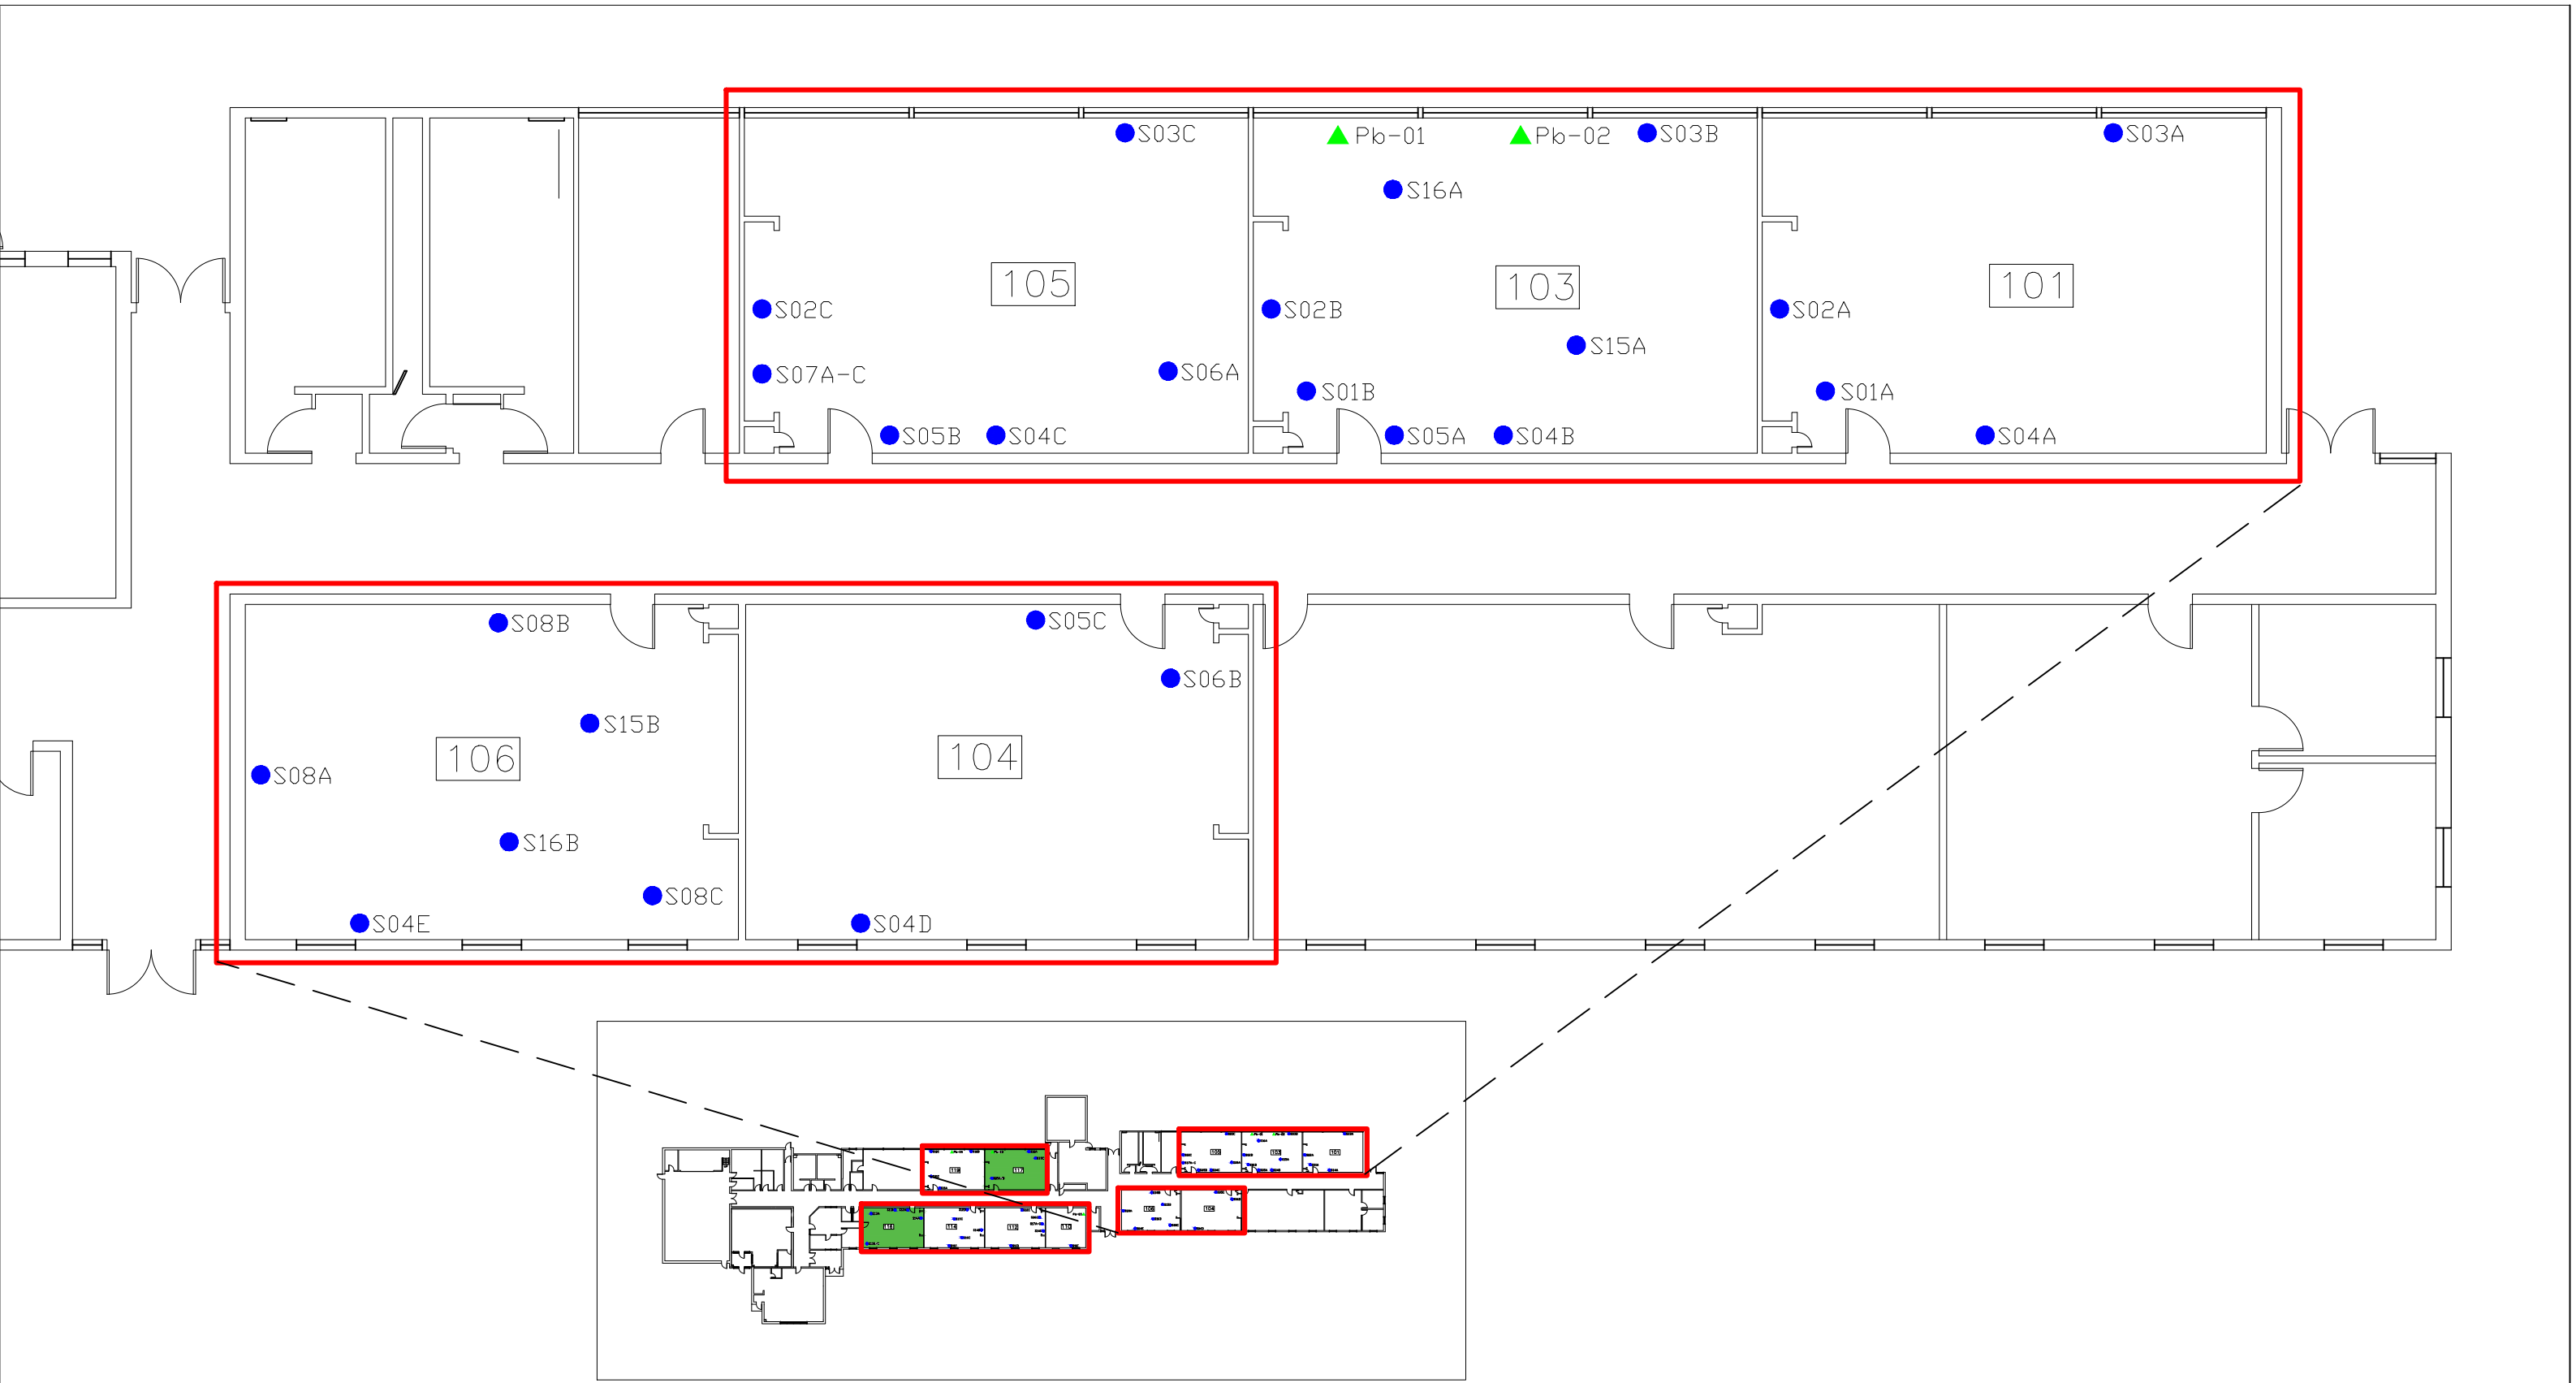
DRAWING NO
DSR-03
 SCALE
NTS
 DATE
October 16, 2025

TITLE
**Limited Designated Substance Survey
 First Floor Plan - Partial**
 CLIENT
 Durham District School Board
 LOCATION
 Woodcrest Public School
 506 Woodcrest Avenue
 Oshawa, Ontario

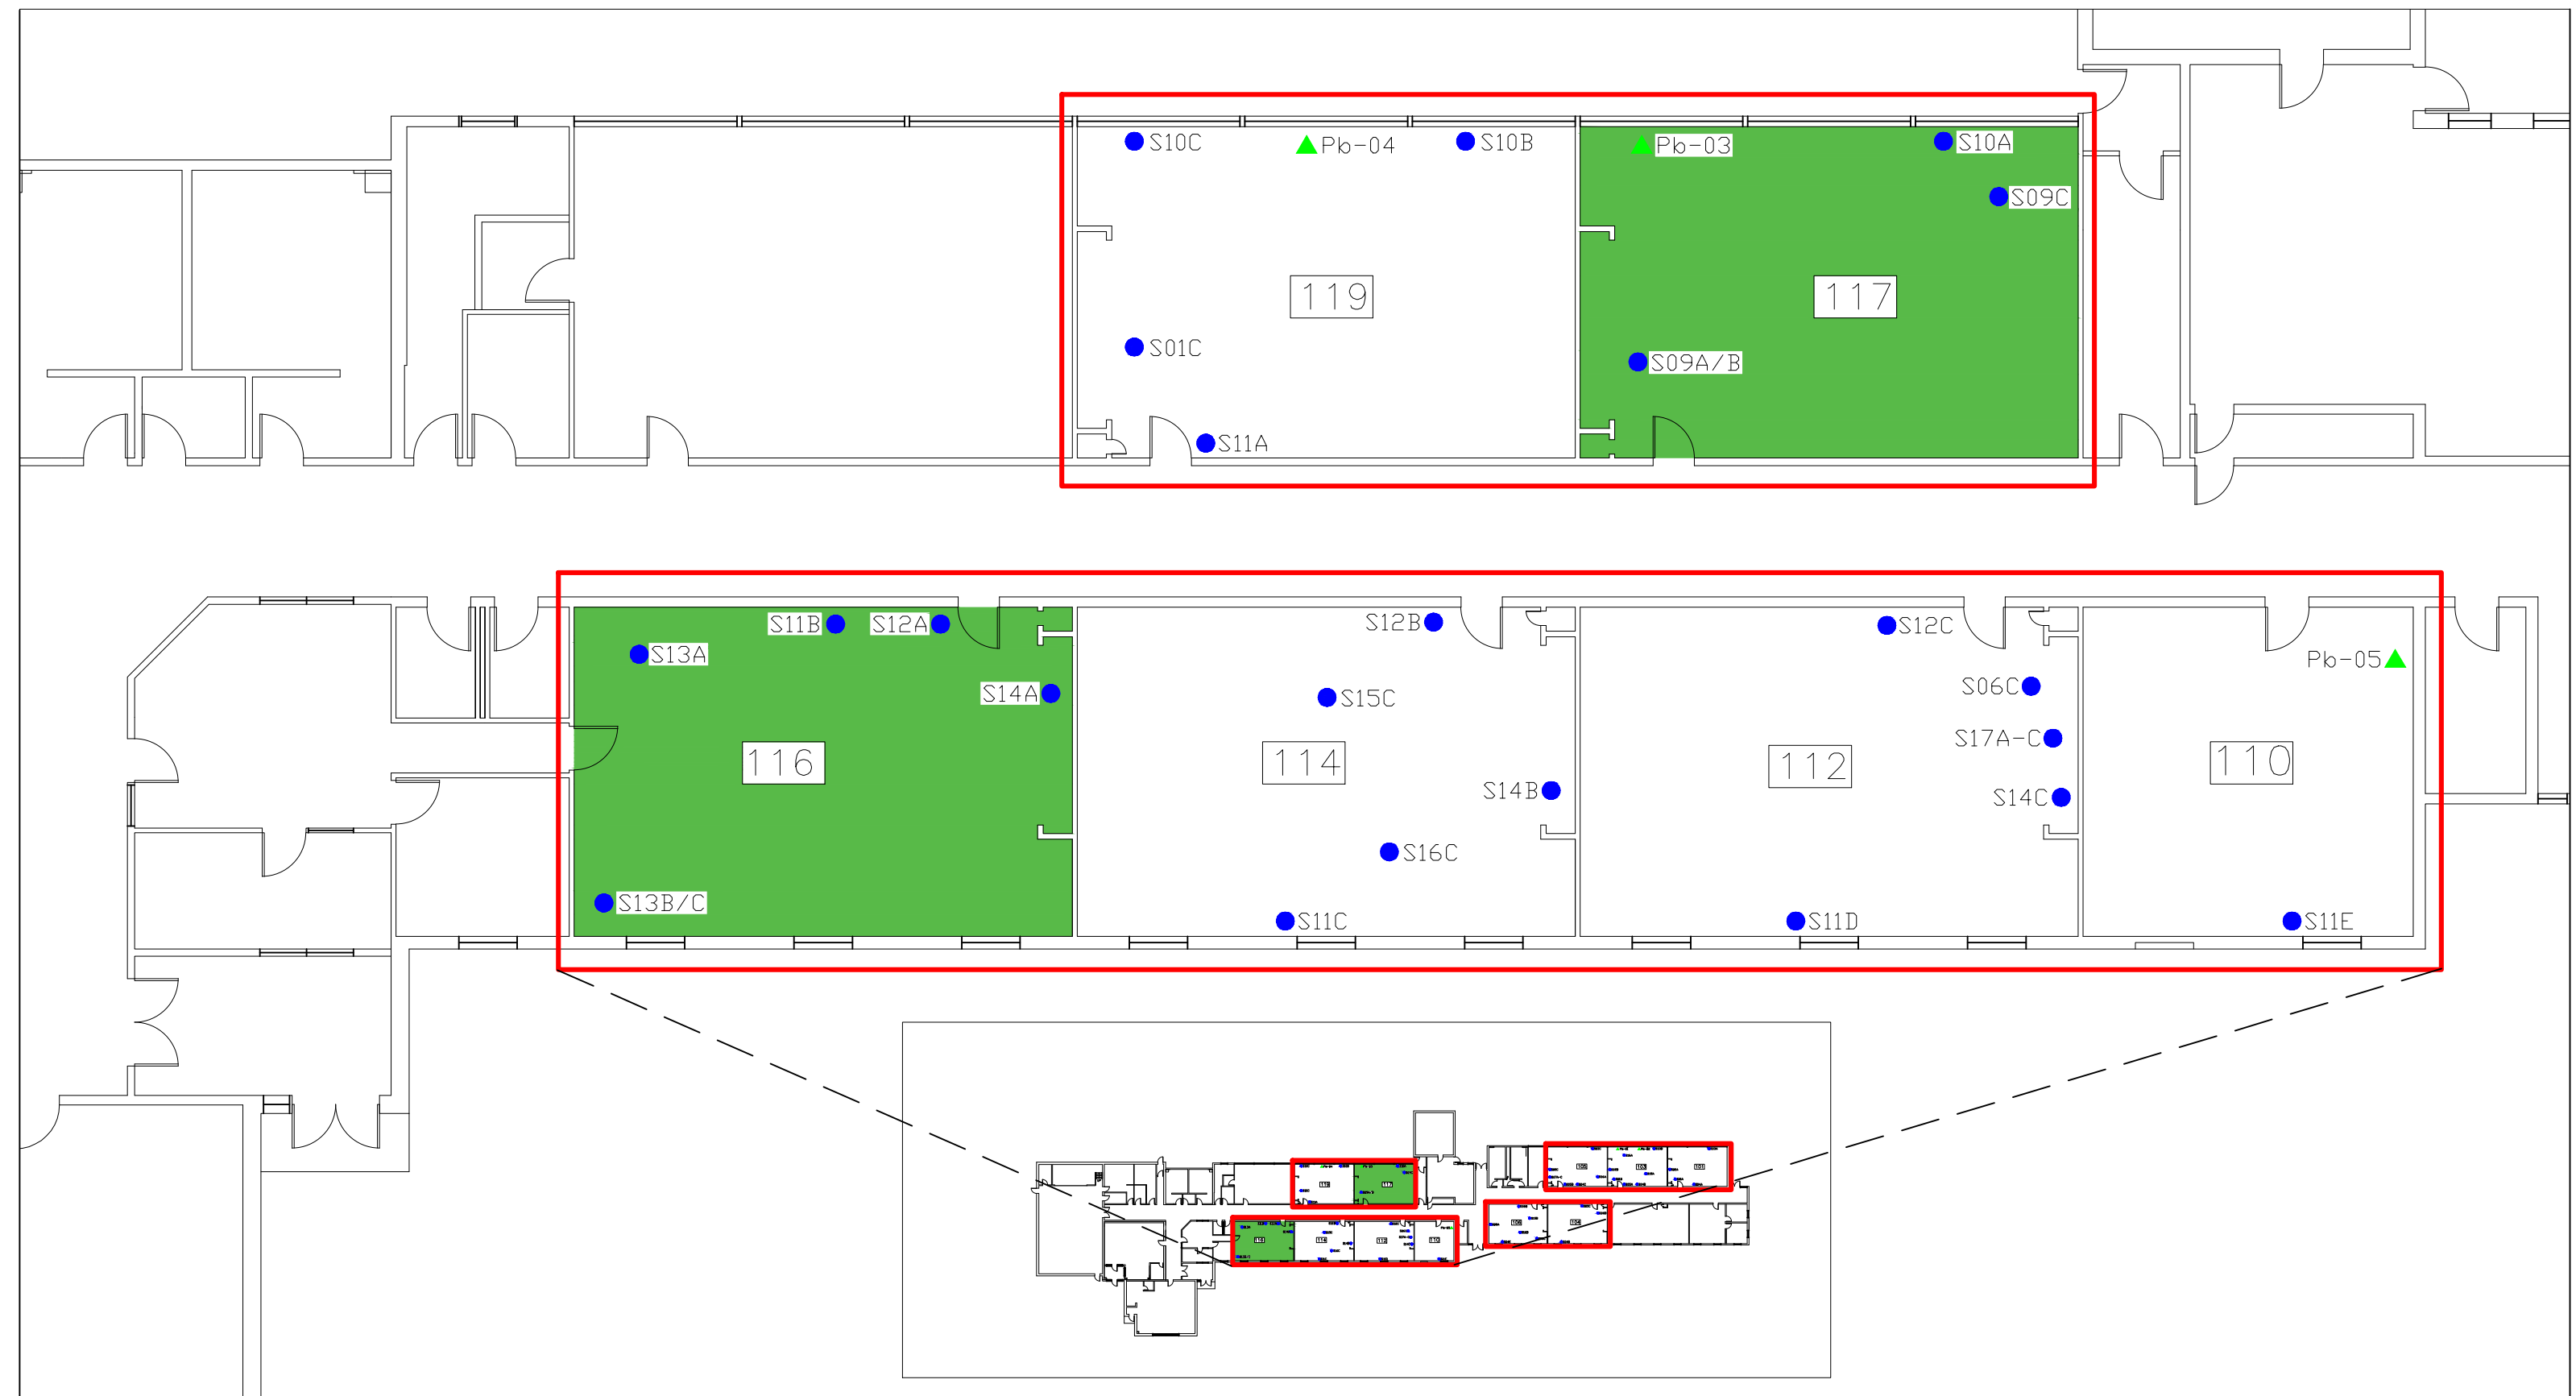
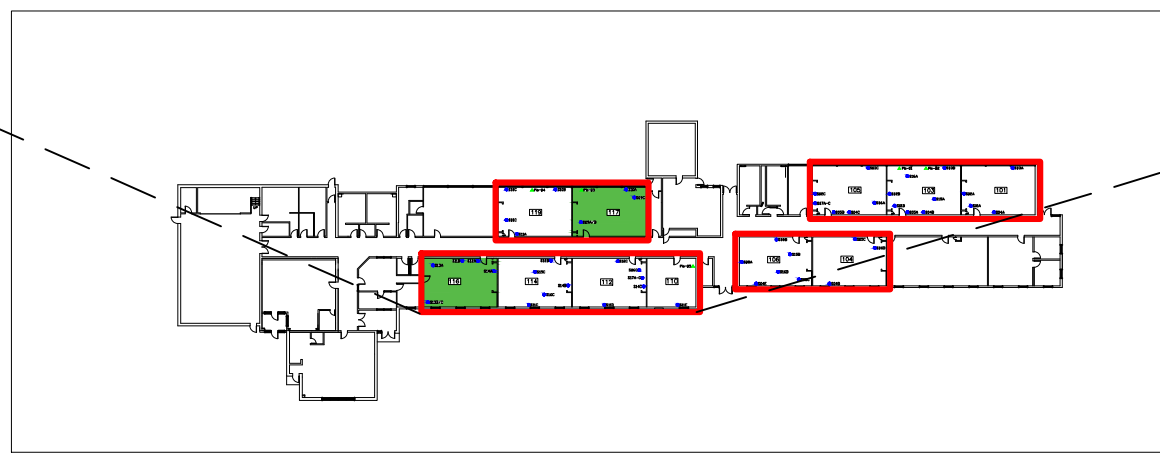
DRAWING NO DSR-04
SCALE NTS
DATE October 16, 2025

TITLE
**Limited Designated Substance Survey
 First Floor Plan - Partial**
 CLIENT
 Durham District School Board
 LOCATION
 Woodcrest Public School
 506 Woodcrest Avenue
 Oshawa, Ontario
