ASBESTOS-CONTAINING BUILDING MATERIALS RE-ASSESSMENT REPORT

Bracebridge Muskoka Lakes Secondary School

100 Clearbrook Trail
Bracebridge, Ontario

Maple Project No. 22300-50

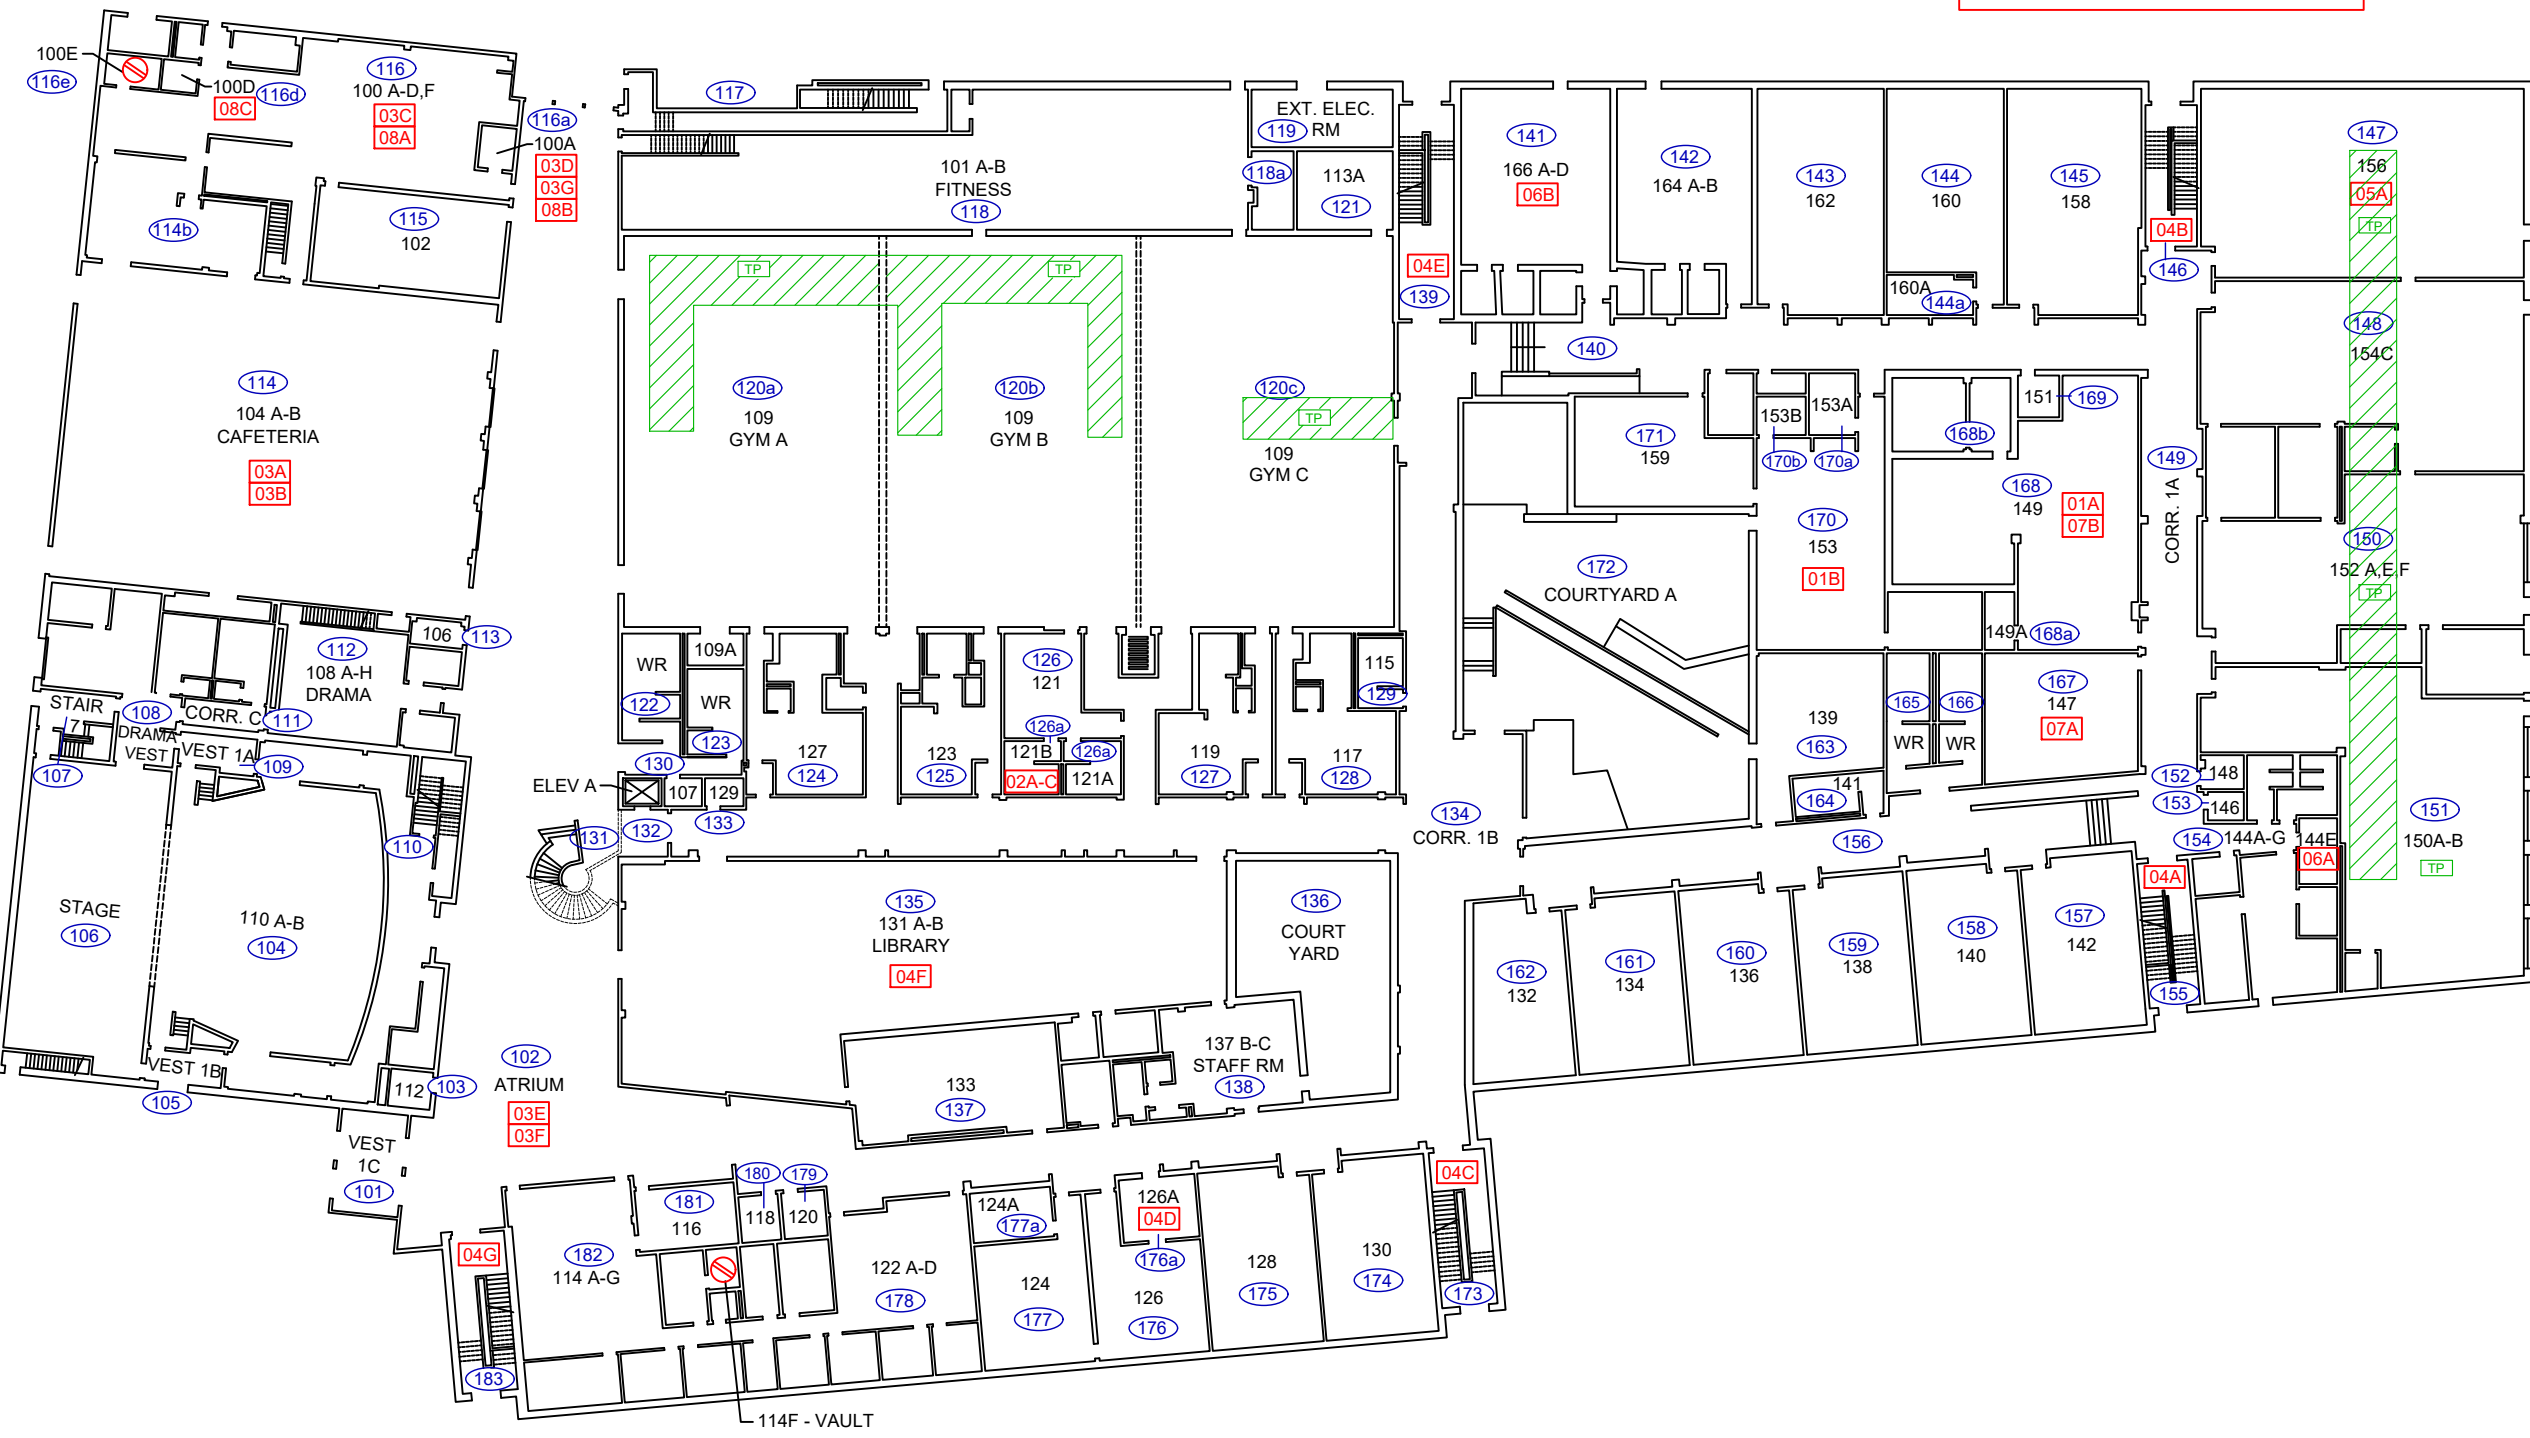
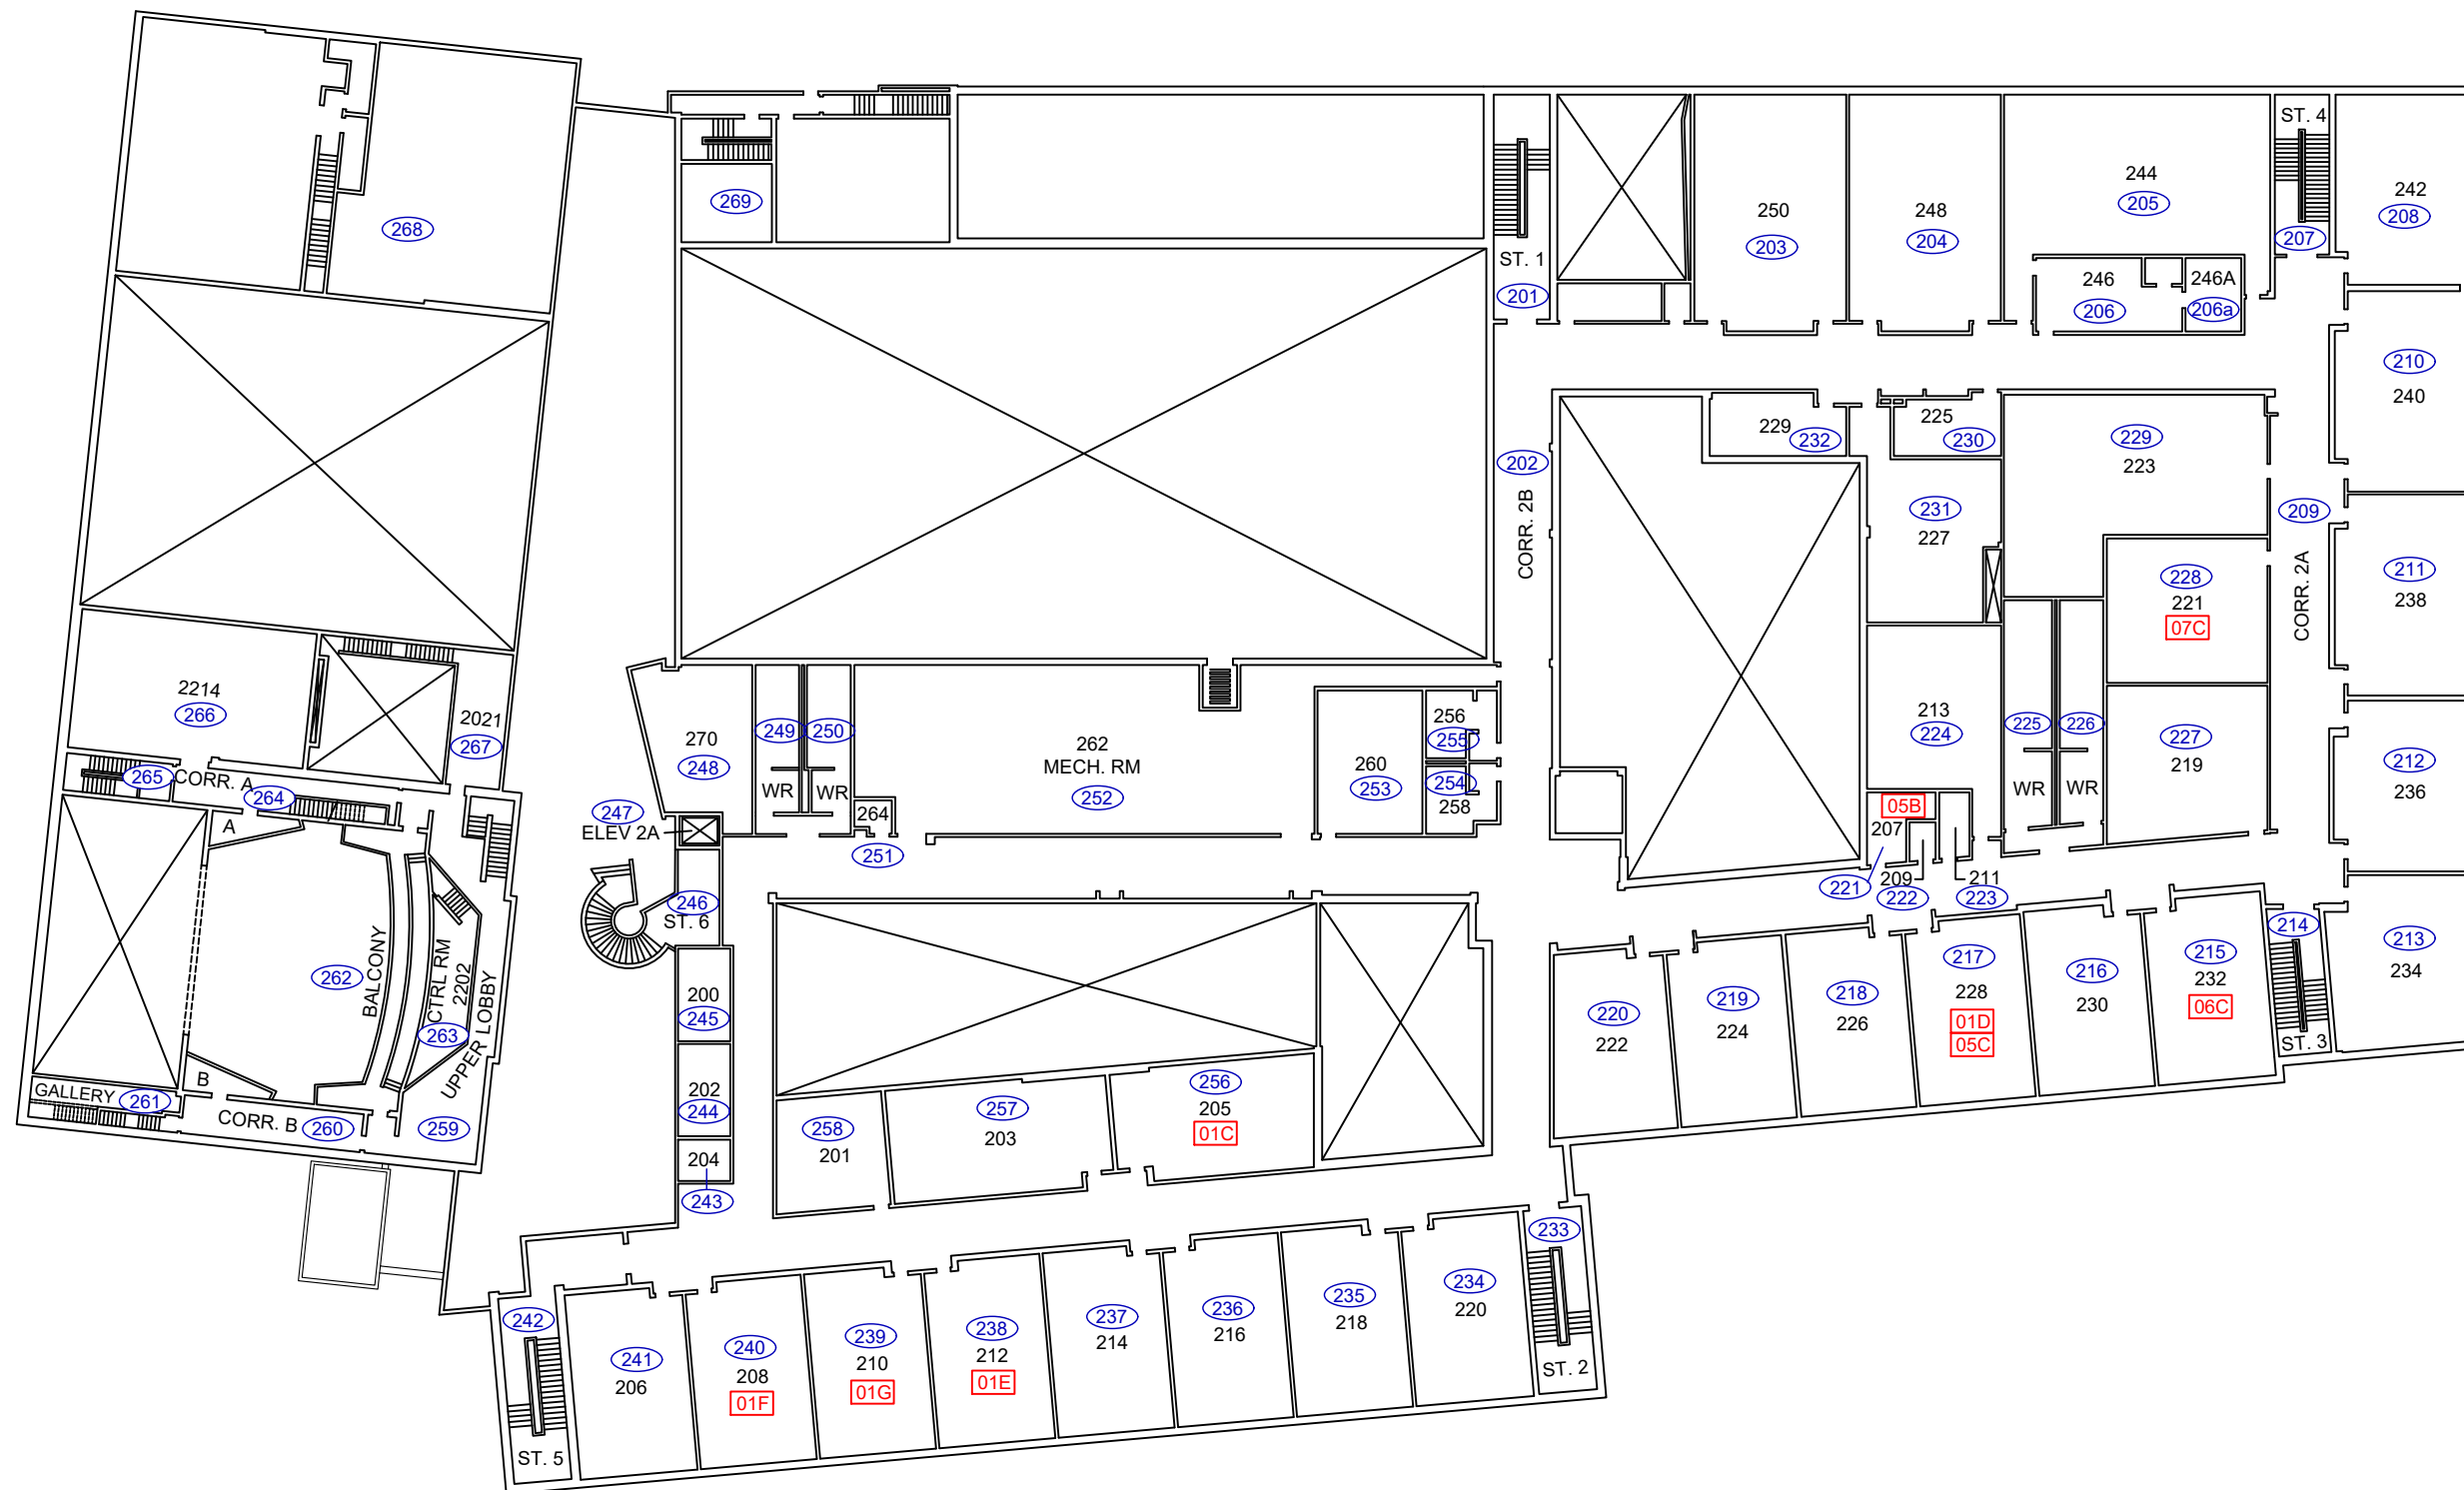
For Detailed Information as to Location, Type, Quantity, Condition and Access to ACM, Please Refer to the Room-by-Room Sheets Provided in the Report.

- 01A Sample Location - 14152-46-xx
- # Ebase Number
- No Access into Room
