# **EXTERIOR OPENING REPAIRS AT MULTIPLE SCHOOL SITES**

**Tender No. T22-15**

## **SUPPLEMENTARY INFORMATION PROJECT MANUAL VOLUME 2**

**Re: Asbestos-Containing Materials Reassessment**

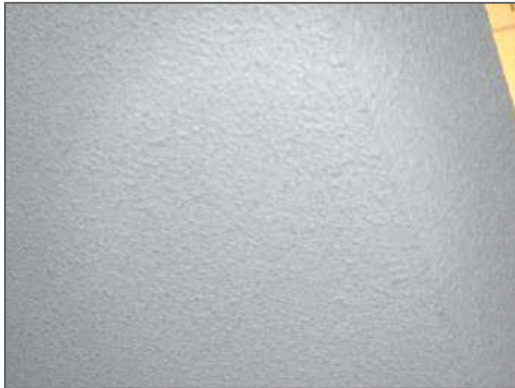
Non-asbestos texture finish present in the Main Foyer  
(Location 9).

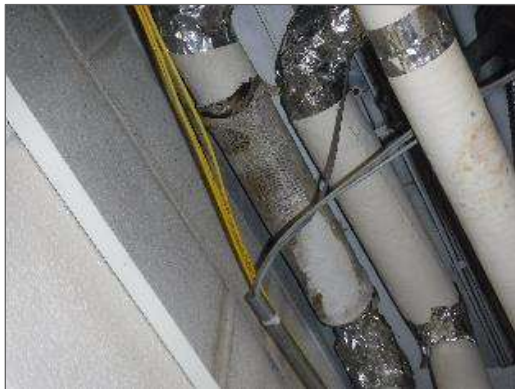
Pipes insulated with non-asbestos fibreglass present in the  
assessed area.

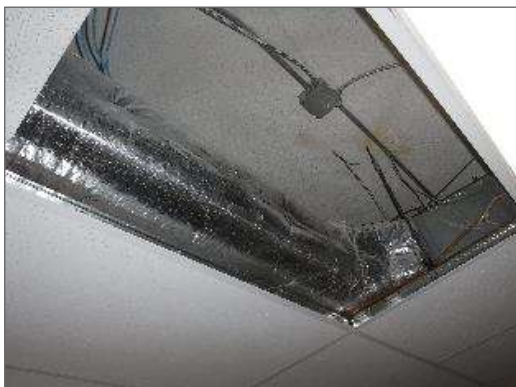
Non-asbestos fibre glass insulation on ventilation ducts present in assessed area.

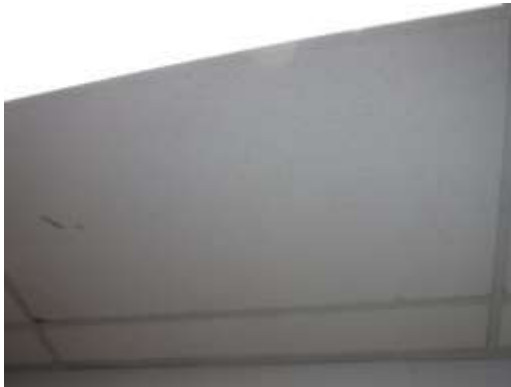
Non-asbestos 12" x 24" lay-in small fleck and pinhole ceiling tiles are present in the assessed area.

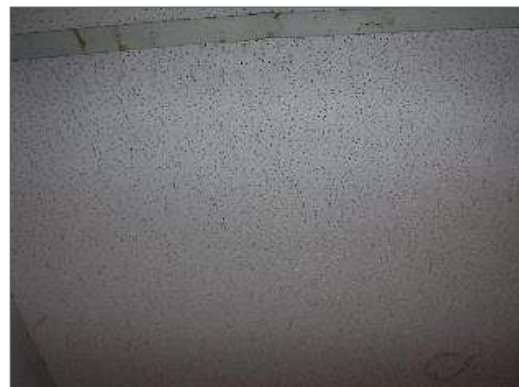
Non-asbestos 12" x 24" lay-in white ridges and medium pinhole ceiling tiles are present in the assessed area.

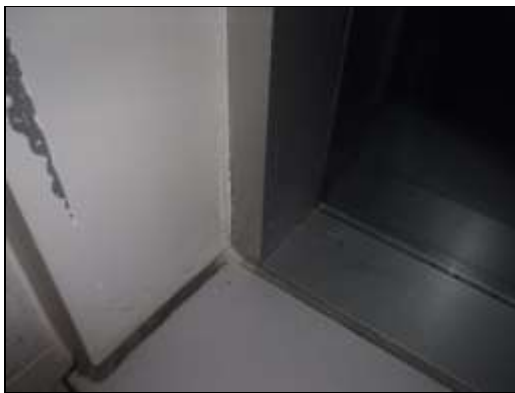
Non-asbestos drywall joint compound is present in the building.

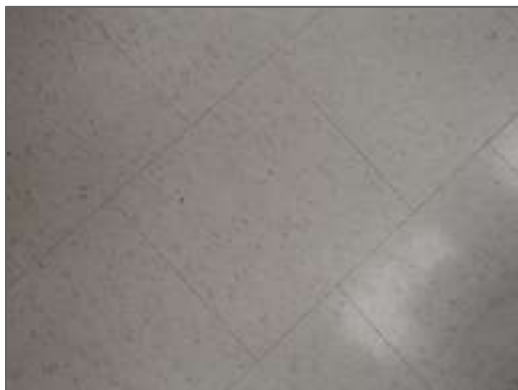
Non-asbestos 12" x 12" blue vinyl floor tile with white spots located in the Career Centre (Location 2).

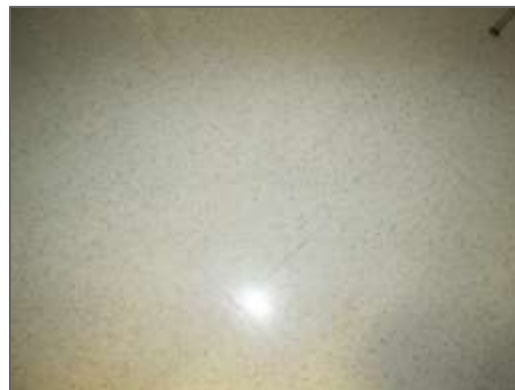
Non-asbestos 12" x 12" off-white vinyl floor tile with grey spots located in the Kitchenette (Location 20).

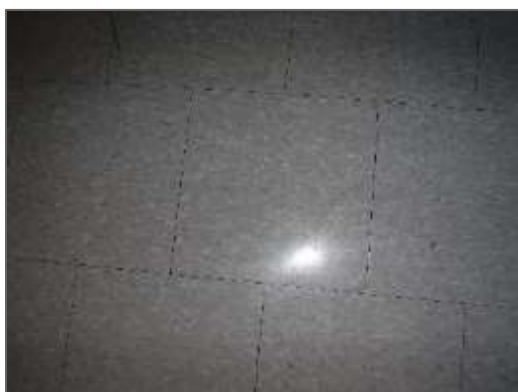
Non-asbestos 12" x 12" grey with grey splotches vinyl floor tile with white spots located in the Staff Work Room (Location 31).

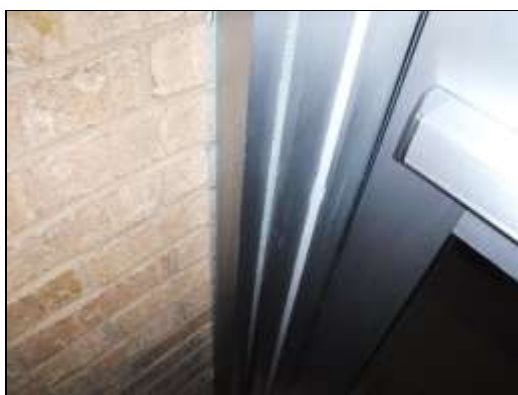
Non-asbestos light and dark grey caulking on interior door frames of the 1963 phase of construction.

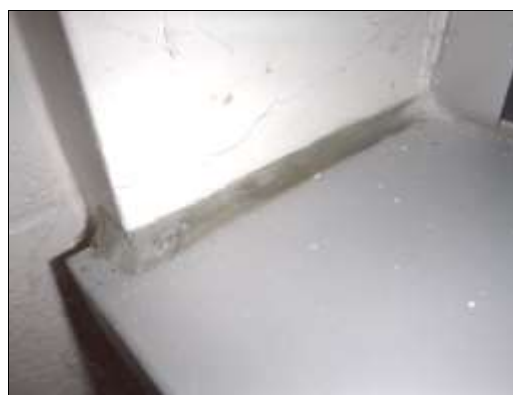
Non-asbestos grey caulking on interior window frames of the 1963 phase of construction.

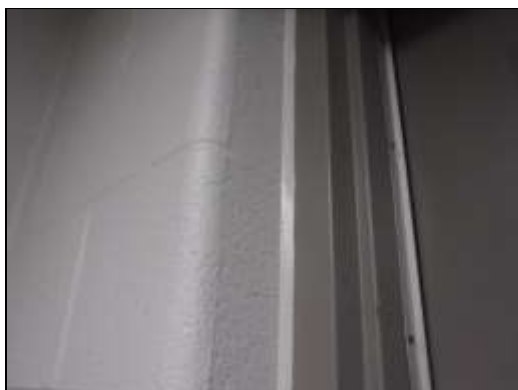
Non-asbestos white caulking on interior door frames of the 2001 phase of construction.

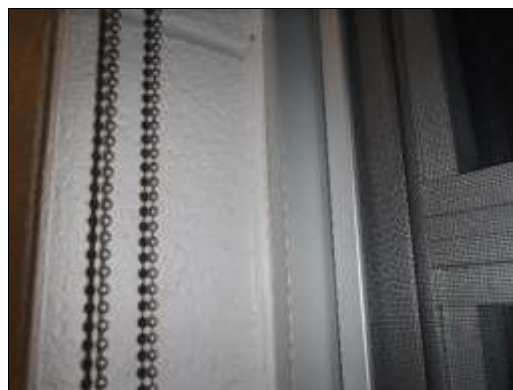
Non-asbestos light grey caulking on interior window frames of the 2001 phase of construction.

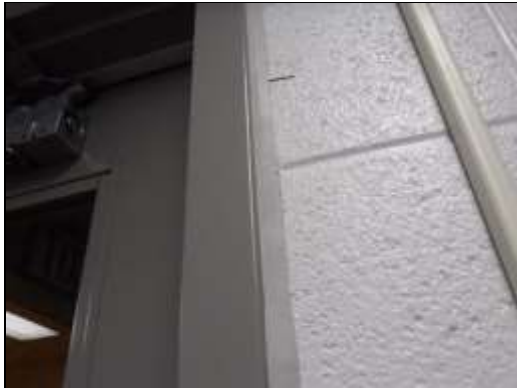
Non-asbestos light grey caulking on interior door frames of the 1990 phase of construction.

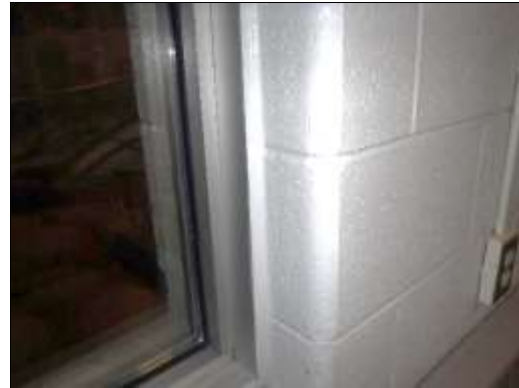
Non-asbestos white caulking on interior window frames of the 1990 phase of construction.

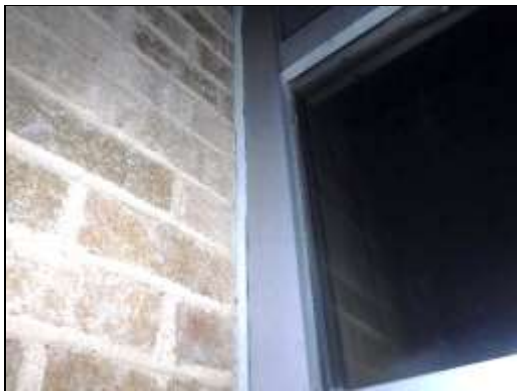
Non-asbestos grey caulking on exterior window and door frames of the 1963 phase of construction.

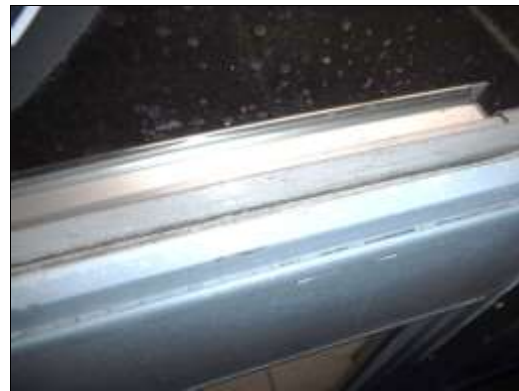
Non-asbestos black putty on exterior windows and doors of the 1963 phase of construction.

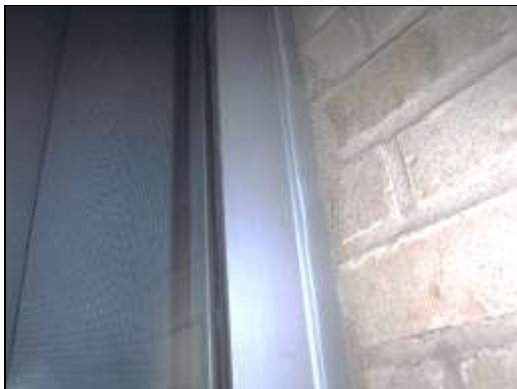
Non-asbestos light grey caulking on exterior window frames of the 2001 phase of construction.

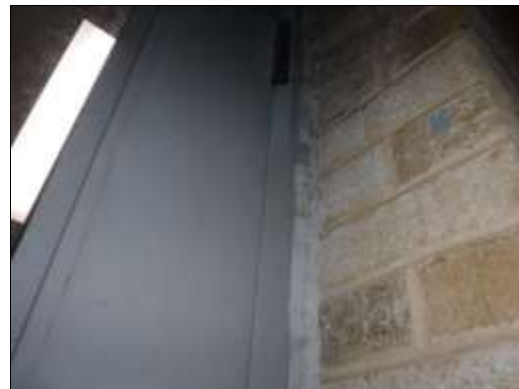
Non-asbestos dark grey caulking on exterior door frames of the 2001 phase of construction.

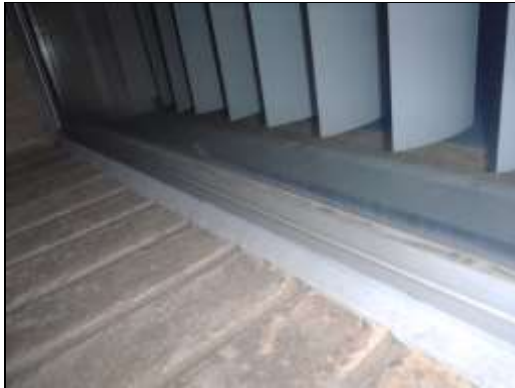
Non-asbestos black putty on exterior windows and doors of the 2001 phase of construction.

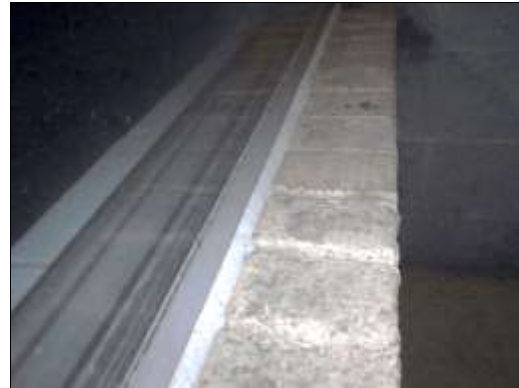
Non-asbestos light grey caulking on exterior window and door frames of the 1990 phase of construction.

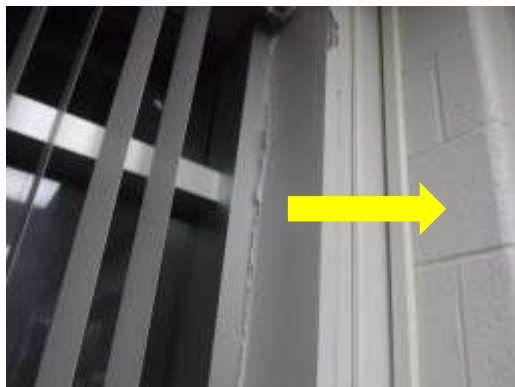
White paint, containing chrysotile asbestos, is present on concrete block in the 1963 phase of construction (samples 0034A-C). Paint is non-friable.

Asbestos-containing paint on the masonry walls is present in the 1963 phase of construction.

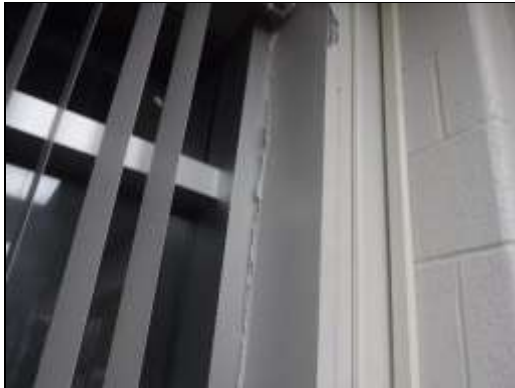
White paint on drywall and masonry walls in the 1963 phase of construction is a non-lead paint.

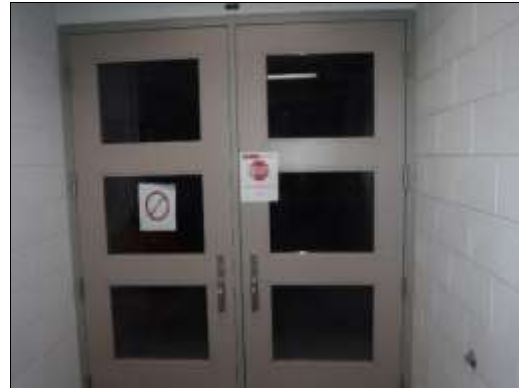
Grey paint on metal doors and frames in the assessed area is a non-lead paint.

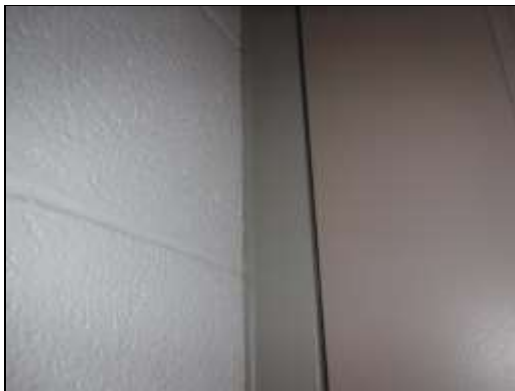
White paint in the 2001 phase of construction is a non-lead paint.

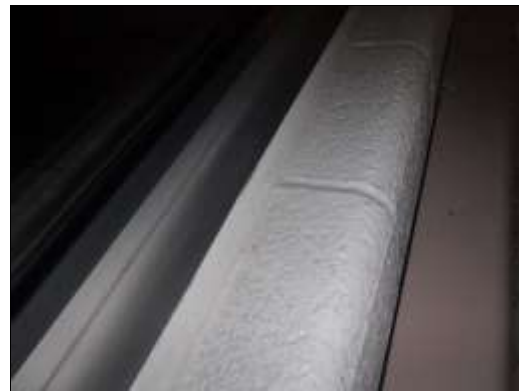
White paint in the 1990 phase of construction is a non-lead paint.

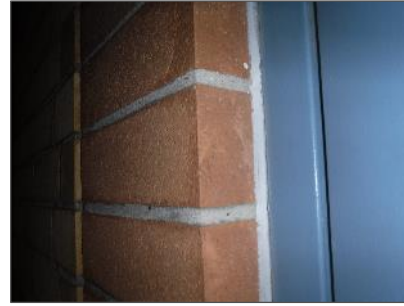
Photo 2 – Asbestos-containing grey caulk is present on the north Exit B doors.

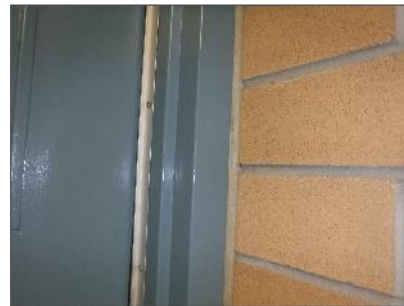
Photo 4 – Non-asbestos grey caulk is present on the interior of the south east Exit D doors.

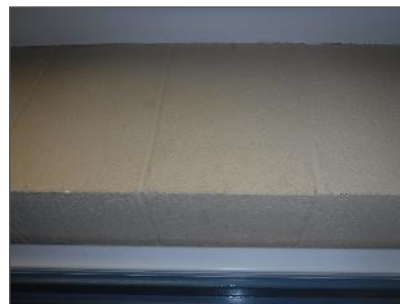
Photo 6 – Yellow paint is present in the south east Exit D assessed area.

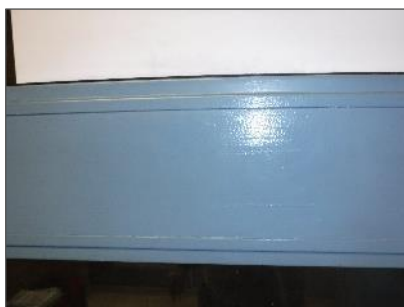
Photo 7 – Blue paint on the metal doors is present in the assessed areas.

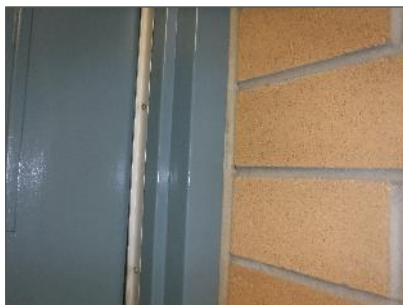
Grey caulking is present on the exterior and interior side of the doors (sample 17-0183) and contains <0.05 ppm PCBs. The material is a non-PCB solid based on the threshold given in SOR/2008-273 (50 ppm).

Photo 8 – Grey caulking on the interior doors does not contain PCBs.

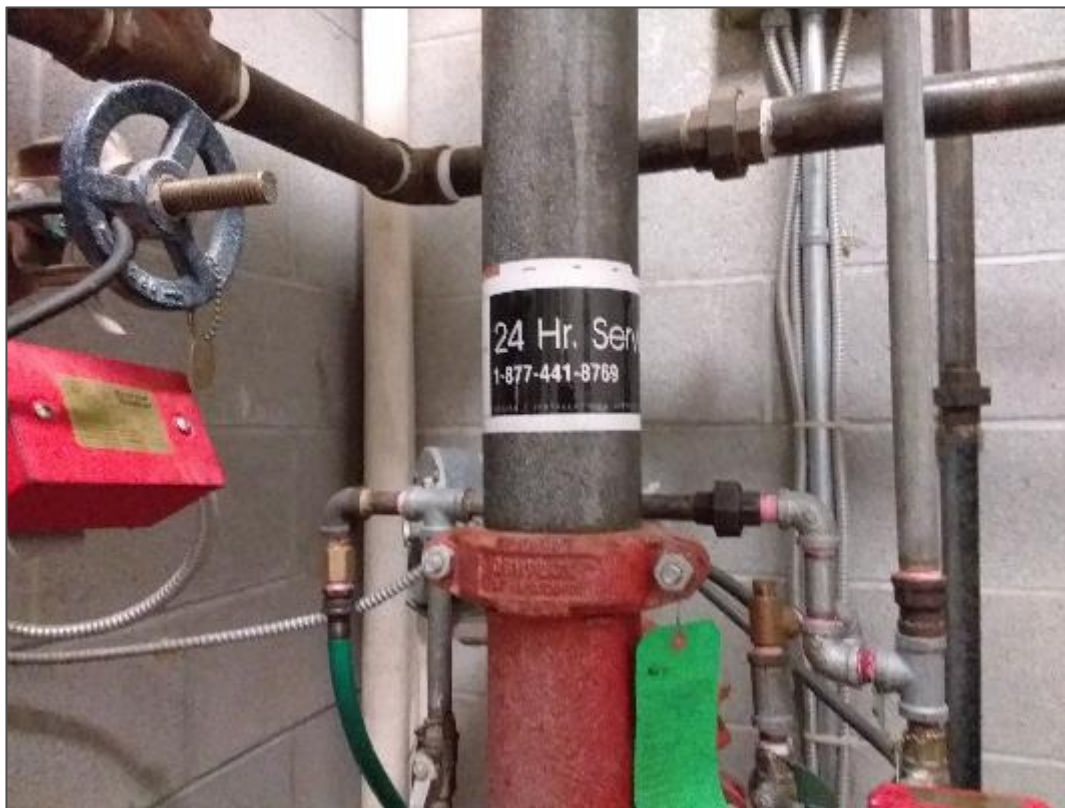
V0000 (None), Piping, All, Not Insulated, Meter Room (Loc. 3).

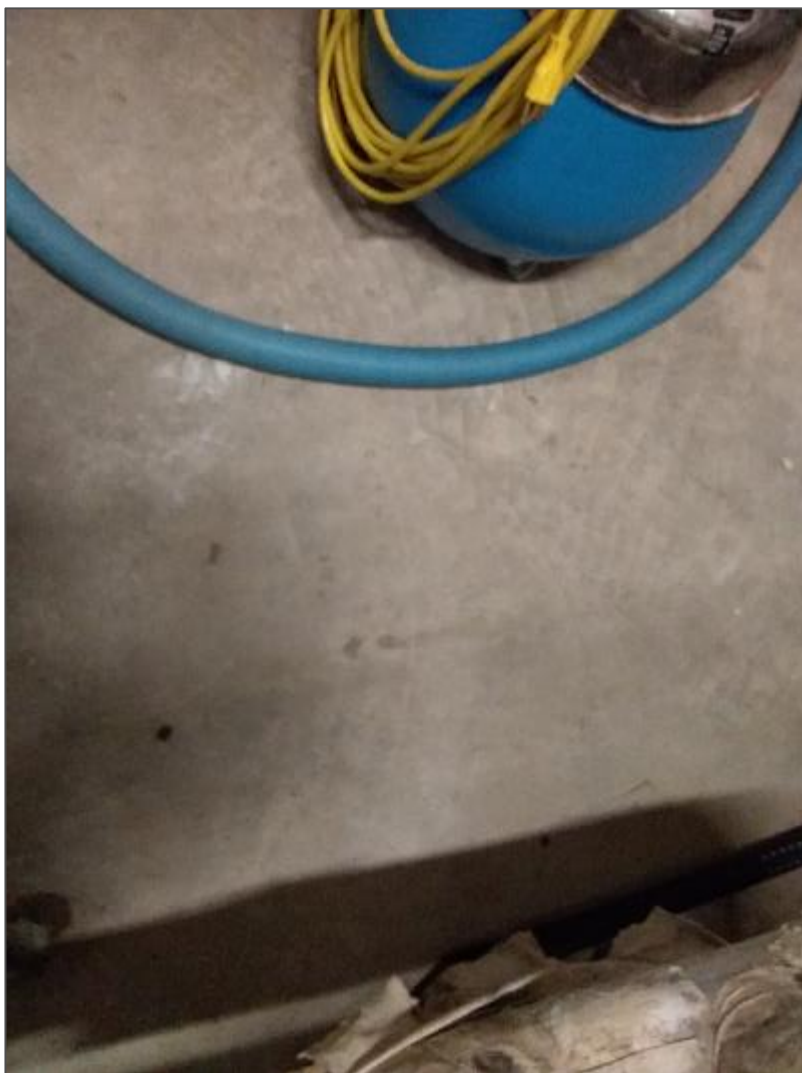
V0000 (None), Floor, All, Concrete (poured), Meter Room (Loc. 3).

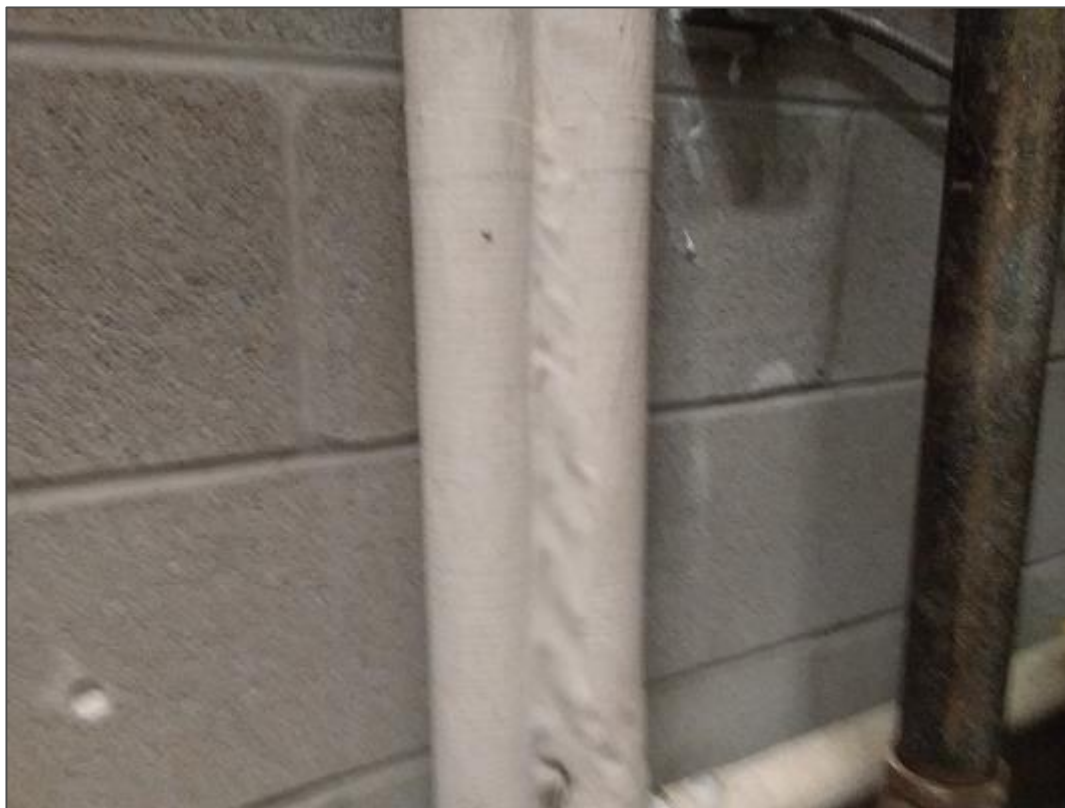
V0000 (None), Piping, All, Fibreglass, Meter Room (Loc. 3).

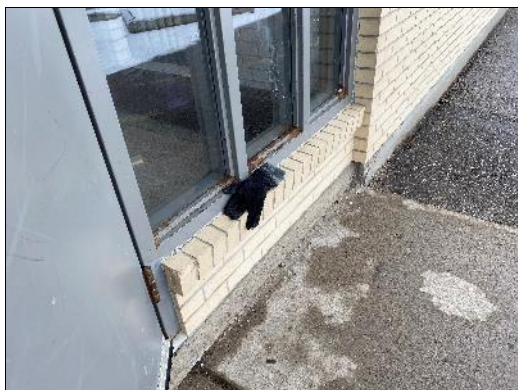
Non-asbestos grey caulking on exterior door frame

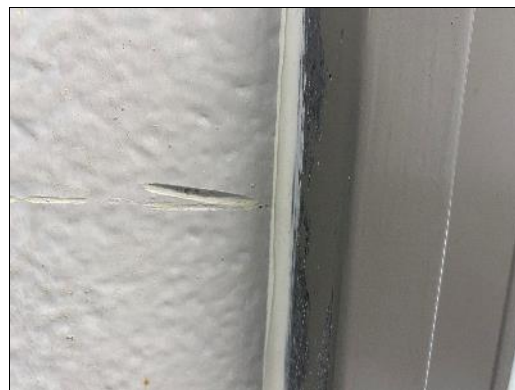
Presumed asbestos-containing white caulking on 1960 phase interior door frame

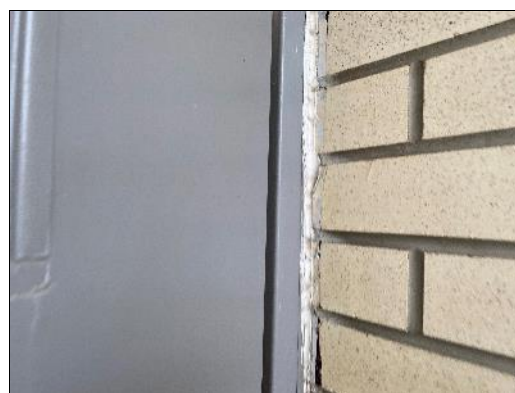
Non-asbestos white caulking on 1960 phase exterior door frame

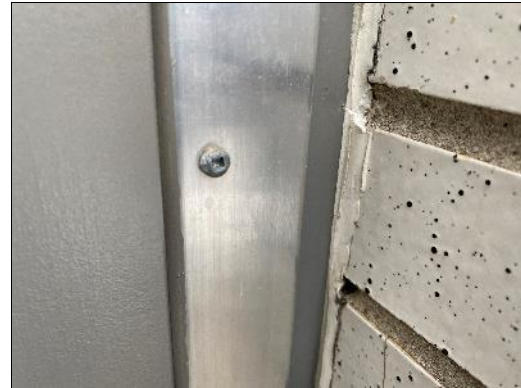
Non-asbestos white caulking on 1970 phase exterior door frame

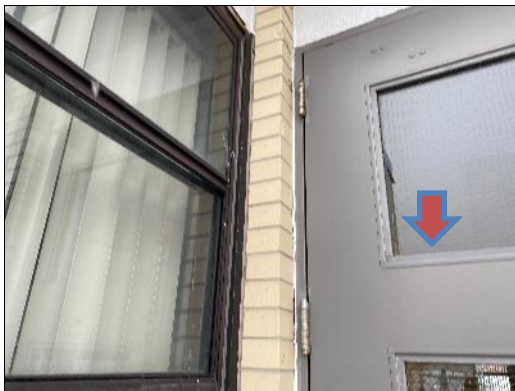
Non-asbestos putty on 1970 phase door frame

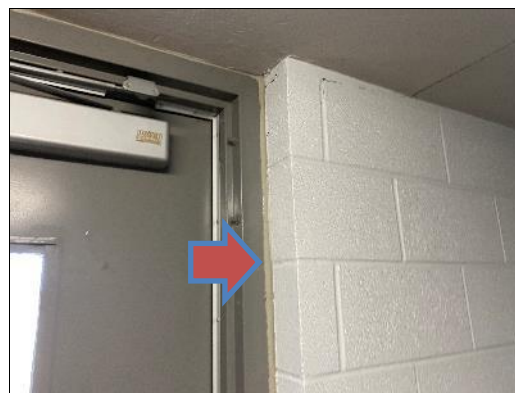
Non-asbestos grey caulking present on interior exterior door frames

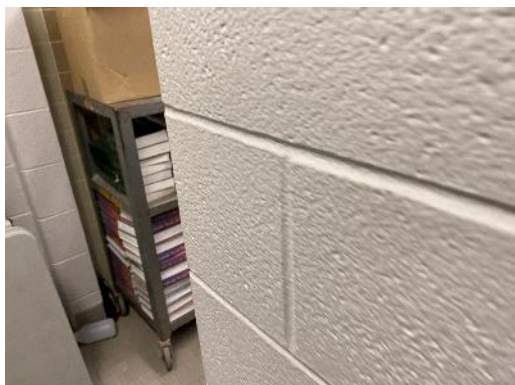
White paint present on concrete block does not contain asbestos within Girls Washroom/Change room/Shower (Location 8) (samples S00023A-C).

Non-asbestos white paint on concrete within Girls Washroom/Change room/Shower (Location 8)
