REVISED Hazardous Building Materials Assessment (Pre-construction)

Eastside Secondary School
275 Farley Avenue, Belleville,
Ontario

July 12, 2023

Pinchin File: 200584.061

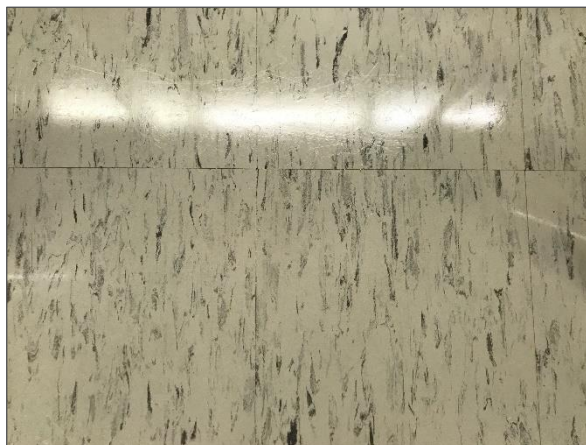
Non-asbestos 12"x12" off-white vinyl floor tiles with black and grey streaks.

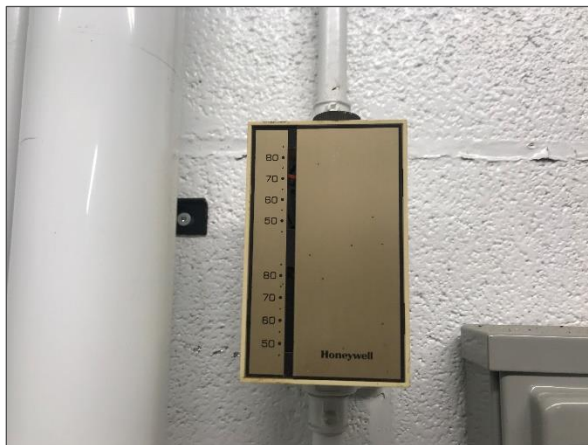
Liquid mercury is present in thermostat ampules.
