Re: Hazardous Building Materials Assessment (Preconstruction)
Eastside Secondary School, 275 Farley Avenue, Belleville, ON
Pinchin File: 200584.112

Hastings and Prince Edward District School Board (Client) retained Pinchin Ltd. (Pinchin) to conduct a desktop hazardous building materials assessment of Eastside Secondary School located at 275 Farley Avenue, Belleville, ON.

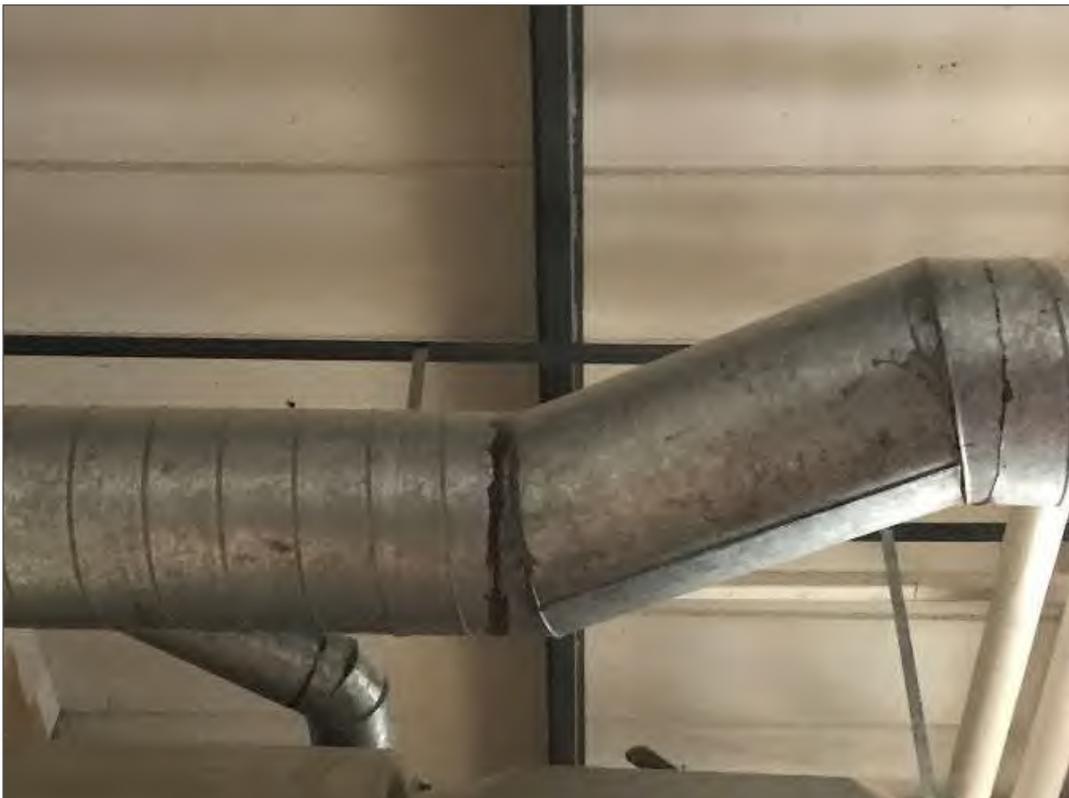
V0007 (None), Duct, Mastic, Brown, Woodshop (Location #: 152)

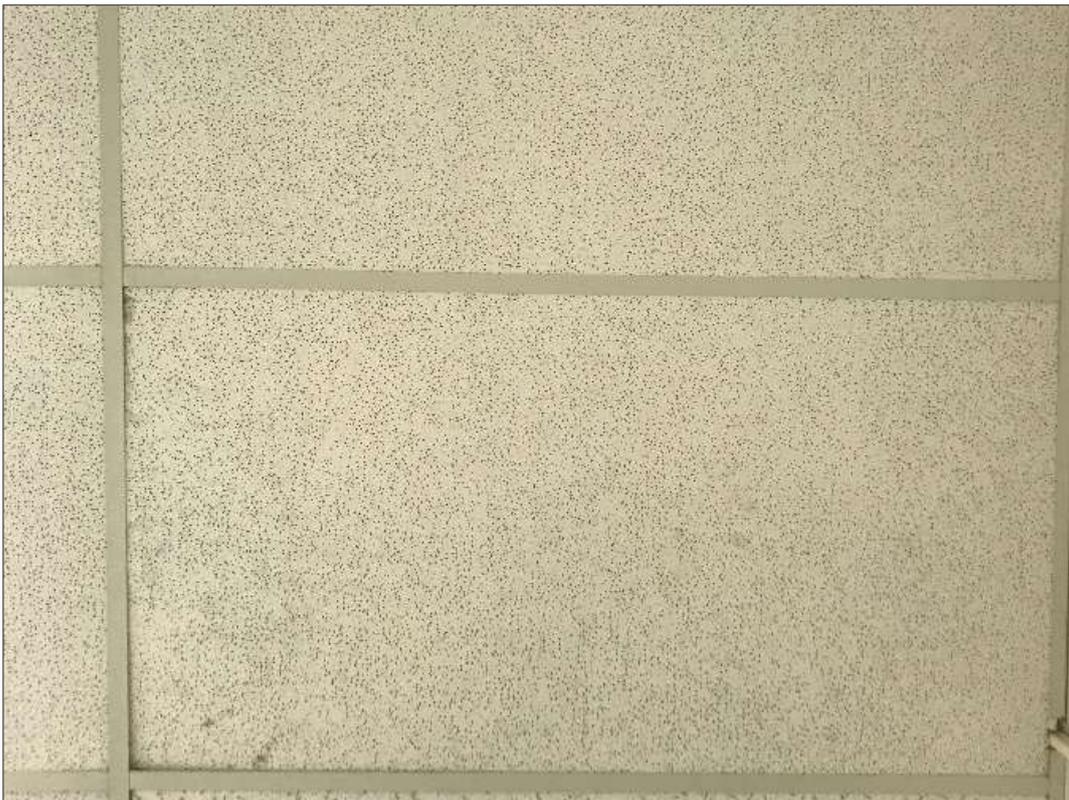
V0010 (None), Ceiling, Ceiling tiles (lay-in), 2x4 dense small and medium pinholes, Manufacturing Shop (Location #: 154)
Room 154A

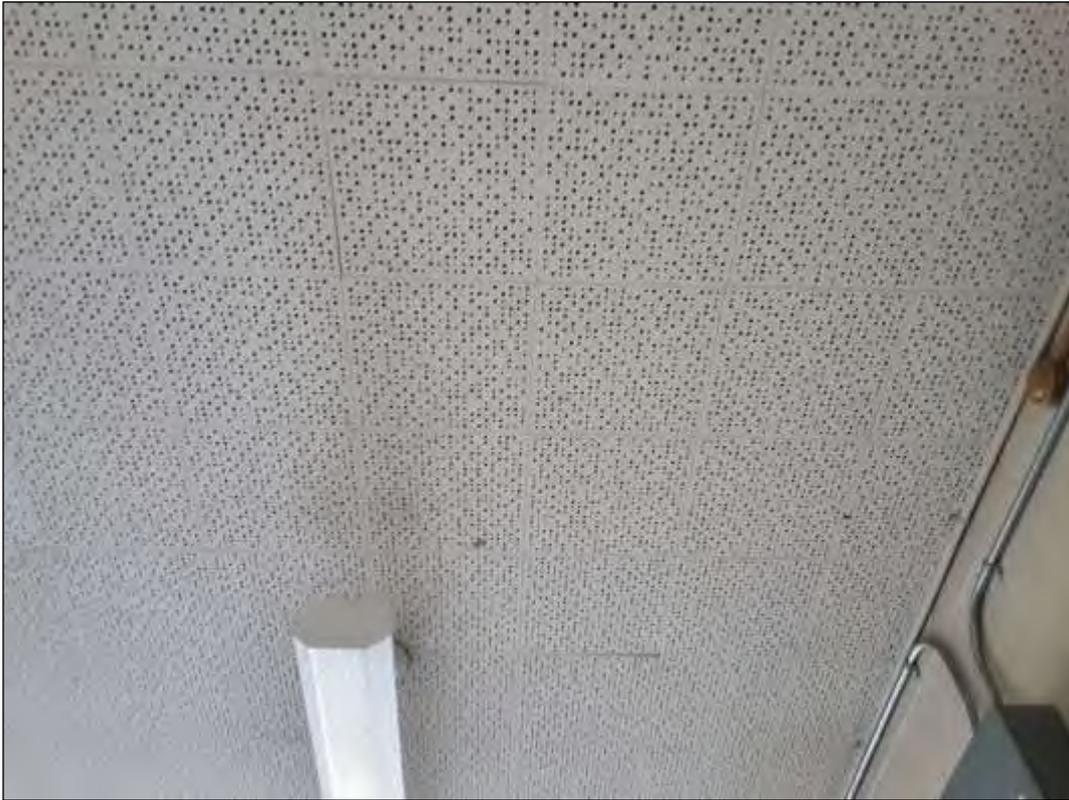
V0011 (None), Ceiling, Ceiling tiles (glue-on), 1x1 large and medium uniform pinholes, Classroom (Location #: 255)

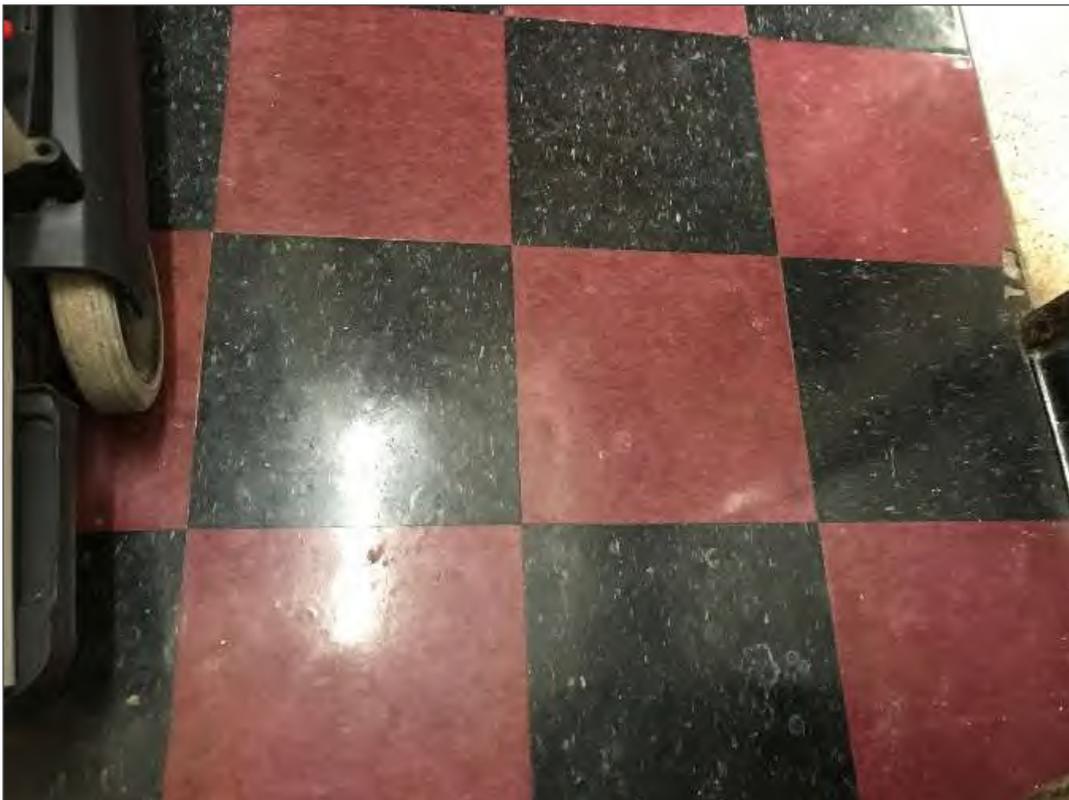
S0013A (None), Floor, Vinyl Floor Tiles and Mastic, 12x12 red and black checkered, Custodial Room (Location #: 160)

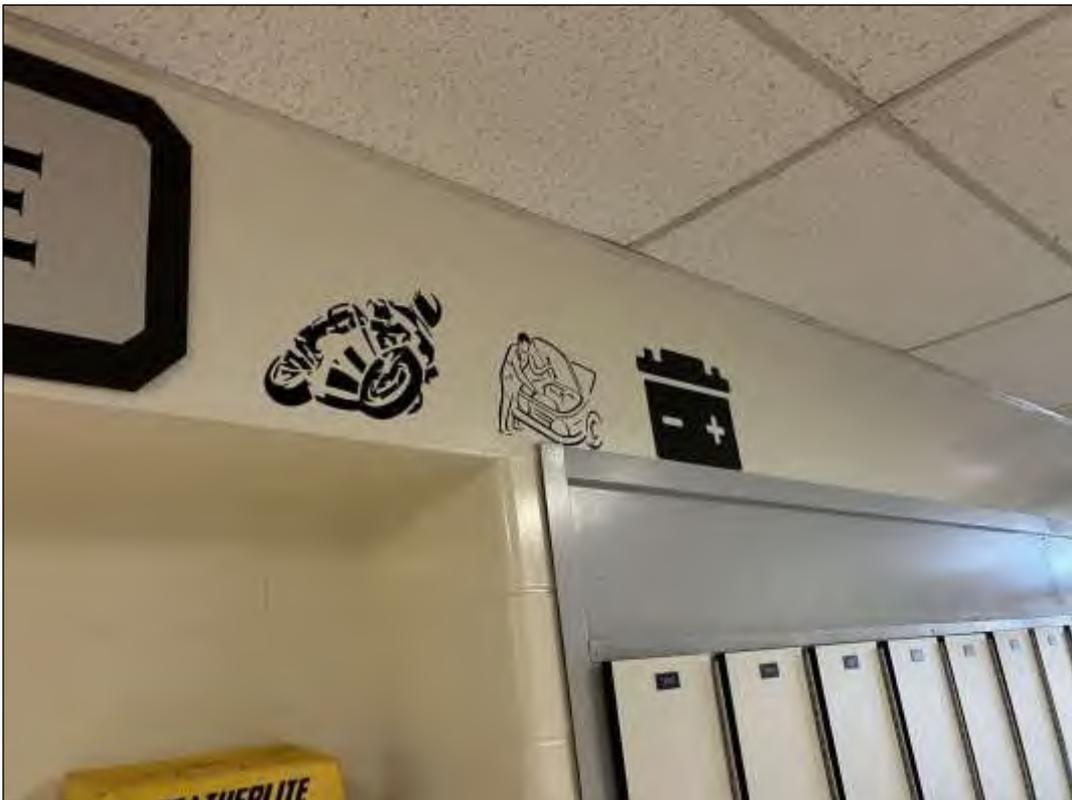
S0016A (None), Wall, Plaster, Above lockers, Corridor (Location #: 194)

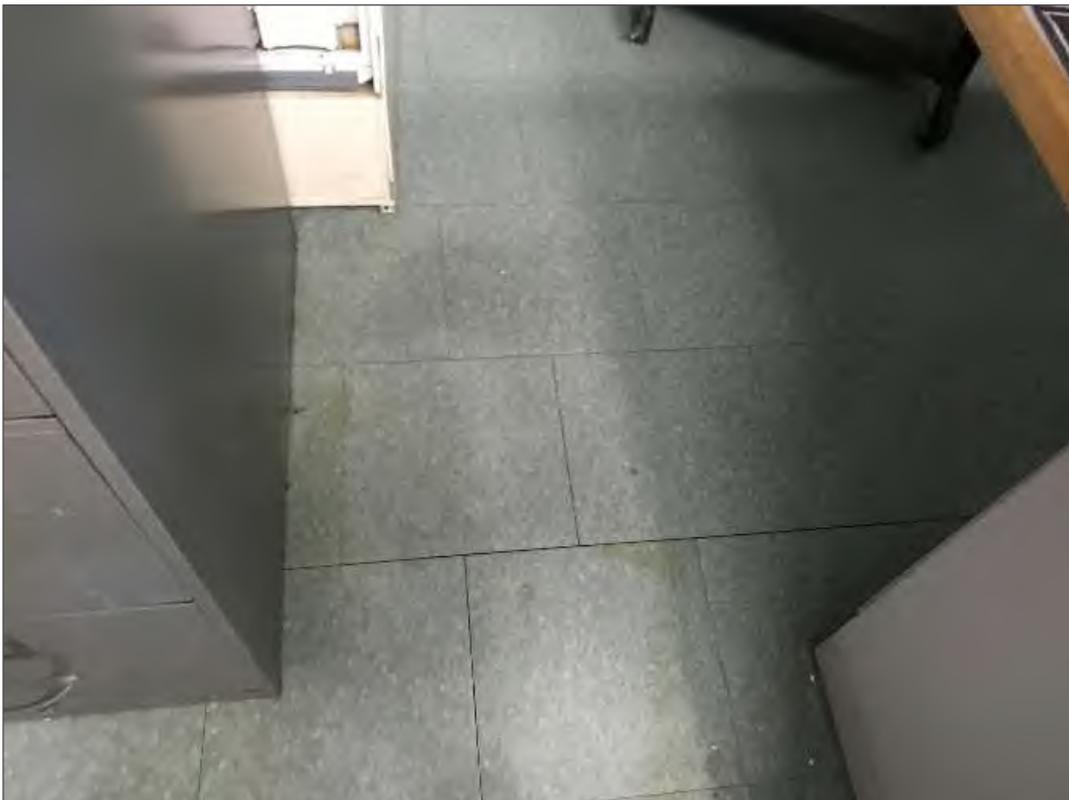
V0023 (None), Floor, Vinyl Floor Tile, 12x12 turquoise with white flecks, Resource Room (Location #: 227)

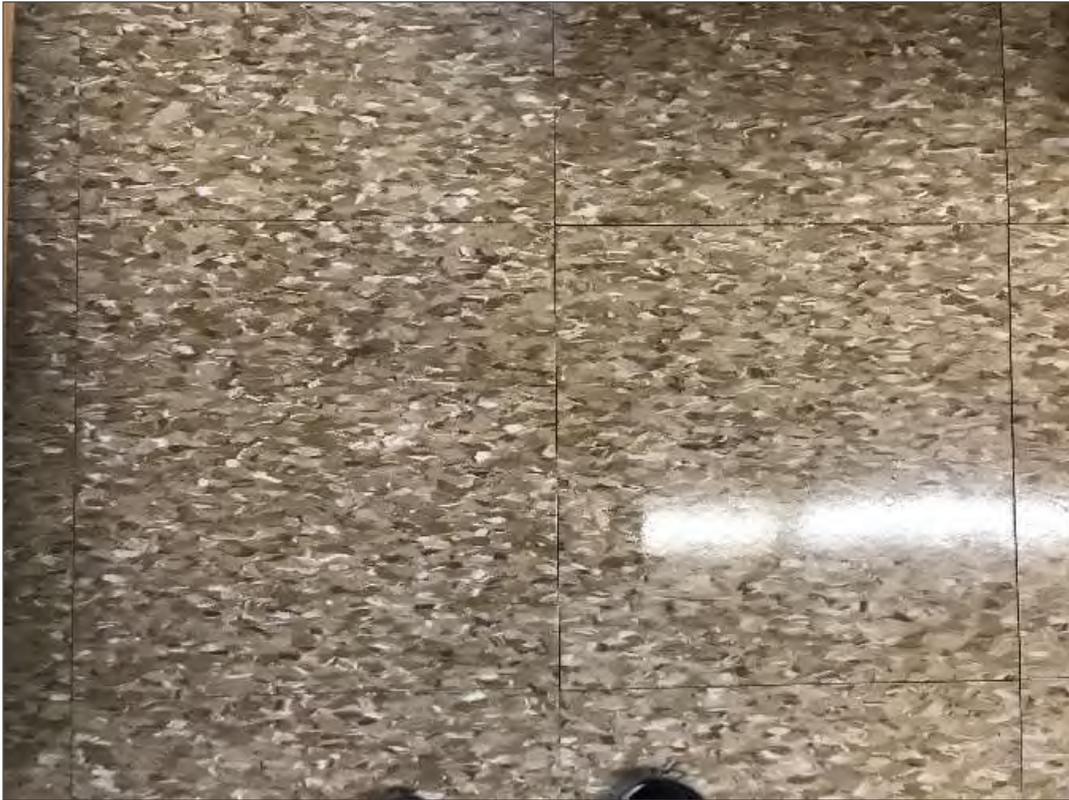
V0024 (None), Floor, Vinyl Floor Tile, 12x12 beige with white and beige blotches, Classroom (Location #: 111)

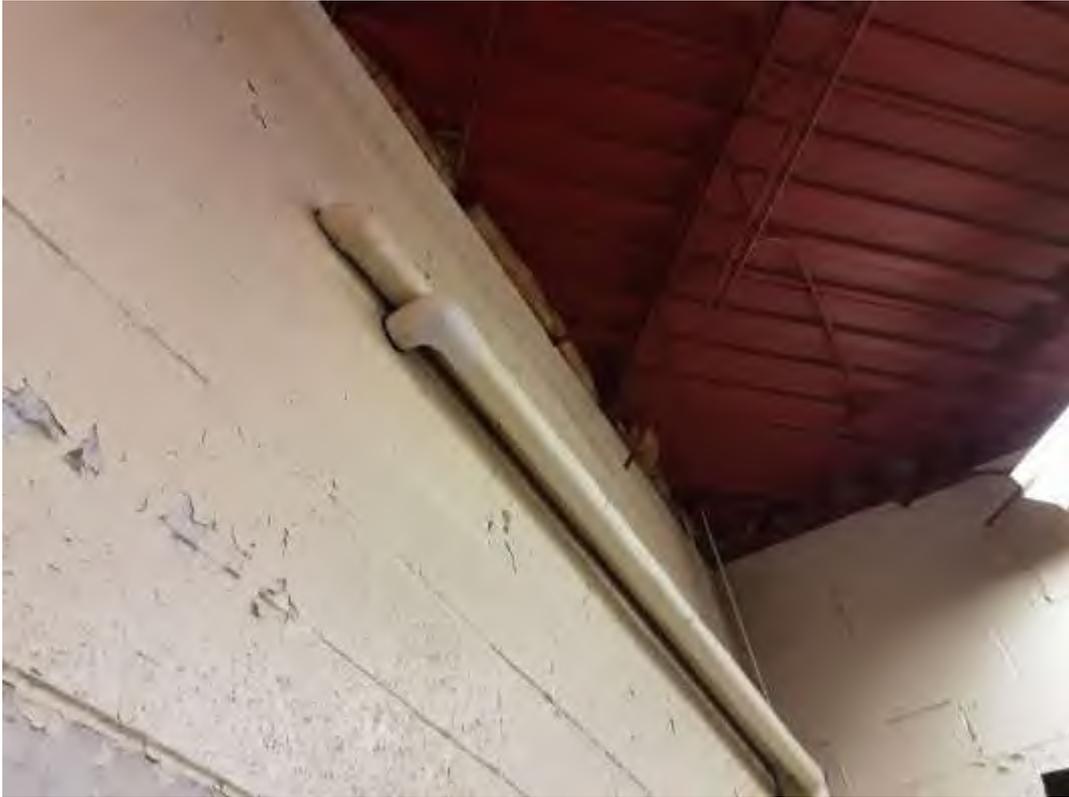
S0025A (**Confirmed Asbestos**), Piping, Parging Cement, Storage Room (Location #: 139)

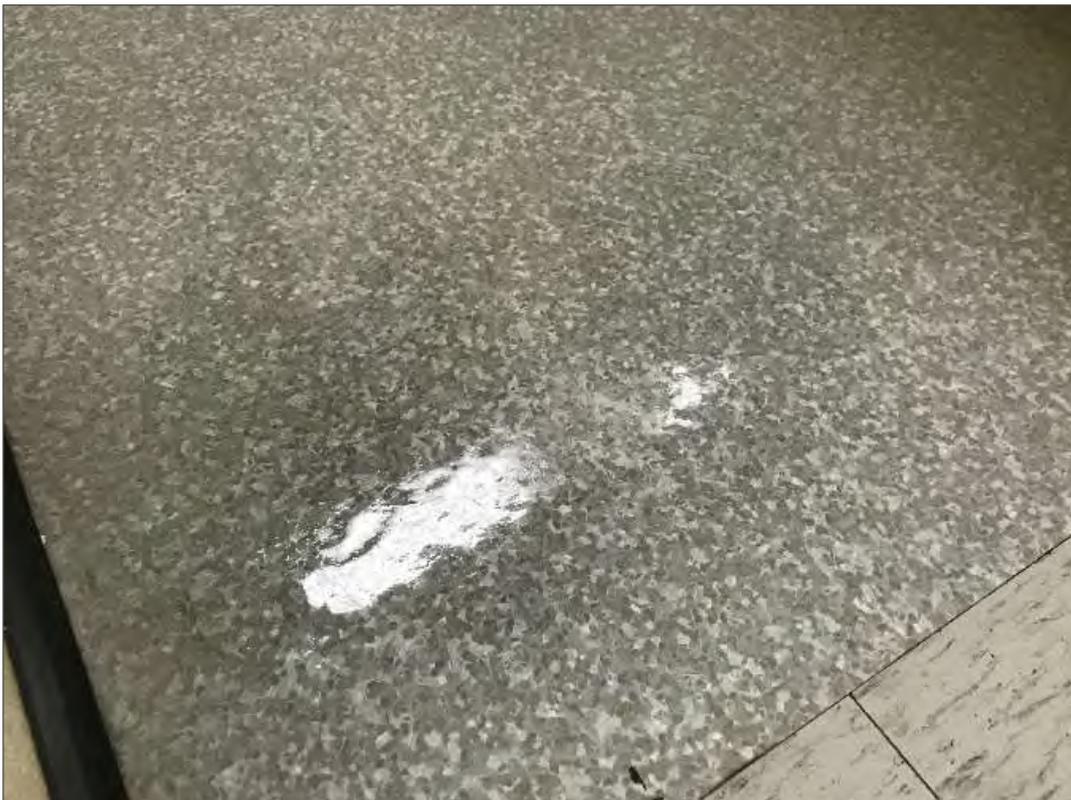
S0028A (None), Floor, Vinyl Sheet Flooring, Beige/grey with a pebbled pattern, Change Room (Location #: 131)

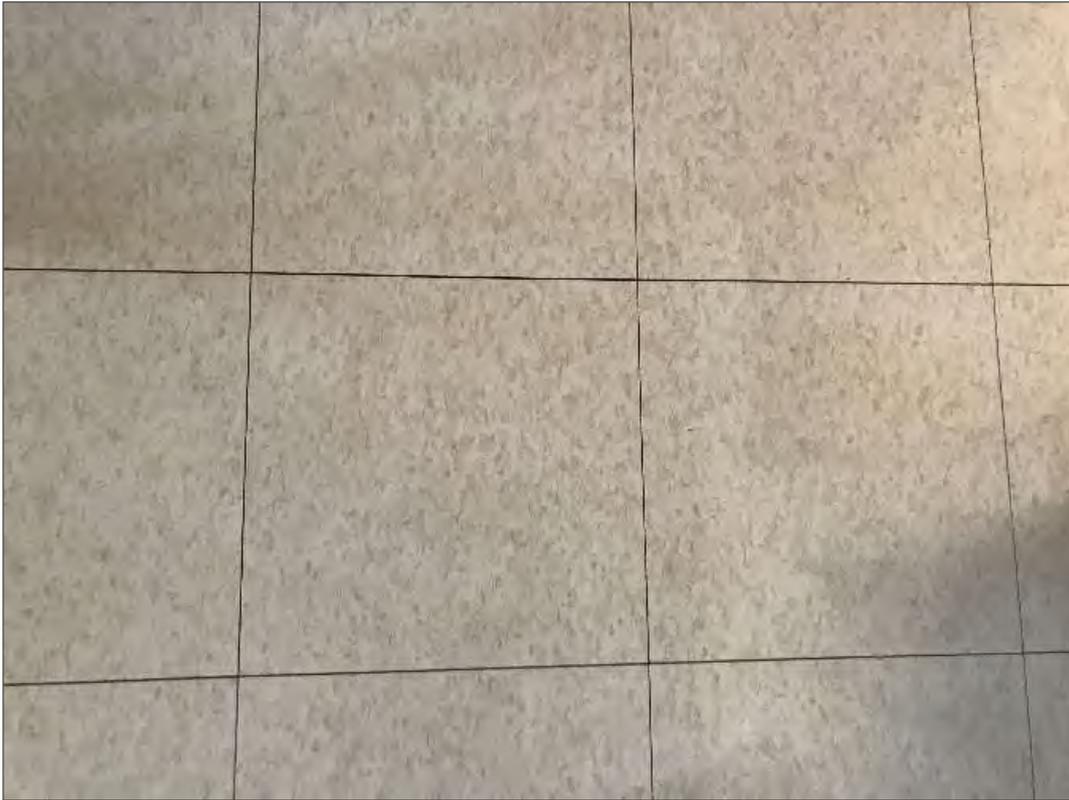
S0029A (None), Floor, Vinyl floor tiles and mastic, 12x12 white with grey flecks, Classroom (Location #: 219)

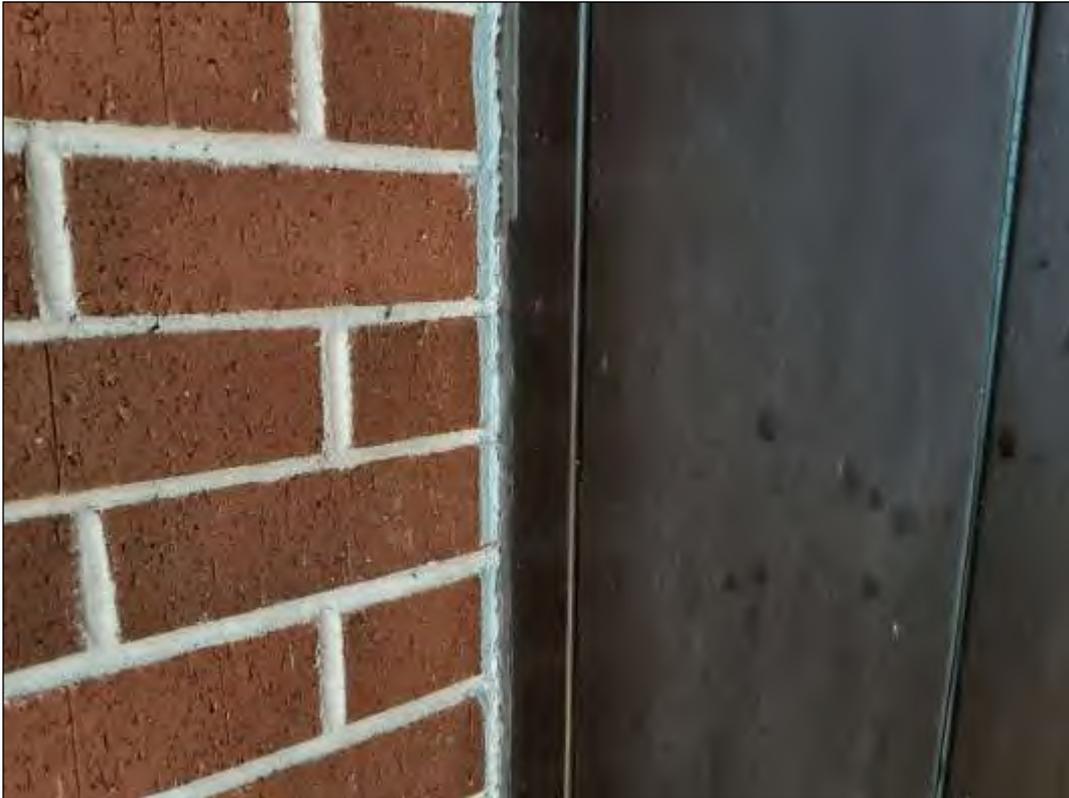
S0031B (**Confirmed Asbestos**), Wall, Door, Caulking, Beige, Exterior (Location #: 3)

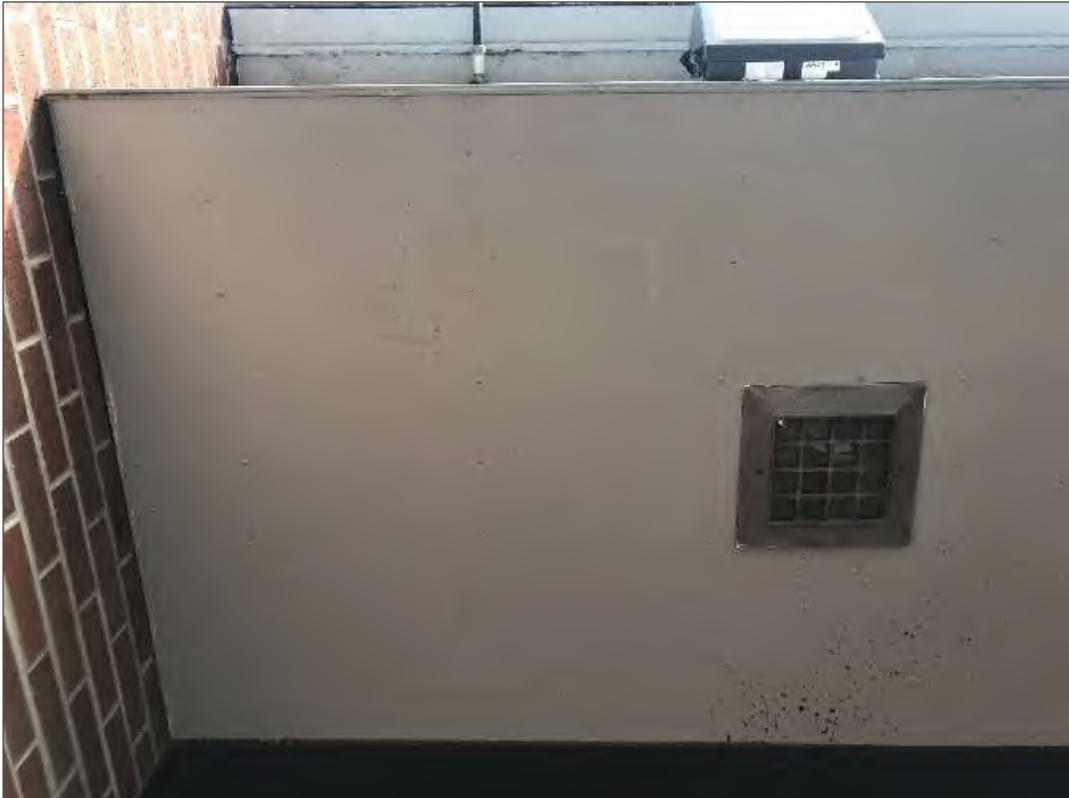
S0034A (None), Structure, Canopy, Texture Coat, Exterior (Location #: 3)
Southwest Entrance

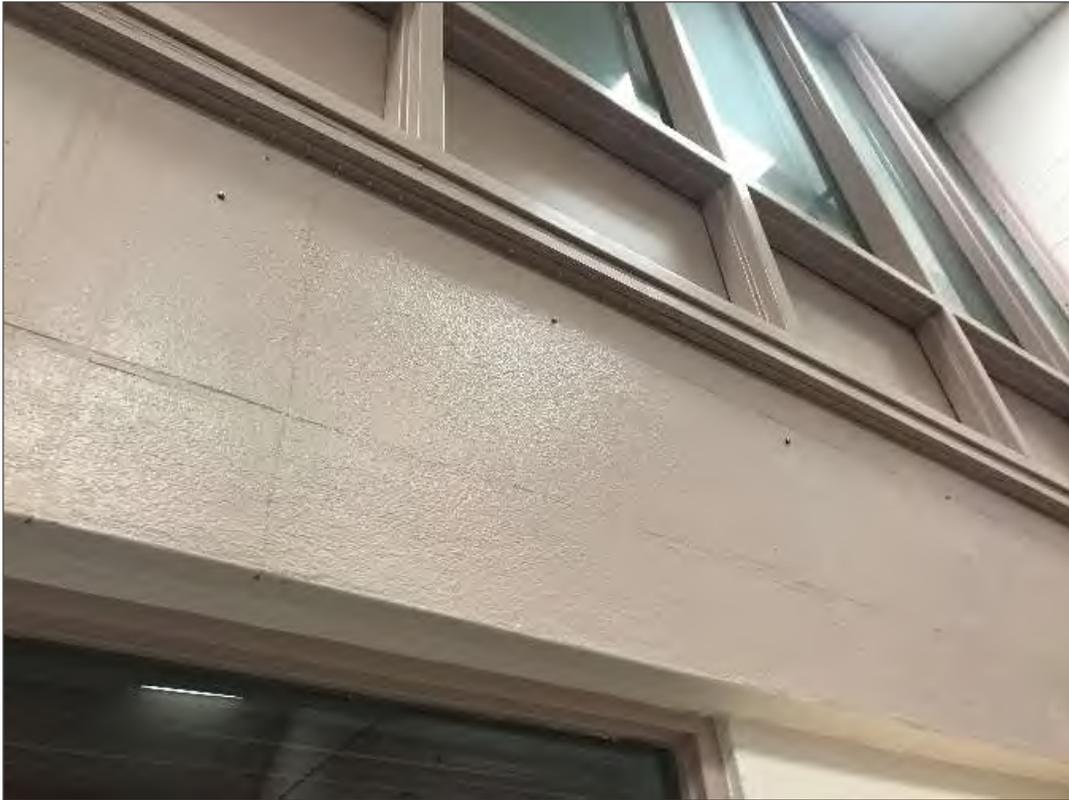
S0038A (None), Wall, Plaster, Textured. Resource Room, (Location #: 129)

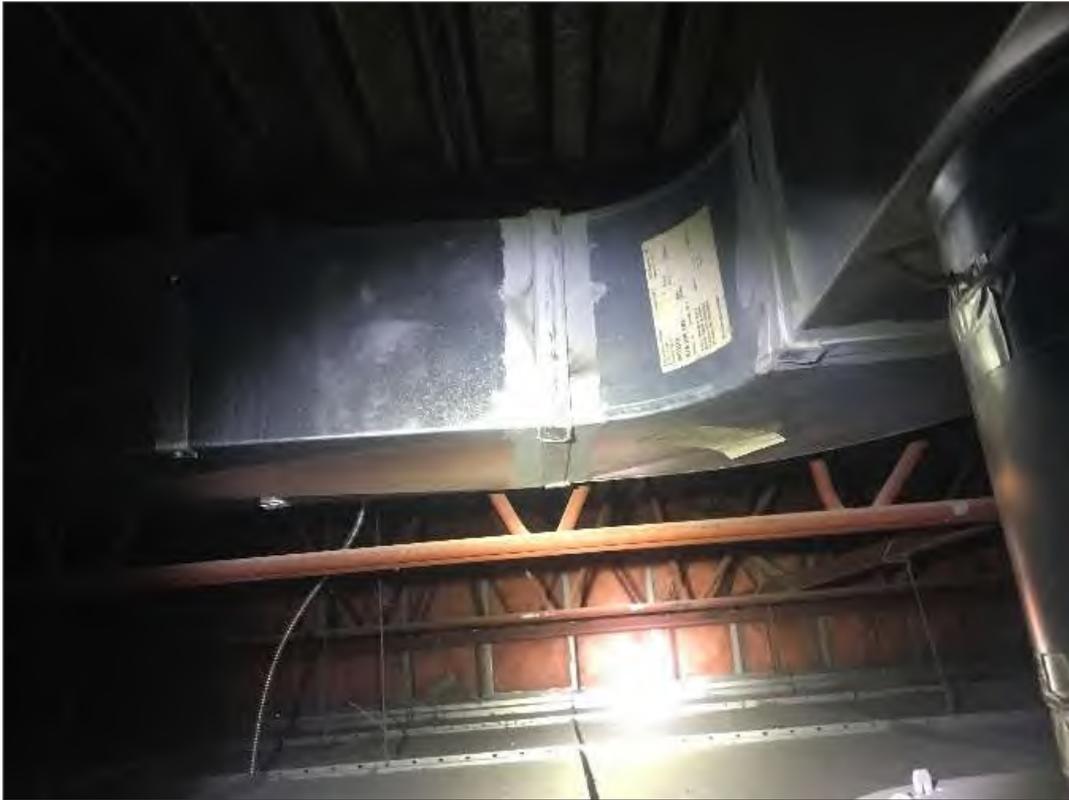
V0046 (None), Duct, Mastic, Grey, Music Room (Location #: 188)

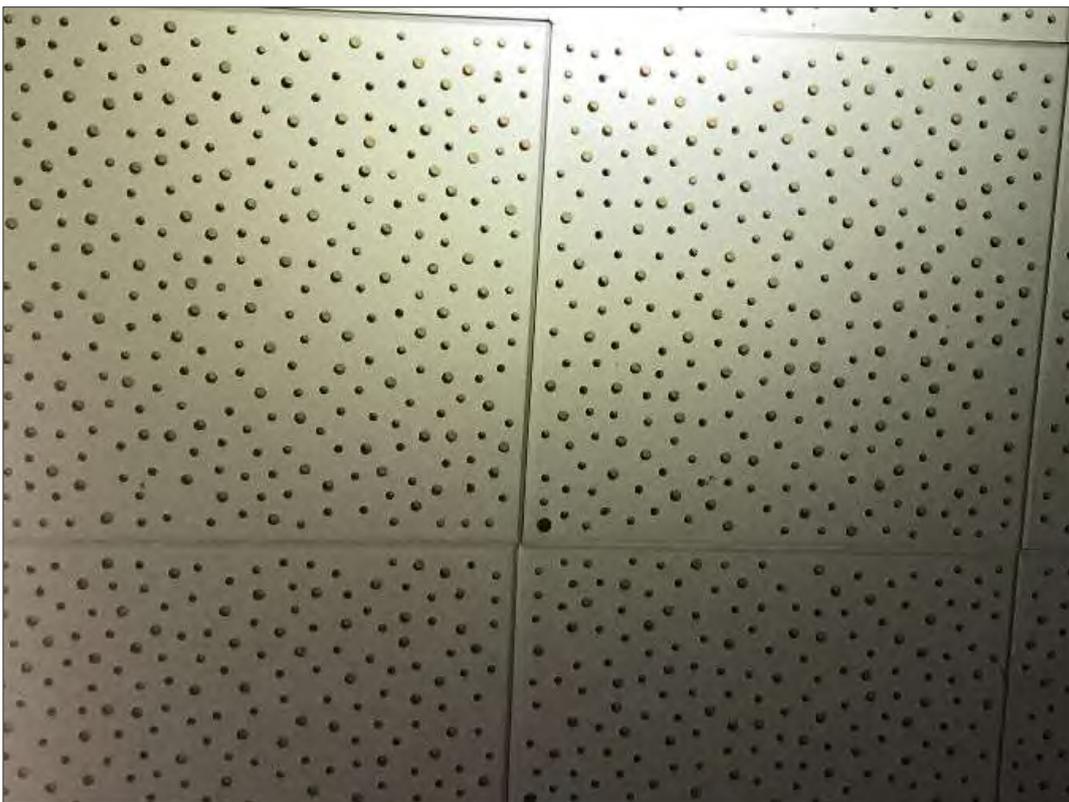
V0047 (None), Ceiling, Ceiling tiles (glue-on), Random pinholes, Tech Area (Location #: 156)

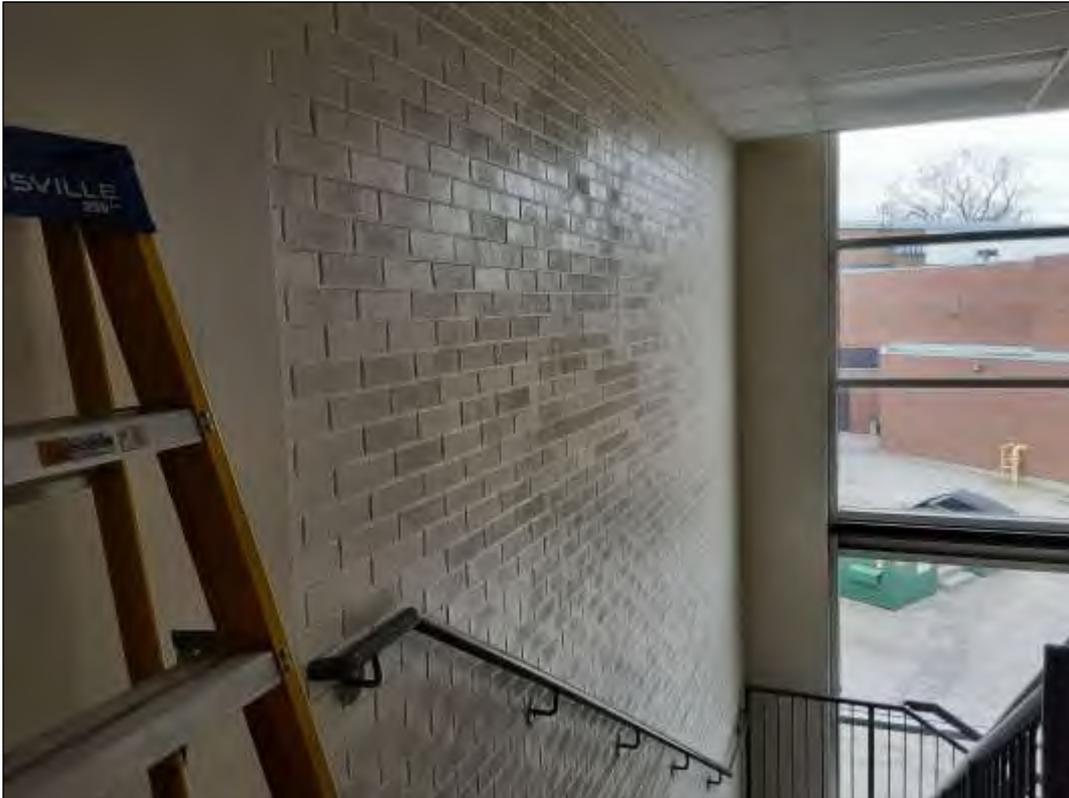
V0061 (Confirmed Asbestos), Wall, Paint, On brick and concrete block, Stairwell (Location #: 267)

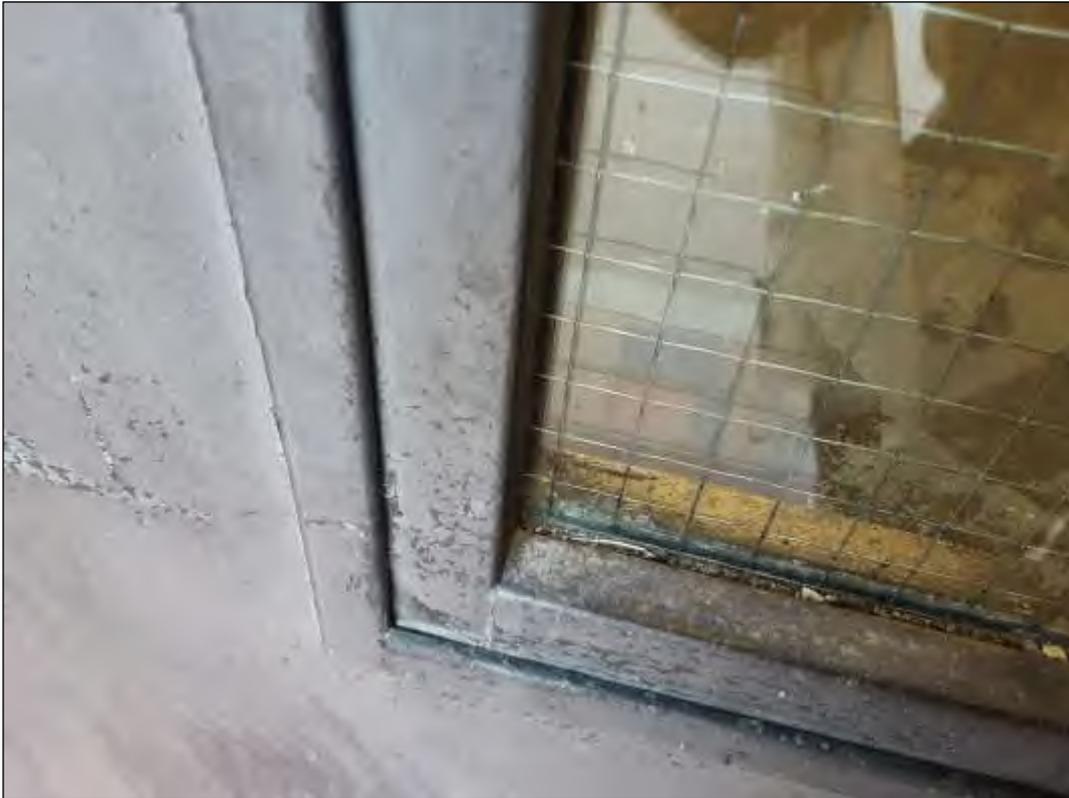
S0080C (None), Wall, Window Liner, Sealant, Grey, Corridor (Location #: 194)

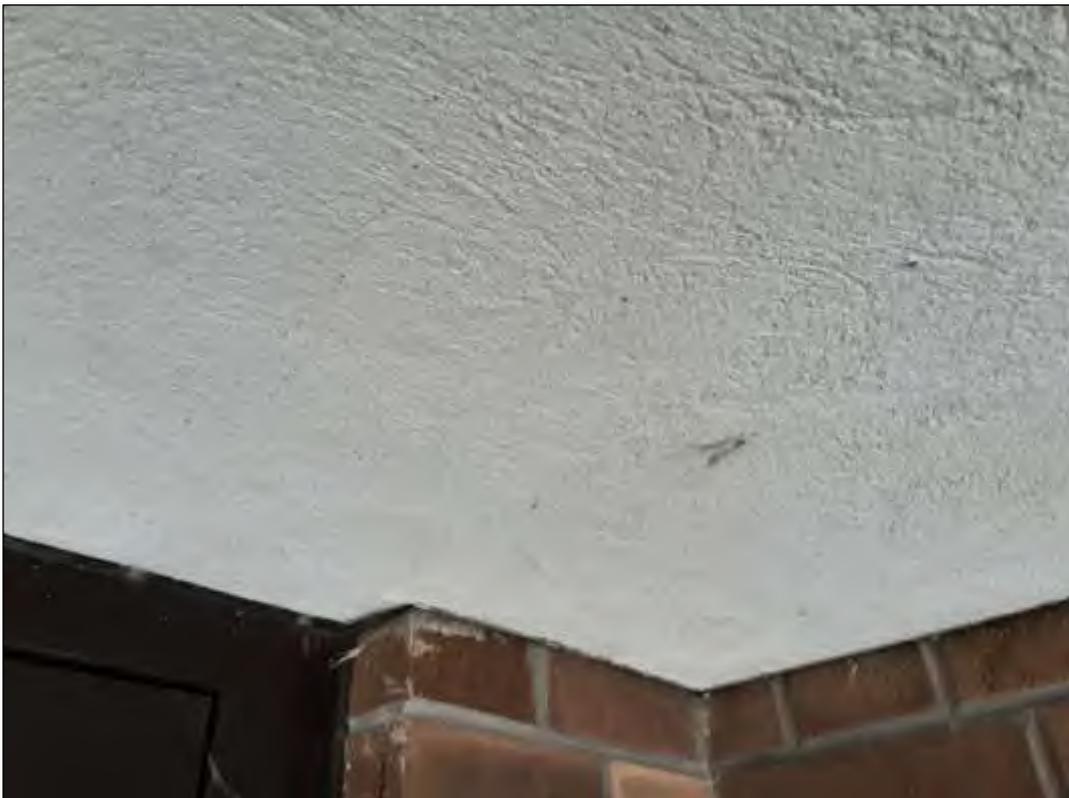
S0087C (**Confirmed Asbestos**), Structure, Texture Coat, Corridor (Location #: 195)
Exterior canopy

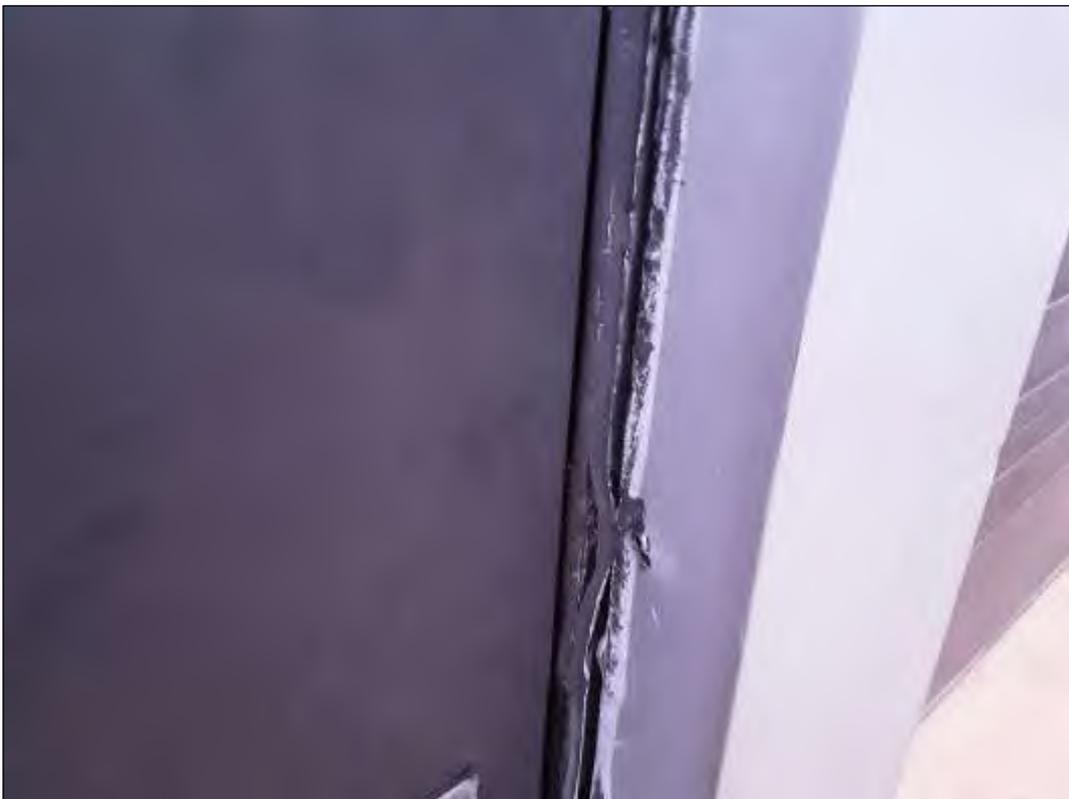
S0091A (None), Wall, Door Frame, Caulking, Grey, hard, Manufacturing Shop (Location #: 155)

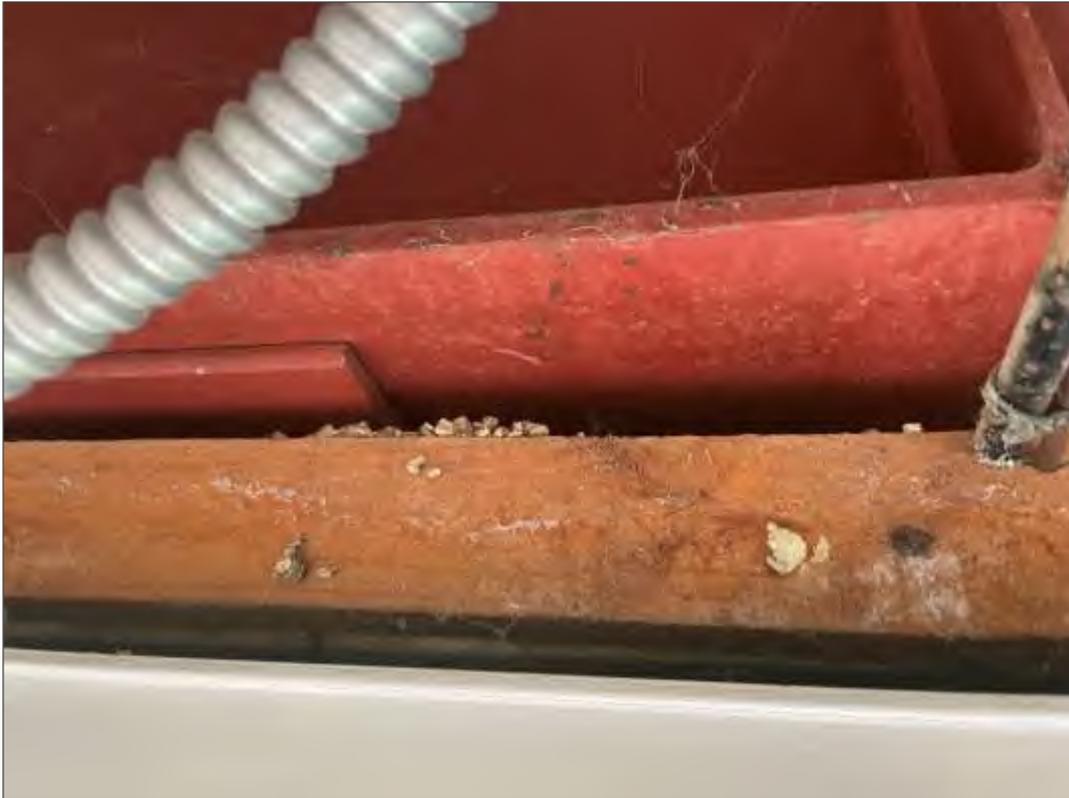
S0092A (**Confirmed Asbestos**), Wall, Vermiculite, Classroom (Location #: 111)
Within perimeter wall behind the steel beam above windows

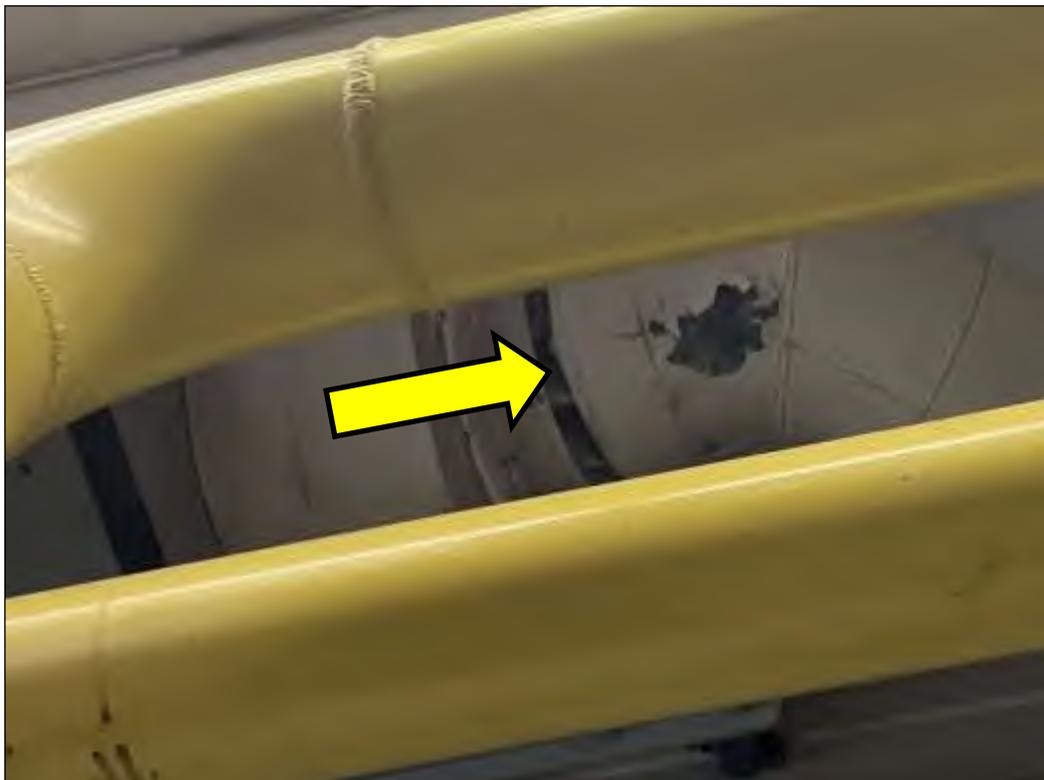
V9500 (**Presumed Asbestos**), Duct, Textile, Vibration damper, Autoshop (Location #: 153)

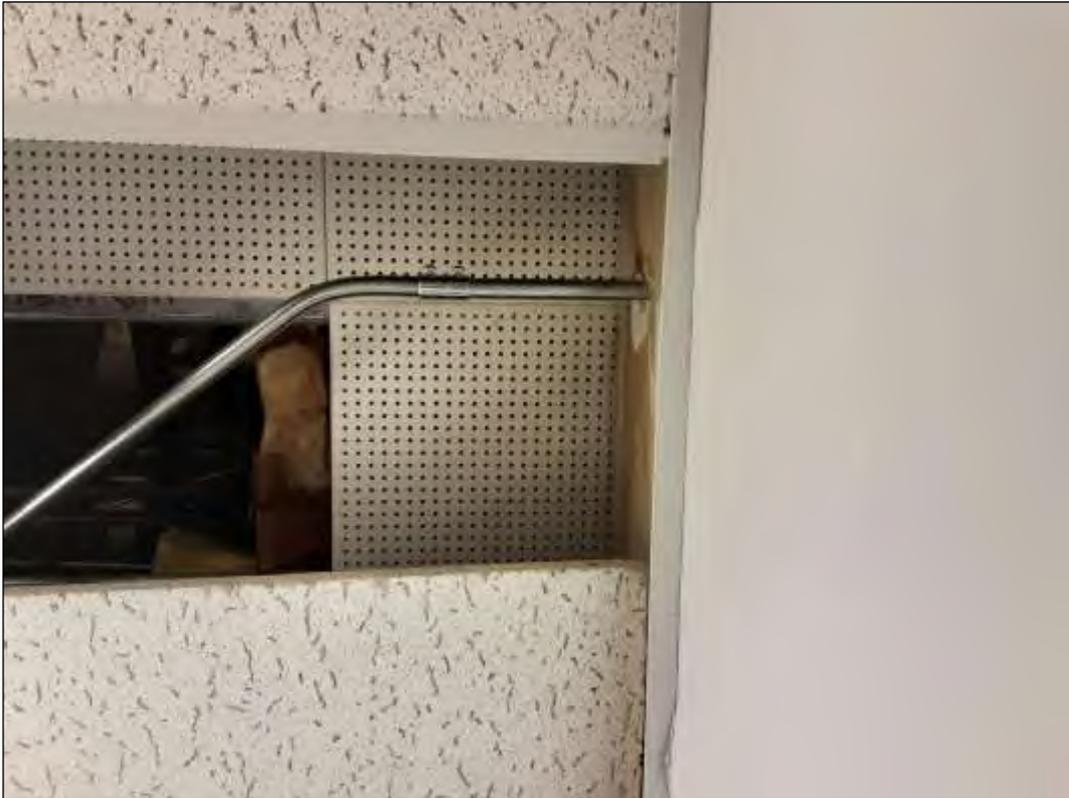
V9500 (**Presumed Asbestos**), Ceiling, Cement Product, Transite panels, Offices (Location #: 100)

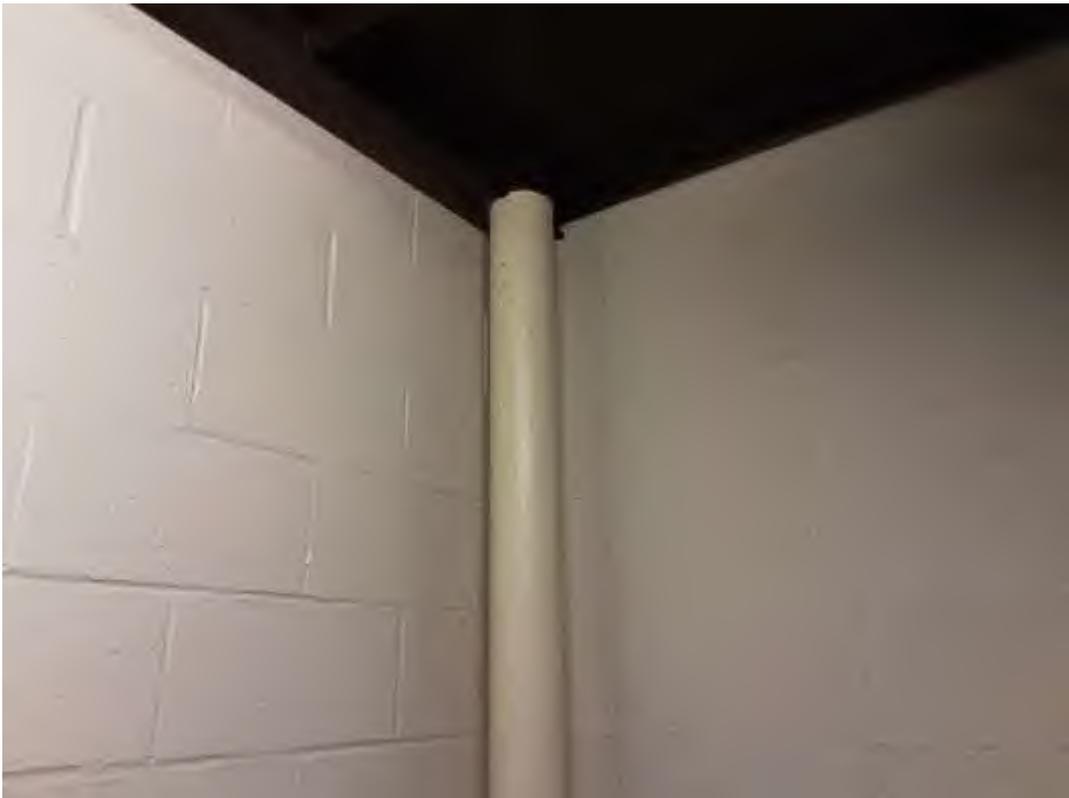
V9500 (**Presumed Asbestos**), Piping, Rain Water Leader, Cement Product, Transite, Stage (Location #: 140)

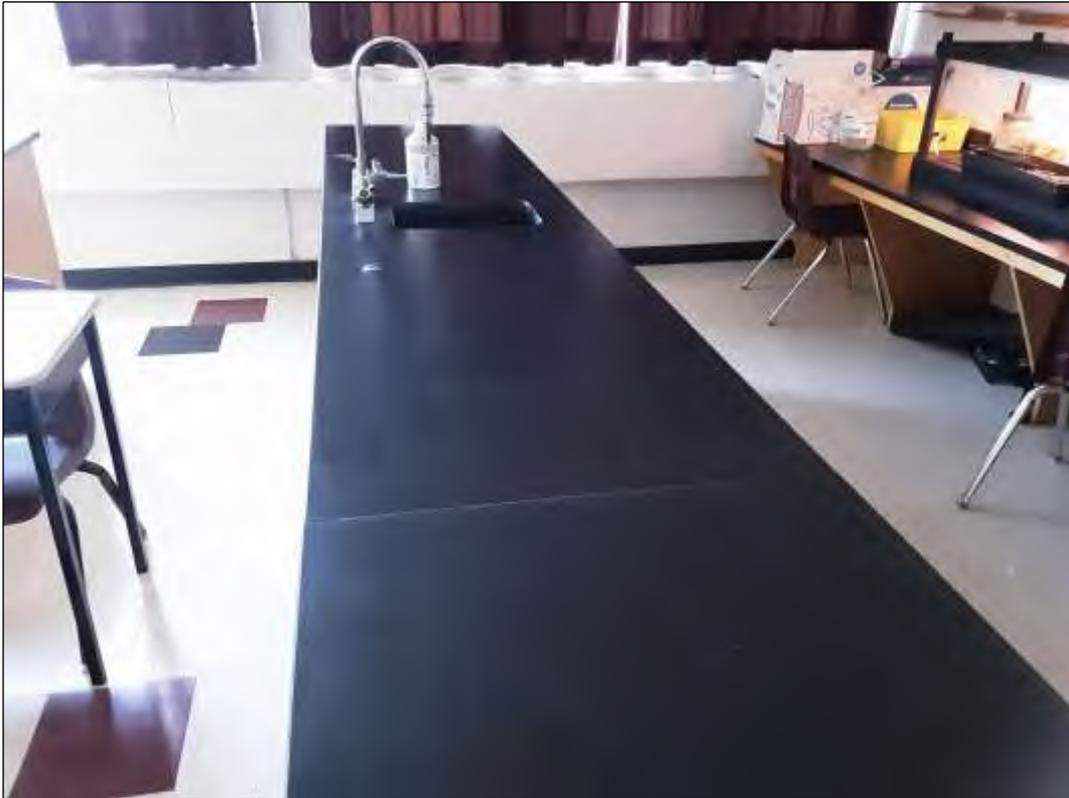
V9500 (Presumed Asbestos), Other, Countertop, Cement Product, Transite, Classroom (Location #: 217)

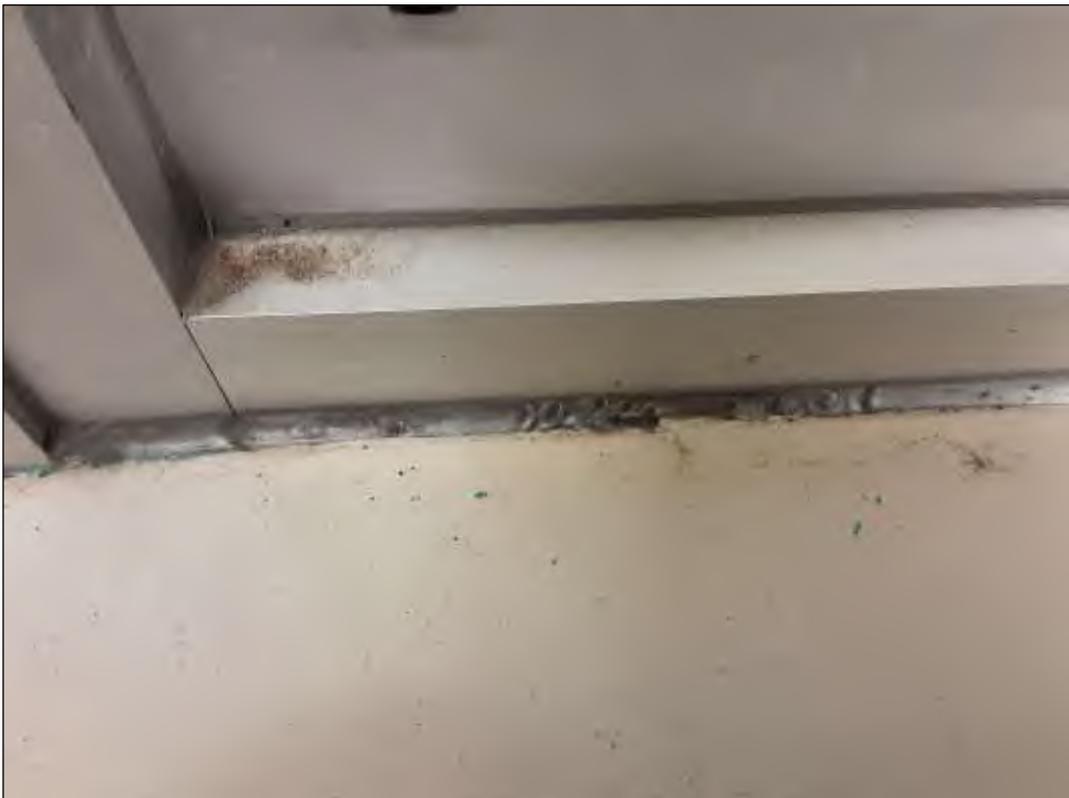
V0000 (None), Wall, Window, Silicone, Silver, Tech Area (Location #: 156)

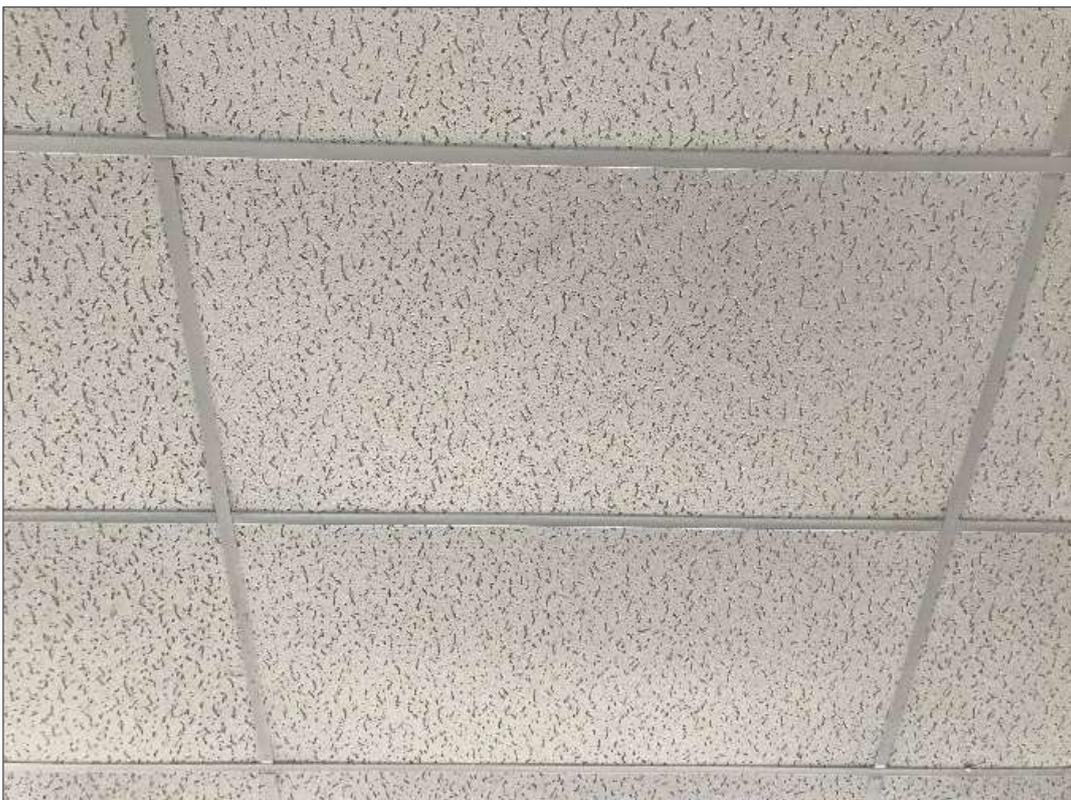
V0000 (None), Ceiling, All, Ceiling Tiles (lay-in), 2x4 thick widthwise fissures and pinholes, 2007, Office (Location #: 22)
