Re: Hazardous Building Materials Assessment (Preconstruction)
Eastside Secondary School, 275 Farley Avenue, Belleville, ON
Pinchin File: 200584.112

Hastings and Prince Edward District School Board (Client) retained Pinchin Ltd. (Pinchin) to conduct a desktop hazardous building materials assessment of Eastside Secondary School located at 275 Farley Avenue, Belleville, ON.

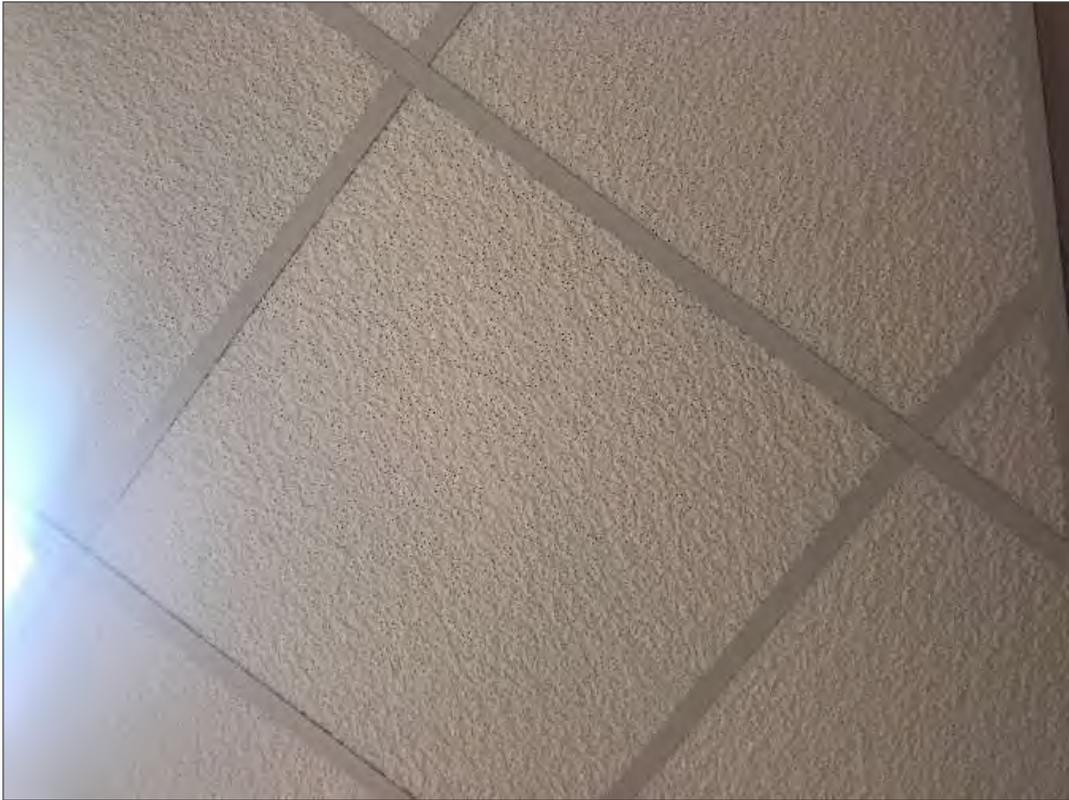
V0000 (None), Ceiling, All, Ceiling Tiles (lay-in), 2x2 textured with pinholes, 12/14/2005, Corridor (Location #: 192)

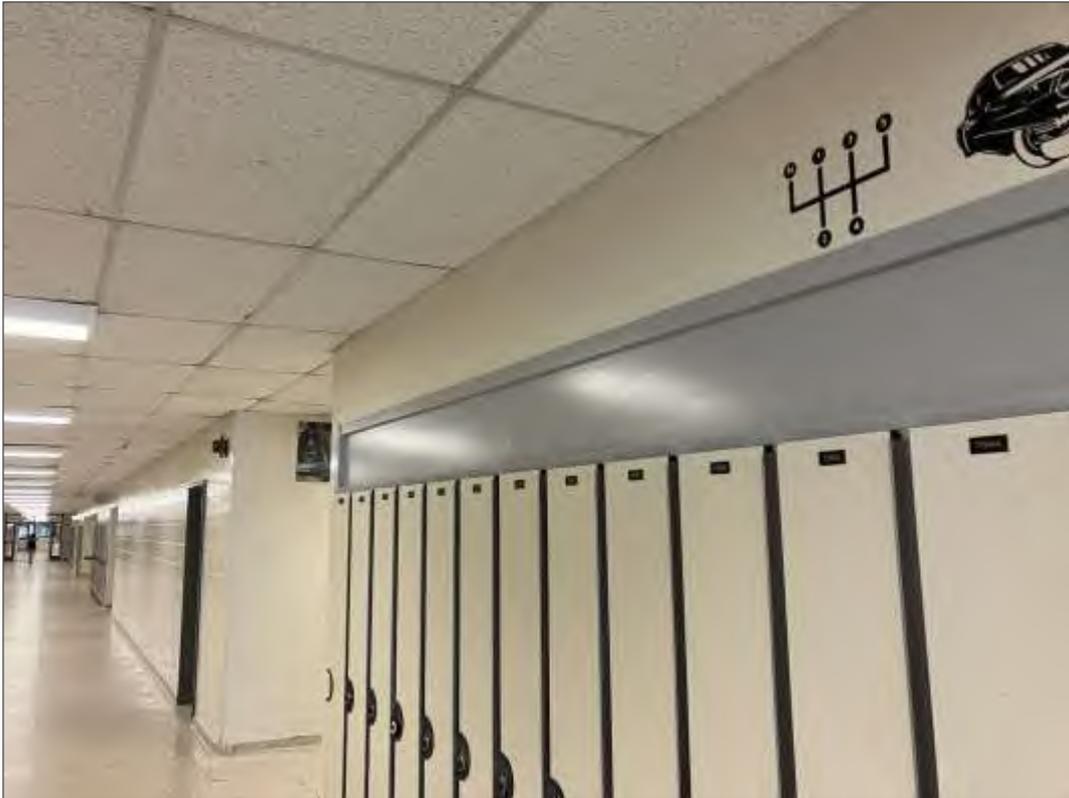
V0004(Lead, Low), Off-white, Wall, Plaster, Corridor (Location #: 194)

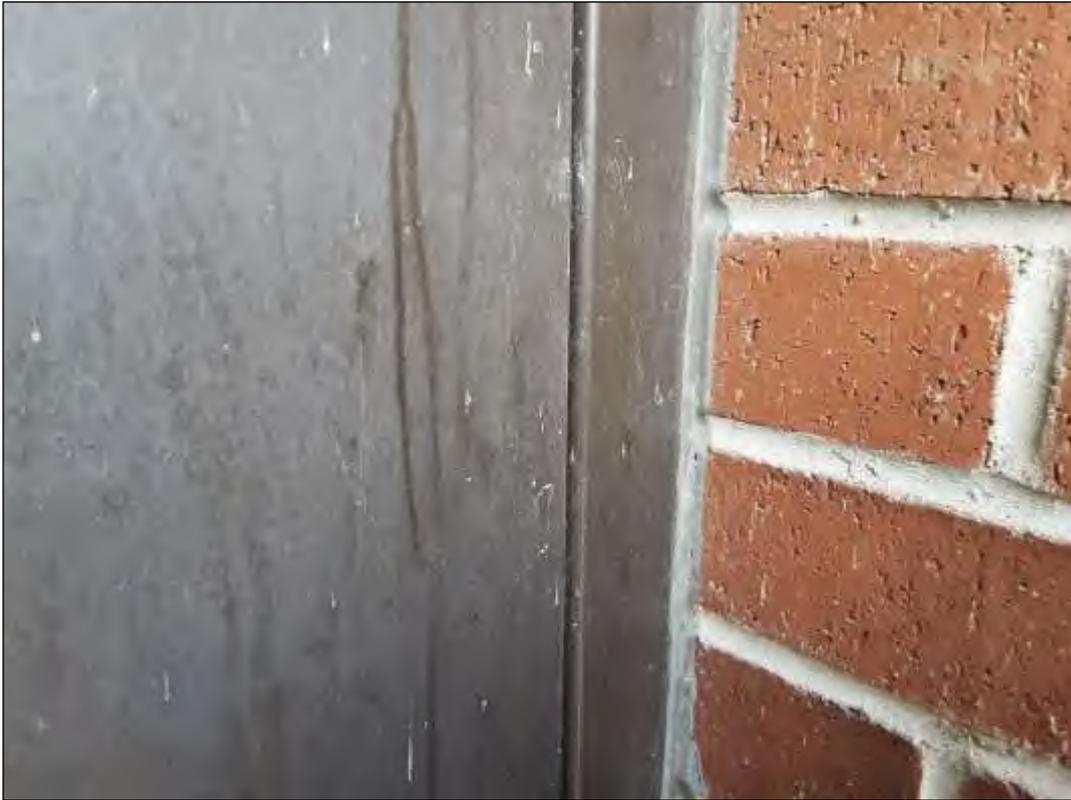
PCB, V0000(No), CAULKING, Silicone, Exterior, Corridor (Location #: 194)
