**REVISED**  
**Hazardous Building**  
**Materials Assessment**  
**(Pre-construction)**

Eastside Secondary School  
275 Farley Avenue, Belleville,  
Ontario

July 12, 2023

Pinchin File: 200584.061

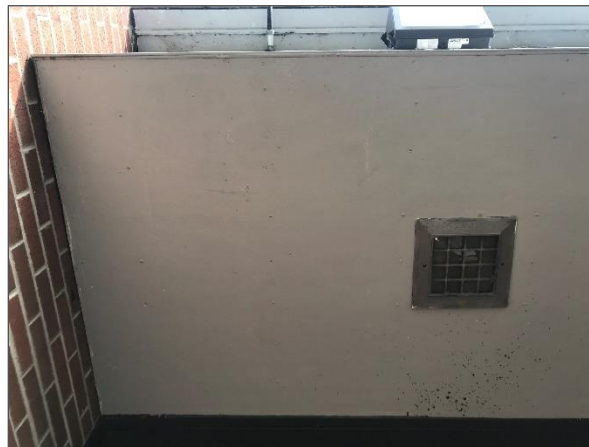
Non-asbestos texture finish on underside of exterior canopy.

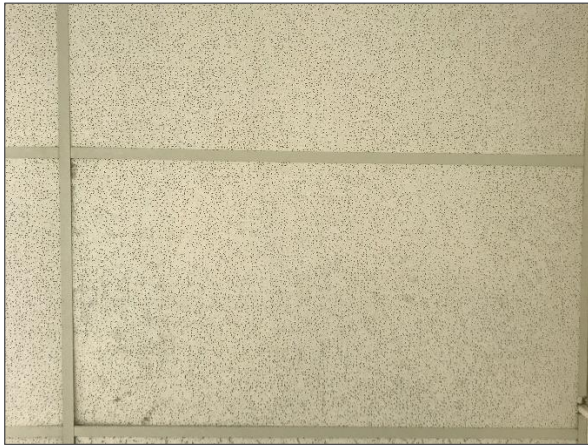
Non-asbestos 2'x4' acoustic ceiling tiles with dense small and medium pinholes.

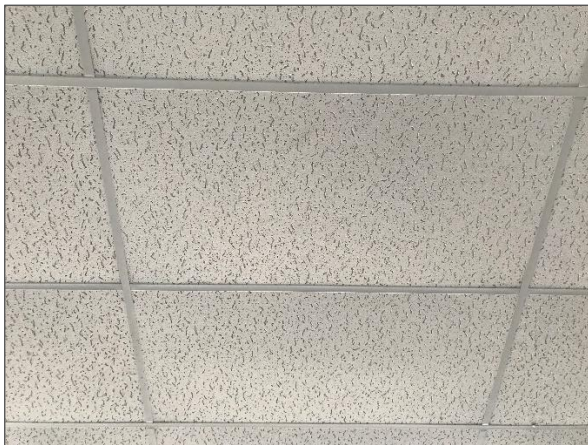
Non-asbestos 2'x4' acoustic ceiling tiles with thick widthwise fissures and pinholes.

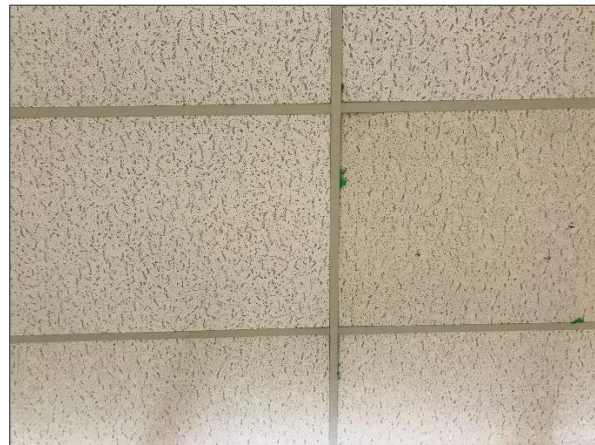
Non-asbestos 2'x4' acoustic ceiling tiles with dense short widthwise fissures.

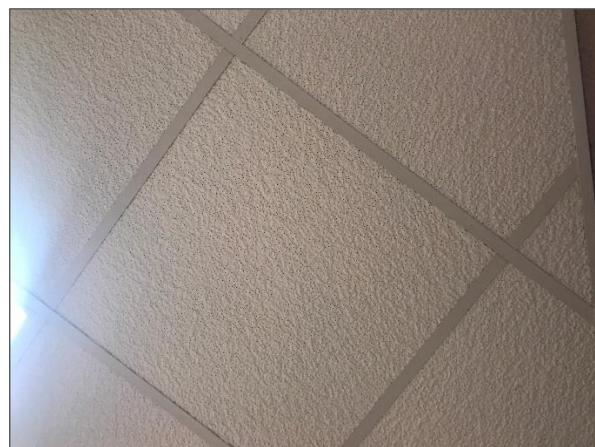
Non-asbestos 2'x2' textured acoustic ceiling tiles with pinholes.

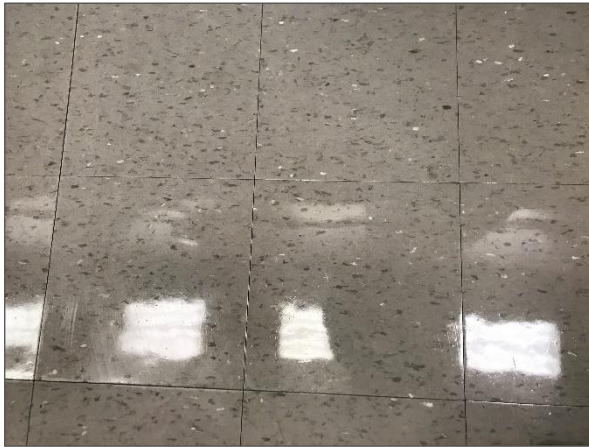
Non-asbestos 12"x12" grey vinyl floor tiles with white and grey flecks.

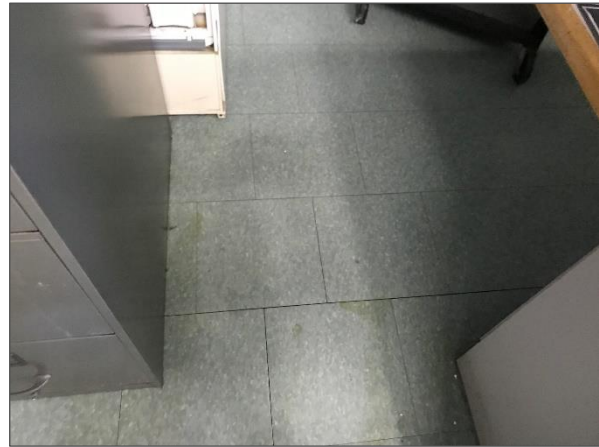
Non-asbestos 12"x12" turquoise vinyl floor tiles with white flecks.

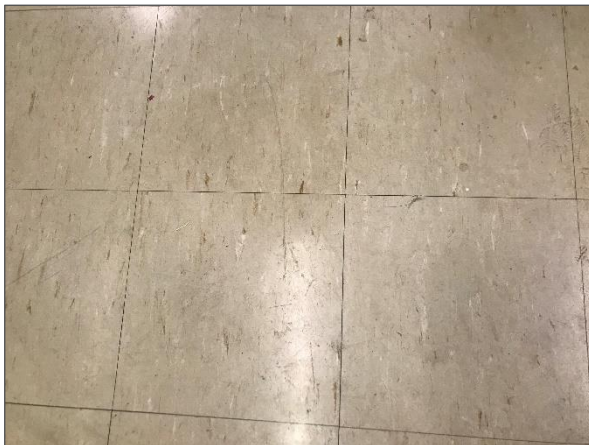
Non-asbestos 12"x12" beige vinyl floor tiles with sparse white and brown flecks.

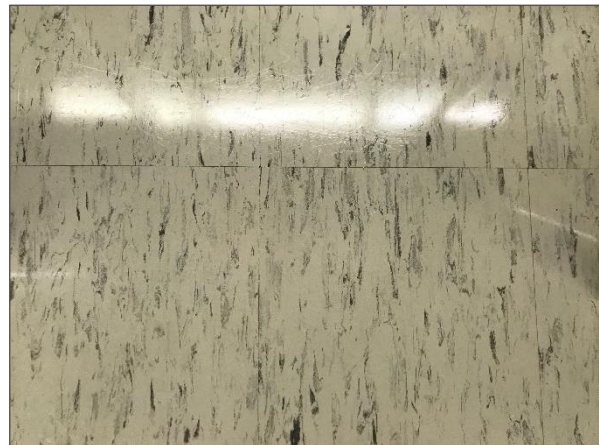
Non-asbestos 12"x12" off-white vinyl floor tiles with black and grey streaks.

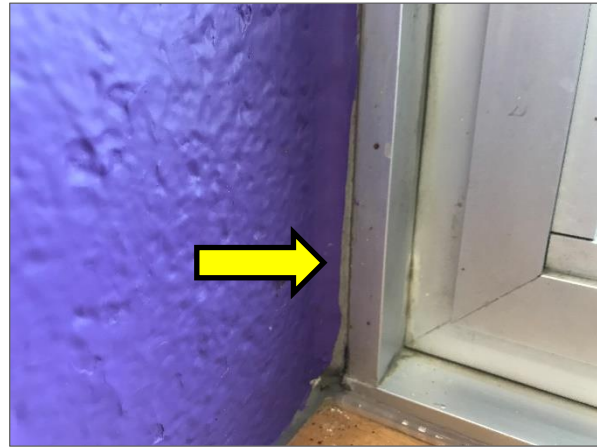
Non-asbestos firm grey caulking on interior window frame.

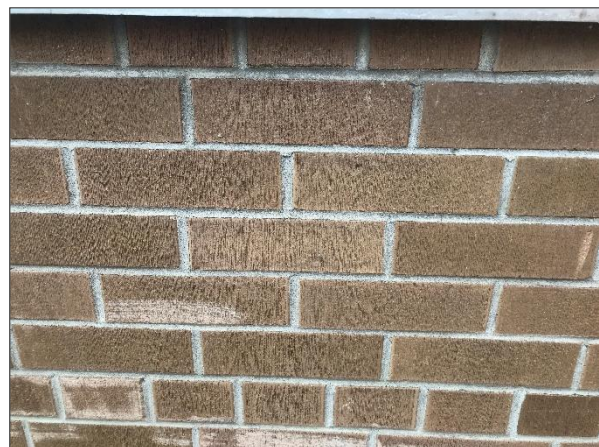
Non-asbestos mortar present between joints of exterior brick cladding.
